A review of SA line markings for suitability with lane support systems: a video analysis trial

CASR172

February 2023

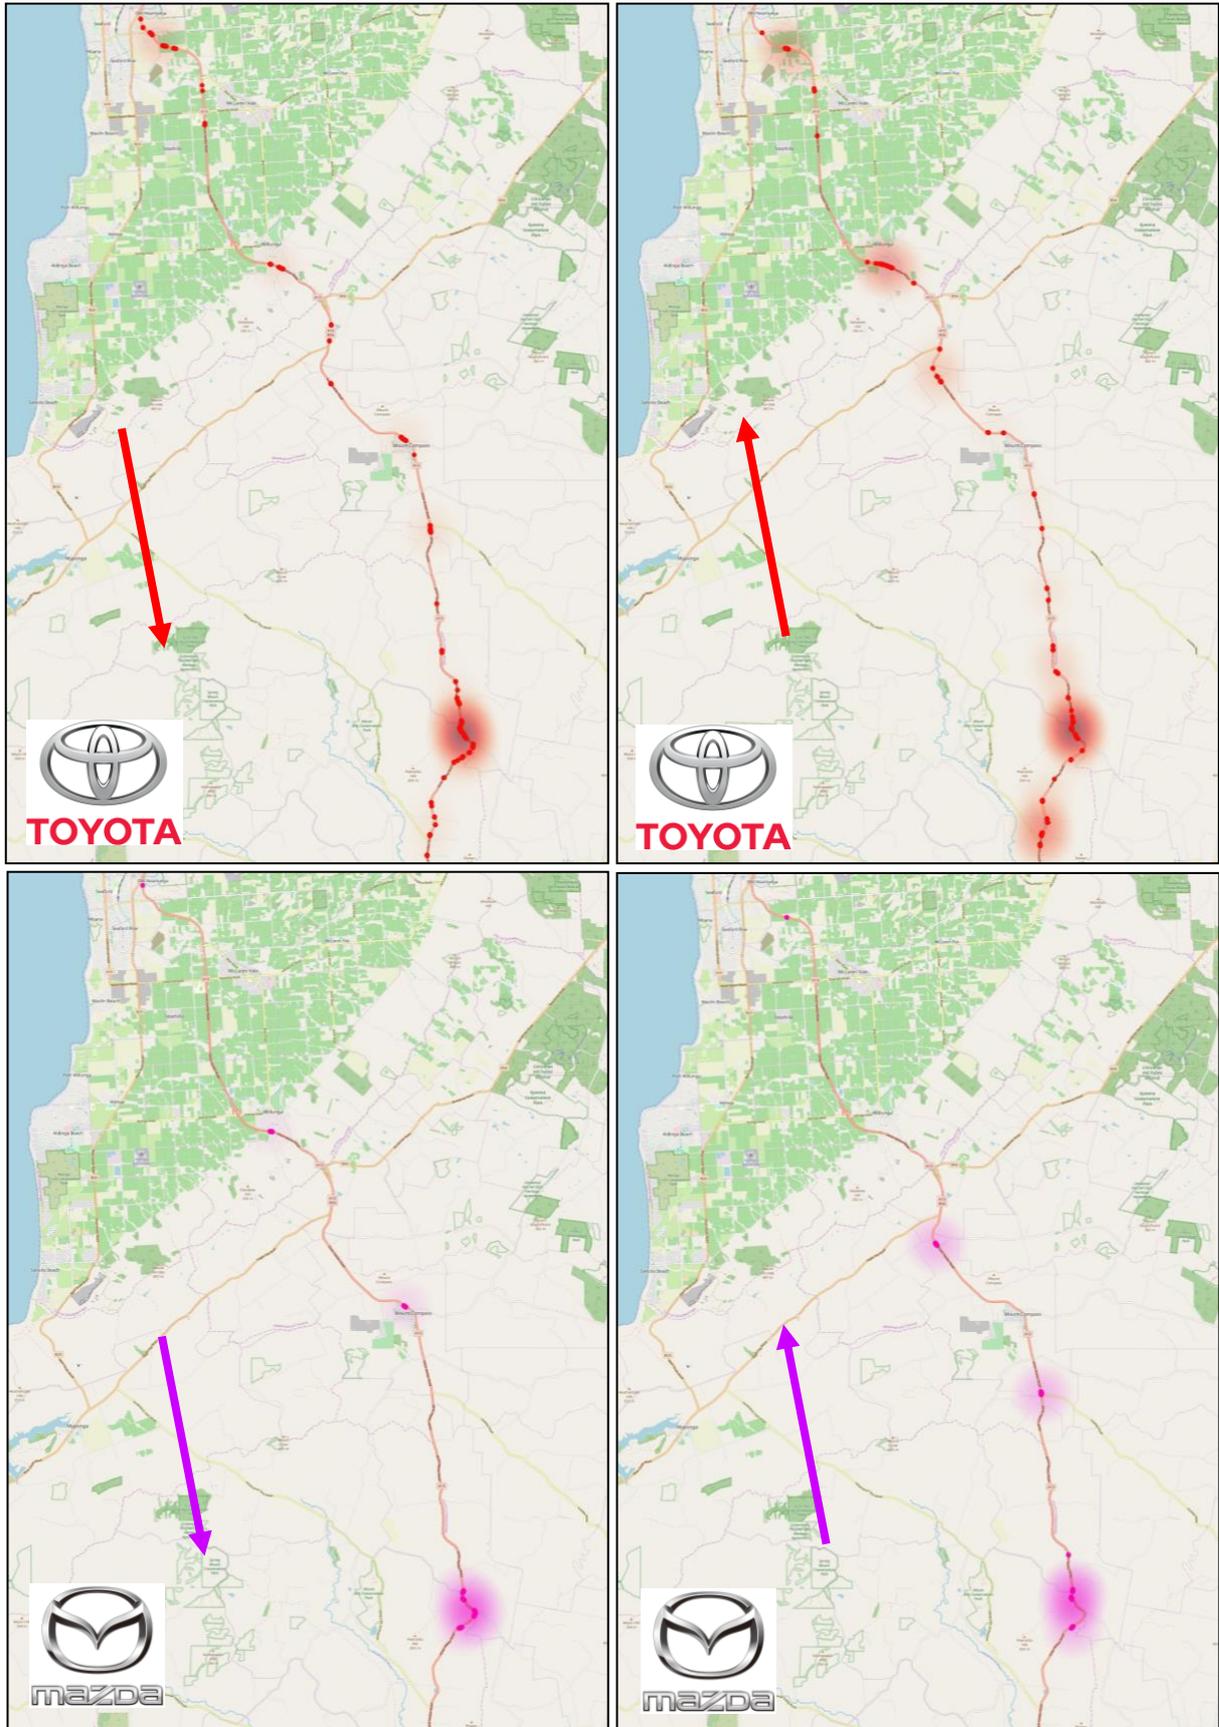
Figure 3.1

The locations where the vehicles did not detect line lane markings are shown by the dots on the route map in Figure 3.1. The Toyota showed a larger number of locations, but it is important to note that many of the non-detections happened for only a short period.

Map of line marking non-detections by vehicle lane support systems.

Left to right, top to bottom: Toyota heading south, Toyota heading north, Mazda heading south, Mazda heading north

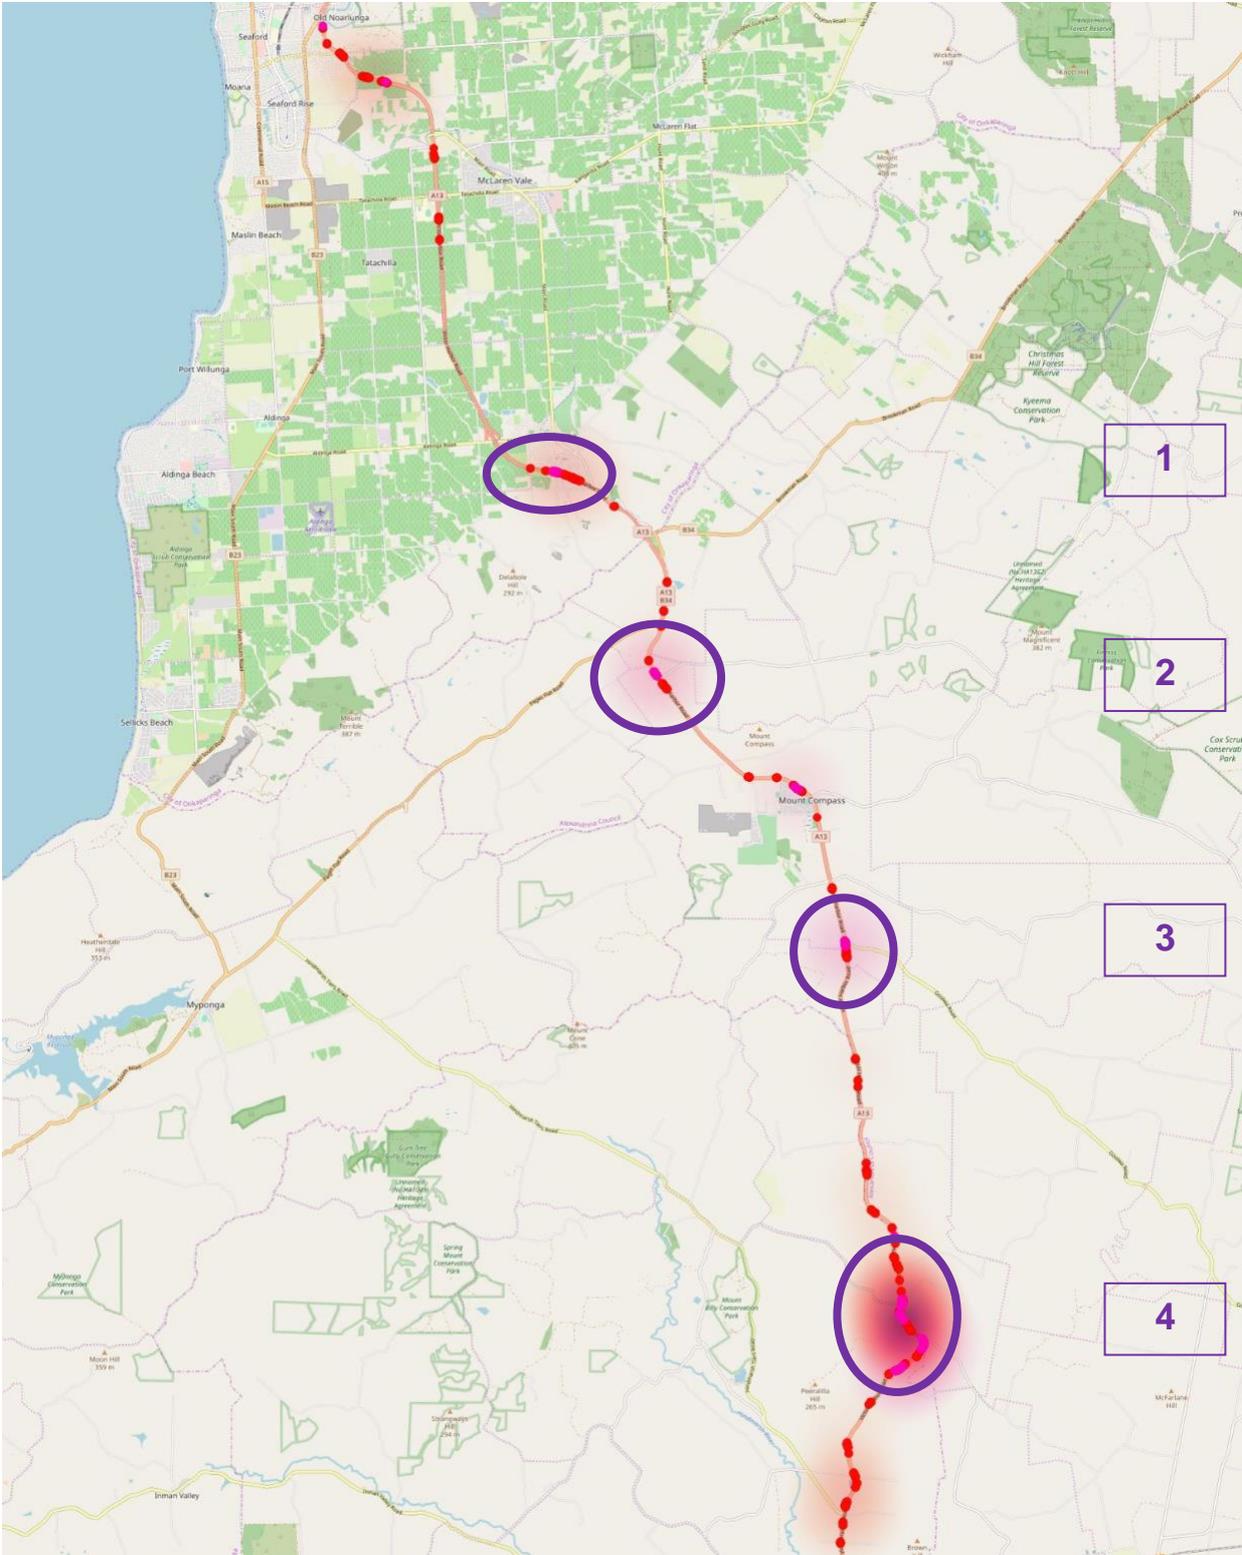
The common locations for non-detections between both vehicles have been identified and highlighted in Figure 3.2. Each of these hotspots is analysed more closely in the following sections.

Figure 3.2 Hotspots and locations of non-detections in both vehicles

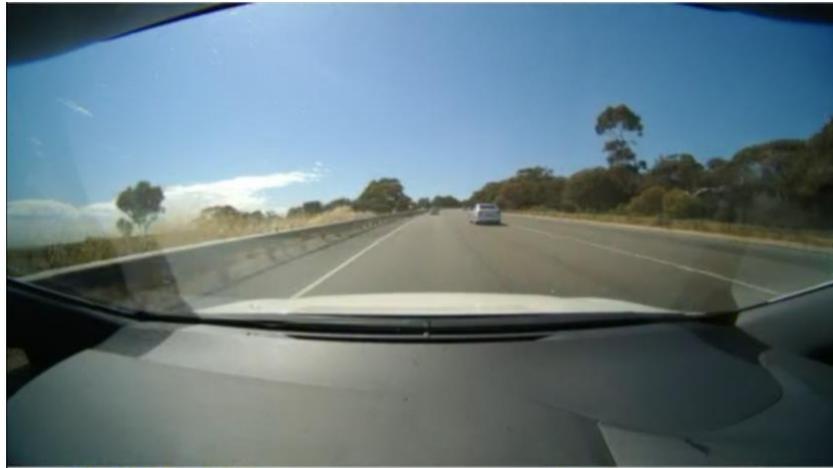
The first hotspot occurred travelling southbound up Willunga Hill. A video snippet from the Toyota at the specific location is shown in Figure 3.3. In both vehicles, the right-side lane line (of the left lane) was not detected for a period of up to three seconds.

Figure 3.3
View from Toyota at Hotspot 1

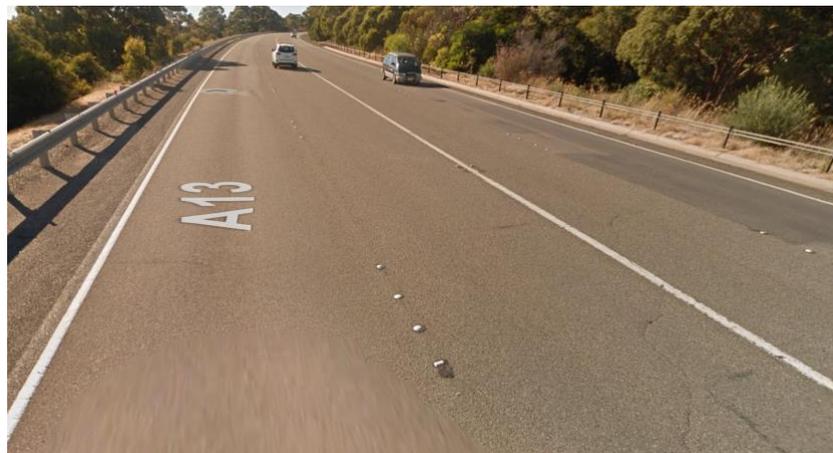
The location of the hotspot was investigated using Google Maps Street View to identify possible sources of the non-detection. Figure 3.4 shows a screenshot of the scene. Noticeably, the line markings dividing the southbound lanes are not typical painted lines, but rather collinear white dots. Along with the slope of the hill, these lane markings are believed to cause the lane support systems in both vehicles some confusion. Although it is worth noting that this line marking type was detected successfully for the majority of the Willunga Hill section.

Figure 3.4
Image at Hotspot 1 from Google Street View

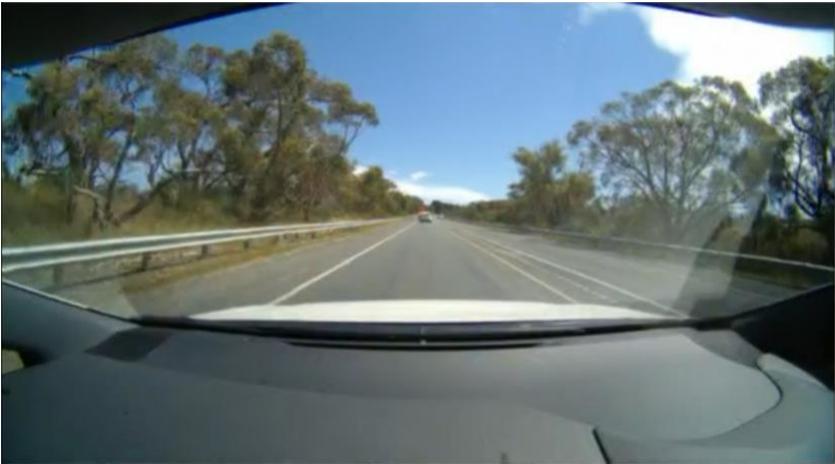
The second hotspot occurred travelling in a northbound direction just after the intersection with Yundi Road. The lane marking layout immediately after the intersection changed to a painted centre median with safety bars, then transitioned to a painted centre median with an audio-tactile line in the middle of the centre median. It is possible that the lane support systems were confused by this additional audio-

tactile line. However, both vehicles recovered within six seconds of initial non-detection. Figure 3.5 shows the view from the Toyota at this location and Figure 3.6 shows a Google Street View image where the transition of the centre median, which is believed to cause confusion for the lane support systems, can be seen.

Figure 3.5
View from Toyota at Hotspot 2

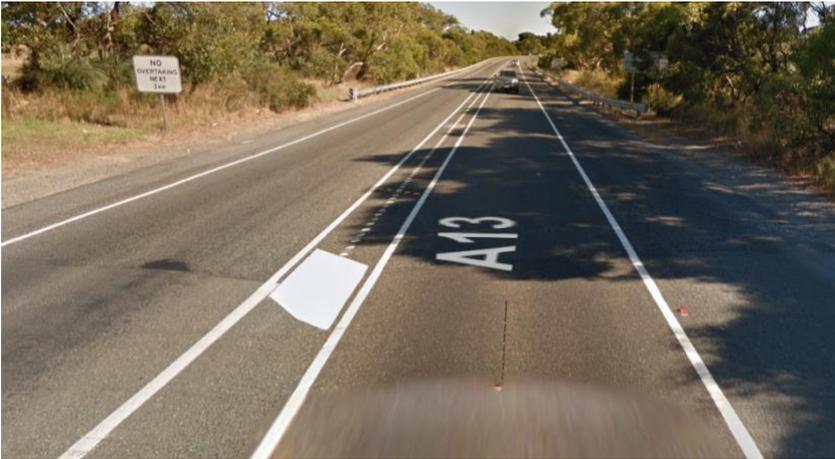
Figure 3.6
Image from Google Street View at Hotspot 2

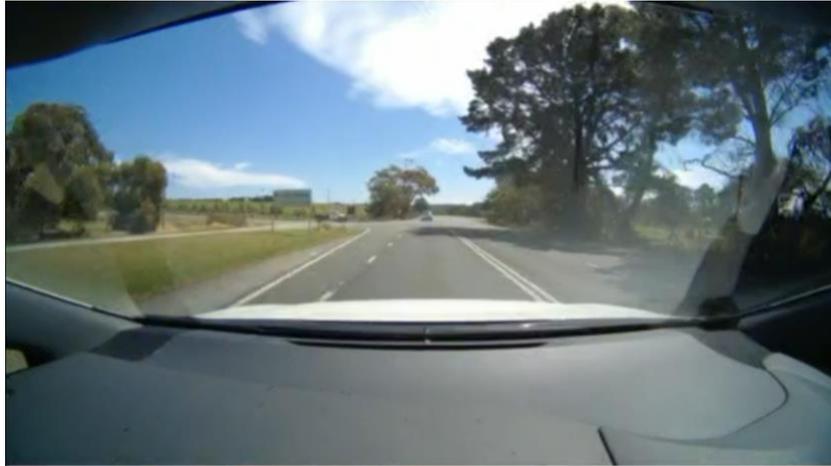
The third hotspot was not a specific location but a cluster of non-detections within the same vicinity. After analysing the recorded video, it is believed that the non-detections occurred when a turning lane was introduced, causing the solid edge line to be replaced by a dashed line. This error repeated a handful of times for both trial vehicles. Although, in similar situations at other locations the lane support systems were observed to detect the dashed lines with no apparent error. Figure 3.7 and Figure 3.8 show views from the Toyota and Mazda respectively in situations where the lane support systems did not recognise the new dashed line.

Figure 3.7
View from Toyota near Hotspot 3

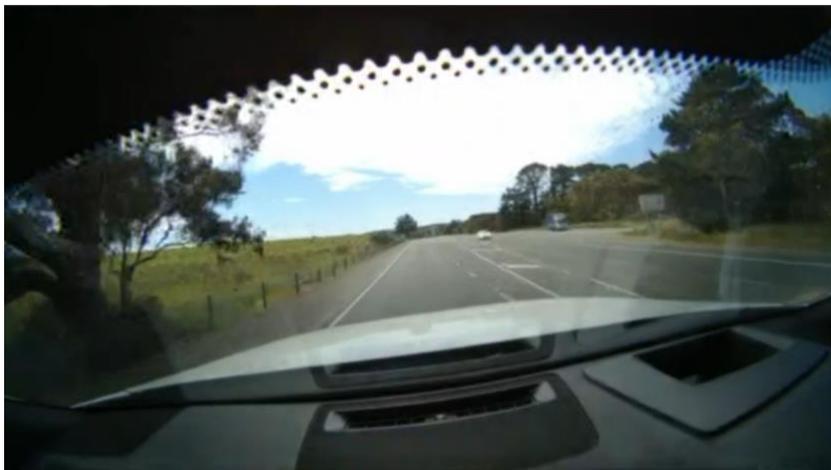
Figure 3.8
View from Mazda near Hotspot 3

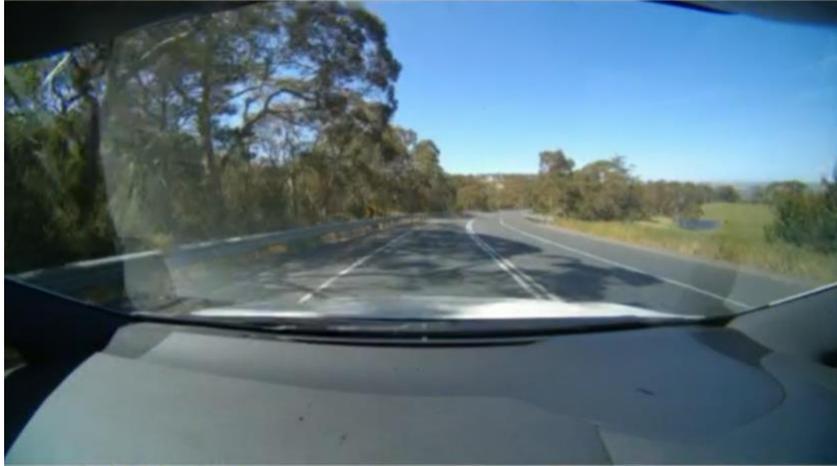
The final hotspot was in a section of Victor Harbor Road that had tighter curves and had more vegetation on the side of the road. Two sources were suspected to be causing non-detections for both trial vehicles. Firstly, shadows were suspected to cause the lane support systems for both vehicles to lose track of the edge and centrelines. Shadows were mentioned in the vehicles' limitations for their respective lane support systems. Figure 3.9 shows the view from the Toyota in a situation where shadows are covering the edge line where a non-detection occurred.

Figure 3.9
View from Toyota where shadows are suspected to cause a non-detection

The 2.2% of the road tested that had no detections of lane line markings had some common scenarios which may have caused the non-detections. Shadows and absences of line markings may have been the most common cause of issues. A solution for the shadows covering the line markings could involve improvement of the lane support systems to operate more robustly in the presence of shadows. And a potential solution to the absence of the lane markings is for a dashed line to fill the gap between lines, to provide the lane support system a guide to where the line will be continuing.

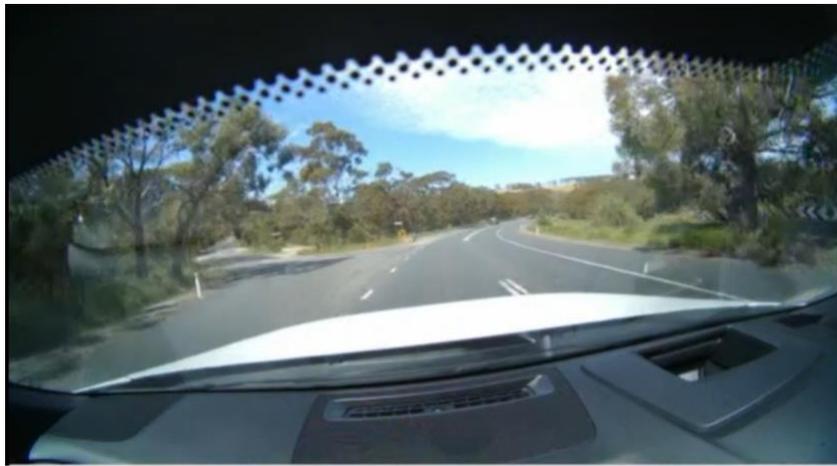
The other suspected cause for non-detections for both vehicles may be the absence of centrelines, shown in Figure 3.10 and Figure 3.11.

Figure 3.10
View from Mazda where absence of centreline is suspected to cause a non-detection

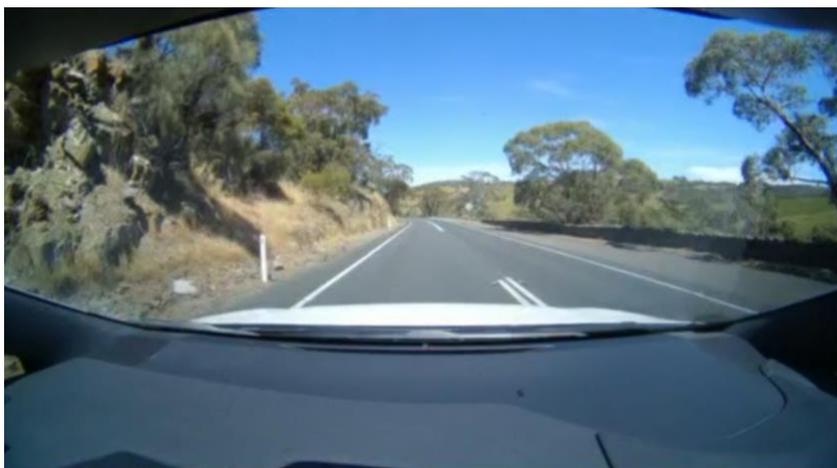
Figure 3.11
View from Toyota where absence of centreline is suspected to cause a non-detection
