ENGINEERING ASPECTS

TRAFFIC ACCIDENTS

ADELAIDE, SOUTH AUSTRALIA.

A thesis presented for the degree of Master of Engineering of
the University of Adelaide, based on work in the Traffic Accident
Research Unit of the Department of Pathology of the University
of Adelaide.

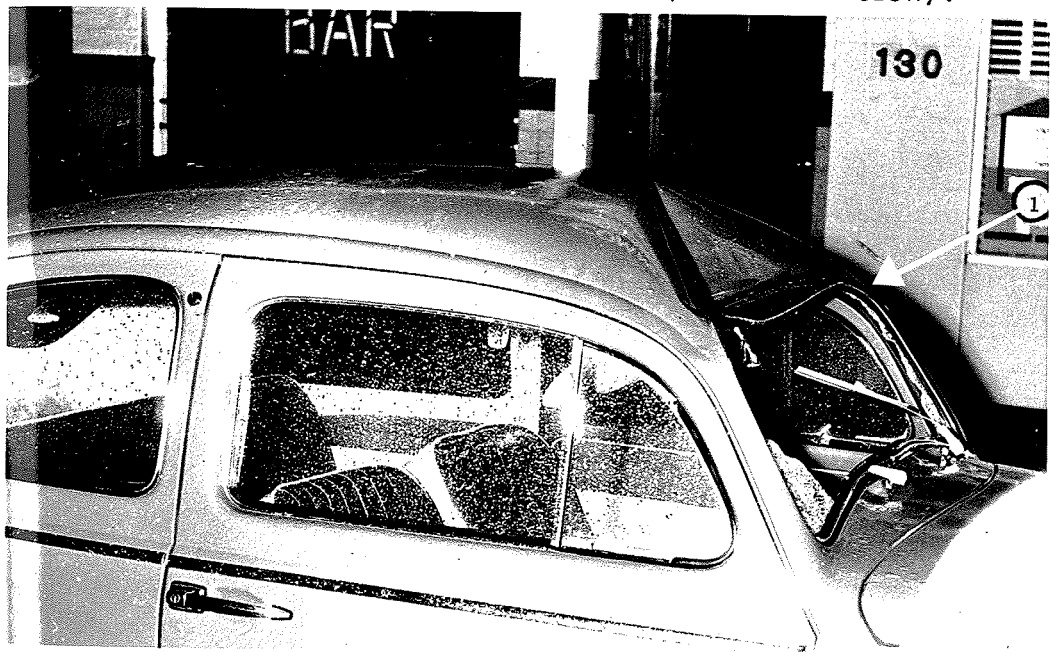
Fig. 4.21
Case 0414: Volkswagen versus pedestrian. Arrow shows dent 5 in. deep in roof, produced by the impact of the pedestrian's head (third impact point).

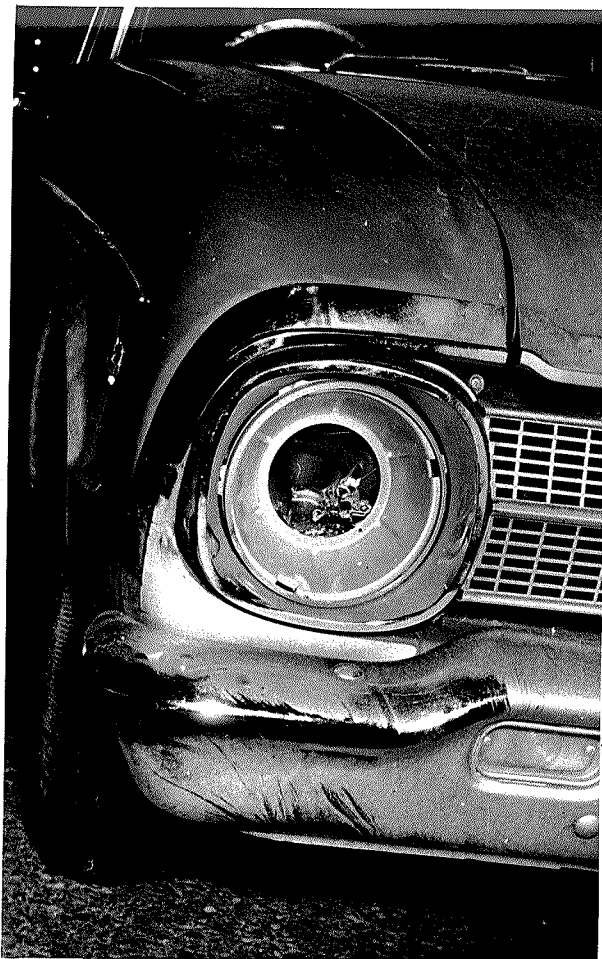
Fig. 4.32
1965 Ford Falcon after collision with pedestrian. (This accident was attended by the author in the year following the TARU survey.) Note the modification to the shape of the bumper bar (compare with Fig. 4.30) which resulted in the injuries shown in Figure 4.31.

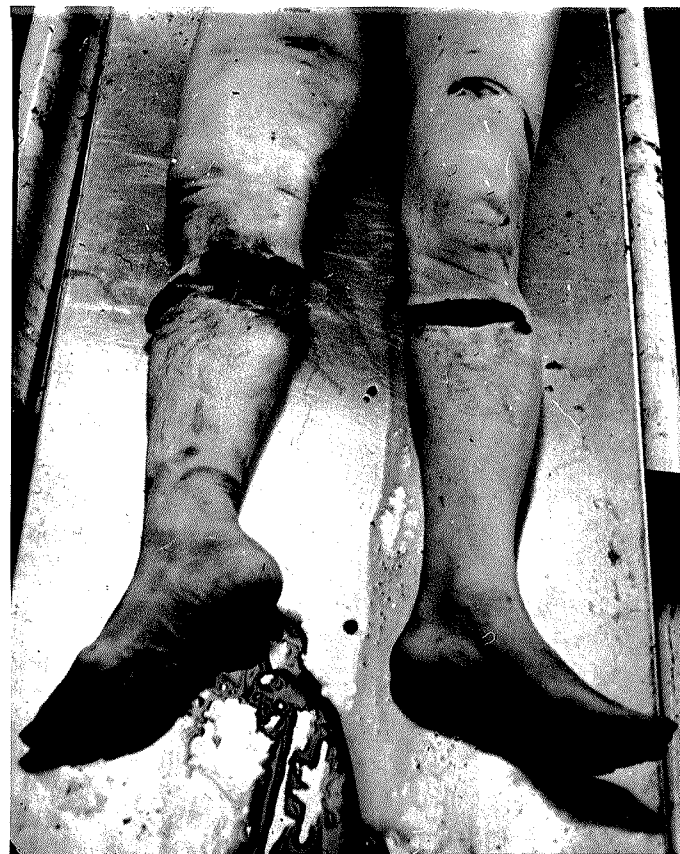
Fig. 4.31
Pedestrian's legs almost completely severed by bumper bar shown in Figure 4.32.

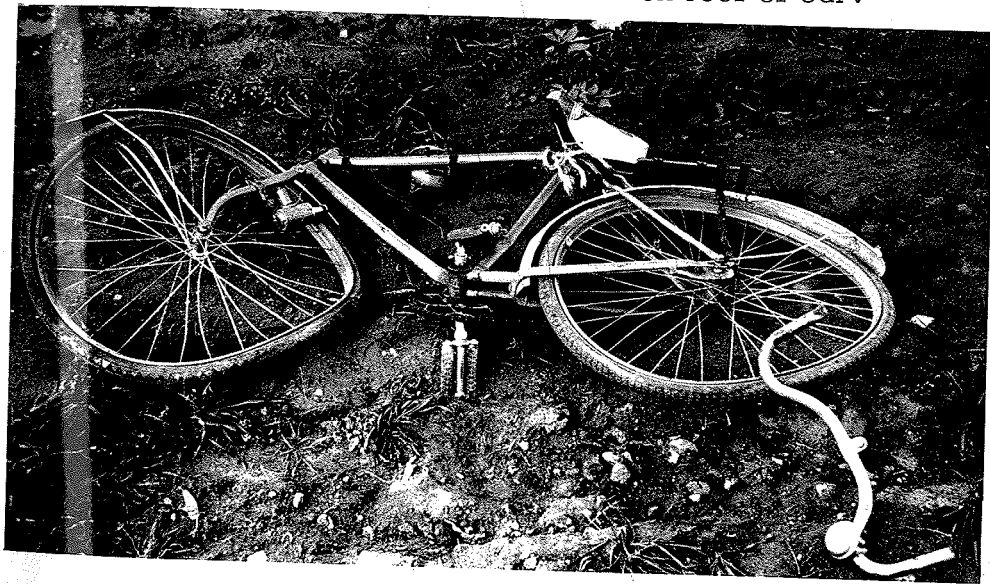
Fig. 5.9
Case 0367: bicycle which was struck by the car shown in Figure 5.8.

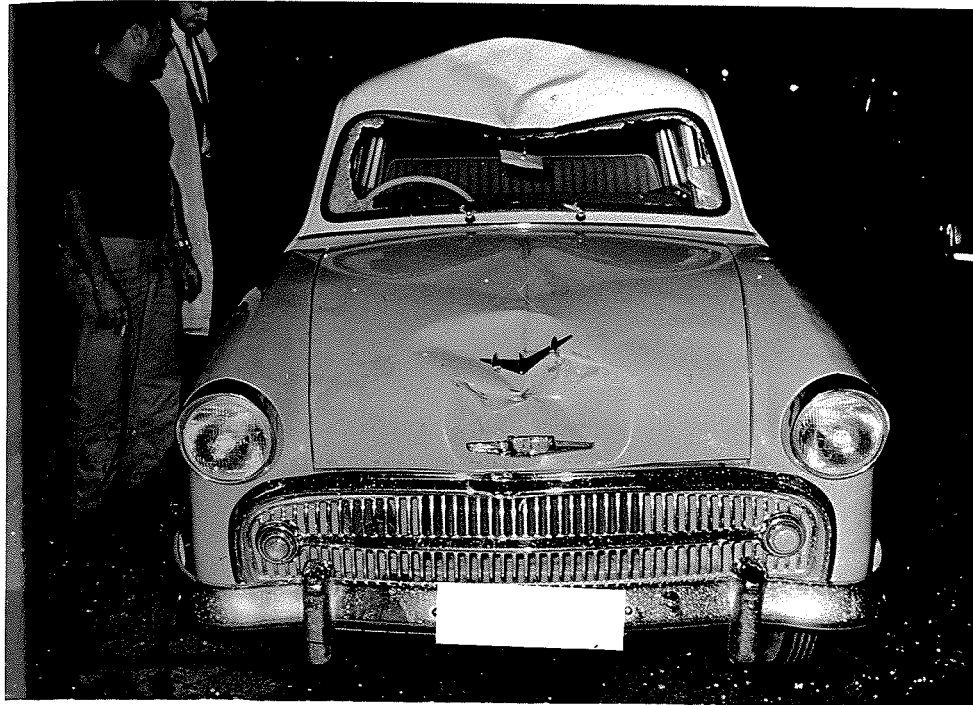
Fig. 5.12
Head-on collision between car and bicycle. Dent in roof made by rider's head.

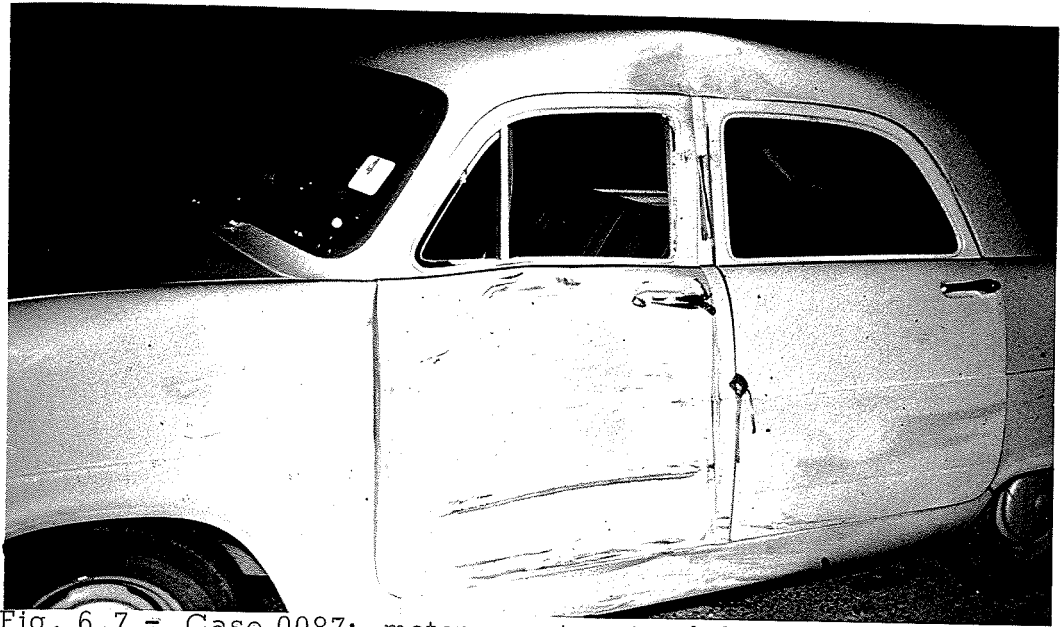
Fig. 6.7 - Case 0087: motor-scooter struck left door of car. Damage around centre post caused by impact of rider's head.

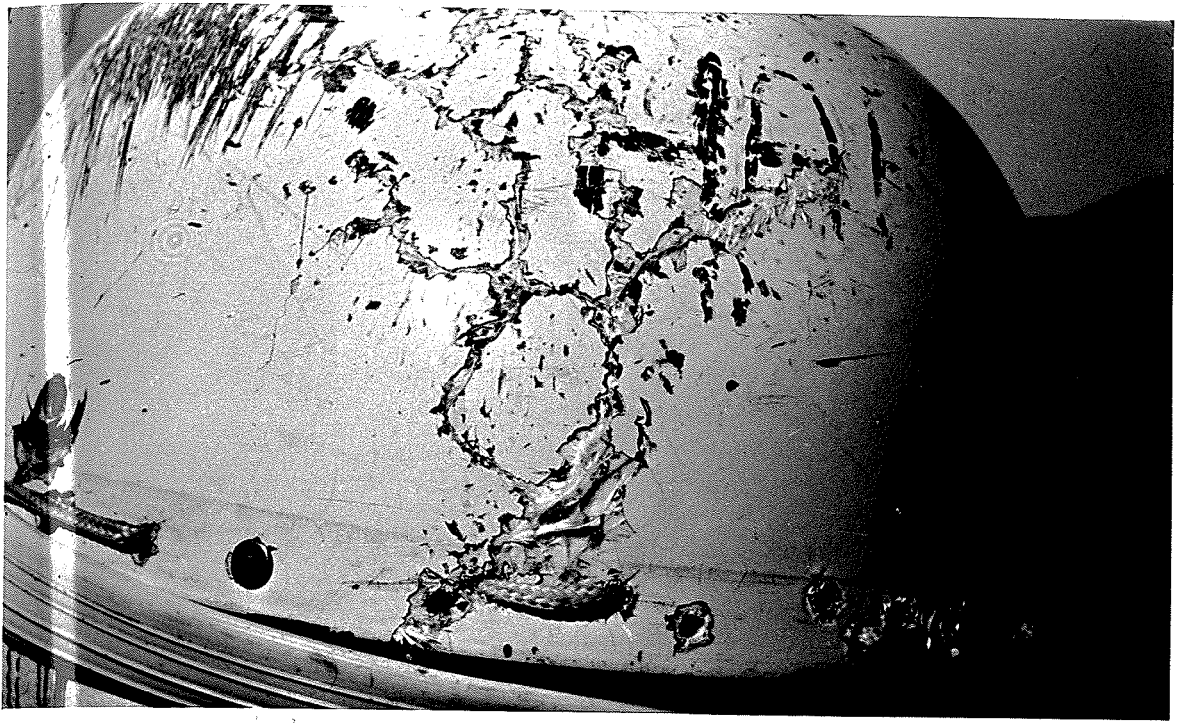
Fig. 6.14
Note fracture lines in shell of helmet.

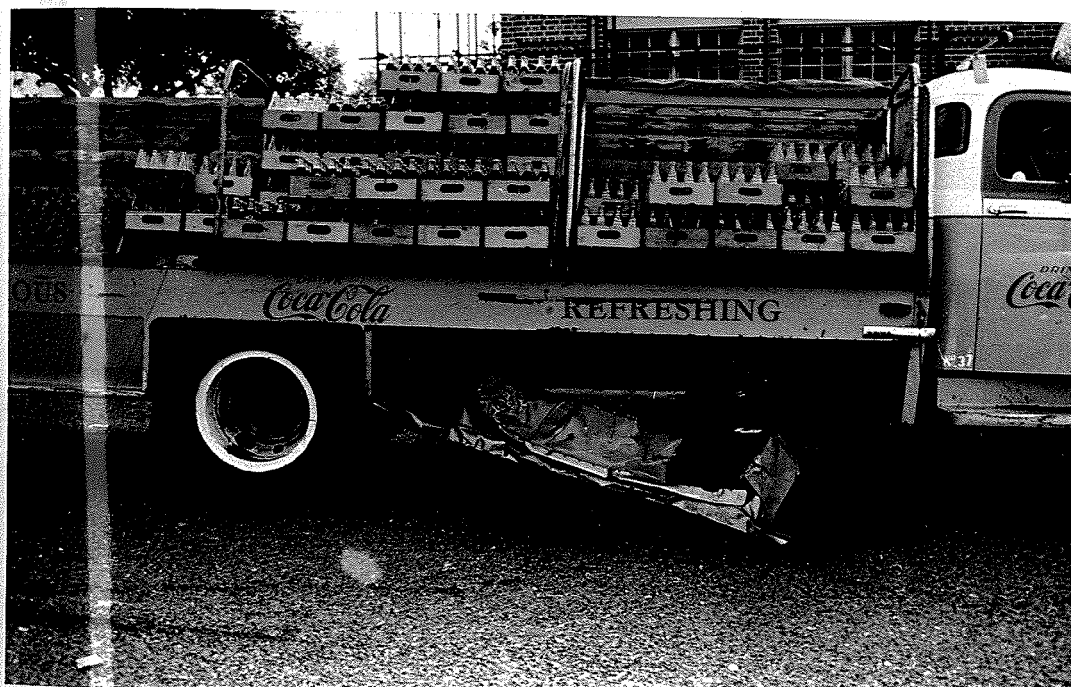
Fig. 7.13
The fuel tank on this truck was ruptured when struck by a car.

7.49 One feature, related to the safety of both truck occupants and the occupants of a colliding vehicle, is shown in Figure 7.13. This truck collided with a Holden Station Sedan at an intersection. The car hit just behind the cab on the right hand side, tearing away a side panel and rupturing the fuel tank. In this case the spilt fuel did not ignite, but the hazard is obvious. Relocation of the fuel tank may be practicable in some cases. When the tank must be mounted in a vulnerable location such as this, it would be most desirable for it to be fitted with an inner, leak resistant, fuel cell to minimise spillage in a case such as that illustrated in Figure 7.13.

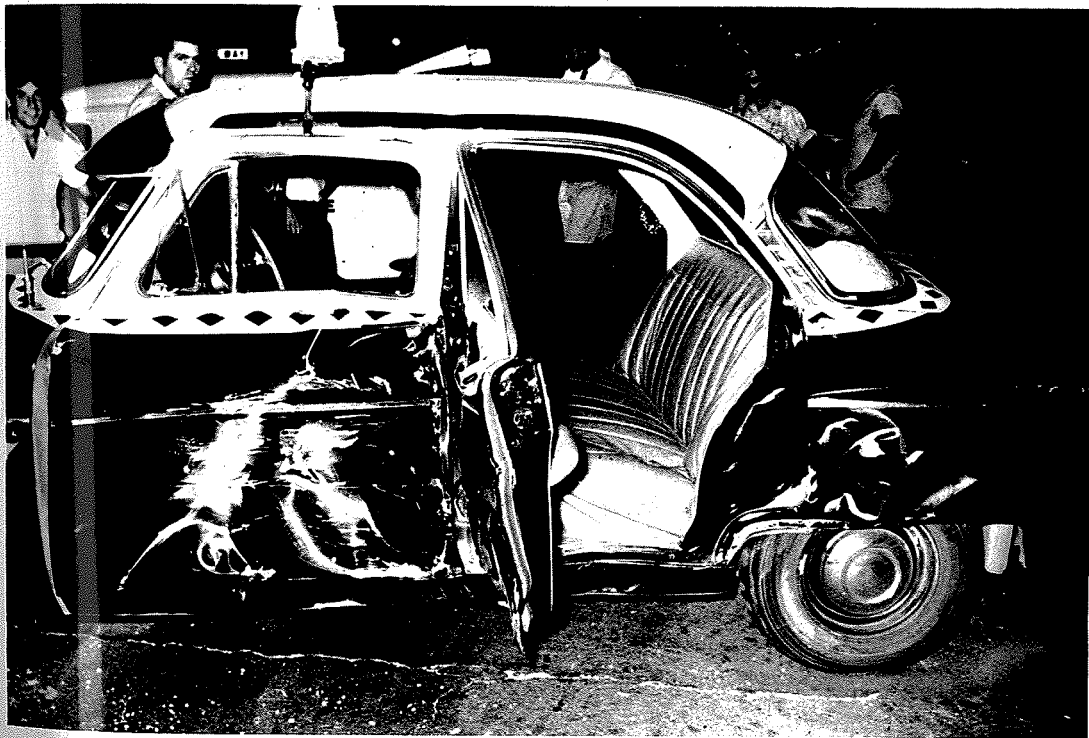
Fig. 8.4
1959 Ford Zephyr, struck by the Peugeot shown in Figure 8.3.
Note that the rear door has come open.

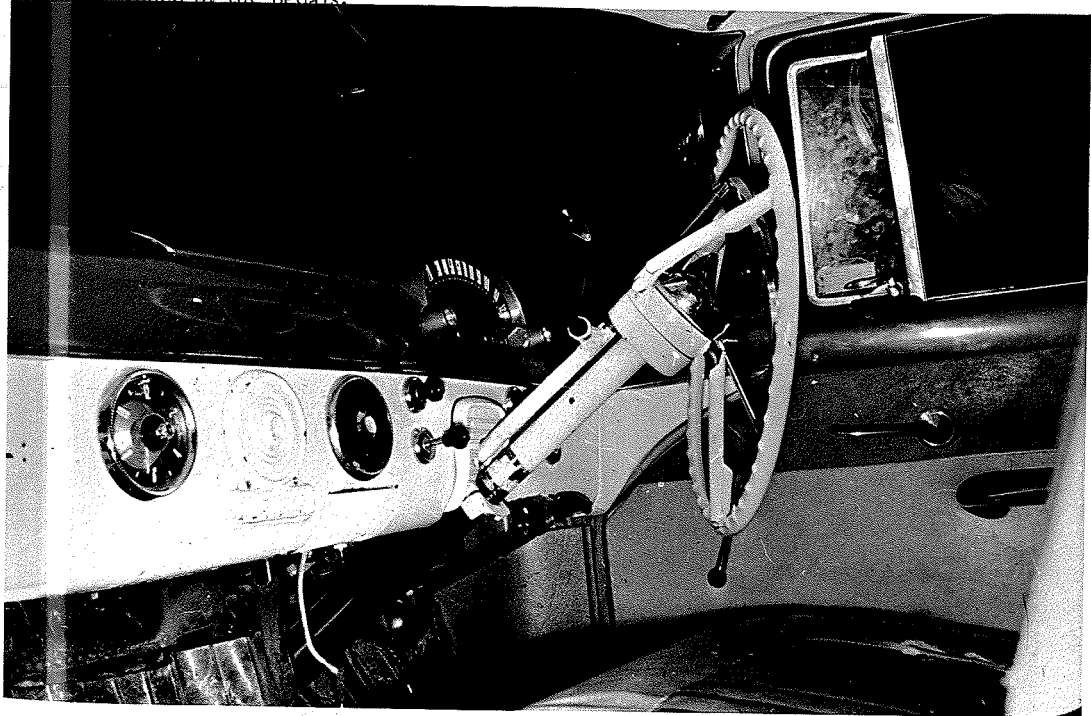
Fig. 10.3
Three-spoke 'dished' wheel of a 1957 Ford Customline, damaged by the driver being thrown against it in a head-on collision with another car.

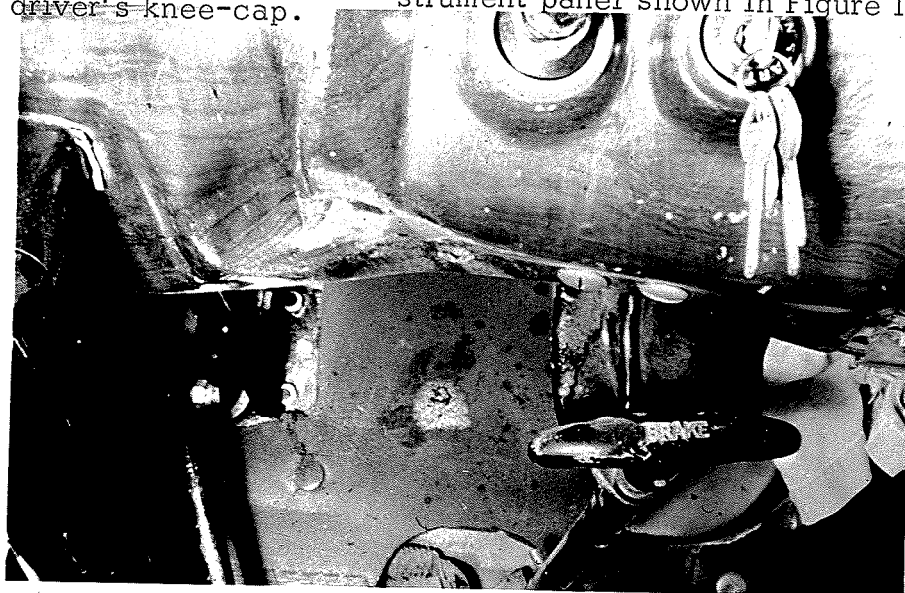
Fig. 10.8
 Dent in instrument panel of Ford Customline made by driver's knee. Note flesh mark on bulkhead.

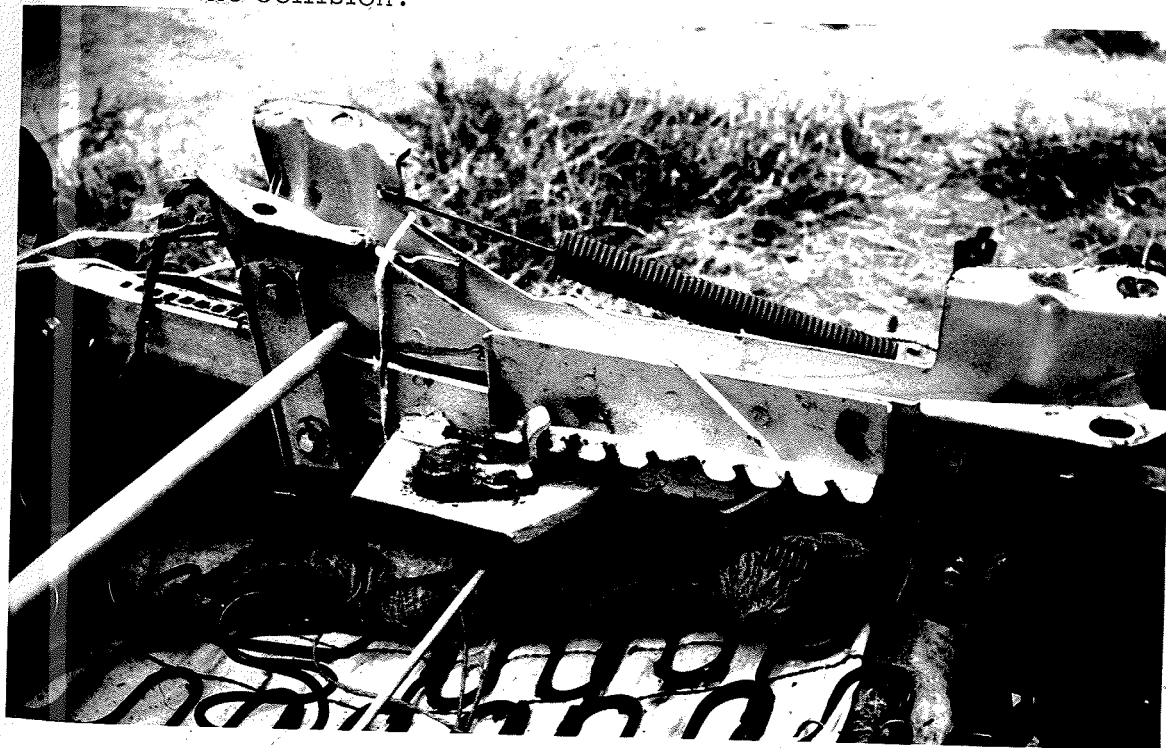
Fig. 10.18
Seat adjustment locking mechanism (passenger's side) of the 1952 FX Holden
shown in Figure 10.16.

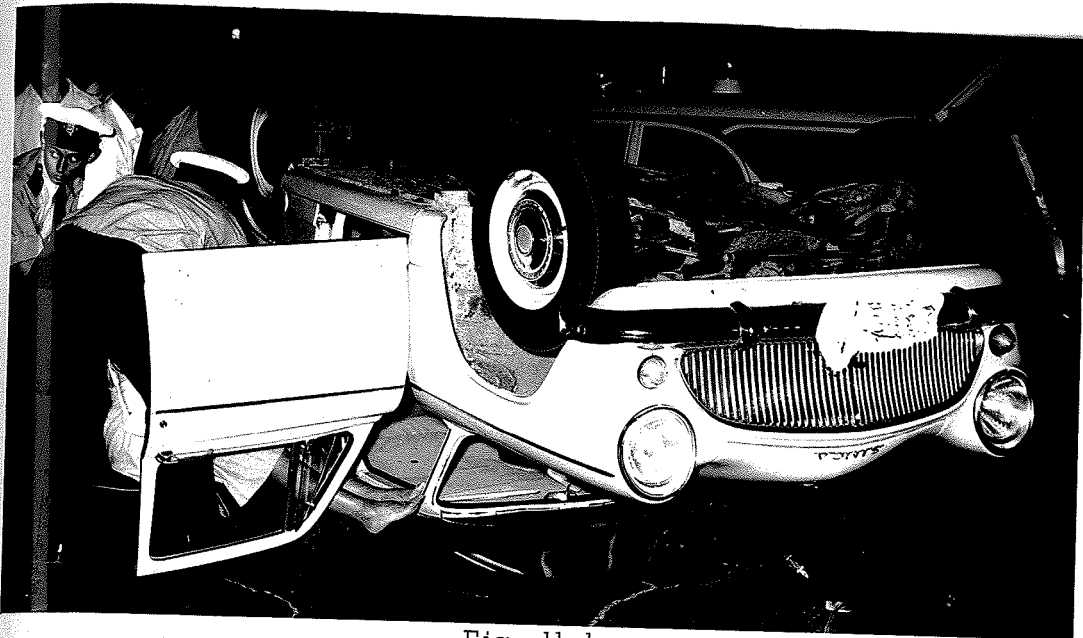
Fig. 11.1
Windscreen ejected unbroken from Simca Station Sedan on rollover.

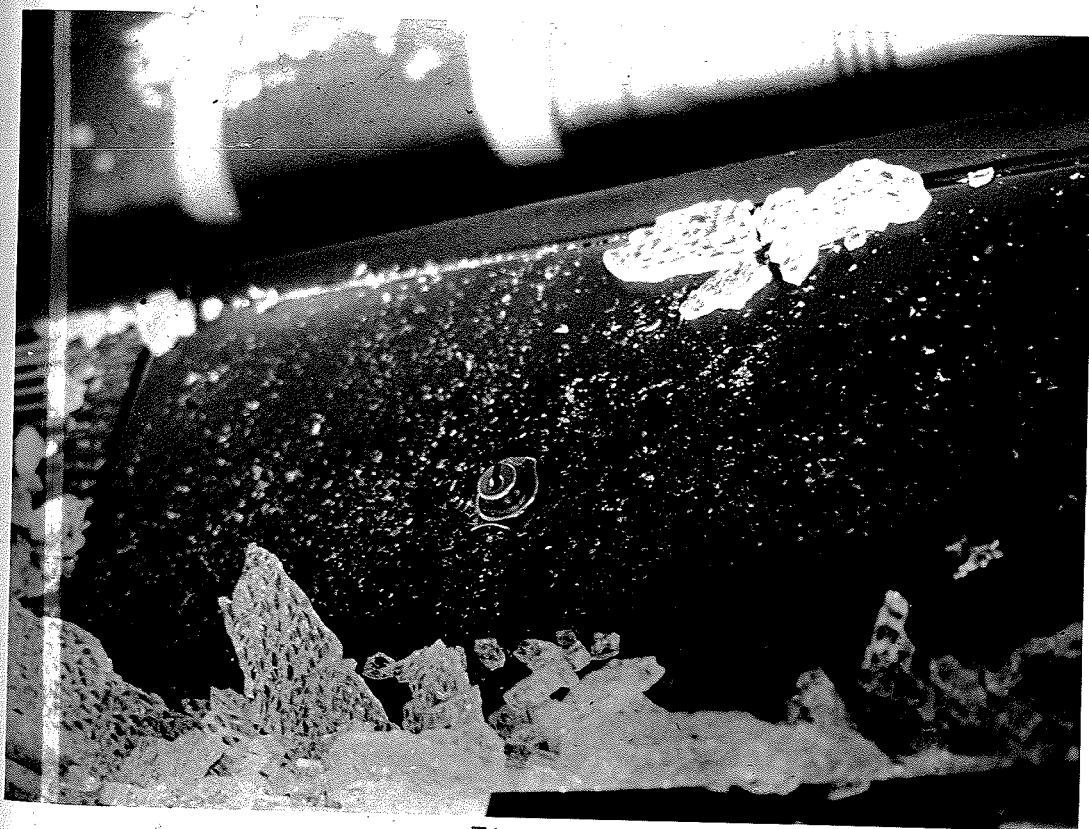
Fig. 11.2
Fine fragments of toughened glass from shattered 1962 Holden windscreen.

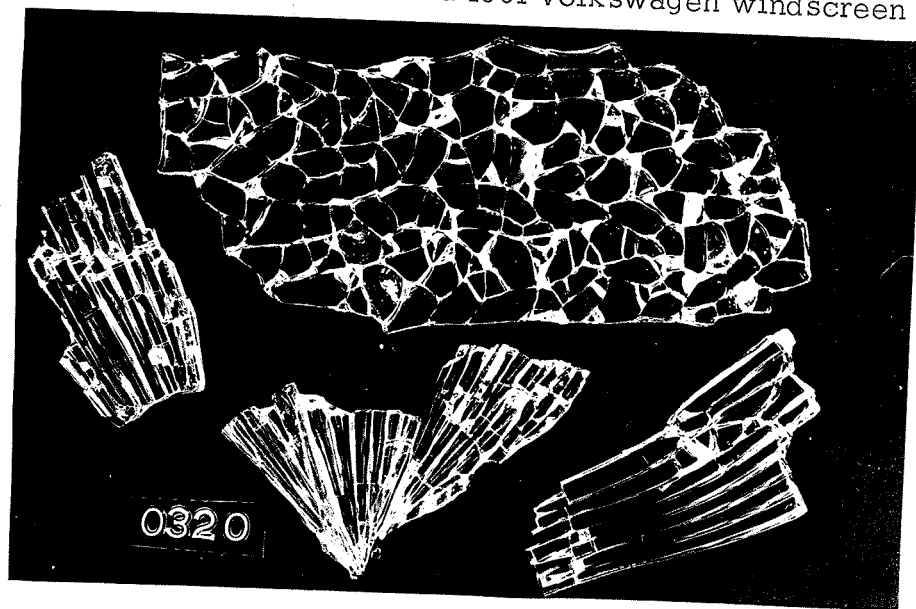
Fig. 11.4
Fracture lines radiate out from point of impact. (Passenger's head hit the windscreen.)

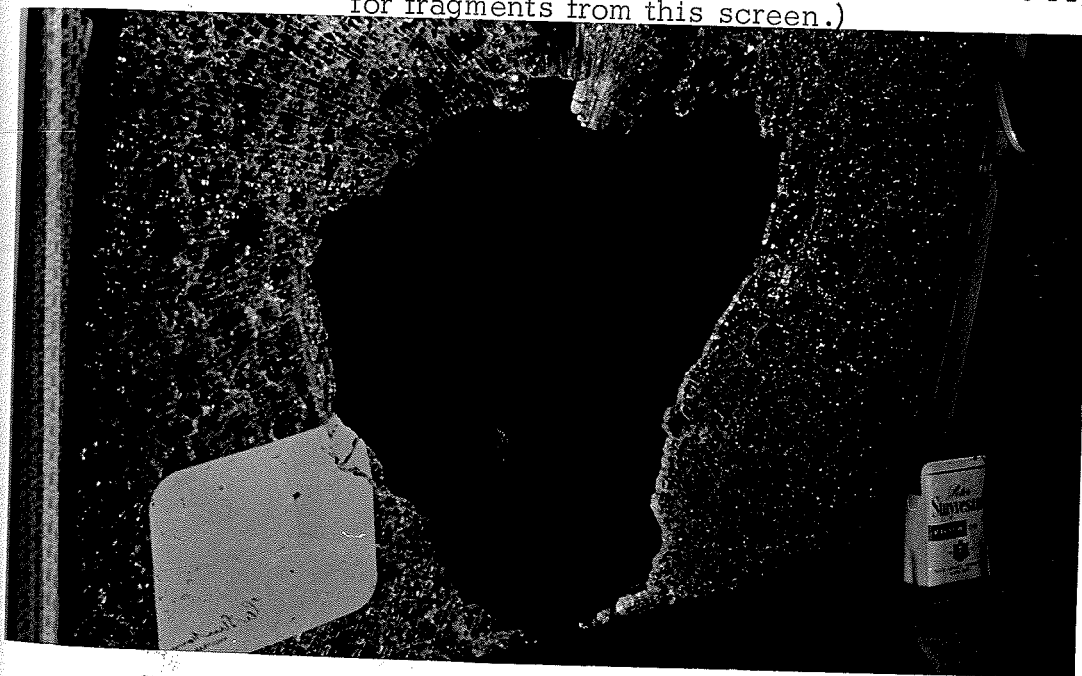
Fig. 11.8
1956 FJ Holden windscreen, broken by the passenger's head.

11.37 A fracture of one side of a two piece flat screen is shown in Figure 11.8. The vehicle is a 1956 FJ Holden Utility. The other piece of the screen was marked **ARMOURPLATE**. The passenger's side of the screen was broken by the head of the 22 year old female passenger. The point of impact can be determined from inspection of the "streamlines" in the fracture pattern of the glass. Case 0320, Figure 11.4, shows the fan-shaped fragments which radiate from the point of impact. Further away from the point of impact the customary fracture pattern is resumed, as is shown by the large fragment. The samples shown in Figures 11.3 and 11.4 were both taken from Volkswagen windscreens; in Case 0079 the screen was broken by frame deformation. In Case 0320 the screen was

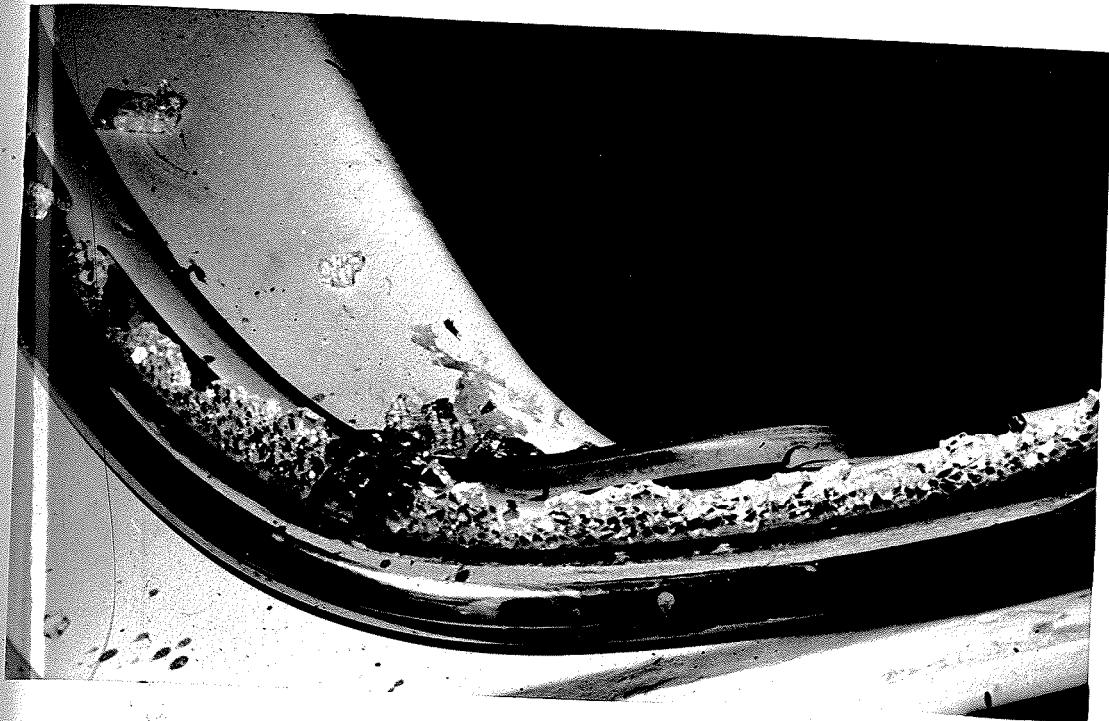
Fig. 11.9
Jagged edge of broken glass re-
tained in rubber mounting strip
(Ford Customline).

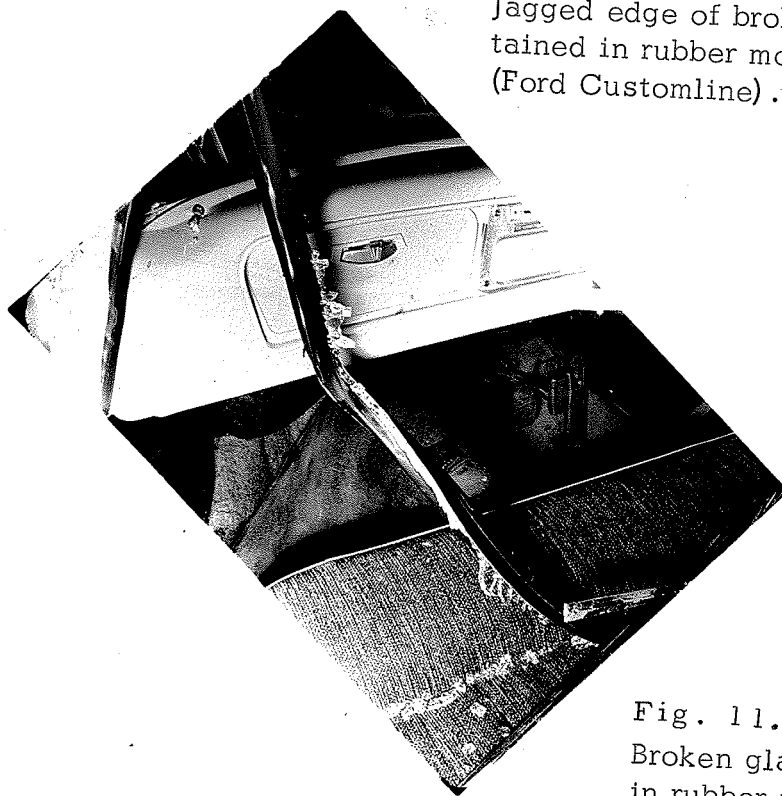
Fig. 11.10
Broken glass retained
in rubber mounting strip
(1960 Simca).

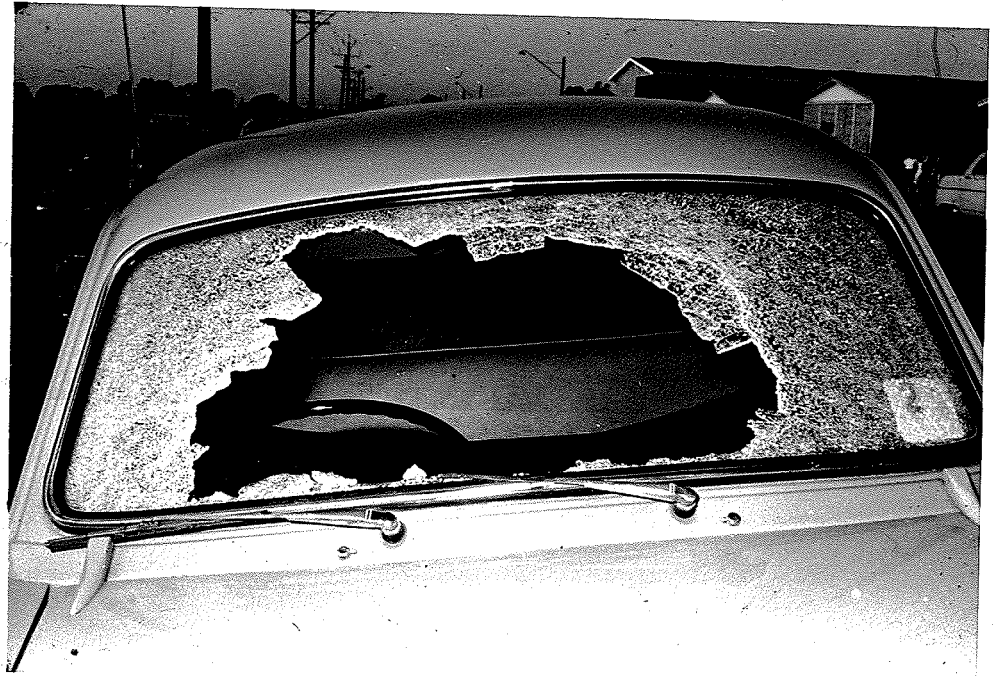
Fig. 11.11
Windscreen of 1962 Morris Elite, broken by cyclist
being hurled against it.

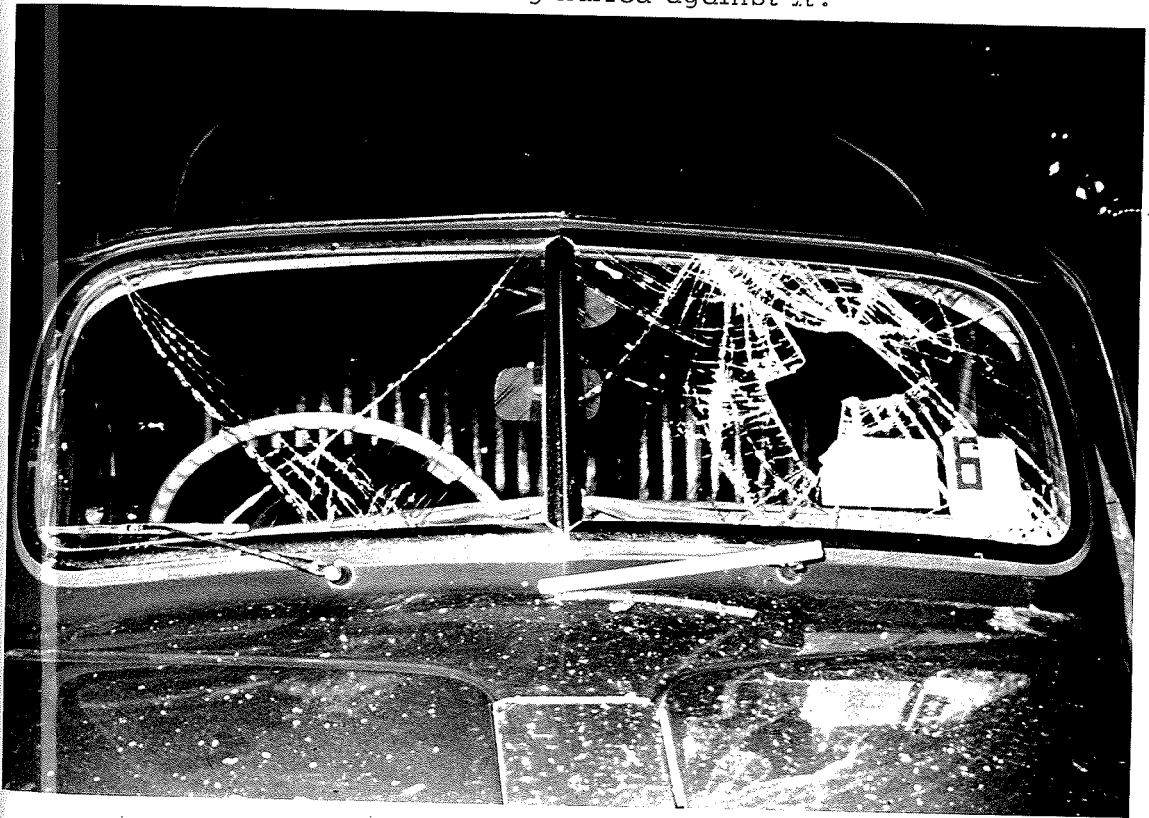
Fig. 11.12
1952 Riley. 'Grid' fracture on driver's side, 'web' fracture of
laminated glass on passenger's side.

11.44 The glass fragment from Case 75, shown in Figure 11.15, is from a laminated glass windscreen. The fractured screen is shown in Figure 11.12. The vehicle is a 2 1/2 Litre Riley Saloon, manufactured in 1952. Each side of the two piece windscreen displays a different type of laminated glass fracture. The piece on the driver's side is "grid" cracked. The piece on the passenger's side is "web" cracked. These two types of failure are further illustrated in Reference 55. The grid type of failure is caused by distortion of the frame of the glass. The web type of failure is caused by an object striking the glass. In the case shown the driver, on realizing a collision was imminent, put her left arm across in front of the front seat passenger. On impact the passenger was thrown forwards pushing the driver's forearm through the laminated windscreen, resulting in extremely severe lacerations. The fragment

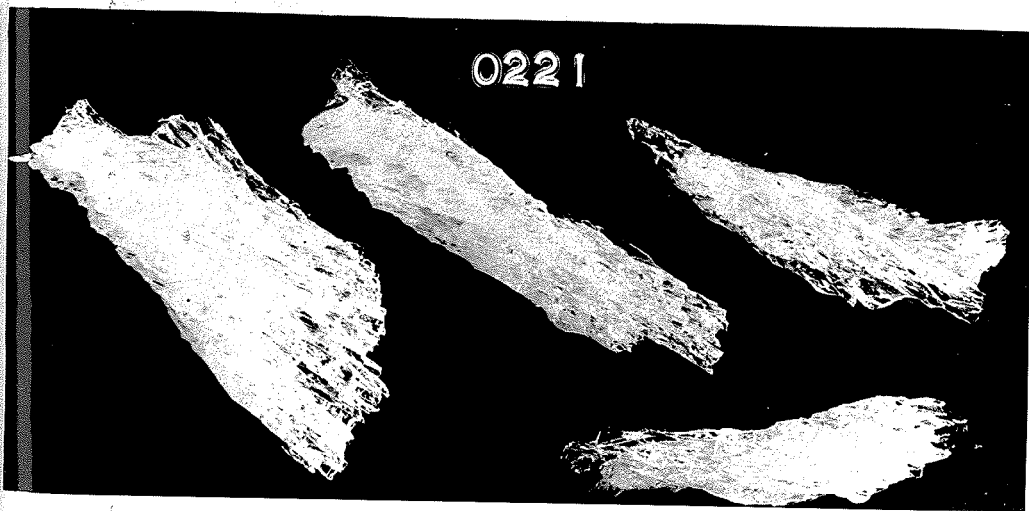
Fig. 11.13
Fragments from the windscreen shown in Figure 11.11 (full size).

11.41 Samples taken from the screen of the vehicle shown in Figure 11.11 show a regular fracture pattern in some fragments (those at the top of Figure 11.13, which have particle counts varying between 56 and 42 per sq. inch). Other fragments from this same screen display most irregular

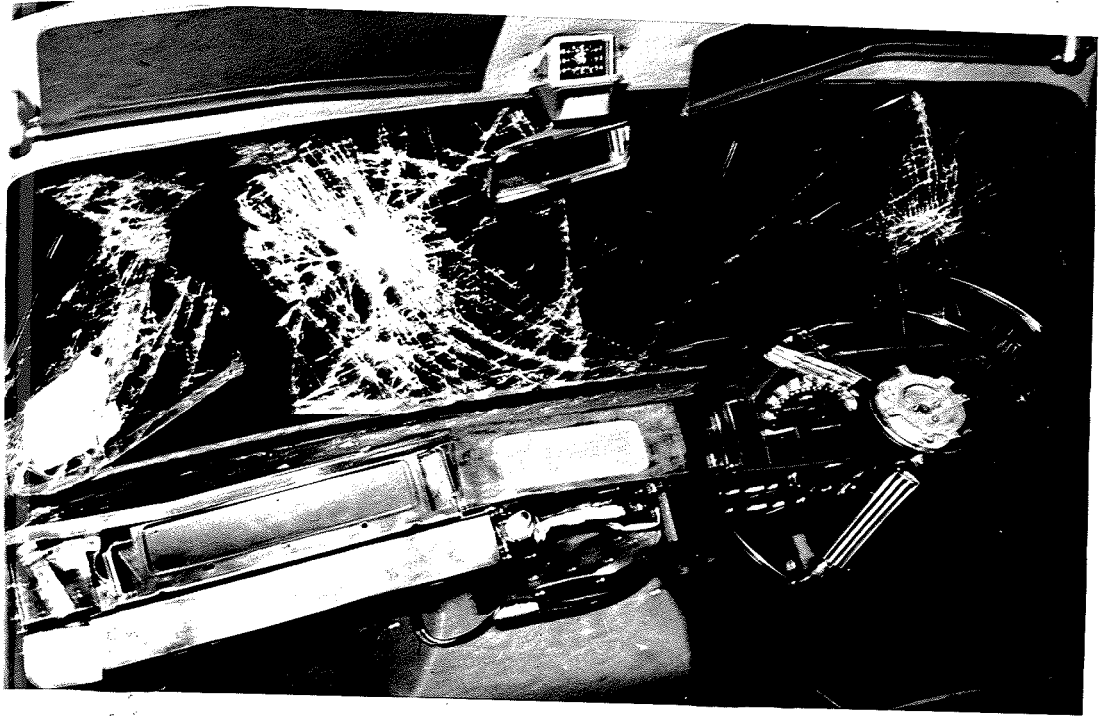
Fig. 11.17
Penetrated laminated glass windscreen.

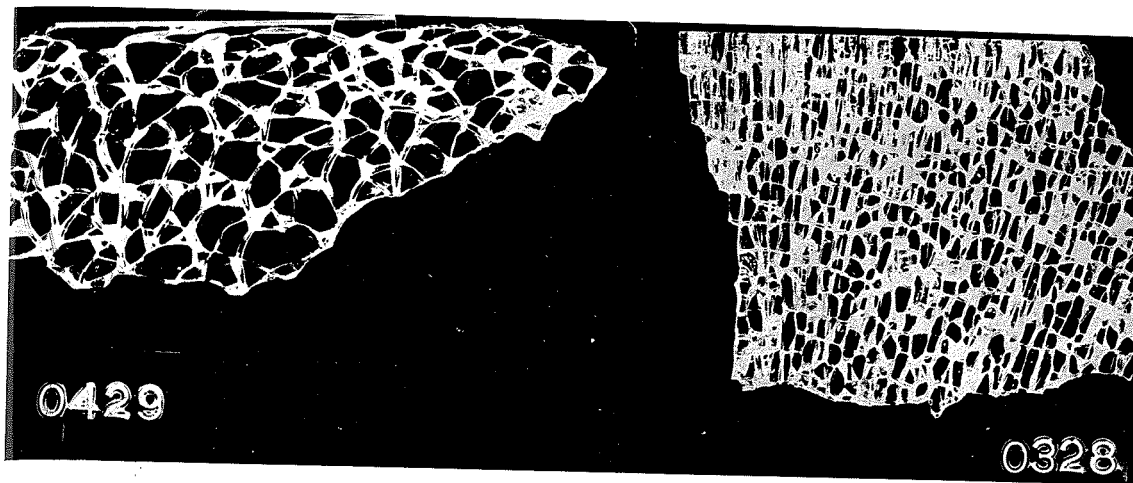
Fig. 11.20
Differences in toughening and hence in particle counts on fracture. Side window glass, full size.

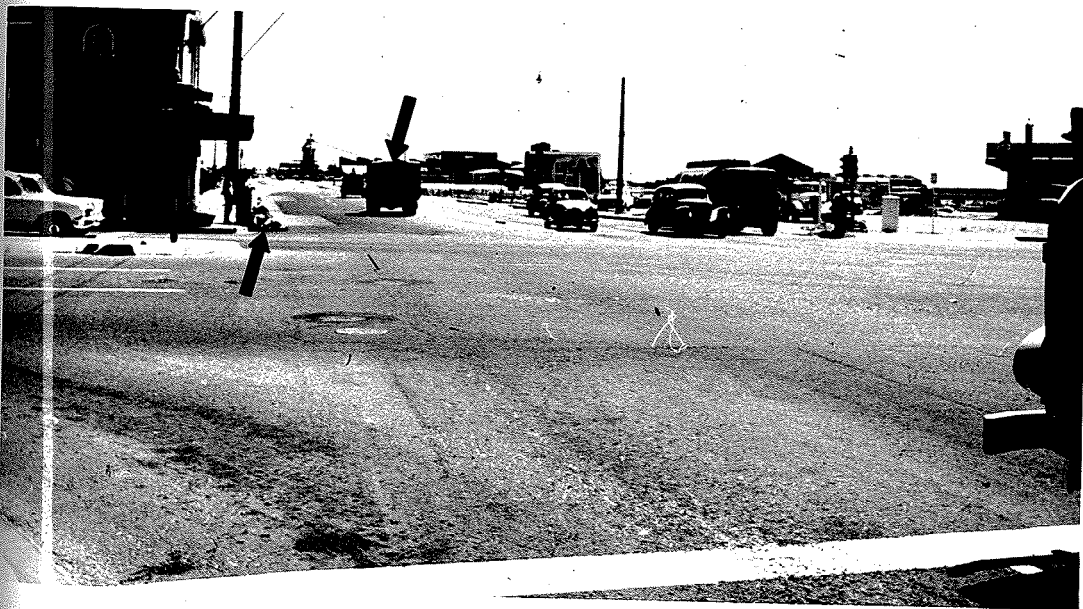
Fig. 14.6
Gepps Cross: view looking west along Grand Junction Road. Arrows indicate wrecked motor-scooter and immobilized truck (accident 0239).
