Post impact trajectory of vehicles at metropolitan intersections

CASR REPORT SERIES

CASR060

December 2012

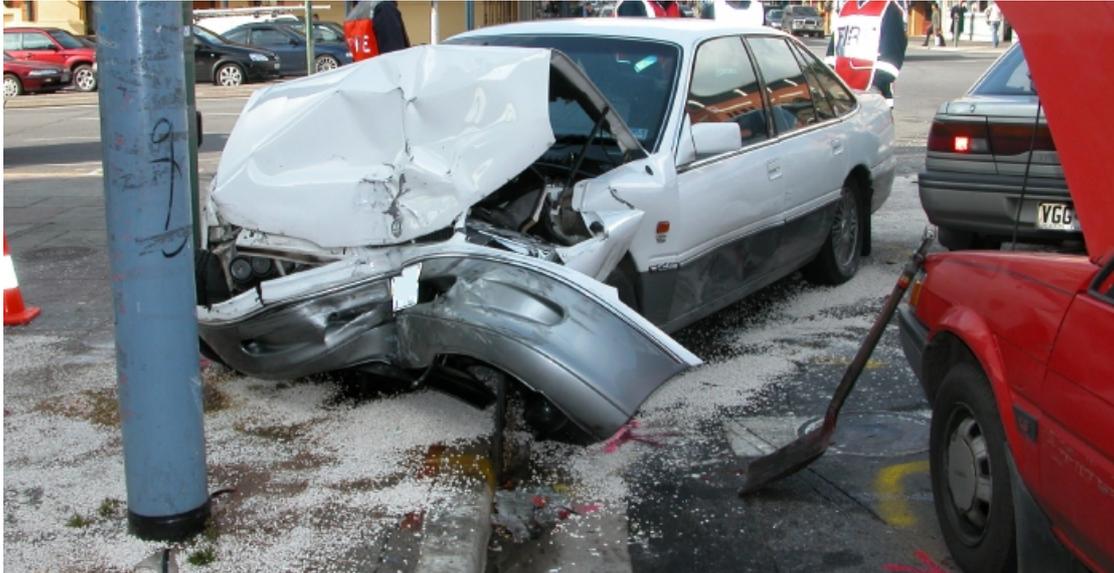
Figure A.2

Unit 1 after the crash. The initial impact and secondary impact are shown in this picture as they were both frontal impacts. The traffic light pole is also shown

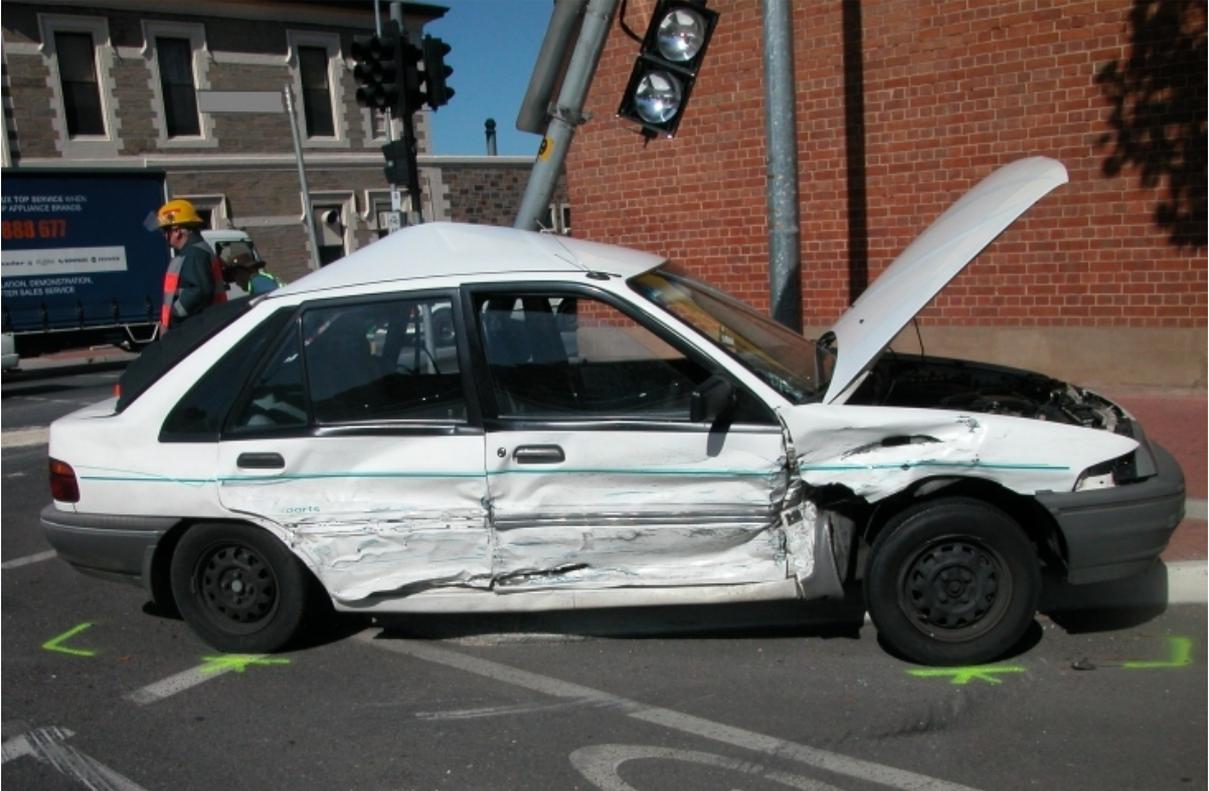
Figure A.4
Unit 2 after the crash showing the damage from the initial impact

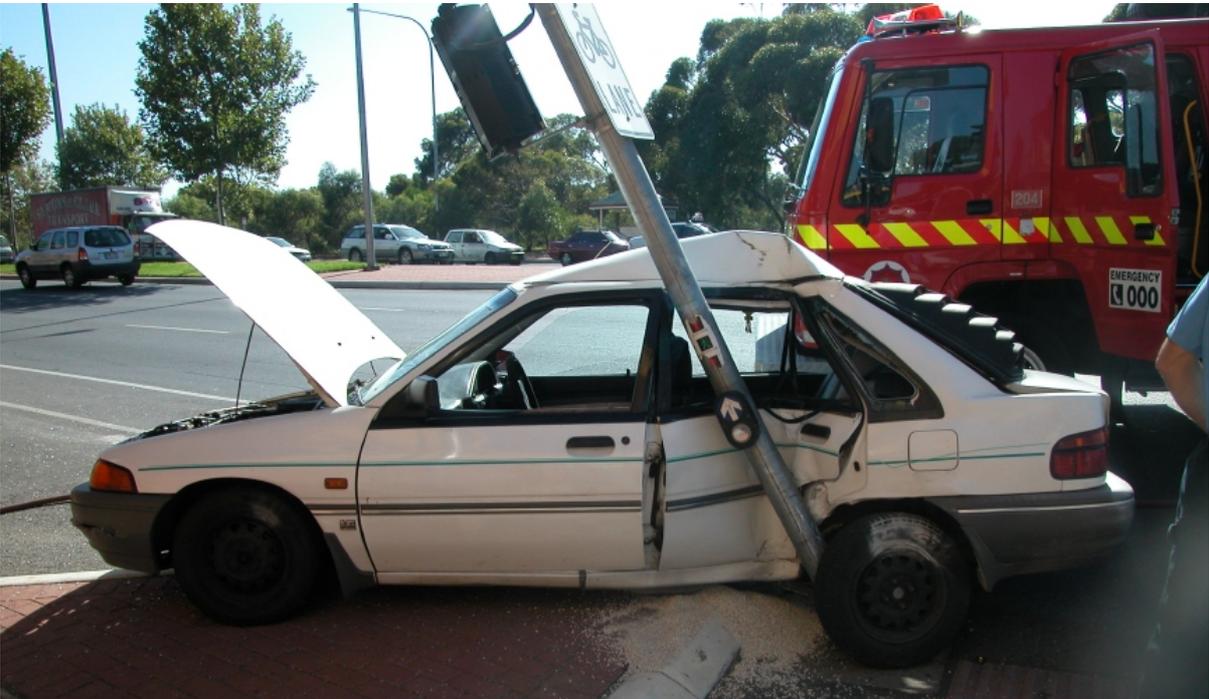
Figure A.5
Unit 2 after the crash showing the damage from the secondary impact with the traffic light pole

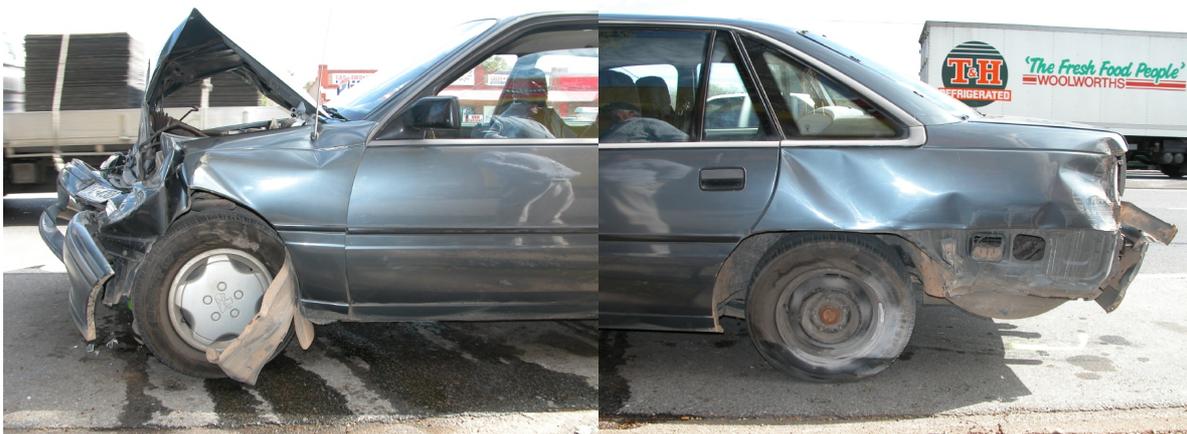
Figure A.7

Unit 1 after the crash. The damage at the front is from the secondary impact with the parked vehicle. The impact at the rear is from the initial impact

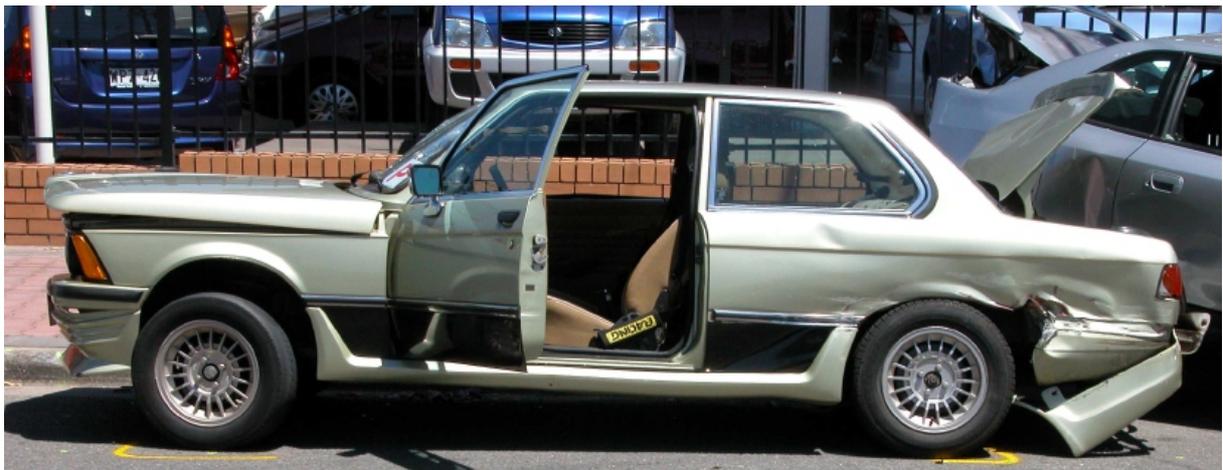
Figure A.9

Unit 2 after the crash showing the damage from the initial impact on the left rear quarter panel

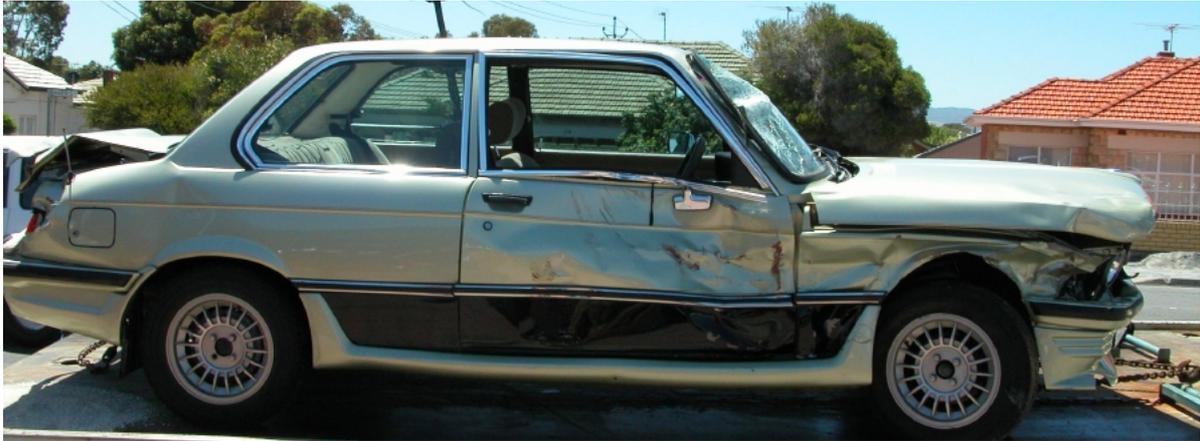
Figure A.10
Unit 2 after the crash showing the damage from the secondary impact

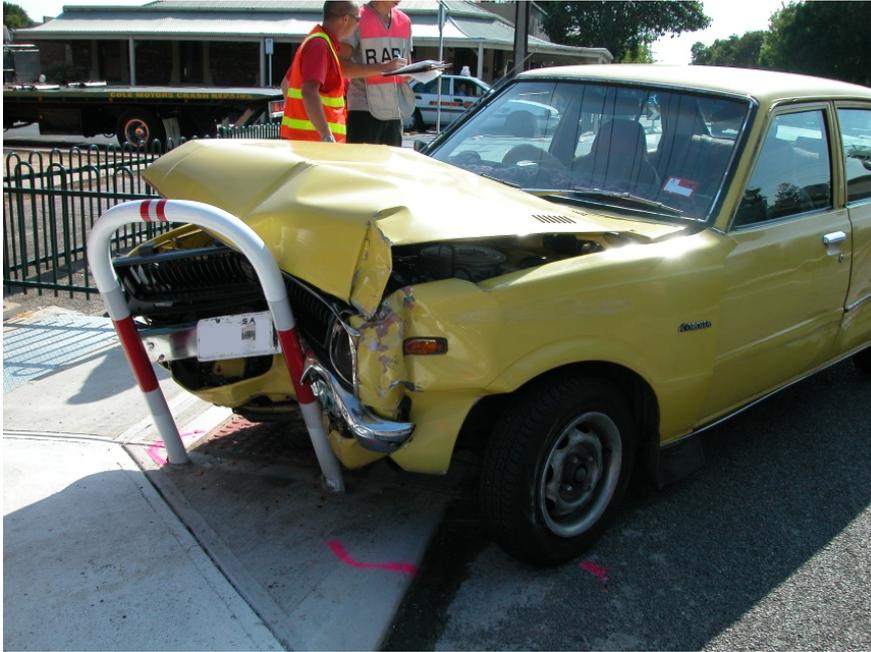
Figure A.12
 Unit 2 after the crash. The initial impact and secondary impact are shown in this picture as they were both frontal impacts. The pedestrian handrail is also shown

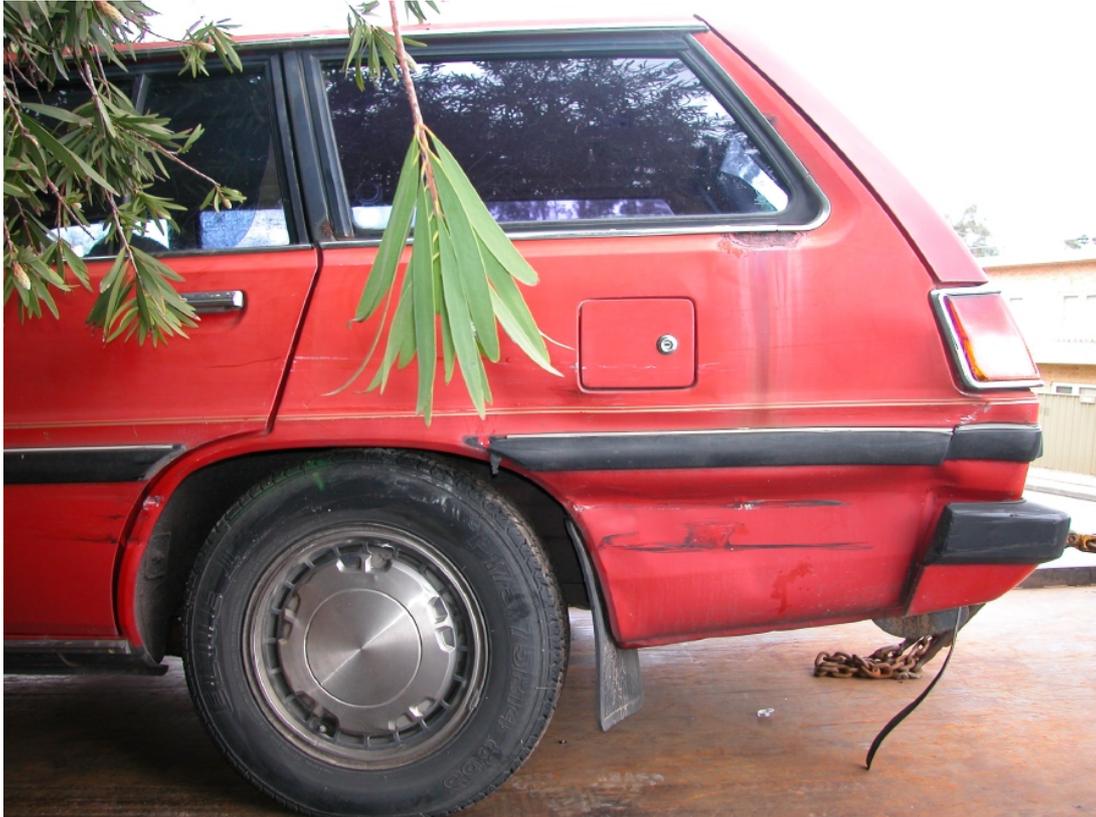
Figure A.14
Unit 2 after the crash showing the damage from the initial impact on the left rear quarter panel

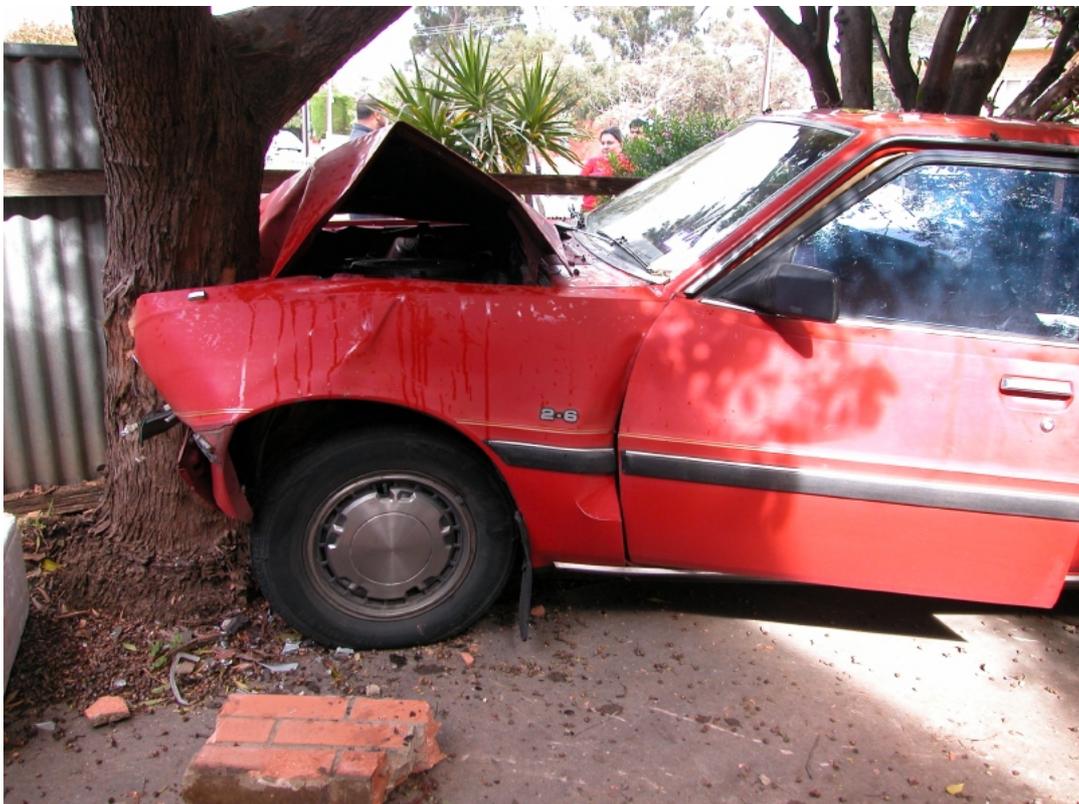
Figure A.15
Unit 2 after the crash showing the damage from the secondary impact with the tree

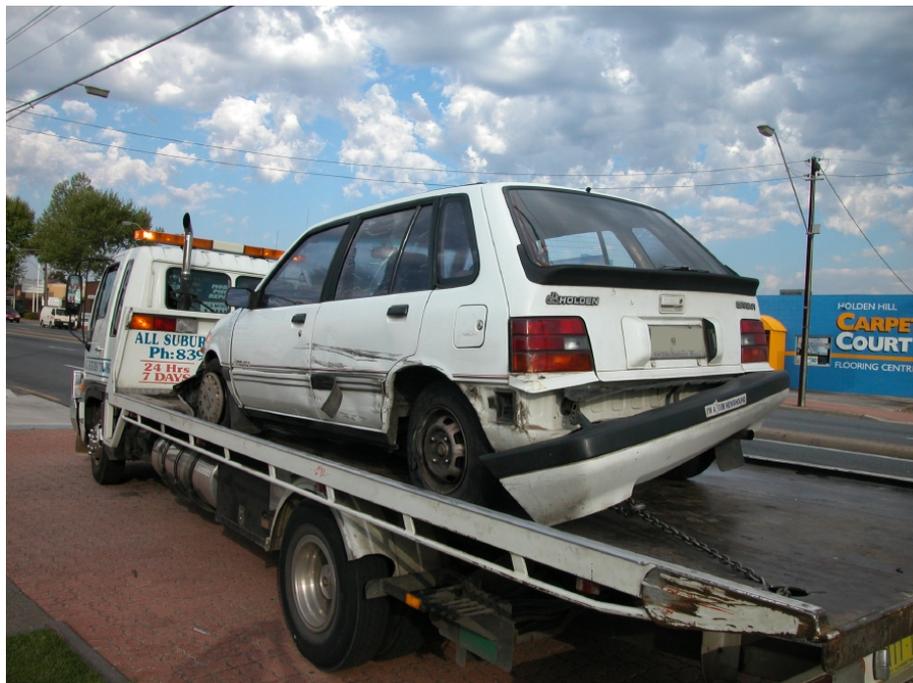
Figure A.17

Unit 1 after the crash showing the damage from the initial impact on the left rear door

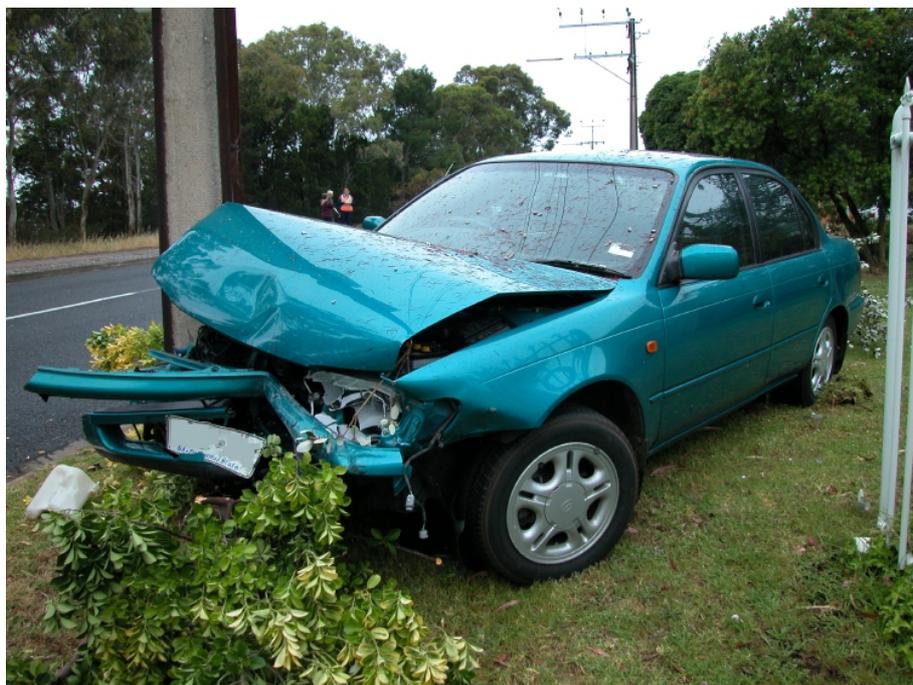
Figure A.22

Unit 1 after the crash showing the damage from the initial impact on the front of the vehicle

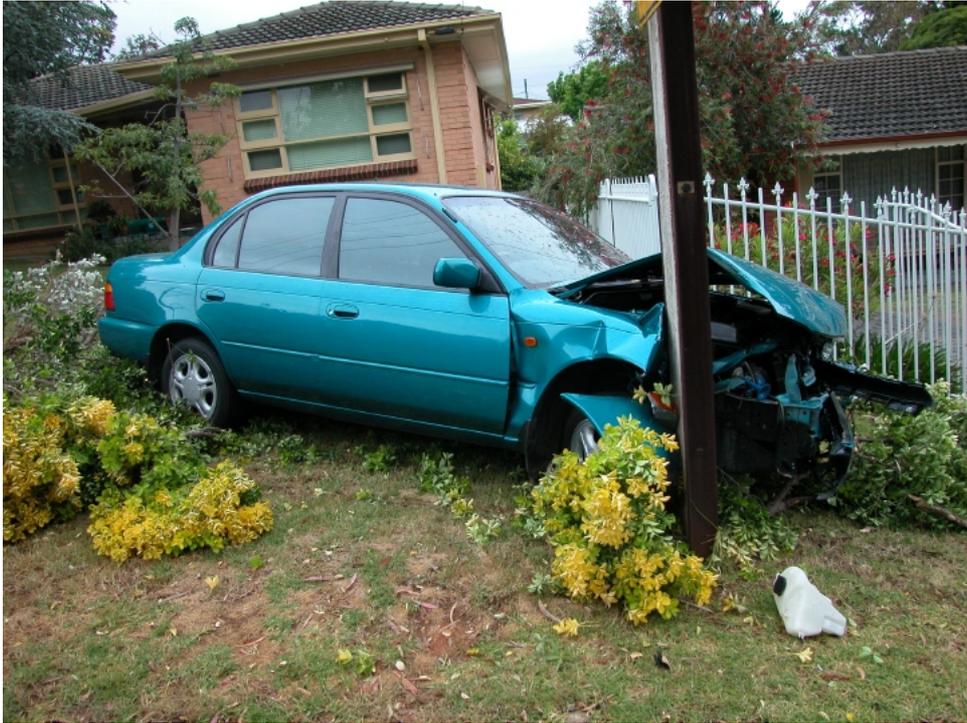
Figure A.23

Unit 1 after the crash showing the damage from the secondary impact on the right front of the vehicle and the stobie pole
