Collection and analysis of EDR data from crash-involved vehicles: 2019-20 summary report

ME Elsegood, SD Doecke, G Ponte

CASR170

September 2020

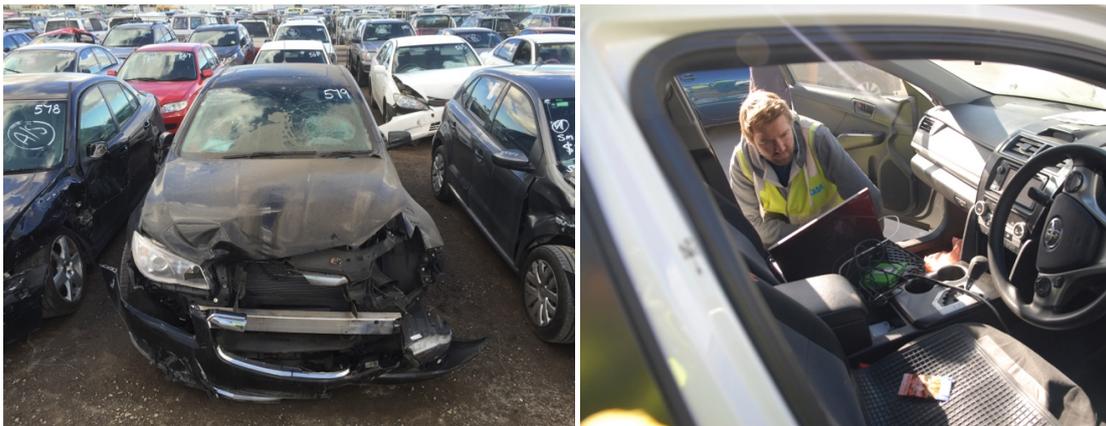
Crashed vehicles at the holding yard (left) and a CASR researcher performing an EDR download via the OBD-II port (right)

Figure 2.1 shows a section of the vehicle holding yard and a CASR researcher undertaking a download. To download the data from a crashed vehicle, a Bosch Crash Data Retrieval (CDR) tool is used to access and decode the data contained in the crashed vehicle's EDR via the OBD-II port. Photographs are taken around the exterior of the vehicle as well as the interior of the vehicle, and basic measurements of the deformation are recorded. On the rare occasions that the OBD-II is not accessible, the airbag control module (ACM) that contains the EDR data is requested from the purchaser of the vehicle for a monetary value. Two modules have been obtained by this method.

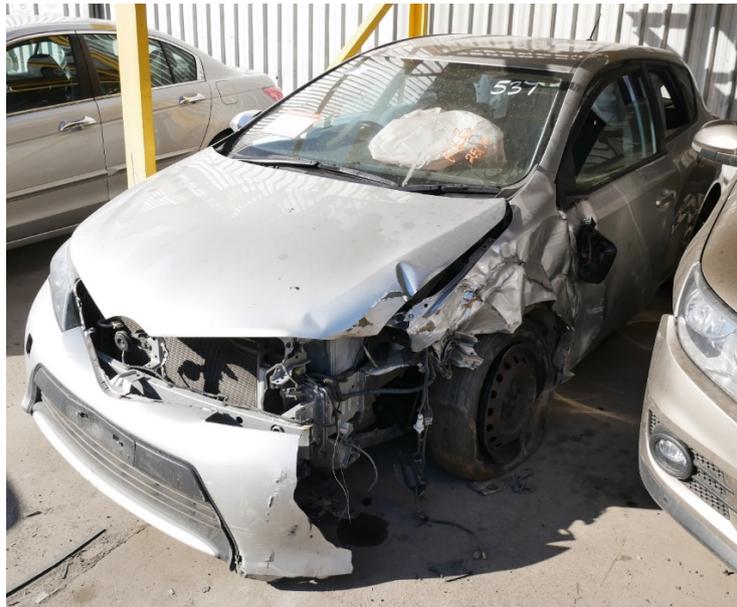
Figure 5.1
Damage on EDR380

Case EDR380 involved a 2012 Toyota Corolla. It had sustained damage to the front of the vehicle, offset to the left, as shown in Figure 5.1. The impact had missed the left chassis rail and the intrusion had continued to the left front wheel. Both front airbags had deployed as had the knee airbag and the curtain airbags on both sides.

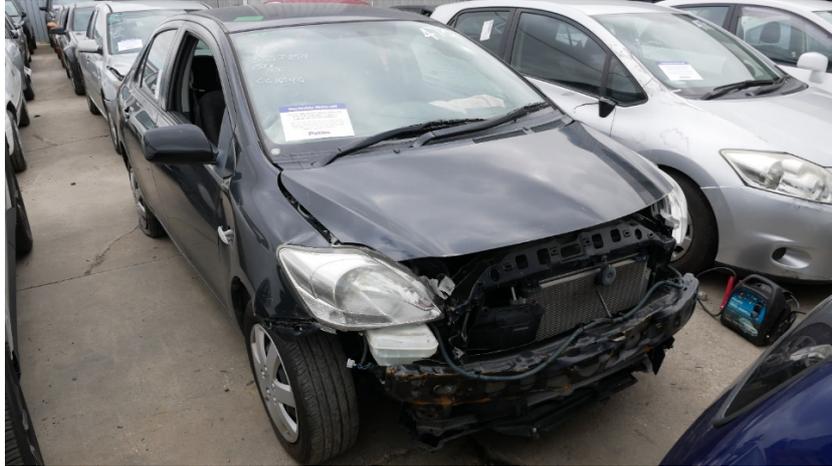
Figure 5.3
Damage on EDR345

Case EDR345 involved a 2006 Toyota Yaris. When inspected at Pickles, the front bumper and grille were missing and there was relatively minor damage to the front cross member, as shown in Figure 5.3. Both frontal airbags had deployed.
