# An assessment of ACT road infrastructure for compatibility with Advanced Driver Assistance Systems

CASR221

REPORT NO.	DATE	PAGES	ISBN	ISSN
CASR221	February 2024	31	978-1-925971-54-5	1449-2237

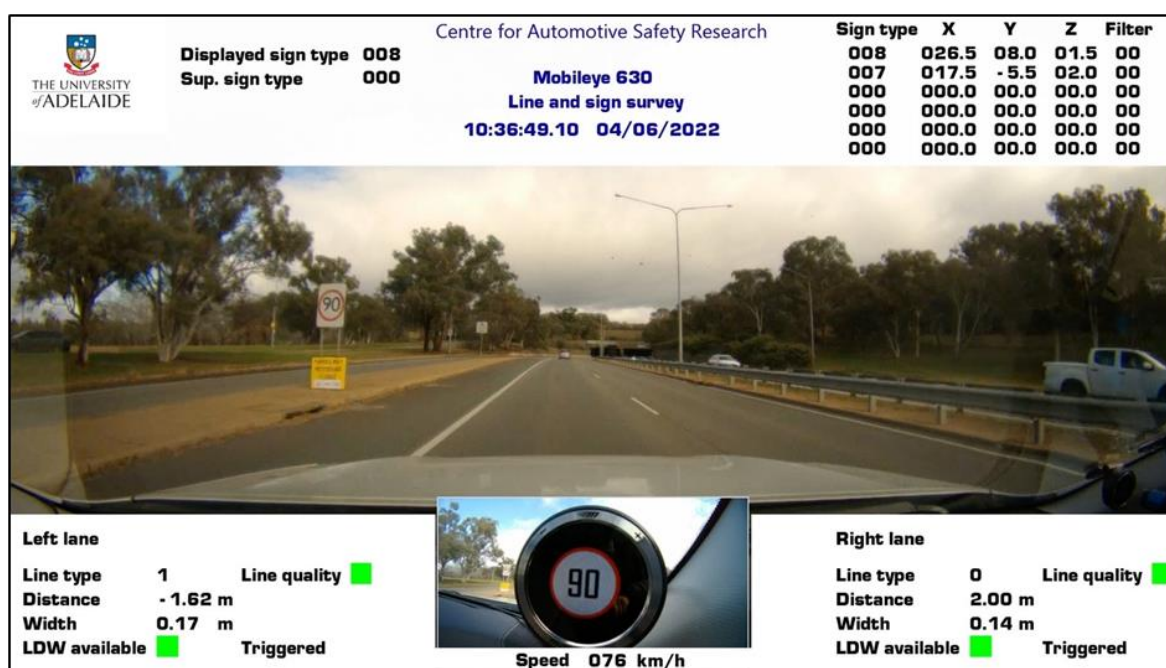
An example of the video recorded by the instrumented vehicle, including a sub-set of data collected, a view of the forward driving scene, and the Mobileye display

An instrumented vehicle was utilised for data collection. The vehicle, a 2014 Subaru Outback, was fitted with a Mobileye dev-kit system as well as a RaceLogic Vbox Video HD2 system. These systems are described in greater detail below but, in tandem, they enable the collection of ADAS data regarding line markings and signage at a frequency of 10 times a second, along with synchronised GPS location and video of the forward driving scene. An example of this video scene, overlaid with various types of ADAS data, is shown in Figure 2.1 below.

The CAN data from the Mobileye was collected in two ways via connections to external systems as shown in Figure 2.2 below. The first connection was to a Vbox Video HD2 system. This system is able to capture, decode, and record the CAN messages along with GPS data and video from two cameras. The HD2 system records up to 80 CAN channels and GPS data synchronously at a frequency of 10 Hz. This recorded data is saved into a “.vbo” file which is formatted in a similar way to a .csv (comma-separated values) file. Additionally, the video from the two cameras is recorded in .mp4 video format with an overlay of other data (see Figure 2.1).

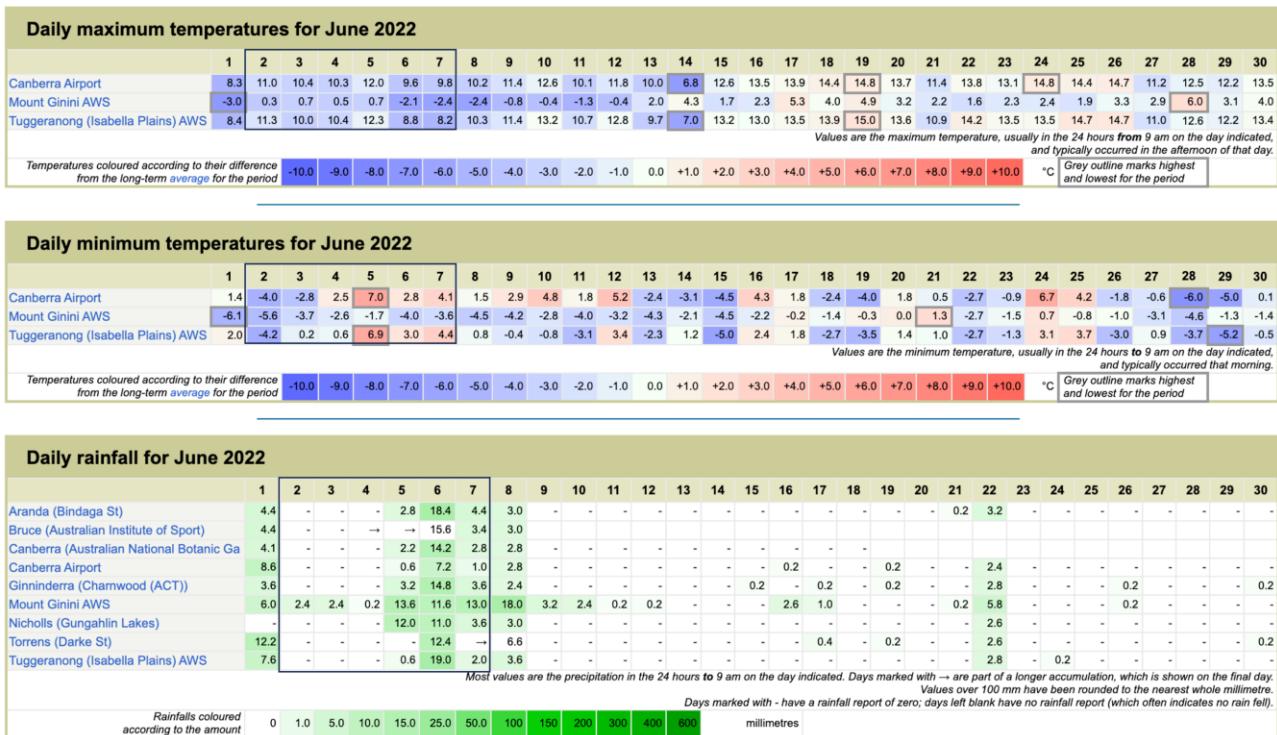
Figure 2.3  
Temperature and rainfall history during data collection period

Weather conditions were dry for the first three days of the data collection period, but there were periods of rain in the final two days. Data collection was still conducted during these last two days, but halted when rainfall intensity was deemed sufficient to hinder the performance of the Mobileye system. Temperature and rainfall history recorded by the Bureau of Meteorology during the data collection period is shown in Figure 2.3.

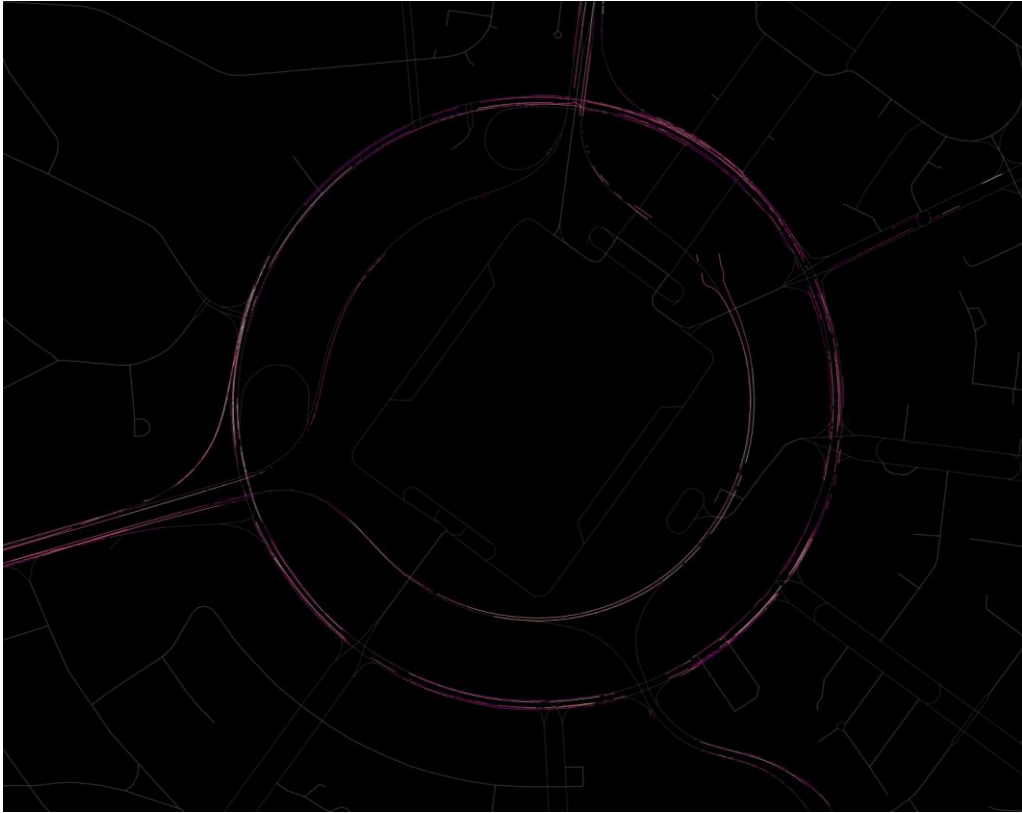
Figure 3.3

Sample of high-resolution map detail showing lane width across the roads where data collection occurred (lighter shades indicate narrower widths progressing to darker shades which indicate wider widths)

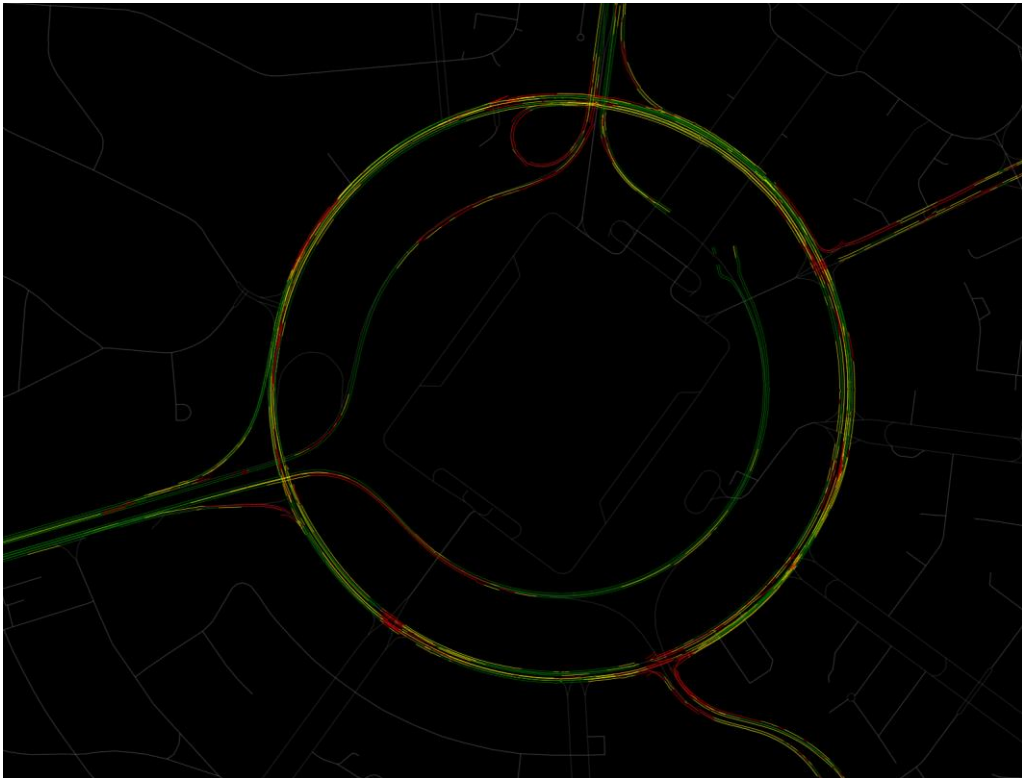
Figure 3.4

Sample of high-resolution map detail showing line marking quality across the roads where data collection occurred (Red: undetectable, Orange: poor, Yellow: satisfactory, Green: good)

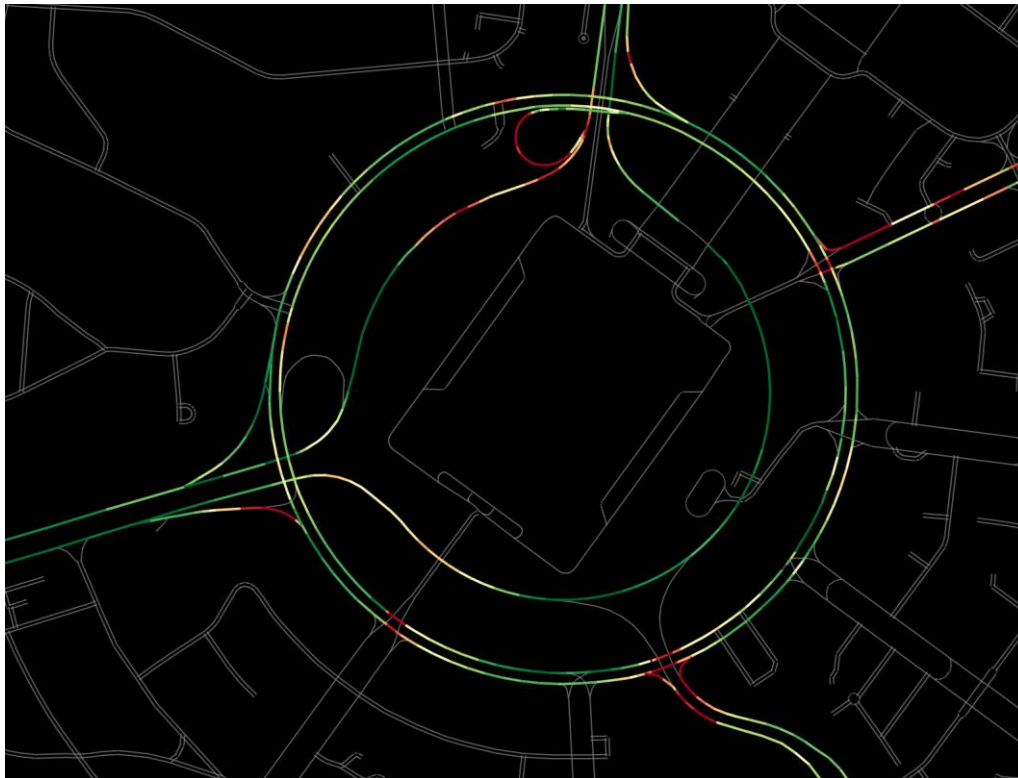
Figure 3.7

Sample of high-resolution map detail showing line quality across the OSM road segments where data collection occurred (Red: undetectable, Orange: poor, Yellow: satisfactory, Green: good)

A final map was then generated by using the data points that were snapped to the Open Street Map (OSM) network. The quality of any left and right line markings from data points associated with each road segment in the OSM network were aggregated to calculate an overall segment quality score. This quality score provides an estimate of the likelihood that ADAS will understand the line markings over that segment of roadway. The quality score aggregates the data collected from all lanes of travel (where data was collected) over each road segment, but different directions of travel were considered separately.

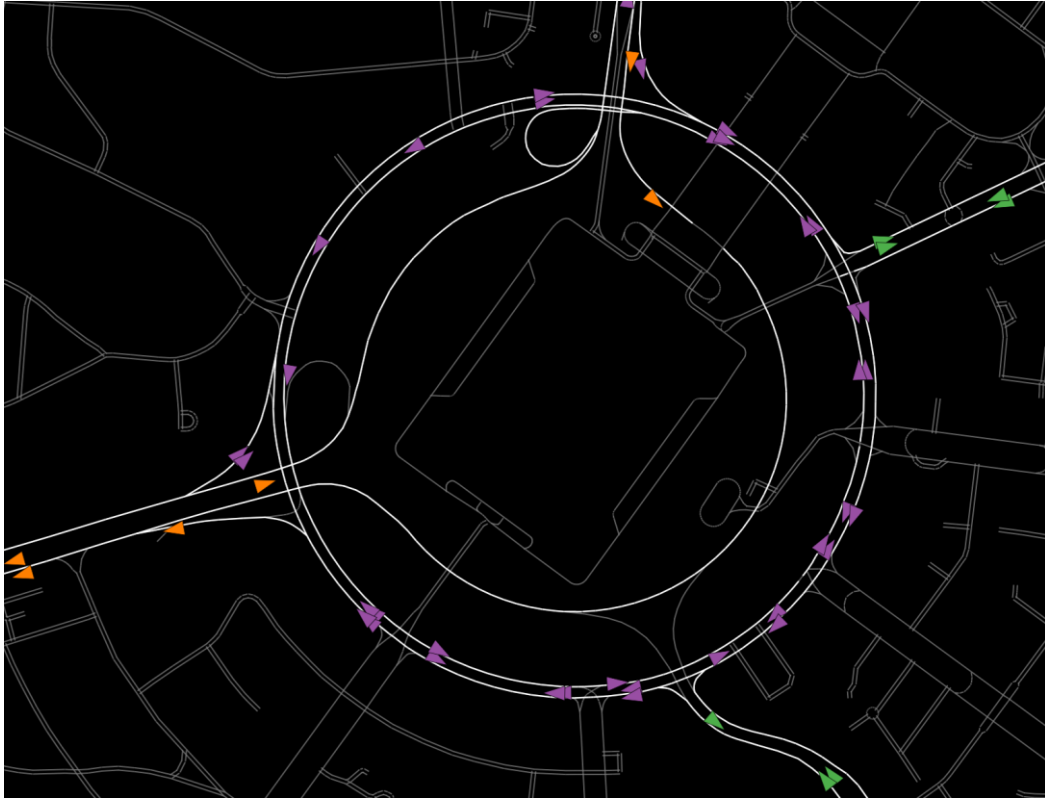
Sample of high-resolution map detail showing detected speed limit signs across the roads where data collection occurred  
(Green: 60 km/h, Purple: 70 km/h, Orange: 80 km/h)

The generation of a high-resolution digital map resulted in an image that was 30,946 pixels wide and 50,450 pixels in height, with a file size of 88 Mb. This image was too large to include within this report, but a sample of the detail and resolution found within the full generated image is shown in Figure 3.8 below.

Different speed limits are shown with different coloured icons that are rotated to indicate the direction of travel for which they are relevant. As there is no official database of sign locations across the ACT, it is not possible to determine whether any signs have been missed. However, there appears to be generally good coverage across the roads that were assessed.

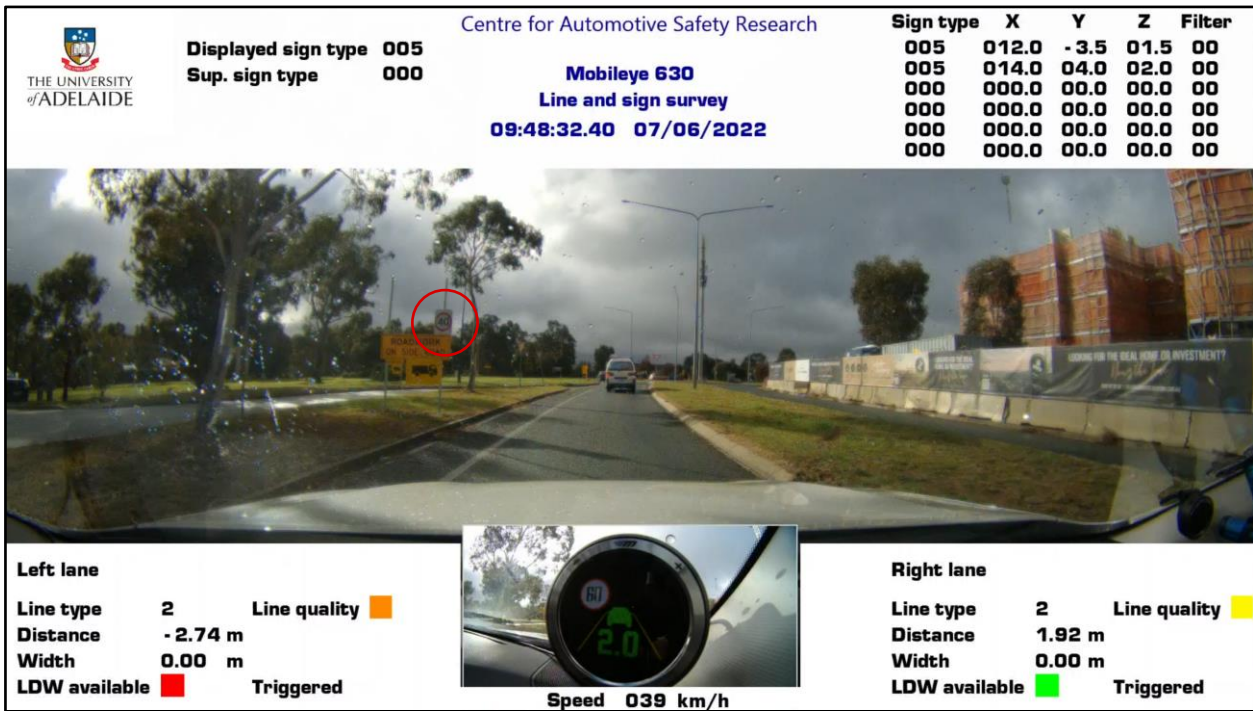
Figure B.1  
 Detected sign with a 40 km/h speed limit with a road segment tagged with a 60 km/h speed limit in the Open Street Map road network

The images below show the result of an ad-hoc audit of instances where the speed limit of a Mobileye detected sign did not match with the listed speed limit of the corresponding road in Open Street Map.

The images show a point in time where the detected speed limit sign can be seen best, as indicated by a red circle. Note that the Mobileye system does not update the display (shown bottom centre in each image) until the vehicle has passed the sign. As such, the speed limit shown on the display may not align with the sign shown in the images.

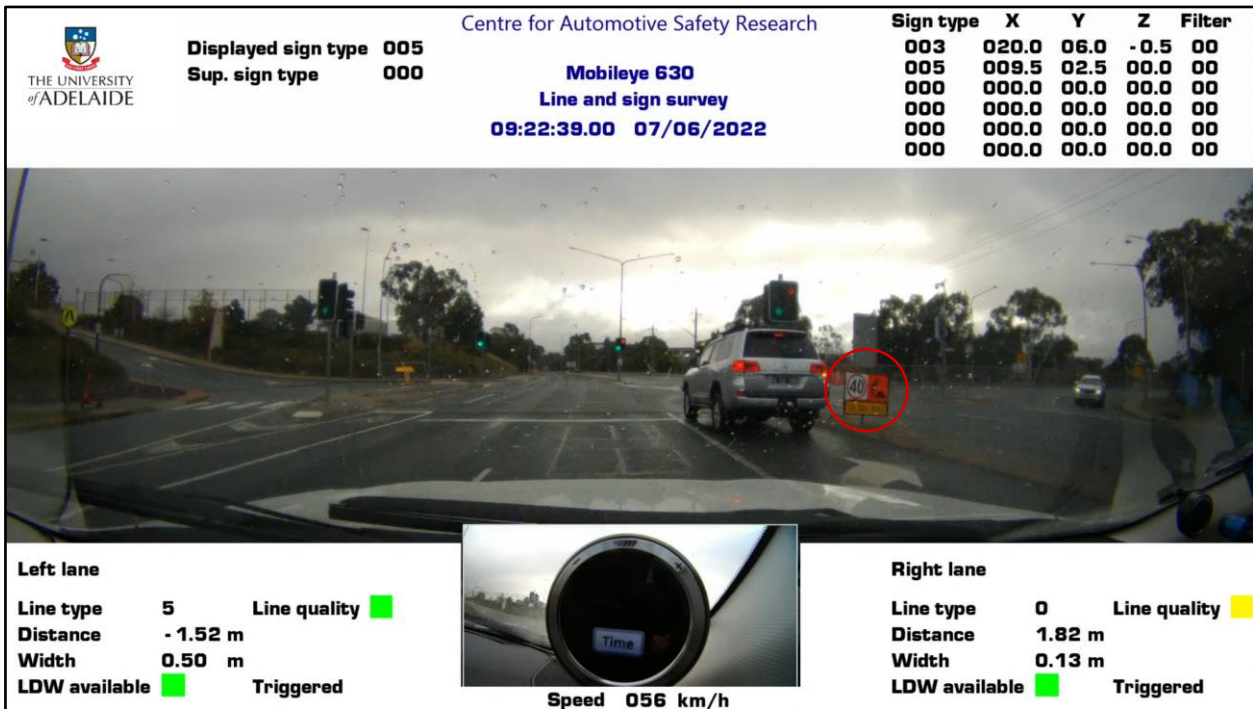
Figure B.2  
 Detected sign with a 40 km/h speed limit with a road segment tagged with an 80 km/h speed limit in the Open Street Map road network

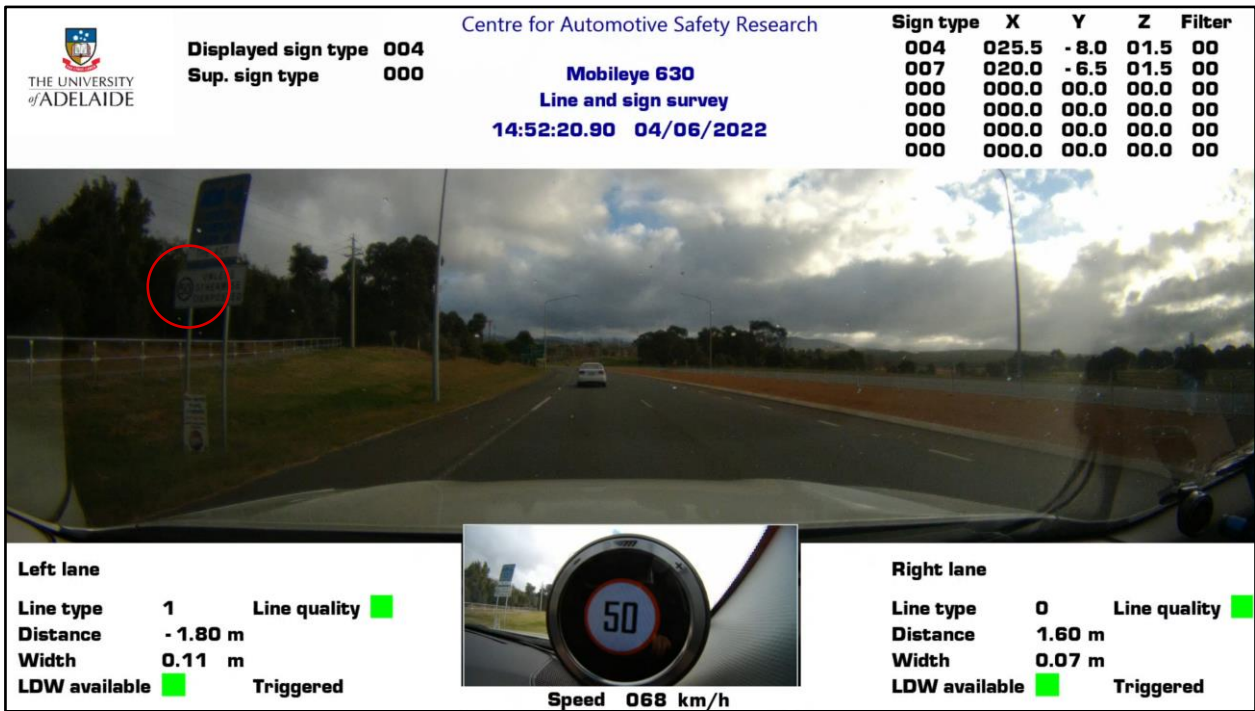
Figure B.3

Detected sign with a 50 km/h speed limit with a road segment tagged with an 80 km/h speed limit in the Open Street Map road network

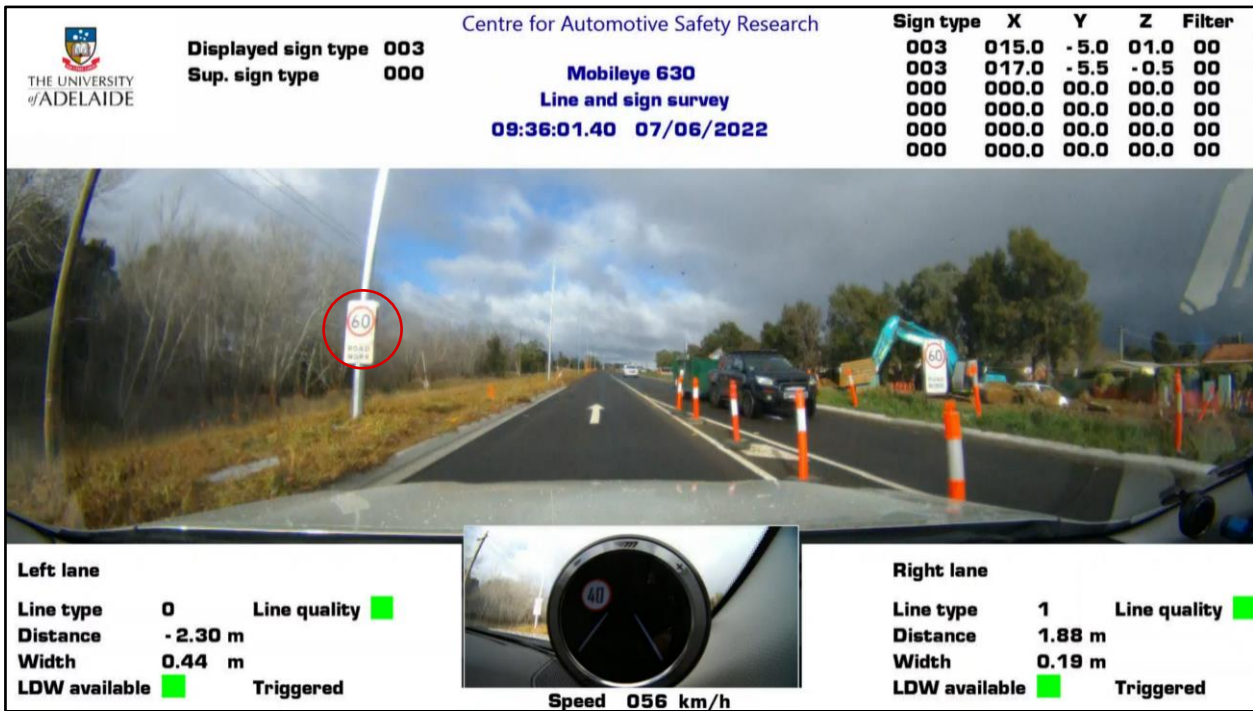
Figure B.5

Detected sign with a 60 km/h speed limit with a road segment tagged with an 80 km/h speed limit in the Open Street Map road network

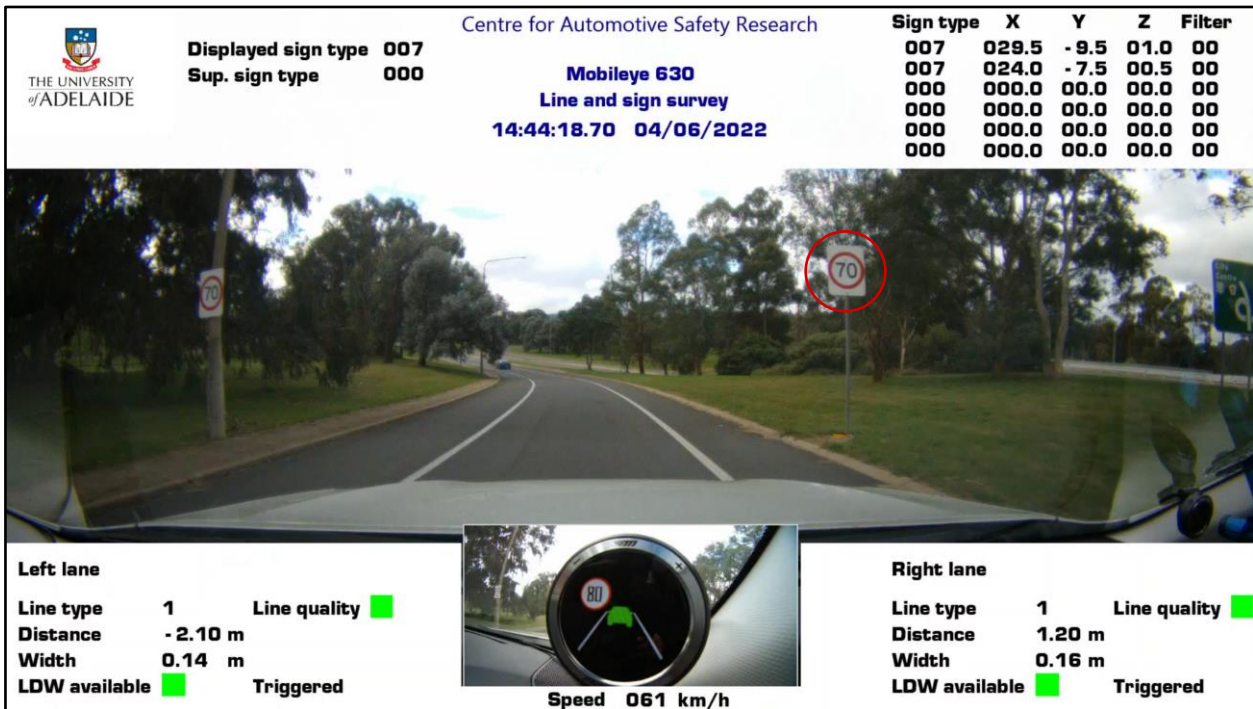
Figure B.6

Detected sign with a 70 km/h speed limit with a road segment tagged with an 80 km/h speed limit in the Open Street Map road network

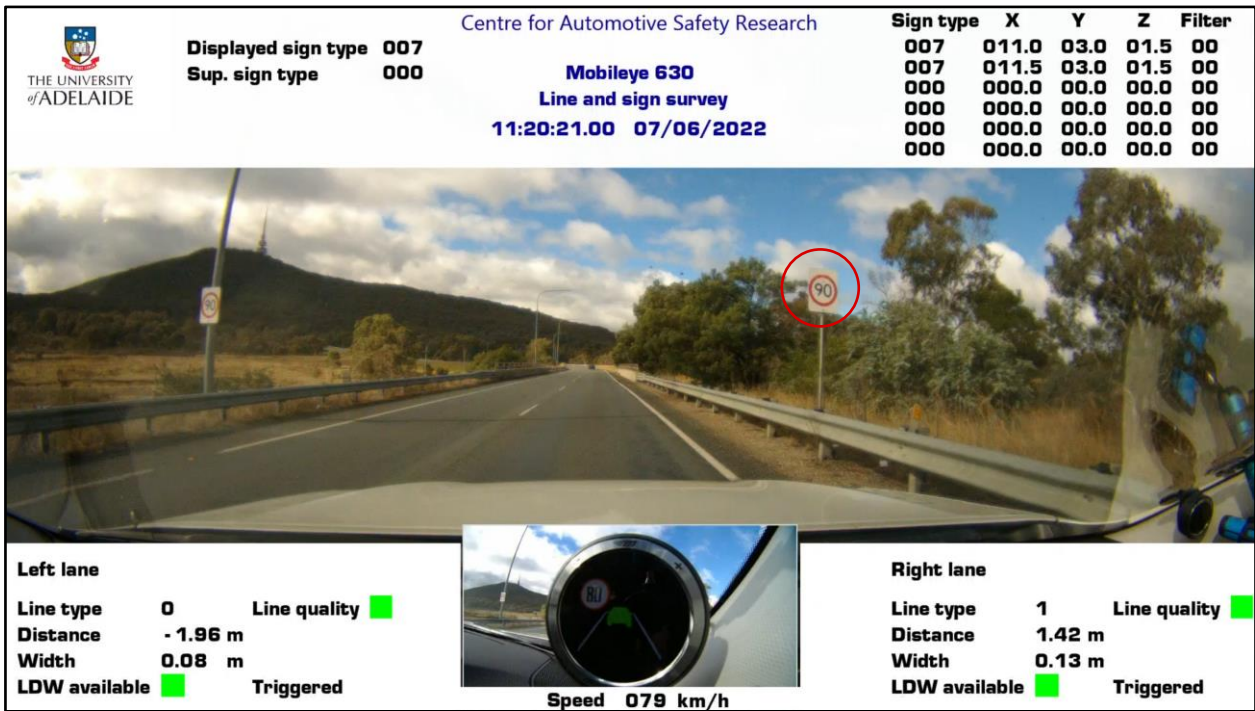
Figure B.7

Detected sign with a 90 km/h speed limit with a road segment tagged with an 80 km/h speed limit in the Open Street Map road network
