Vehicle Design and Operation for Pedestrian Protection

- Accident Simulations and Reconstructions

*A Commissioned Report by
Road Accident Research Unit
Adelaide University*

VSSR 1
2003

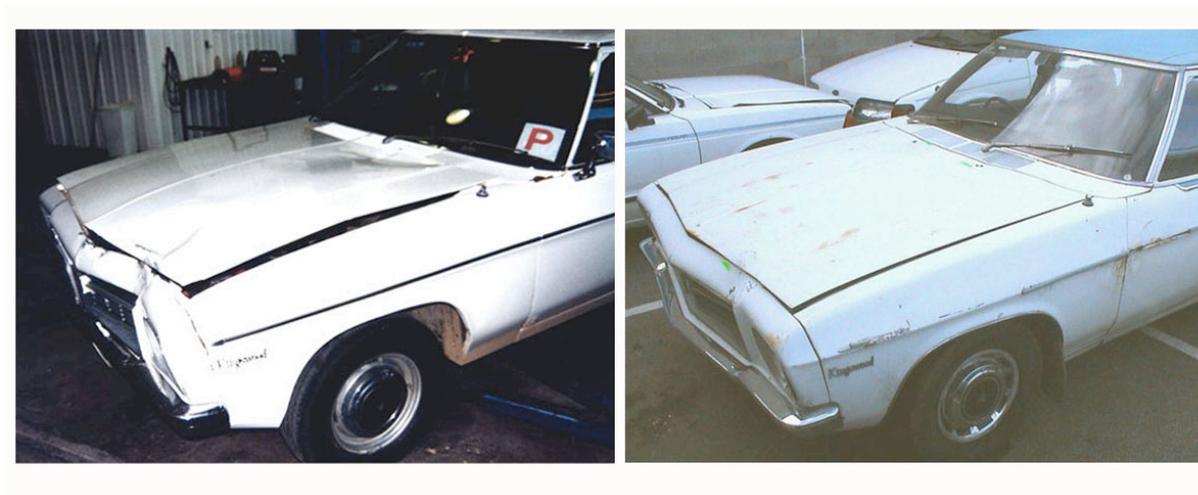
Figure 4-2 The deformation of the bonnet caused in the collision in Case PED057-99 (left). The deformation caused by the reconstruction tests was much less (right). The deformation created in the collision may have protected the head of the pedestrian by lifting the bonnet surface away from the under bonnet components of the car.

- In another case, PED011-99, the head impact reconstruction produced much less damage than expected. In this case, the test was repeated until the damage from the accident was replicated. (In all other cases, the damage produced by the reconstruction was similar to that seen in the actual accident).

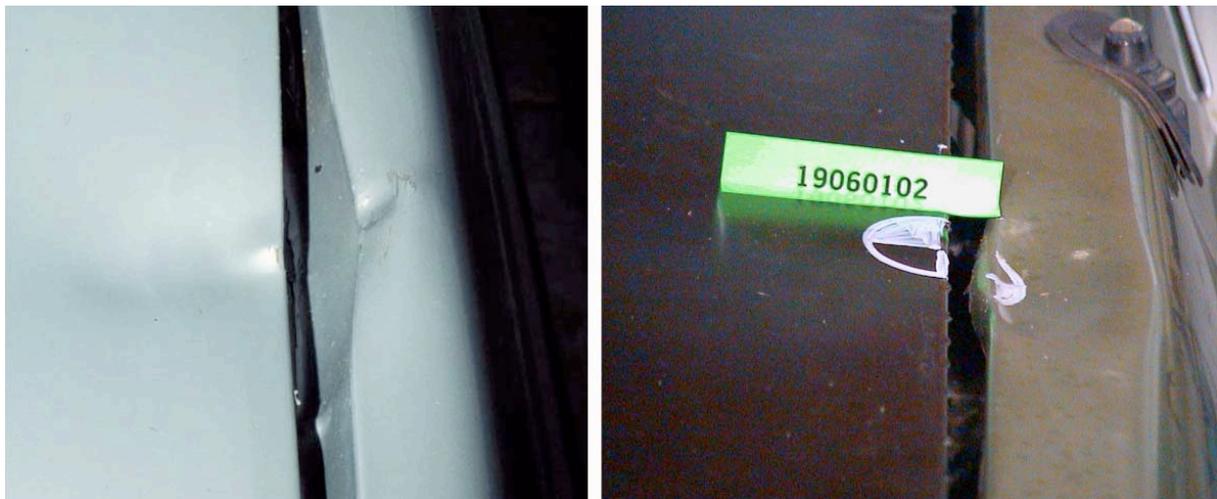
Figure 7-6 Damage caused by impact with the pedestrian’s head (left) and the damage produced in the reconstruction (right) of case PED011-99 (test 19060102).

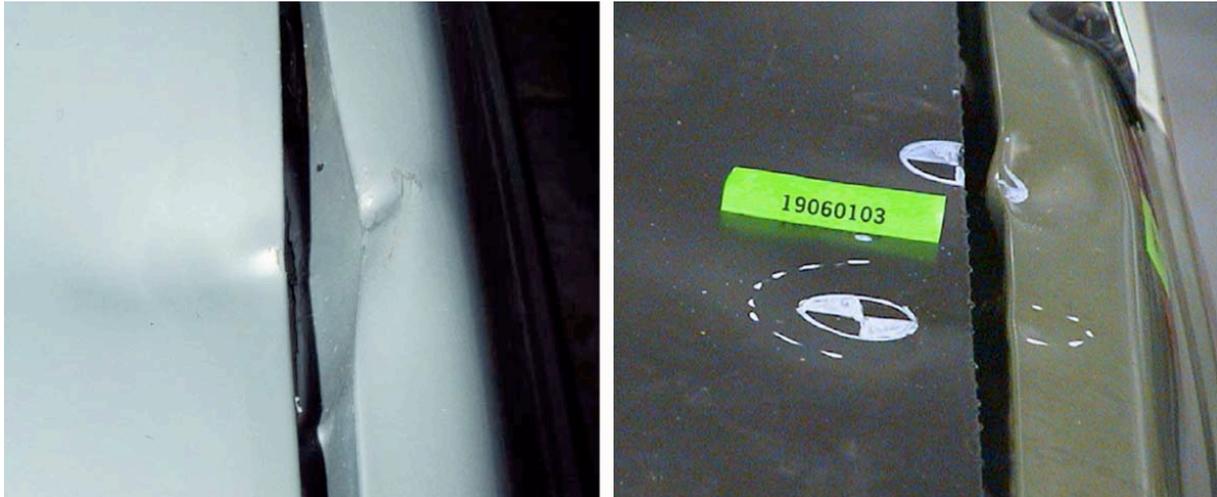
Figure 7-8 Damage caused by impact with the pedestrian’s head (left) and the damage produced in the second reconstruction (right) of case PED011-99 (test 19060103).

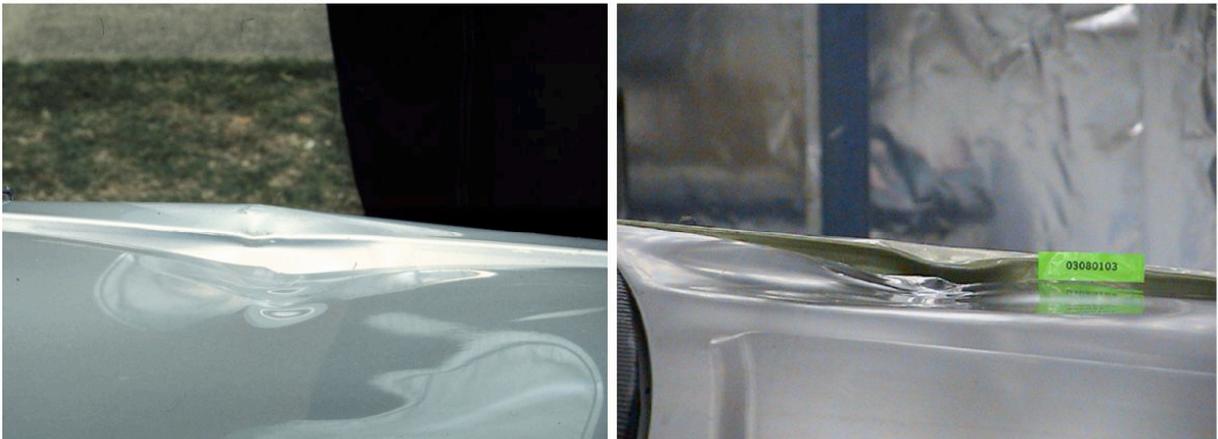
Figure 7-10 Damage caused by impact with the pedestrian's head (left) and the damage produced in the third reconstruction (right) of case PED011-99 (test 03080103).

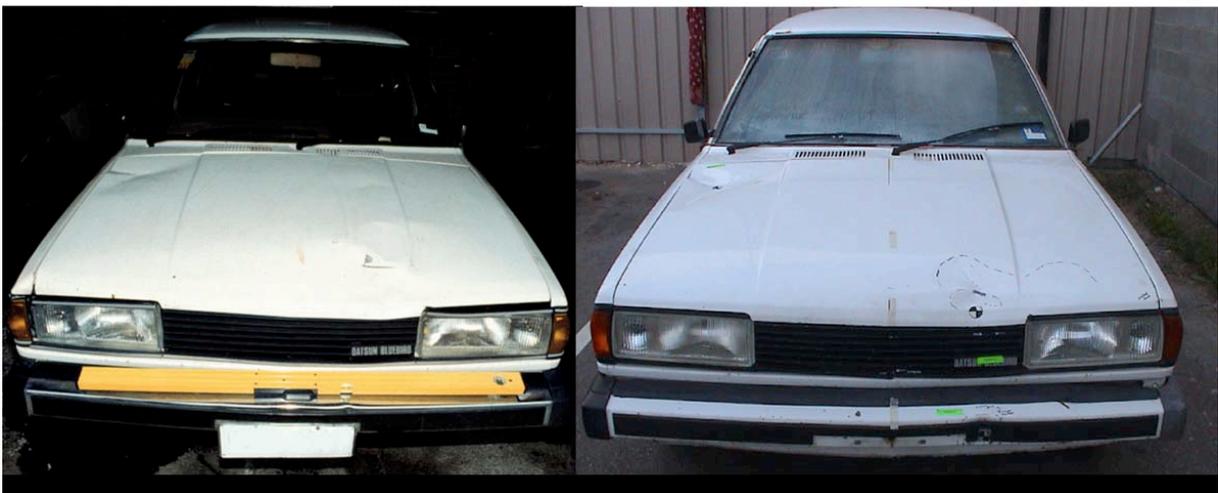
Figure 8-4 A general view of the accident damage from the impact (left) and the damage produced in the physical reconstruction (right) of case PED018-99.

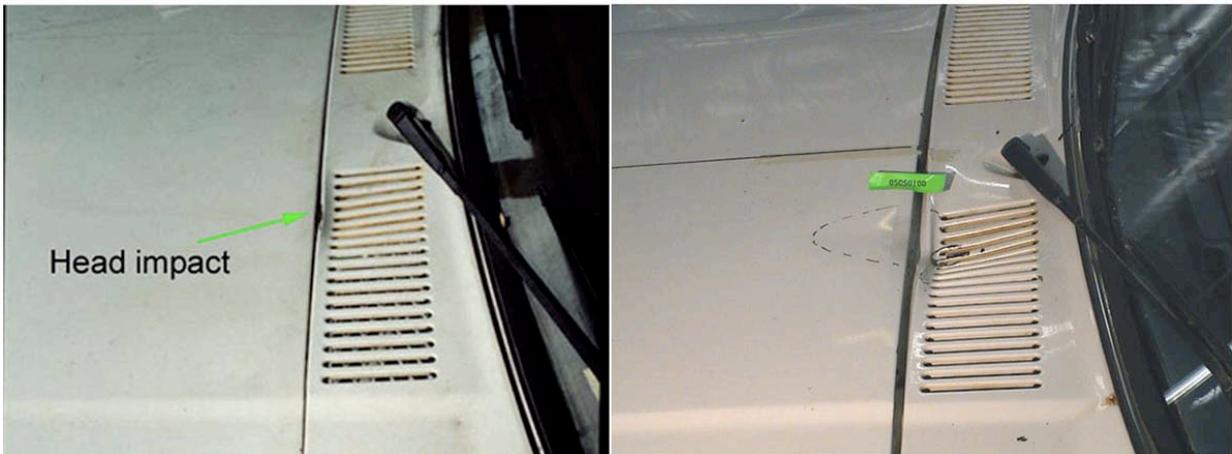
Figure 8-6 A side view of the damage caused by impact with the pedestrian's head (left) and the damage produced in the reconstruction (right) of case PED018-99.

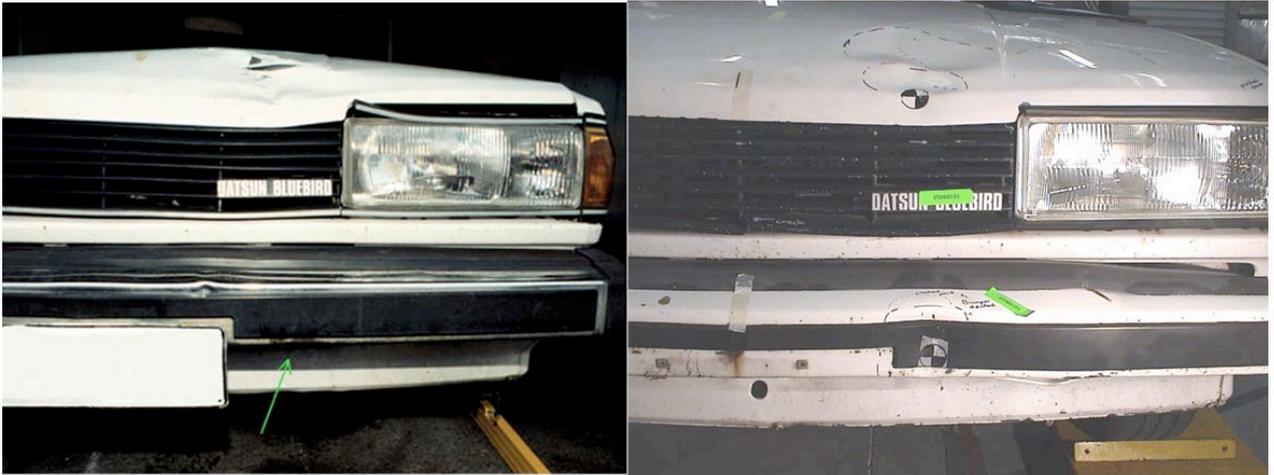
Figure 8-12 A close up front view of the accident damage from impact with the pelvic area (left) and the damage from the reconstruction with the Upper Legform (right) of case PED018-99.

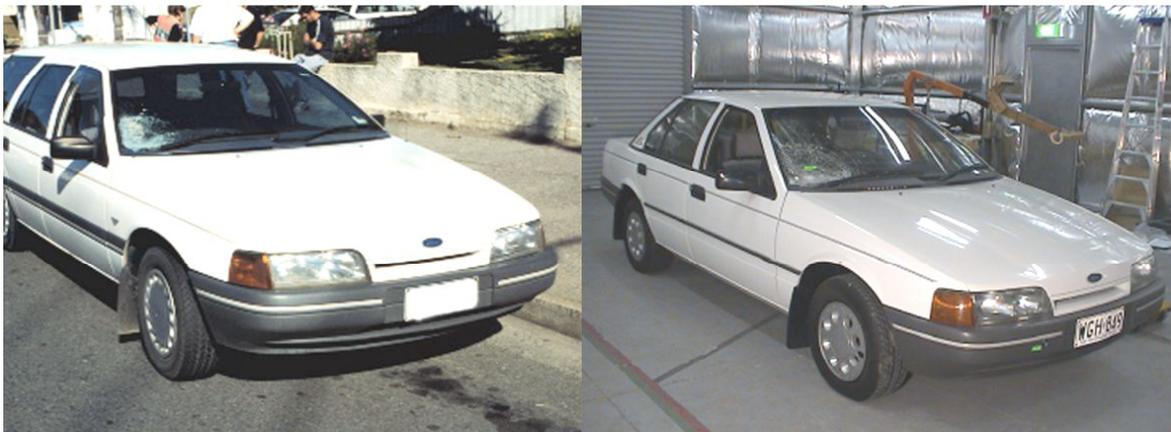
Figure 9-4 A general view of the accident damage (left) and the damage produced by the reconstruction (right) of the head and leg impacts in case PED035-99.

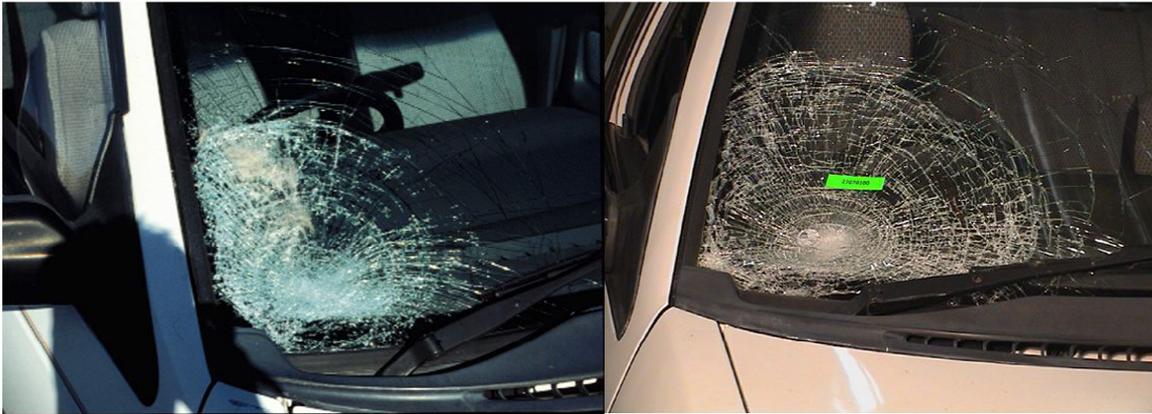
Figure 9-6 A front close up view of the vehicle involved, showing where the head impact occurred (left) and the damage as produced by the reconstruction (right) of case PED035-99.

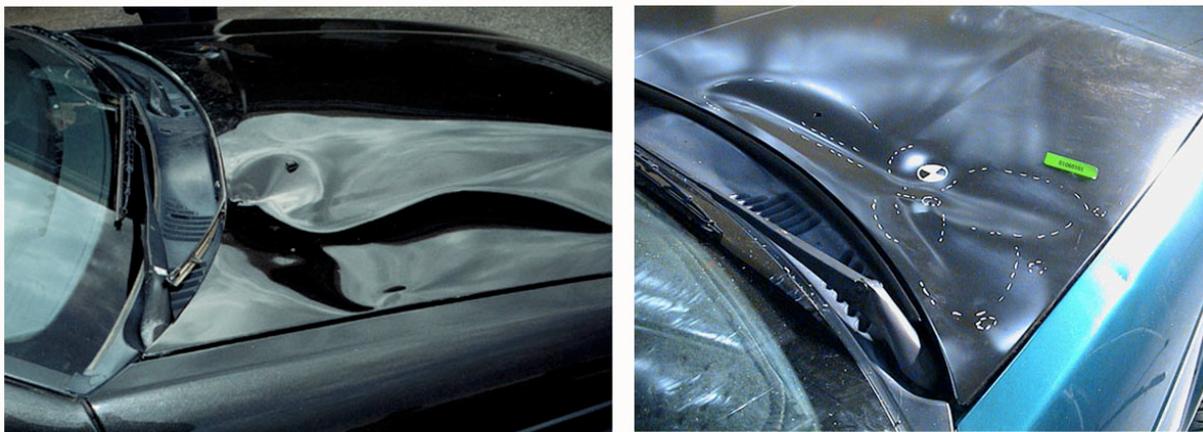
Figure 10-5 A side view of the vehicle involved in case PED043-99, showing where the head impact occurred (left) and the damage as produced by the reconstruction (right).

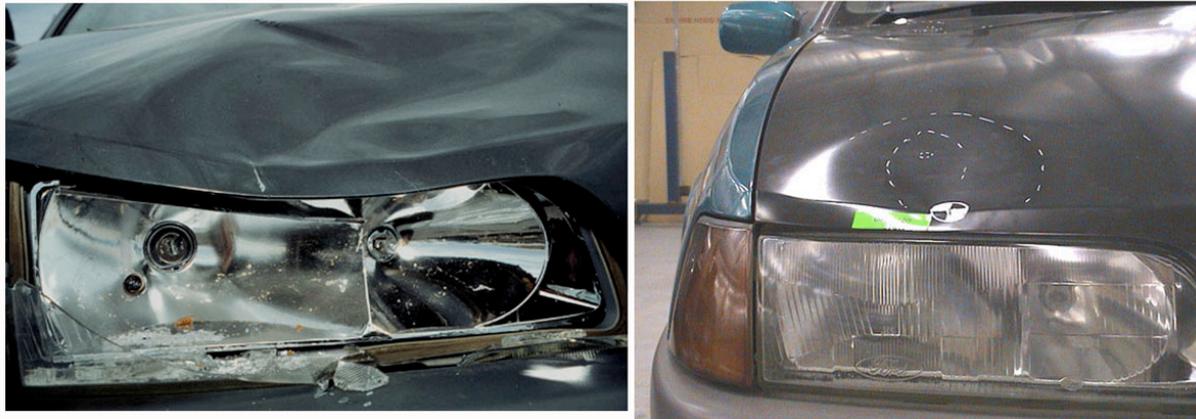
Figure 10-10 The accident damage caused by impact with the pelvic area (left) and the damage produced by the reconstruction with the Upper Legform impactor (right) of case PED043-99.

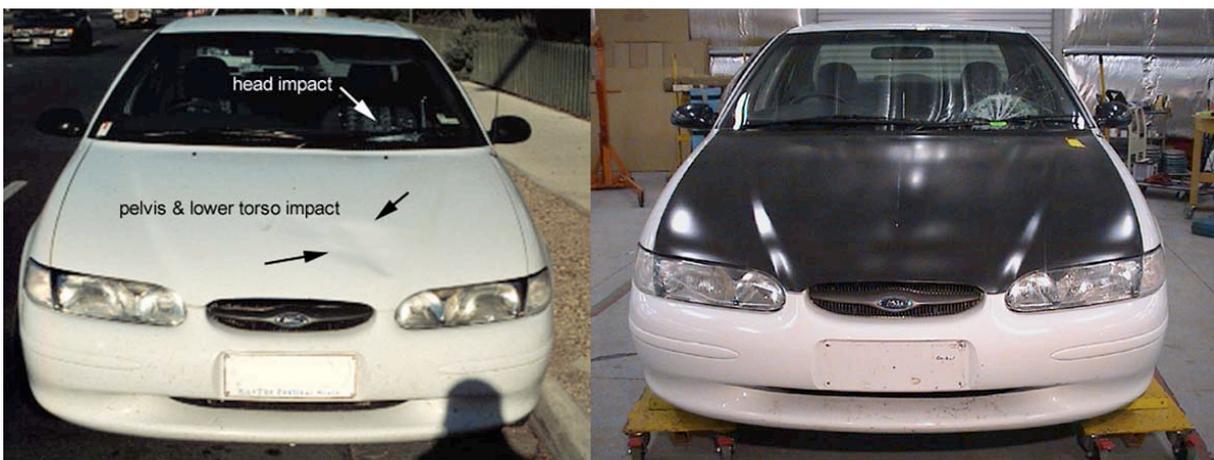
Figure 11-4 A general view of the accident damage (left) and the damage produced by the reconstruction (right) of case PED049-99.

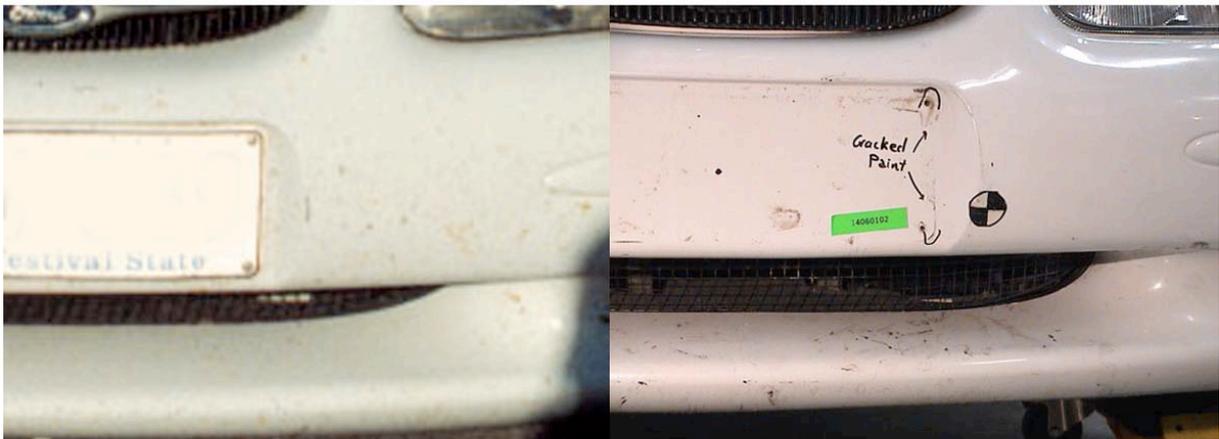
Figure 11-10 The accident damage caused by the pedestrian's leg (left - negligible) compared with the physical reconstruction damage of the full leg impact (right) in case PED049-99.

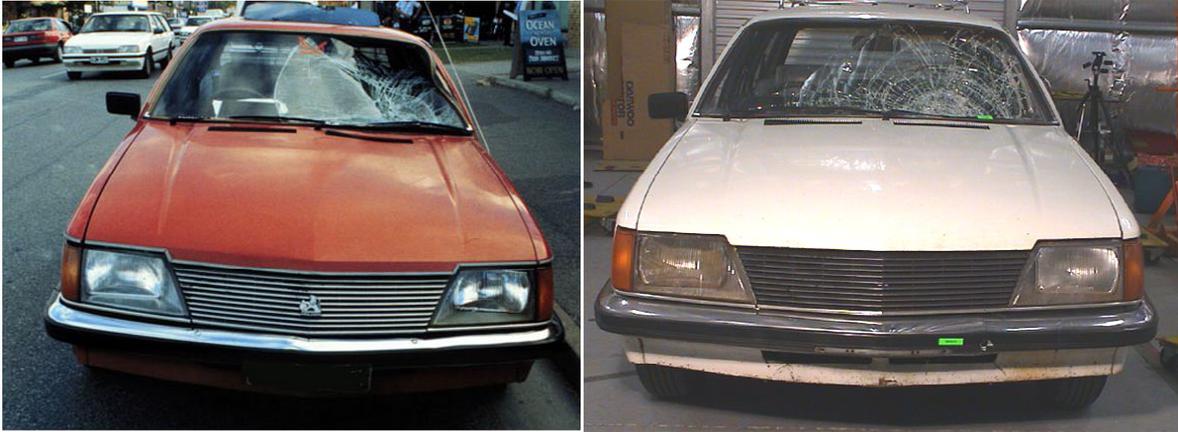
Figure 12-4 A general view of the accident damage (left) and the damage produced by the reconstruction (right) of case PED056-99.

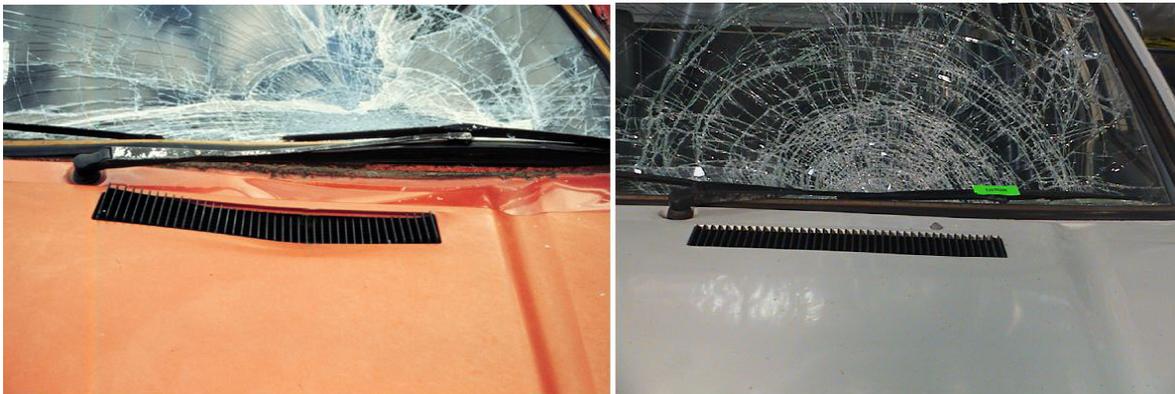
Figure 12-6 The accident damage caused by the impact with the head of the pedestrian (*left*) and the physical reconstruction damage of the head impact (*right*) in case PED056-99.

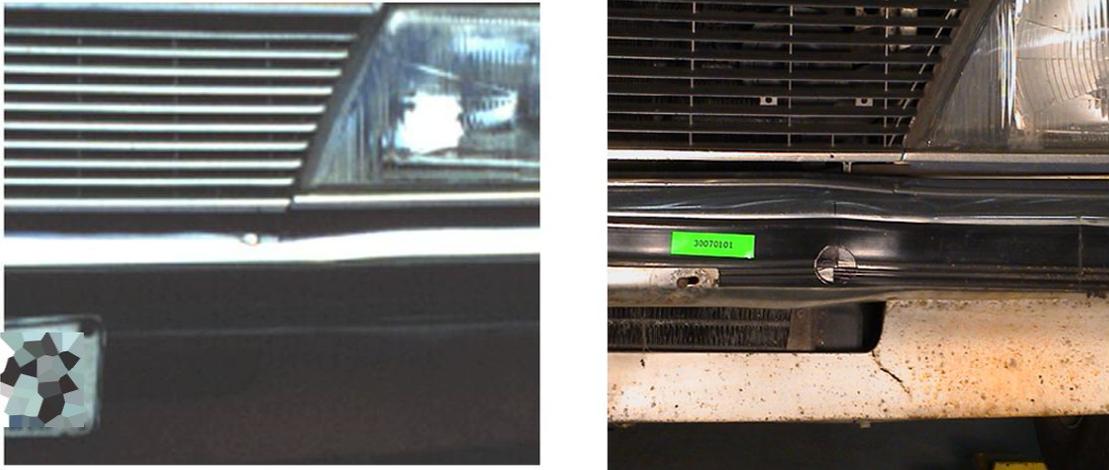
Figure 12-10 Close-up view of the vehicle involved in the actual pedestrian impact compared with the reconstruction of case PED056-99, very minor denting on the steel bumper bar in both cases.

The recordings of the tibia acceleration and the knee kinematics are shown in Figure 12-7 to Figure 12-9. A comparison of the damage caused by the reconstruction and the actual leg impact is shown in Figure 12-10.

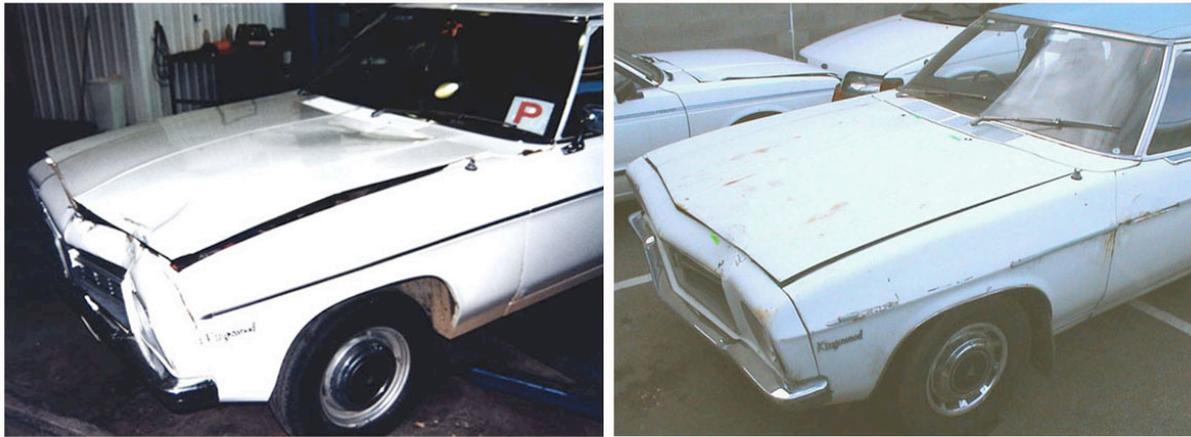
Figure 13-4 The accident damage from the impact (left) and the damage produced in the physical reconstruction (right) of case PED057-99.

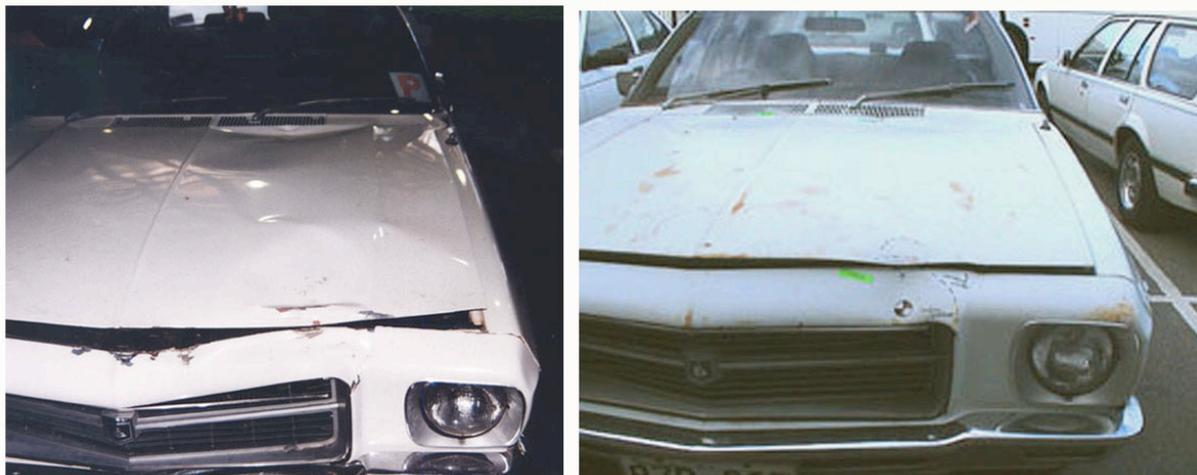
Figure 13-9 A close up front view of the accident damage from impact with the pelvic area (left) and the damage from the reconstruction with the Upper Legform (right) of case PED057-99.

- In Case PED057-99, the test speed in the Upper Legform test was lowered as it was thought that the impact would be severe enough to damage the test equipment. It was decided that if the test at the lower speed did not fail, the test would be repeated at a higher speed.

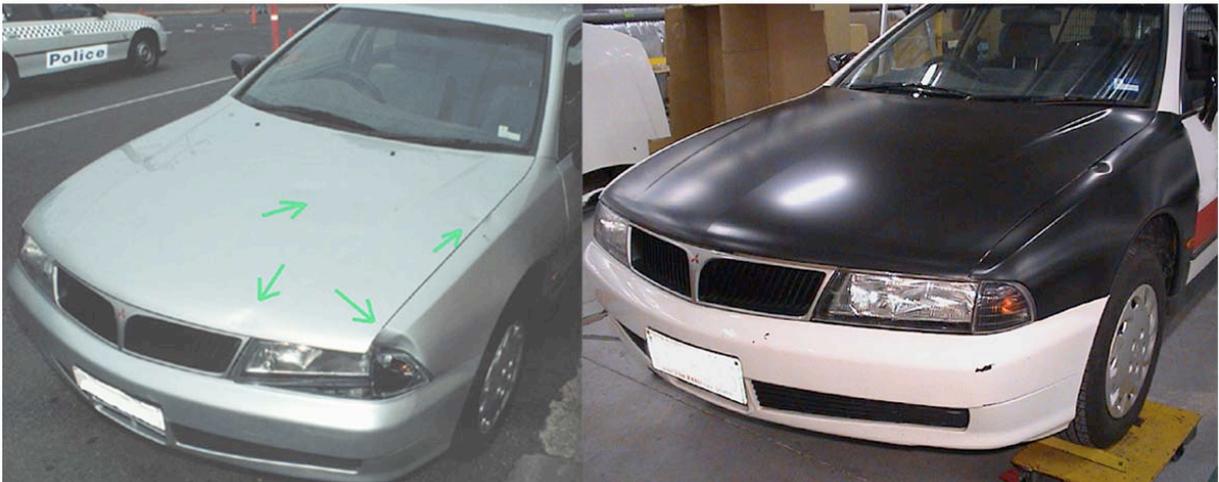
Figure 14-4 A general view of the vehicle involved in case PED061-99 (left) and the general view after the physical reconstruction (right) of case PED061-99.

The head impact experienced by the pedestrian was reconstructed using Child Headform, which was fired at the impact point identified in the crash investigation. Figure 14-4 shows overall shots of the accident-involved vehicle and the vehicle used for the reconstruction.

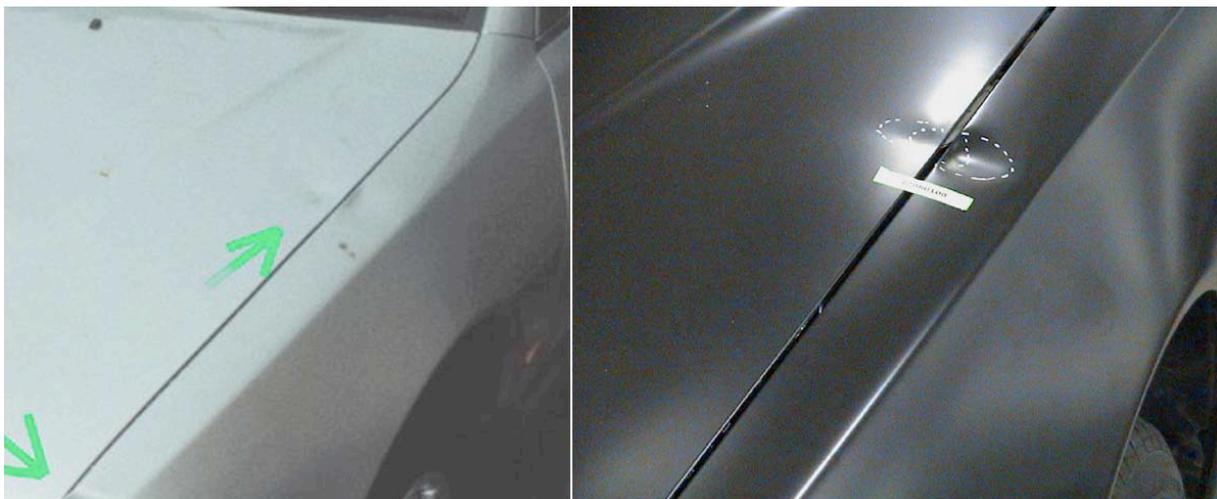
Figure 14-6 Close-up of the damage caused by impact with the child pedestrian's head (left) and the damage produced in the reconstruction (right) of case PED061-99.

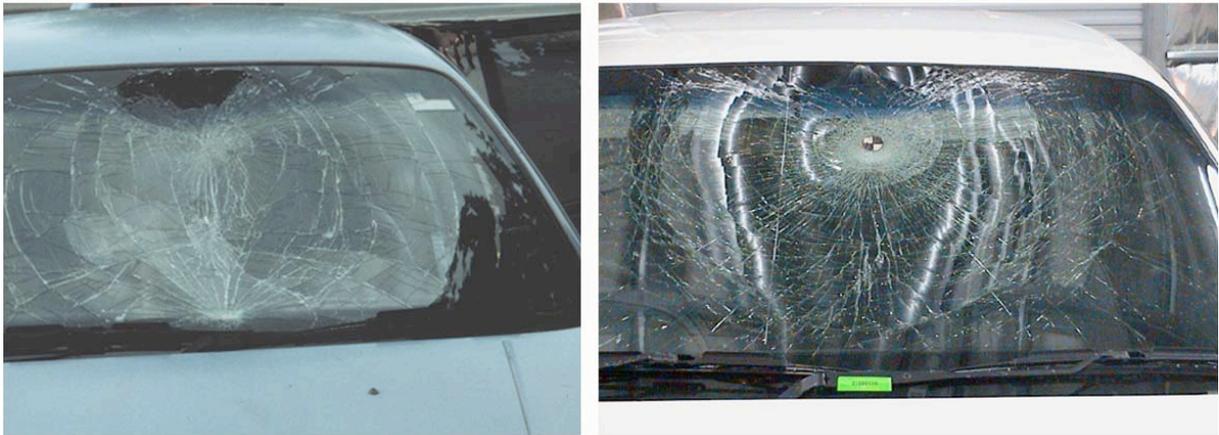
Figure 15-5 Damage caused by impact with the pedestrian's head (left) and the damage produced in the reconstruction (right) of case PED064-00.

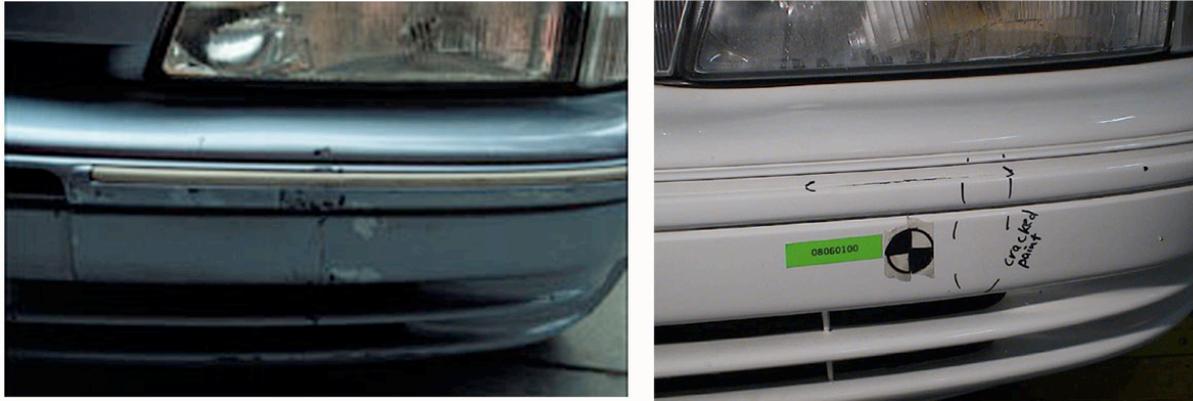
Figure 15-9 Close up front view showing the accident damage to the bumper (left) and the damage produced by the reconstruction (right) with the Legform of case PED064-00.

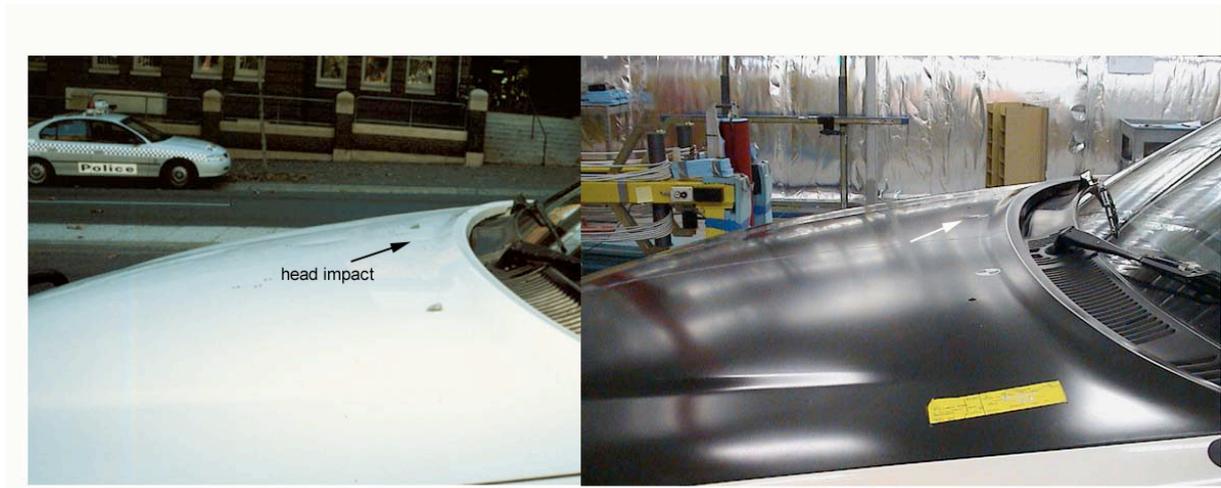
Figure 16-6 The accident damage (left) from impact with the pedestrians head compared to the damage produced by the reconstruction of case PED076-00 (test # 18060100)

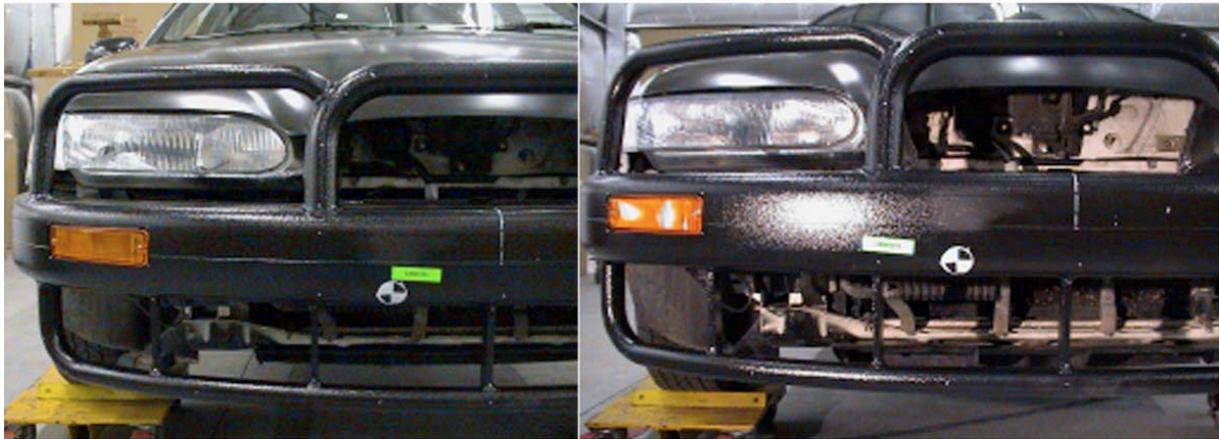
Figure 16-13 Close-up view of impact points of test # 12060101 (left) and test # 14060101 (right) there was no evidence of damage in either test.
