Centreline Treatment Countermeasures to Address Crossover Crashes

Levett S.P, Job R.F.S, Tang J
NSW Centre For Road Safety, RTA

Abstract

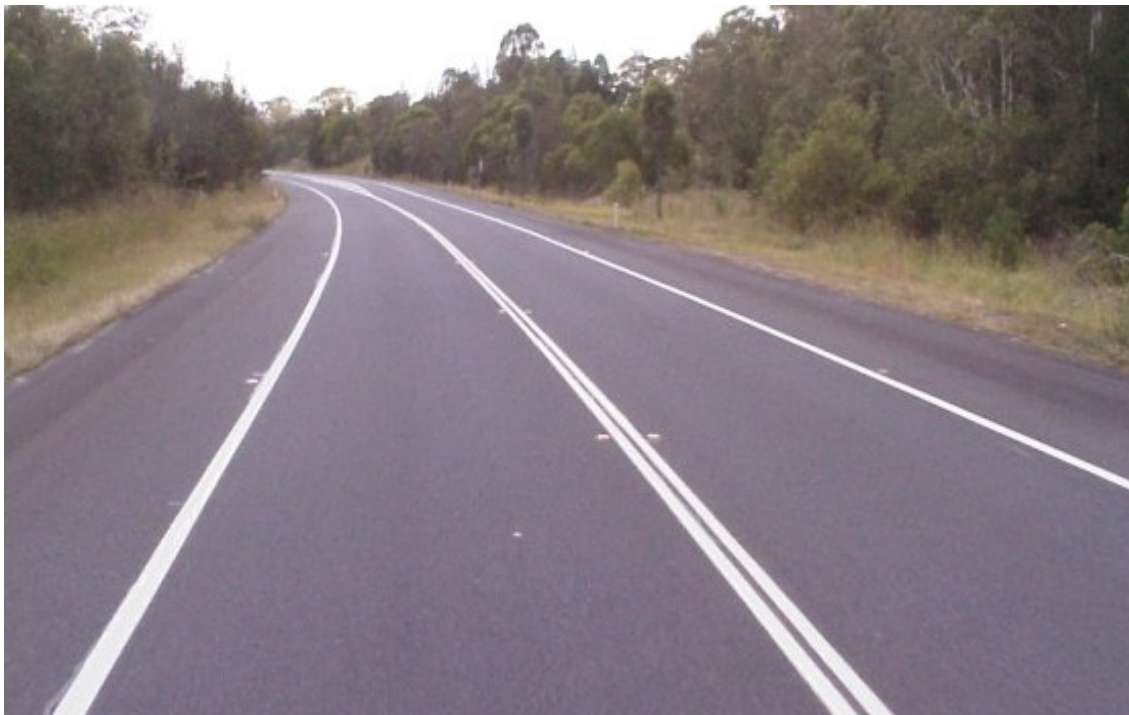
Image 1- Typical control site section of the Pacific Highway – South of Woodburn

The control sites were chosen to replicate similar sections of Highway (Image 1) as to those that had been treated with a wider centreline. There were 6 different sites on the New England Highway totalling 18.37km and 14 sites (Figs.1 & 2) on the Pacific Highway totalling 24.87km (Figs. 3 & 4). The crash data were aggregated and analysed to determine if there had been changes in crash pattern over an 8 year assessment period. The analysis indicates that both total and crossover crashes have shown only minor variations over the 8 years of data which were assessed and that it can be expected that the same number and type of crashes will continue to occur at the same rate.

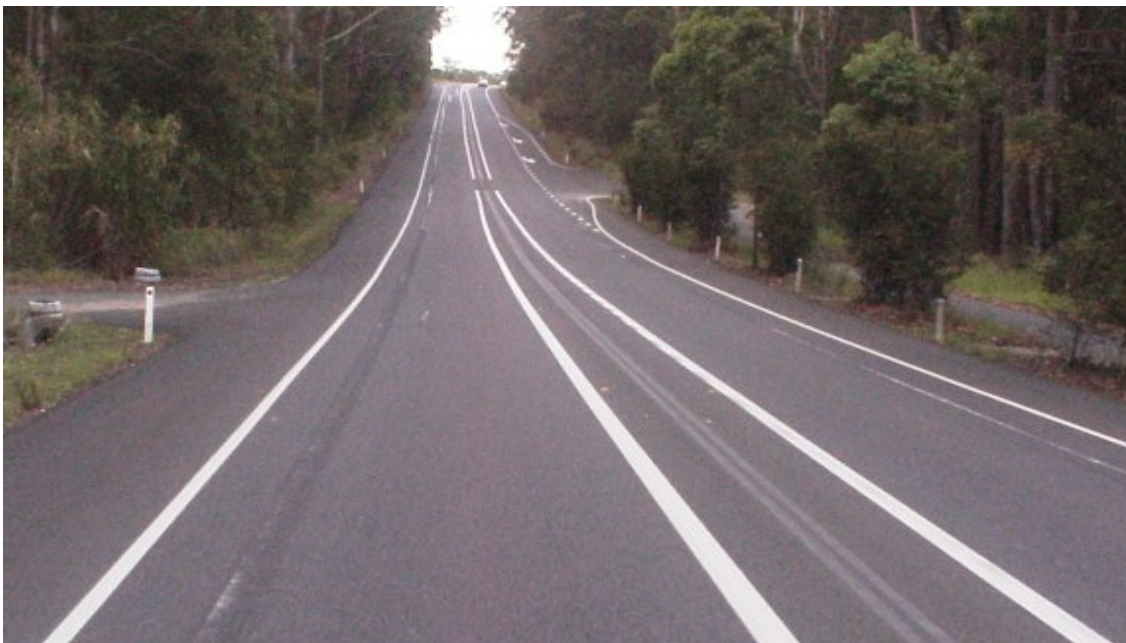
Image 3 - 1.0m wide painted median, Pacific Hwy south of Urunga (note old line marking)

The sections on the Pacific Highway (Image 3) showed that crashes (Table 3) and crash severity were reduced after the 1.0m wide median was installed even though the crash data sets were not large enough to give a high level of confidence in the results.

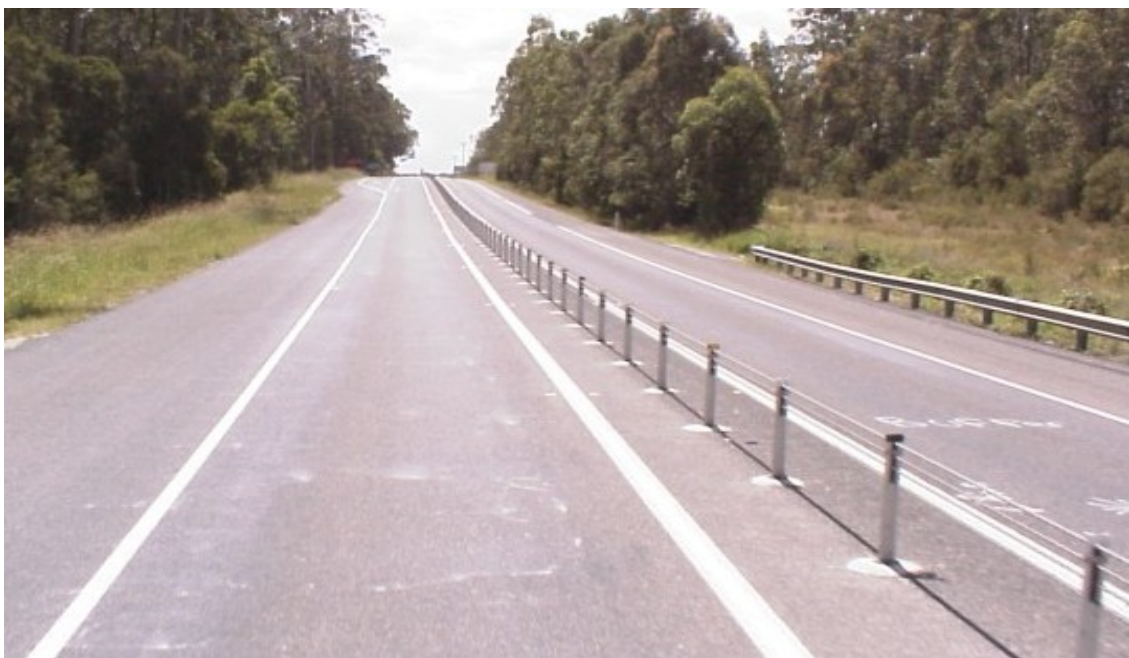
Image 5 - 2.0 metre wide Wire Rope Safety Barrier median – Pacific Hwy, at New Italy

A study of the Wire Rope Safety Barrier (WRSB) medians on the Pacific Highway (Image 5) was undertaken recently for Austroads by ARRB (McTeirnan 2009). The findings from this study showed that although there was limited “after” crash data (Table 5) there was an indication that the WRSB median was reducing crash severity along the sections it had been installed on.
