## Centreline Treatment Countermeasures to Address Crossover Crashes

Levett S.P, Job R.F.S, Tang J  
NSW Centre For Road Safety, RTA

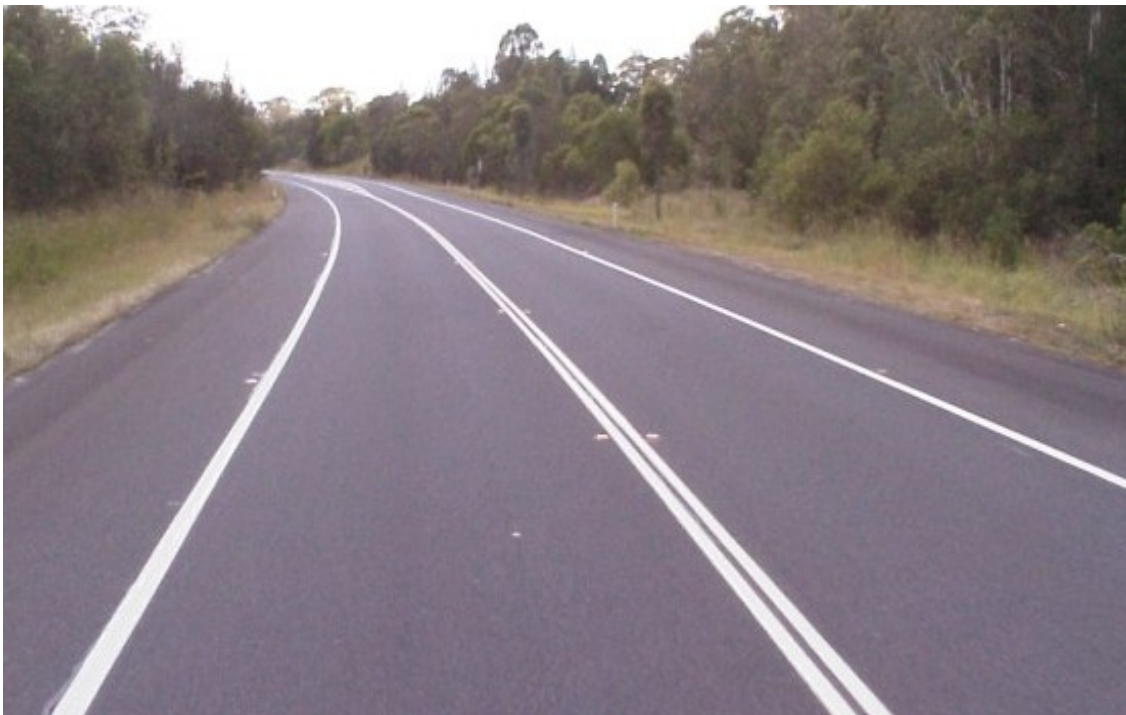
**Image 1- Typical control site section of the Pacific Highway – South of Woodburn**

The control sites were chosen to replicate similar sections of Highway (Image 1) as to those that had been treated with a wider centreline. There were 6 different sites on the New England Highway totalling 18.37km and 14 sites (Figs.1 & 2) on the Pacific Highway totalling 24.87km (Figs. 3 & 4). The crash data were aggregated and analysed to determine if there had been changes in crash pattern over an 8 year assessment period. The analysis indicates that both total and crossover crashes have shown only minor variations over the 8 years of data which were assessed and that it can be expected that the same number and type of crashes will continue to occur at the same rate.

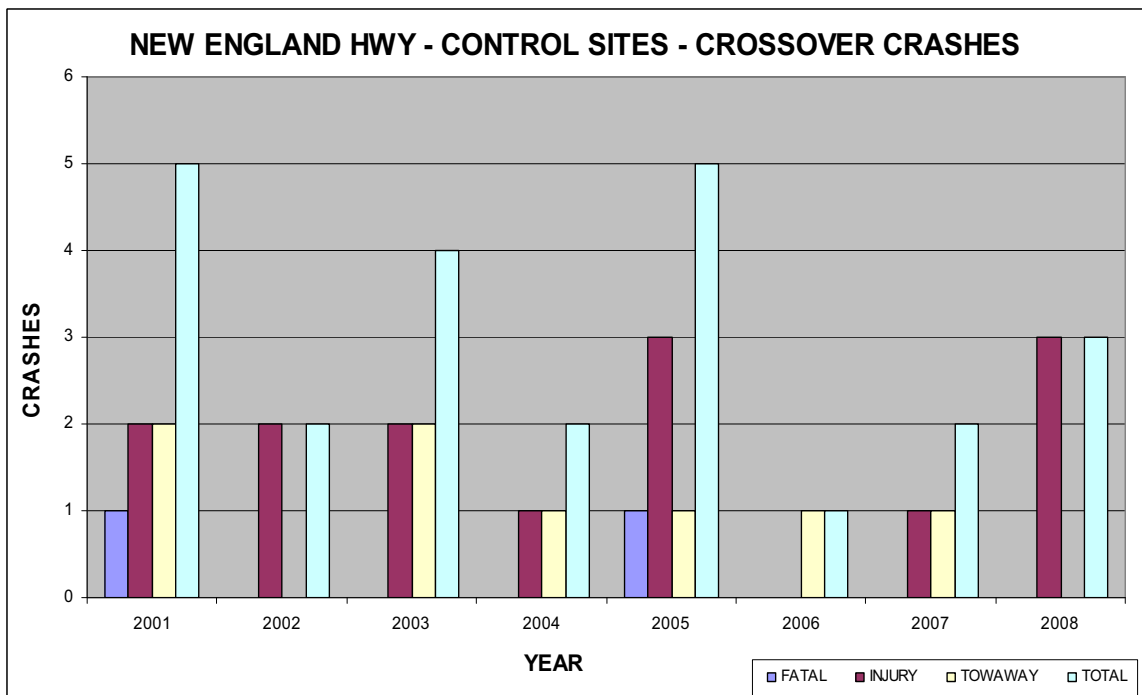
Figure 2 - New England Highway – Control Sites - Crossover Crashes

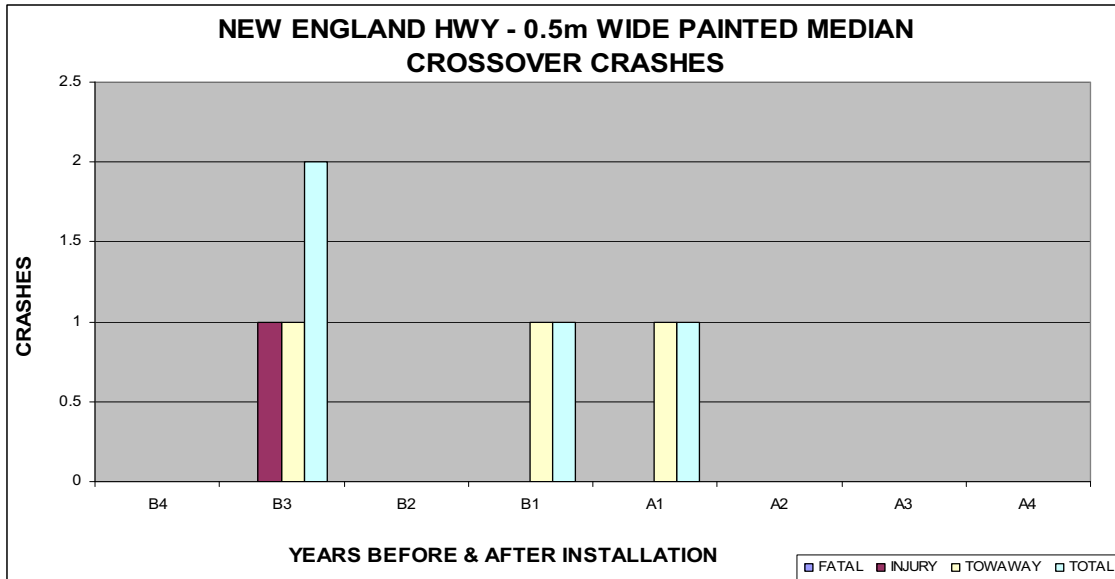
Figures 6 - New England Highway – 0.5m Wide Painted Median - Crossover Crashes

The crashes that occurred on the sections of 0.5m wide painted median were aggregated to determine if the slightly wider median had had an effect on reducing crossover crashes as intended. There were 5 sites on the New England Highway totalling 5.27 km (Figs. 5 & 6) and 10 sites on the Pacific Highway (Image 2) totalling 16.44 km (Figs. 7 & 8). As can be seen from Fig. 6 there were not a lot of crashes (Table 1) along the New England Highway sections although there was a noticeable reduction in crossover crashes.

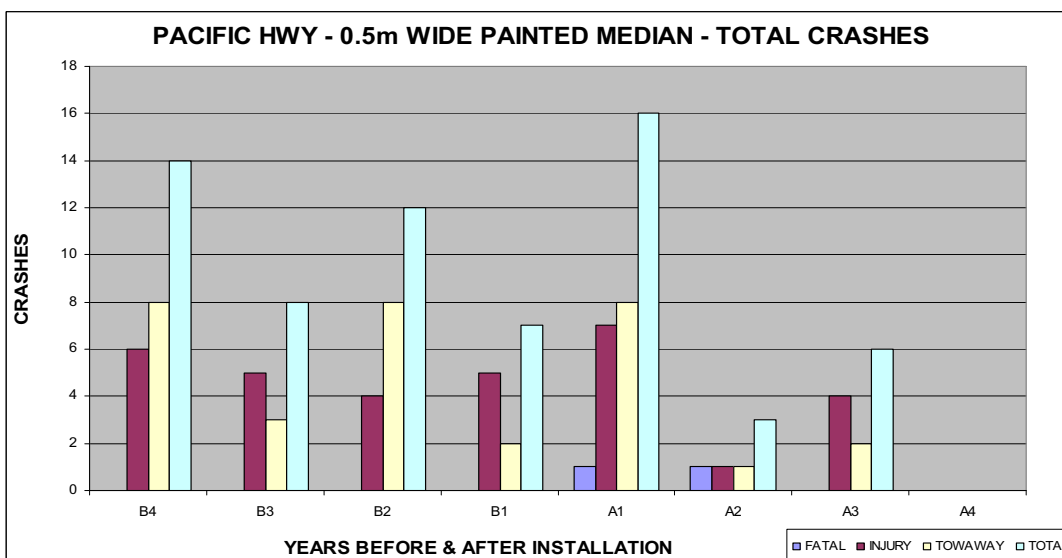
Figure 7 - Pacific Highway – 0.5m Wide Painted Median - Total Crashes

However, the Pacific Highway sections with their much higher traffic volumes show that the 0.5m wide painted median had some effect in reducing total crashes but no effect on crossover crashes (Table 2). These may have actually increased. Also the severity of the crashes seems to have increased after installation.

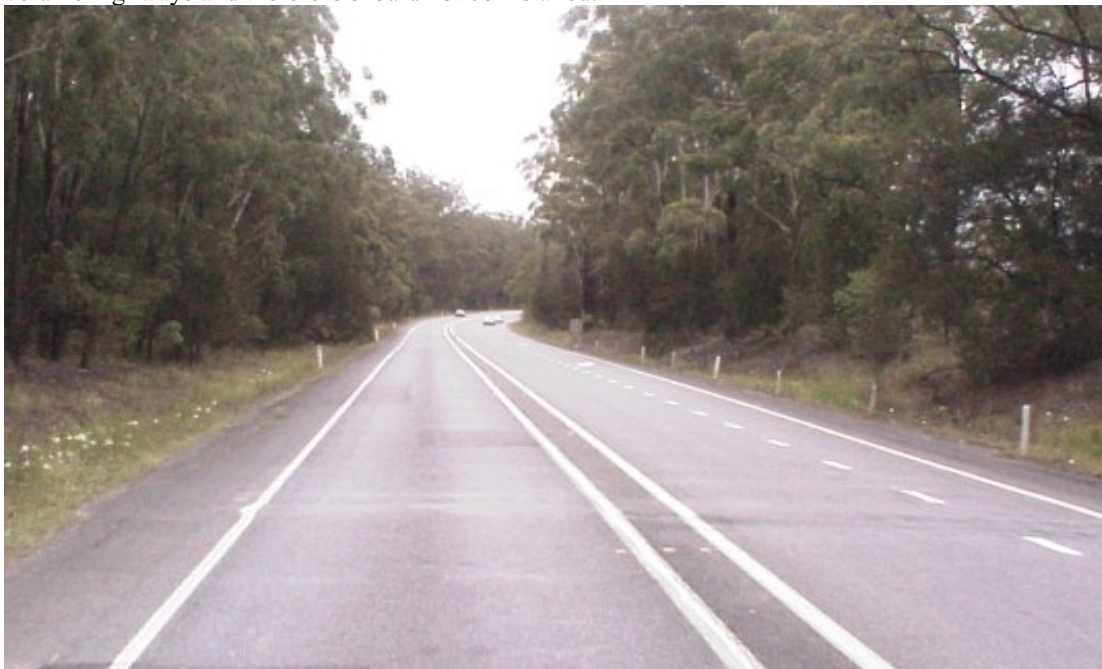
Image 2 - 0.5m wide painted median – Pacific Hwy – north of Port Macquarie

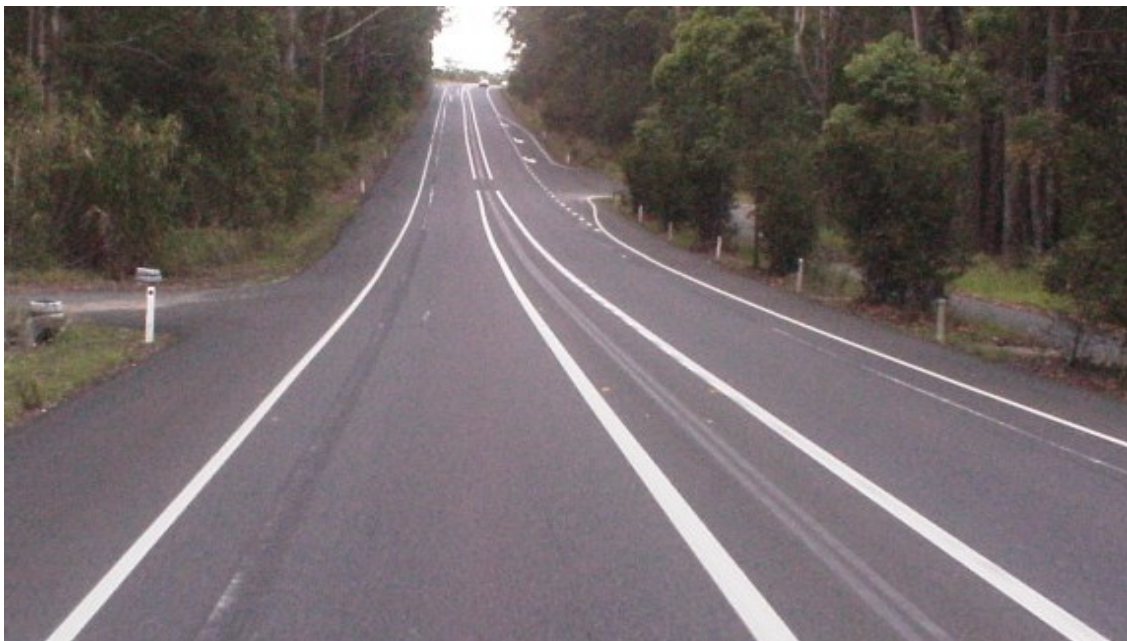
**Image 3 - 1.0m wide painted median, Pacific Hwy south of Urunga (note old line marking)**

The sections on the Pacific Highway (Image 3) showed that crashes (Table 3) and crash severity were reduced after the 1.0m wide median was installed even though the crash data sets were not large enough to give a high level of confidence in the results.

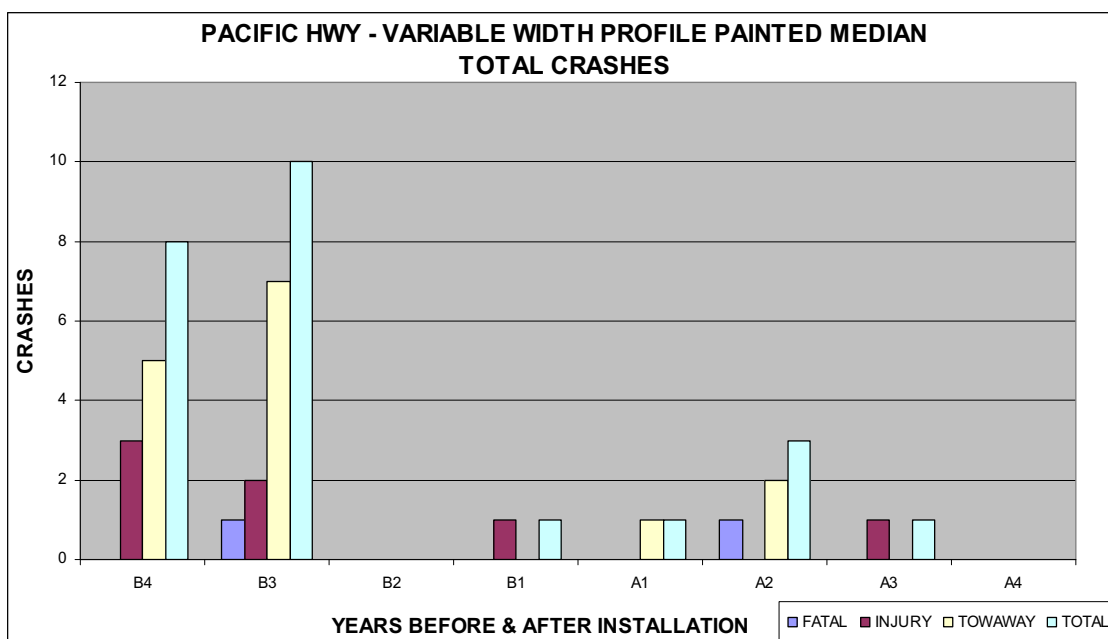
**Figure 11 - Pacific Highway 0.5m - 1.0m Wide Profile Median -Total Crashes**

There were only two sections of the Pacific Highway totalling 1.16 km (Figs 11 & 12) that had median separation using audio-tactile profile line marking (Image 4). The width along these sections varied between 0.5m wide and 1.0m wide, however the variable width seemed to make little difference in the crash reduction. The crash data (Table 4) indicates that the audio tactile qualities of the median delineation had a beneficial effect in reducing both total crashes as well as crossover crashes.

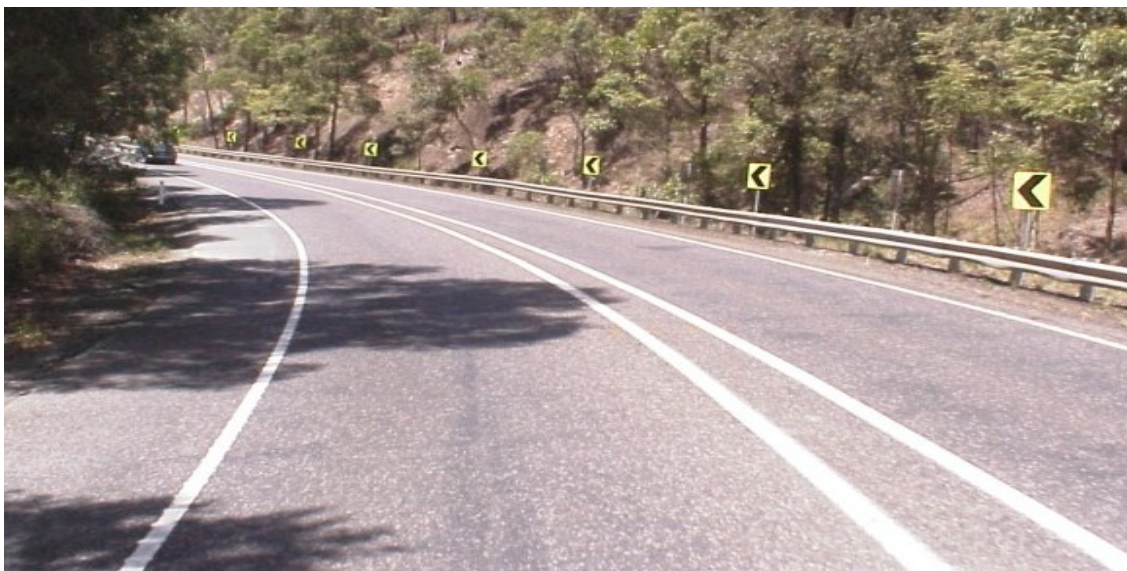
Image 4 - Variable width audio-tactile profile median - Pacific Hwy south of Urunga

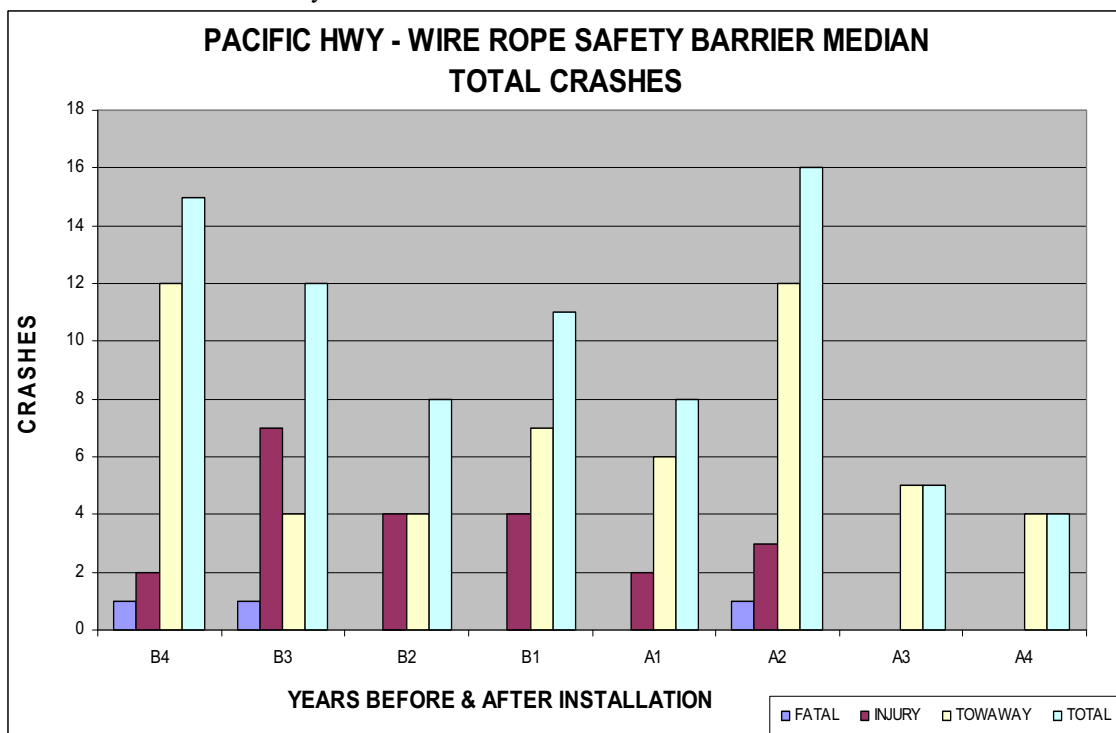
Figure 13 - Pacific Highway - 2.0m Wide WRSB Median - Total Crashes

For this study there were 12 sections of WRSB median identified on the Pacific Highway with a total length of 11.15 km (Figs. 13 & 14). None of these sections had audio-tactile profile line marking either side of the wire rope barrier. The crash data indicates that there was both a reduction in total crashes and a reduction crossover casualty crashes after the WRSB was installed.

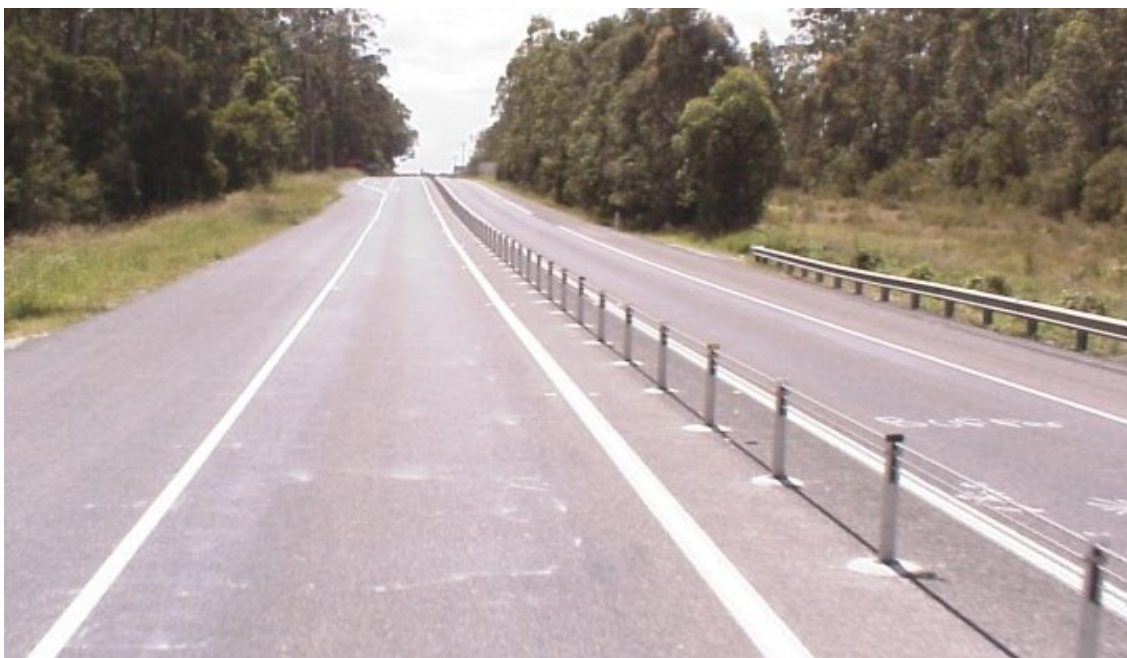
Image 5 - 2.0 metre wide Wire Rope Safety Barrier median – Pacific Hwy, at New Italy

A study of the Wire Rope Safety Barrier (WRSB) medians on the Pacific Highway (Image 5) was undertaken recently for Austroads by ARRB (McTeirnan 2009). The findings from this study showed that although there was limited “after” crash data (Table 5) there was an indication that the WRSB median was reducing crash severity along the sections it had been installed on.
