# **ADELAIDE IN-DEPTH ACCIDENT STUDY**

1975-1979

## **PART 3: PEDAL CYCLE ACCIDENTS**

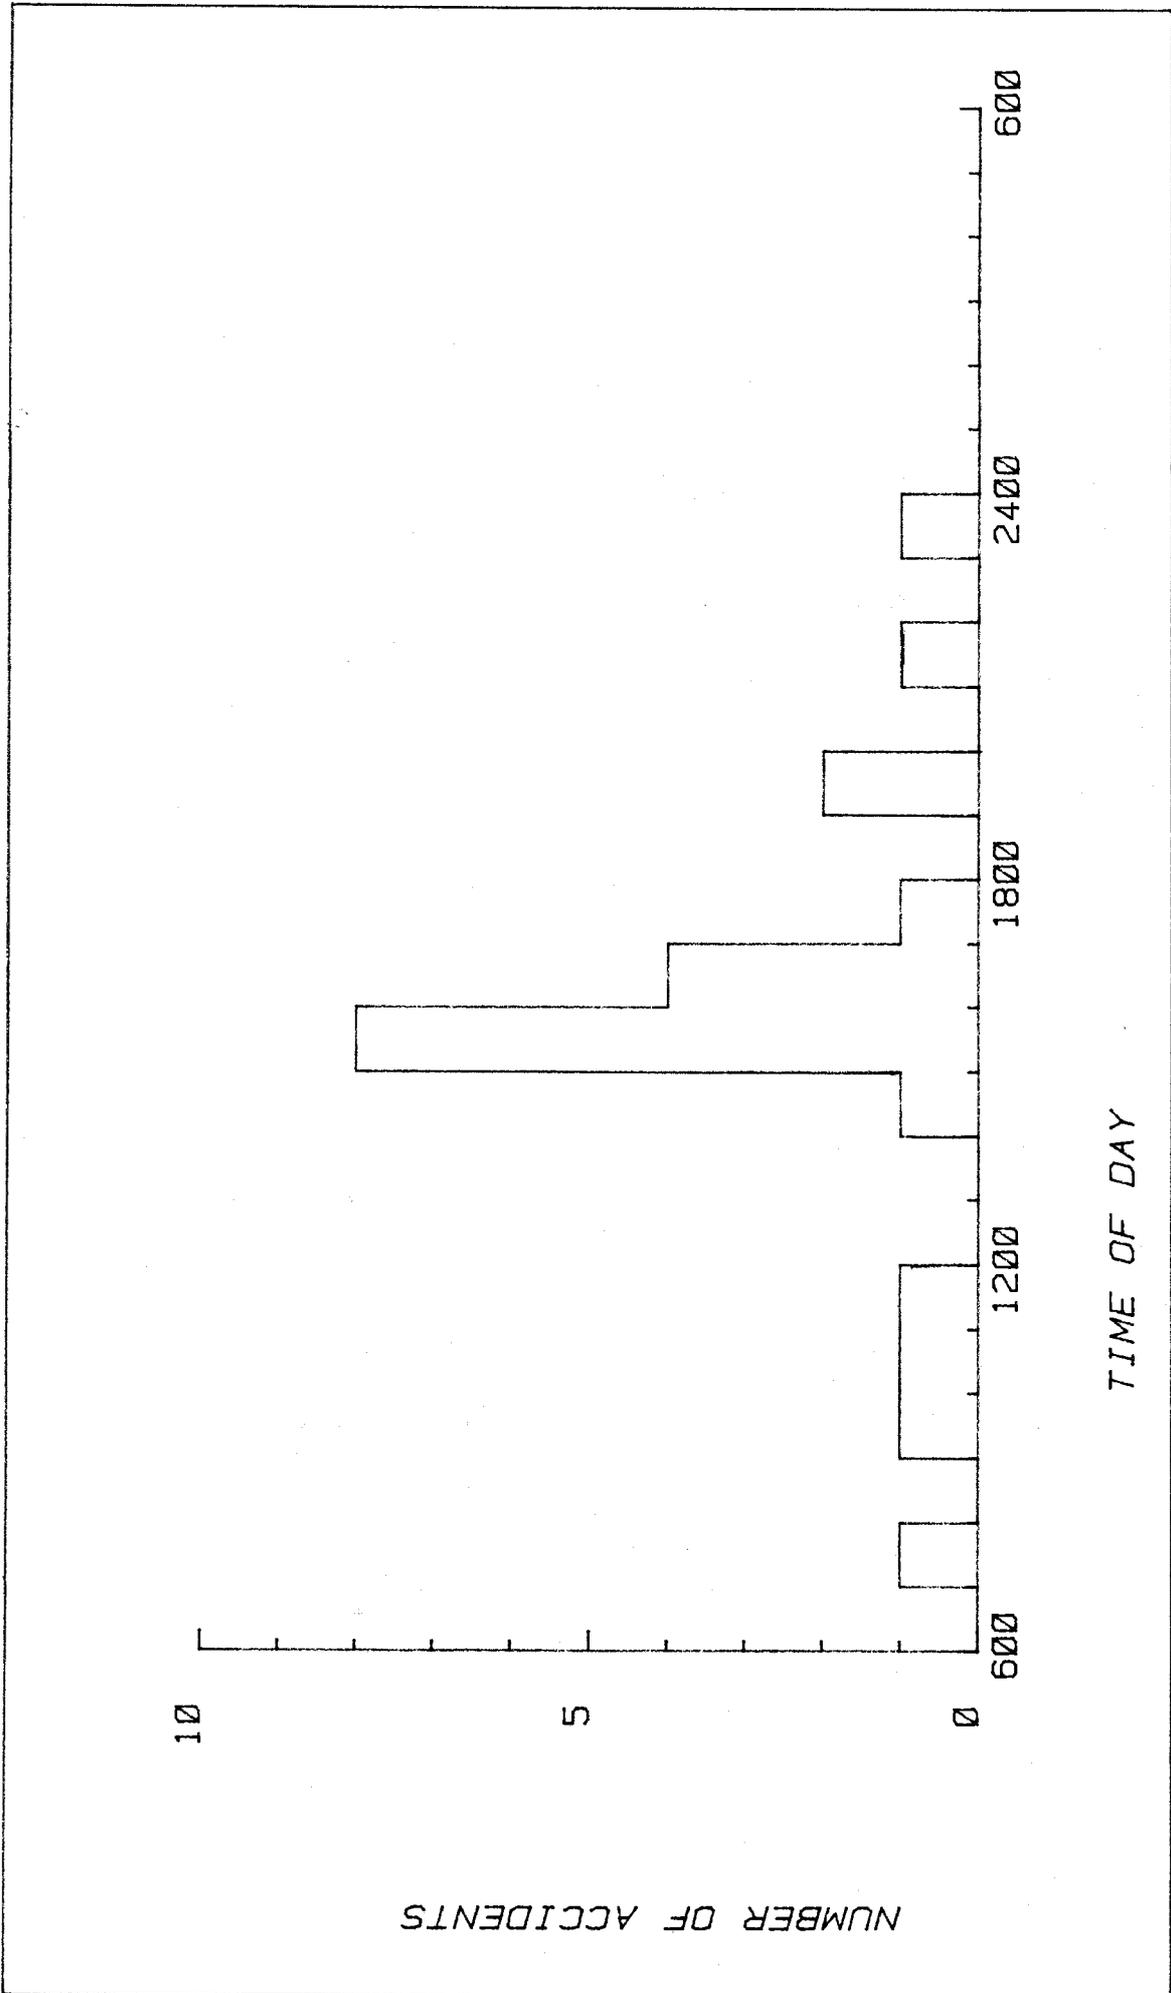
FIGURE 1: Pedal cycle accidents by time of day.

Half of these accidents occurred between 3 p.m. and 5 p.m. on a week day (Figure 1). Children riding home from school, or just riding around after school, accounted for most of the pedal cycle accidents in this two-hour period. In two of the three accidents which happened at night there were no lights fitted to the bicycle. The third of these night-time accidents occurred when it was raining. None of these cyclists, or any of the drivers of the striking cars, was found to have a blood alcohol level above .04, and only three had been drinking at all.

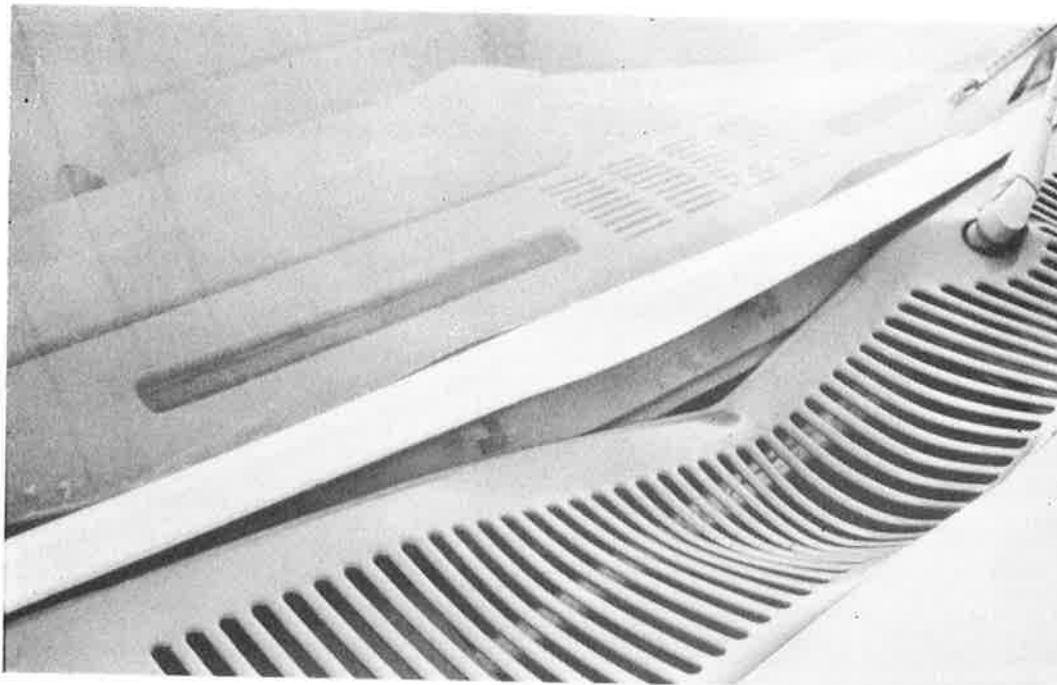
FIGURE 7: Damage resulting from impact by cyclist's head. Accident 023.

The three cyclists who had injuries which were due to contact with the upper surface of the bonnet were all concussed as a consequence of this impact. In two cases the cyclists were of similar age and stature and were hit by the same make and model of car (a Ford Falcon). The head impact in each accident was located on the grille covering the plenum chamber, just to the rear of the bonnet itself. In Accident 023 one or two hairs were stuck to the deformed panel (Figure 7), whereas in Accident 250 a small blood stain matched up with a small laceration on the cyclist's scalp (Figure 8). The impact speed, as estimated from the location of debris and from the statement of a witness in relating the collision point to the end of the braking skid marks, was about 50 km/h in Accident 023, and about 60 km/h in Accident 250. These speed estimates may be in error by as much as 10 to 15 km/h, but it seems to be probable that the impact speed in the latter case was the higher of the two because the head impact point was slightly further back and part of the force of the impact was taken by the base of the windscreen. This may account for the more severe concussion sustained by this cyclist, compared to the one in Accident 023, since the base of the screen is a far more rigid structure than the grille over the plenum chamber.

The windscreen was shattered in Accident 250, but not in Accident 023. This difference was reflected in extensive, though minor, scalp lacerations which were attributed to the shattered glass in Accident 250, and the absence of such lacerations in Accident 023. But both cars had minor damage to the leading edge of the roof, above the windscreen (Figure 8, arrowed) which suggests that some part of the cyclist contacted that area of the exterior of the car in each accident.

The forward part of the bonnet of the car was more severely damaged in Accident 023 than in Accident 250. This damage was likely to have been associated

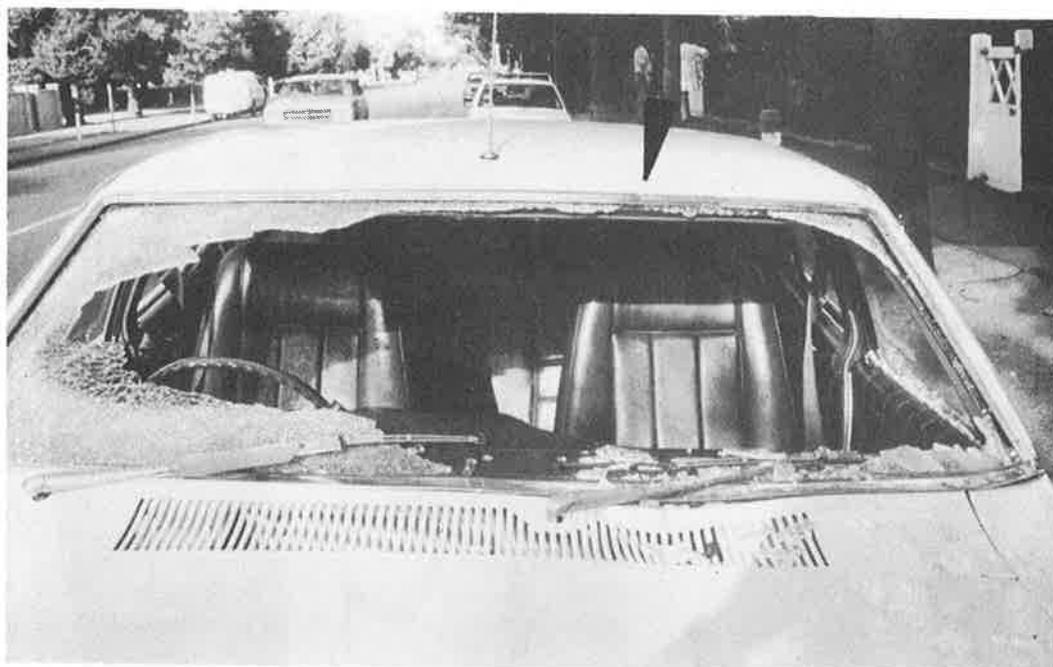
FIGURE 8: Damage resulting from collision with cyclist. Note small dent in trim above windscreen (arrowed). Accident 250.

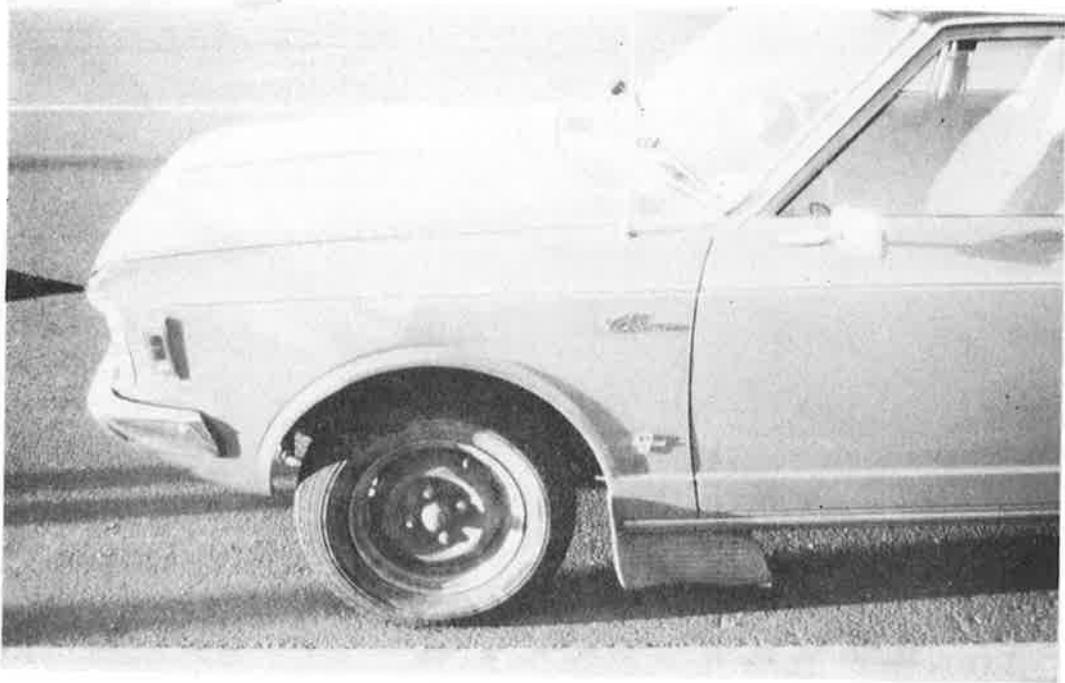
FIGURE 9: Damage to car in Accident 276. Note buckling of panel above wheel arch. Impact point corresponding to mark on cyclist's thigh (Figure 10) is arrowed.

This section of a car is often similar in shape to the leading edge of the bonnet, but may have a more rigid underlying structure. The injury potentials of these two parts of the car are similar, however, as is illustrated by the preceding examples and Accident 276, in which a nine year old boy turned across in front of an overtaking car. The slightly-protruding left front corner of the car (Figure 9), a 1972 Toyota Corona, struck the child high on his right hip. The resulting superficial injury was slight (Figure 10) but his femur was fractured at the top of the shaft.

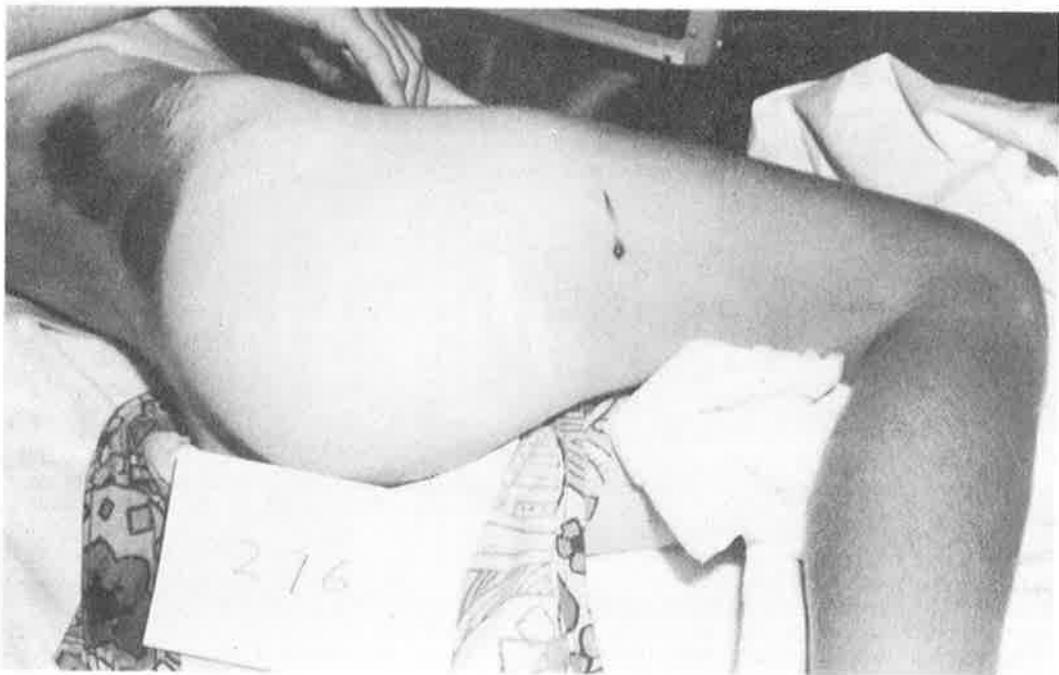
FIGURE 10: Cyclist injured in Accident 276. Note abrasions to back from the road surface and mark on thigh, over site of fracture of femur, due to the leading edge of the front mudguard. (See also Figure 9.)
