ADELAIDE IN-DEPTH ACCIDENT STUDY

1975-1979

PART 4: MOTORCYCLE ACCIDENTS

THE UNIVERSITY OF ADELAIDE

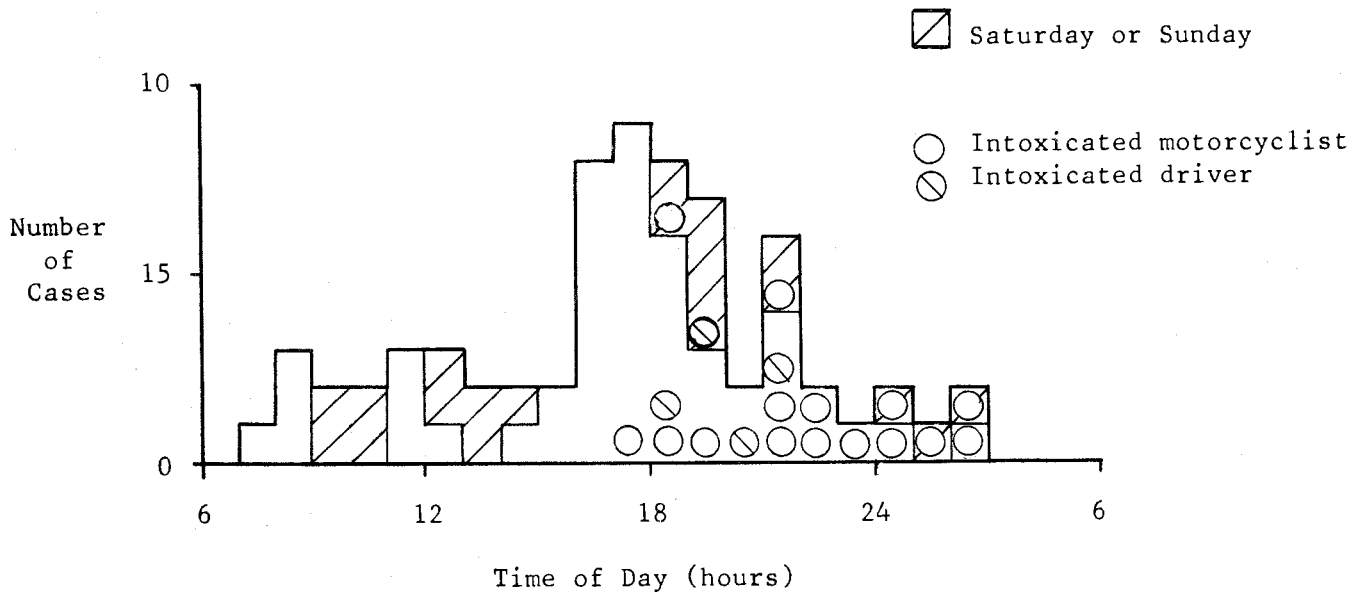
FIGURE 1: Time of day, day of week and alcohol involvement for motorcycle accidents.

The distribution of these accidents by time of day, with weekend cases indicated separately, is shown in Figure 1. Those accidents in which a blood alcohol (BAC) reading above .04 was obtained are also noted. It is apparent in this Figure that almost half of the accidents occurred between 4 p.m. and 8 p.m., and that alcohol was involved in 81 per cent of the accidents after 8 p.m. The role of alcohol intoxication is discussed in detail in Section 3.2.1.

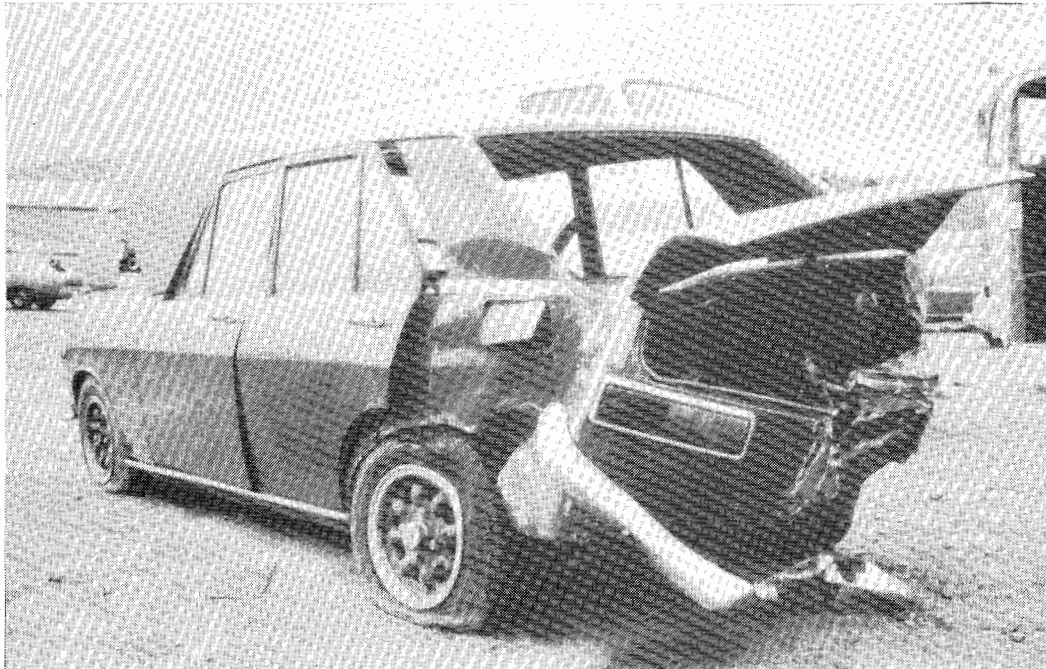
FIGURE 4: Damage due to impact by motorcycle (behind left rear wheel) and subsequent collision with stationary car. See also Figures 5 and 6. Accident 167.

This collision configuration is listed as Vehicle Movement 1 in Table 3. The two accidents noted under 'Sign-Controlled Intersections' were ones in which the car should have yielded to the motorcycle, although in Accident 167 (Figures 4 - 6) there was little doubt that the motorcycle was travelling at a speed well above the legal limit of 60 km/h. The rider also had a BAC of .13 which may have diminished his chances of avoiding the collision. The rider in the other crash of this type was also intoxicated (BAC .15) but the circumstances of the accident were such that a sober rider would not have had sufficient warning to have been able to have attempted any avoiding action (Accident 042, Figures 7 - 9).

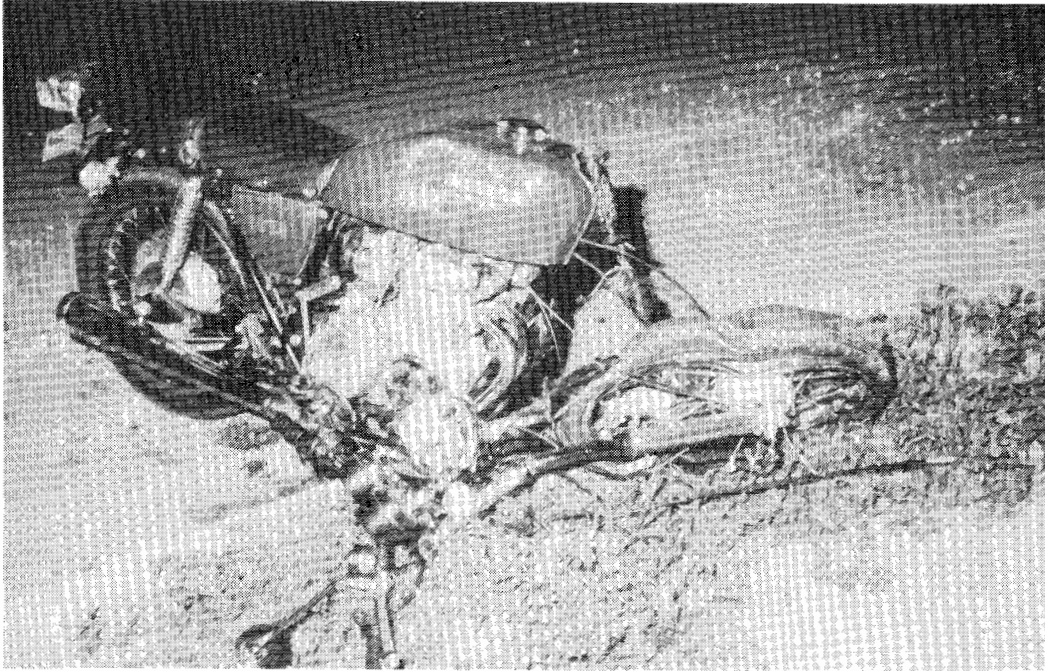
FIGURE 5: Front fork assembly detached from motorcycle after collision with car shown in Figure 4. See also Figure 6. Accident 167.

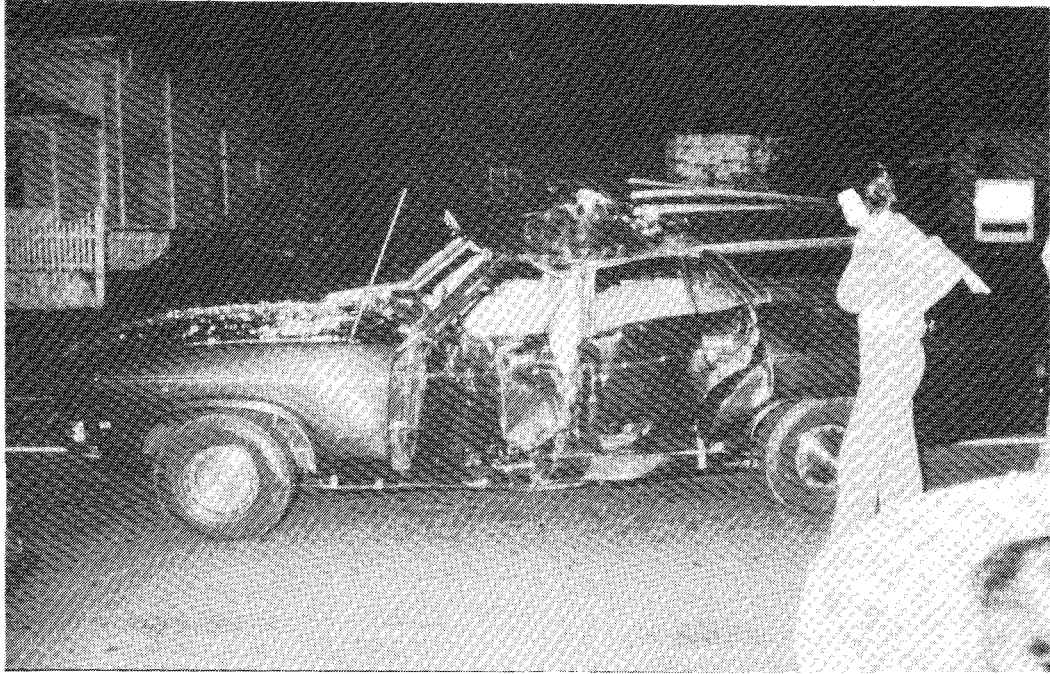
FIGURE 7: Car struck by motorcycle shown in Figure 8. Initial impact by front wheel of motorcycle was just behind the front edge of the front door. Damage to roof was largely due to impact from rider and passenger. See also Figure 9. Accident 042.

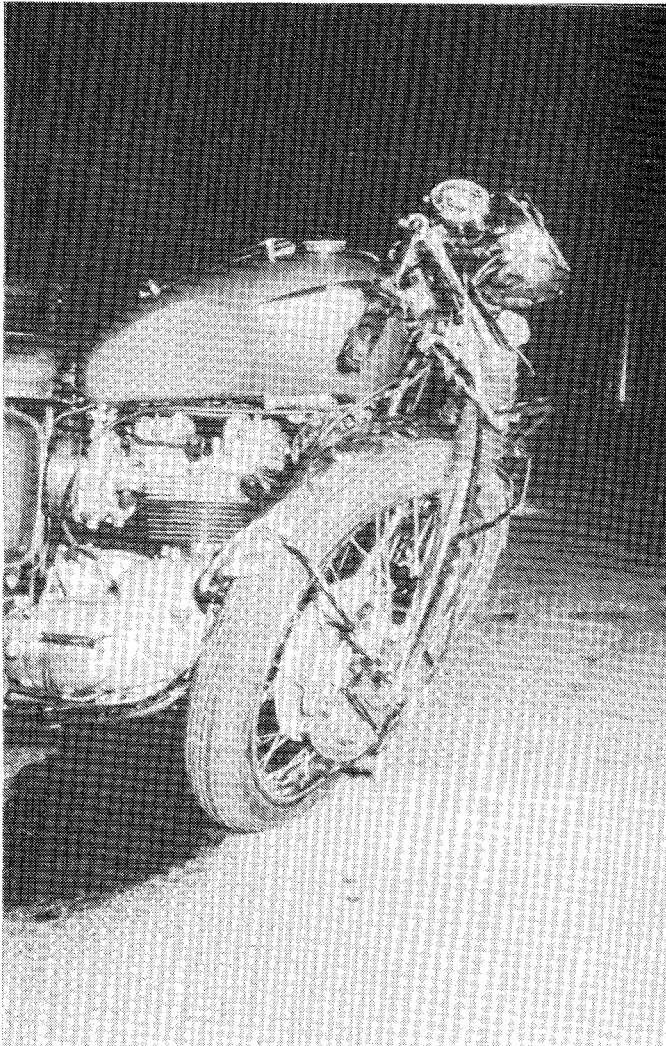
FIGURE 8:

Damage to motorcycle which struck car shown in Figures 7 and 9. Note front wheel deformed to left. Accident 042.

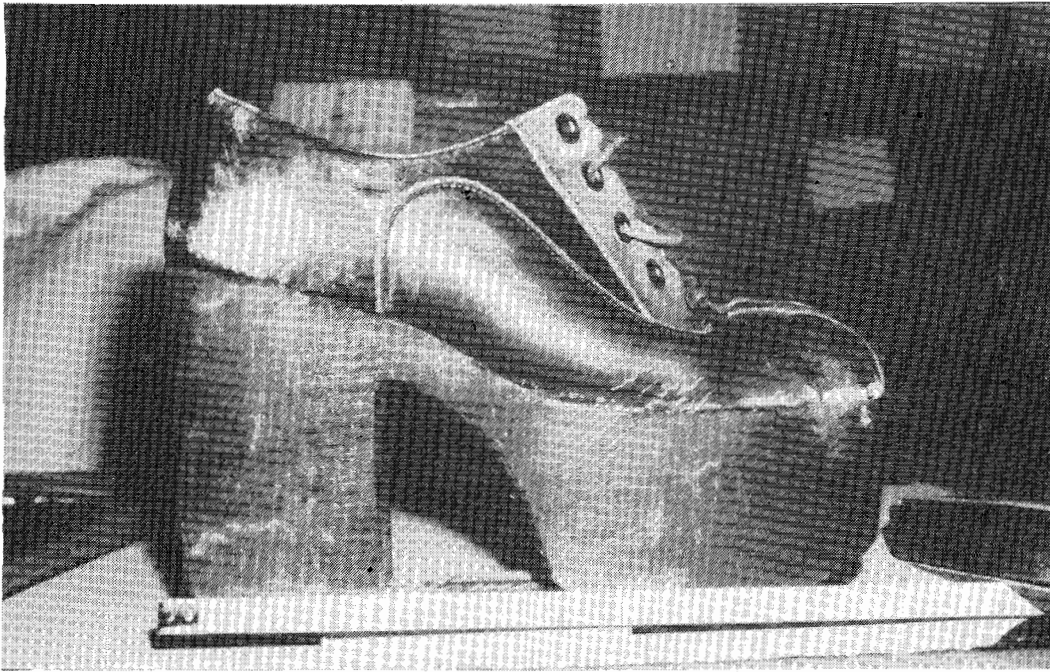
FIGURE 10: Shoe worn by rider in Accident 085.

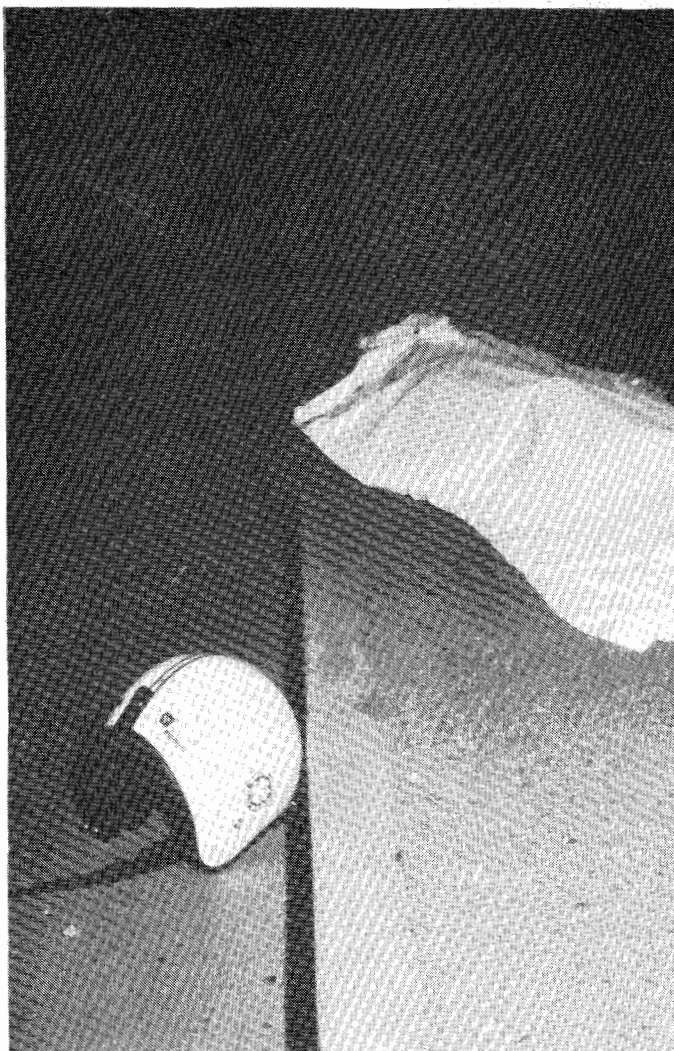
FIGURE 12:
Helmet, with chin strap not fastened, found separated from rider after fatal crash. Accident 045.

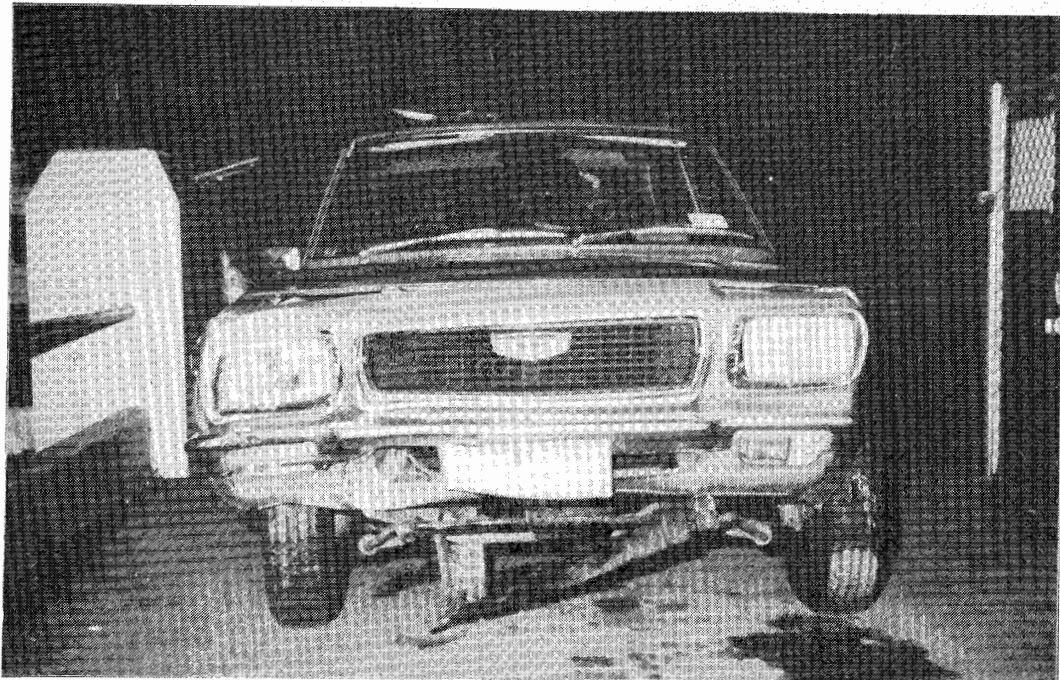
FIGURE 22: Damage to car from collision with motorcycle shown in Figure 21. Accident 078.
