TRAFFIC ACCIDENTS IN ADELAIDE, SOUTH AUSTRALIA

AUSTRALIAN ROAD RESEARCH BOARD

SPECIAL REPORT No. 1, JULY, 1966

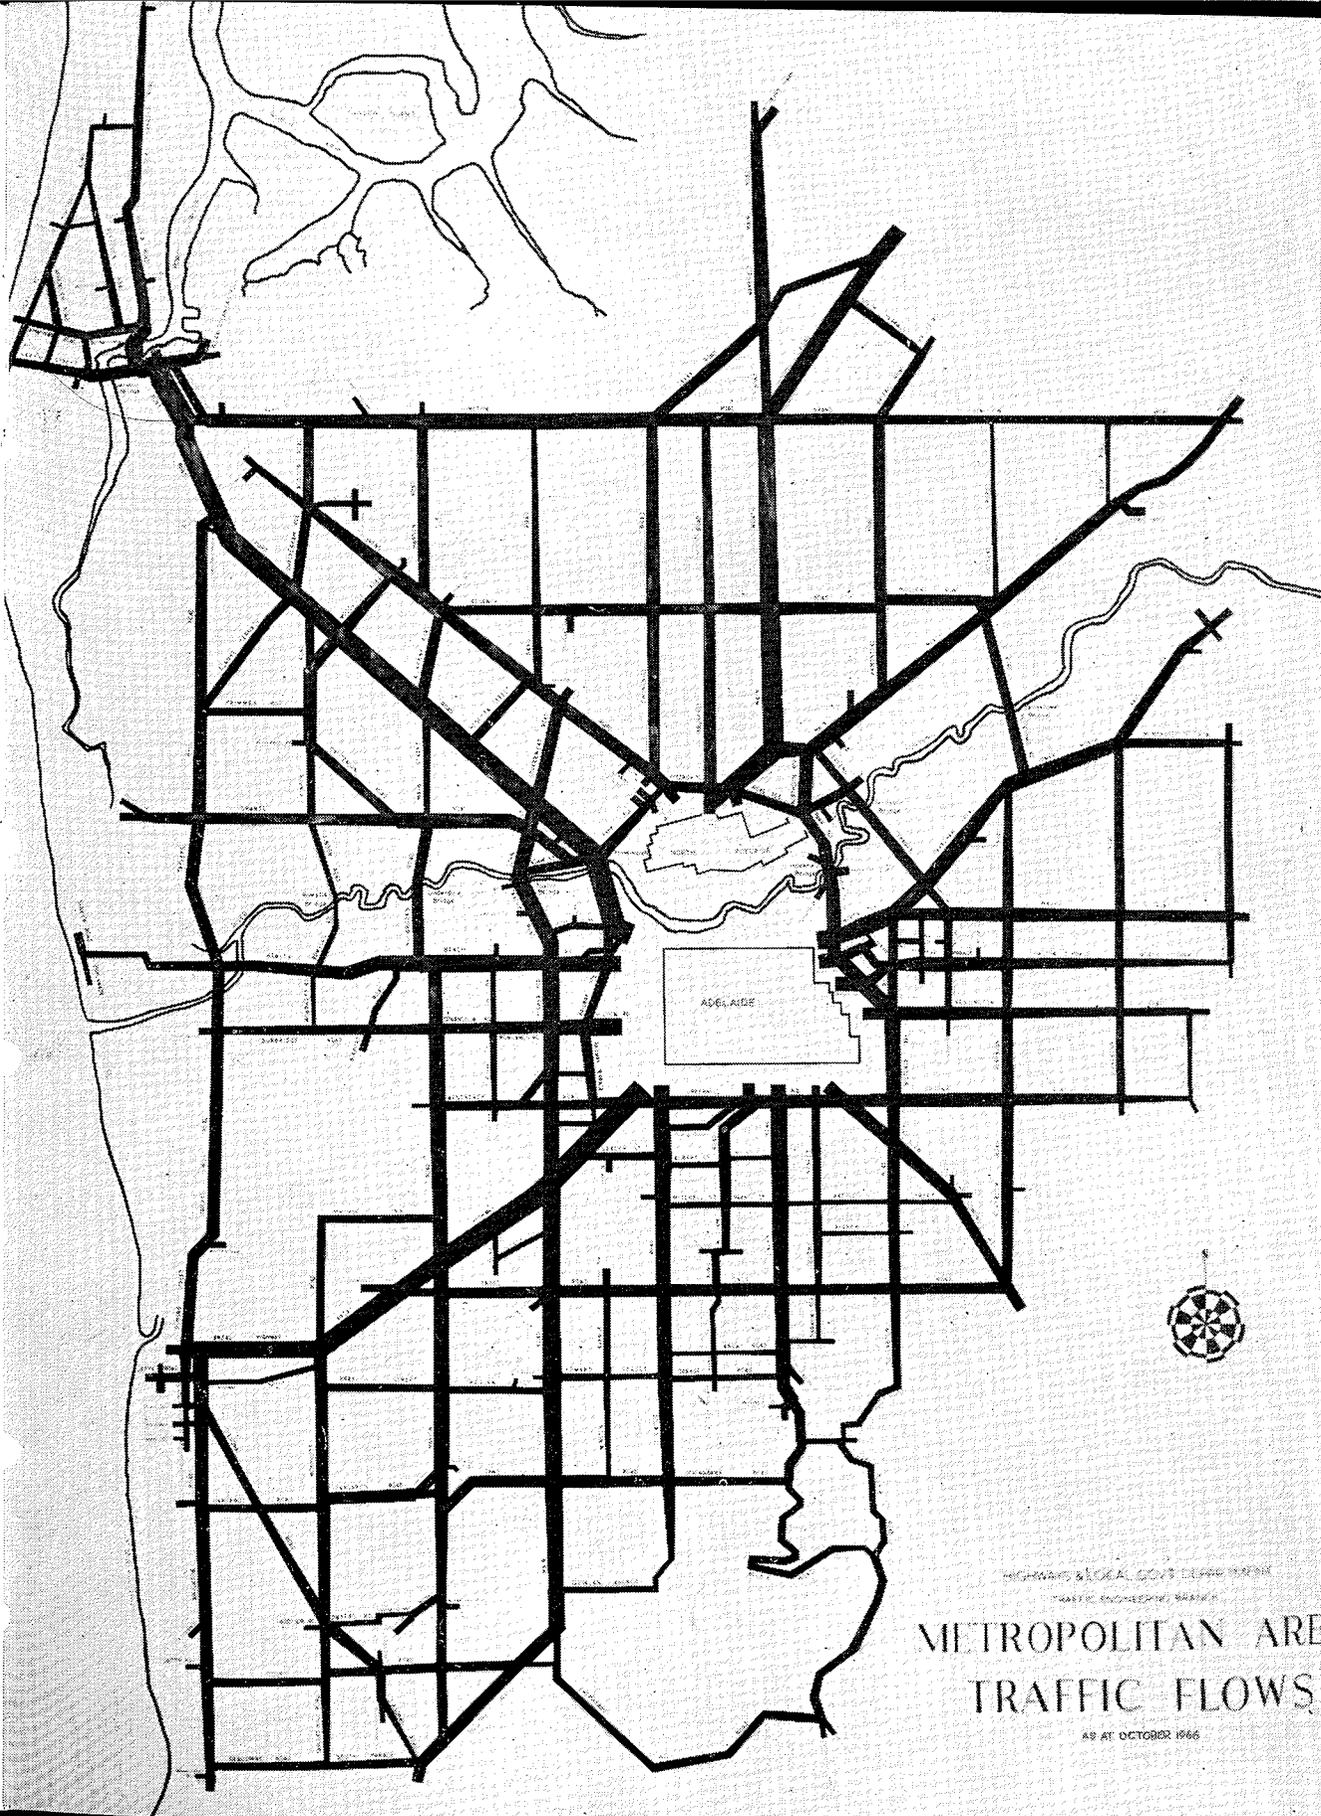
Fig. 3.6—Relative traffic volumes in Adelaide →

3.18 Despite the fact that our study covered only two years (1963 and 1964), traffic flow increased significantly during this period. Counts made at ten intersections in the metropolitan area showed an increase of about 10 per cent between early 1963 and late 1964. (TABLE 3.6A). Motor vehicle registrations in the metropolitan area in January, 1963, were 188,000 and by August, 1964, were 203,500, an increase of 8.3 per cent and 15,500 in total. This increase accounts, partly at least, for the greater rate at which we collected accidents in 1964 than in 1963. There were also more accidents per day in 1964 than in 1963.

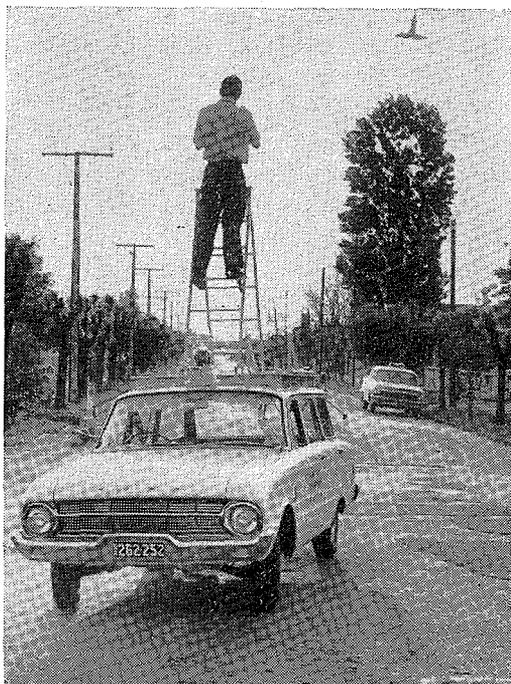
Fig. 3.7— The vehicle, with A. J. McLean photographing skid marks

3.27 A standard Ford Falcon Station Wagon was used. It was fitted with a roof platform equipped with an extendable ladder to provide a high vantage point for photography (Fig. 3.7). The vehicle had a two-way voice radio tuned to the ambulance frequency (call-sign 'Car 99') and a flashing amber light to act as a warning at night accidents. It was painted yellow and was plainly marked 'Australian Road Research Board — Traffic Accident Unit'. The crew wore white dustcoats or white raincoats for safety at night. Extra insurance against personal injury was arranged for them.

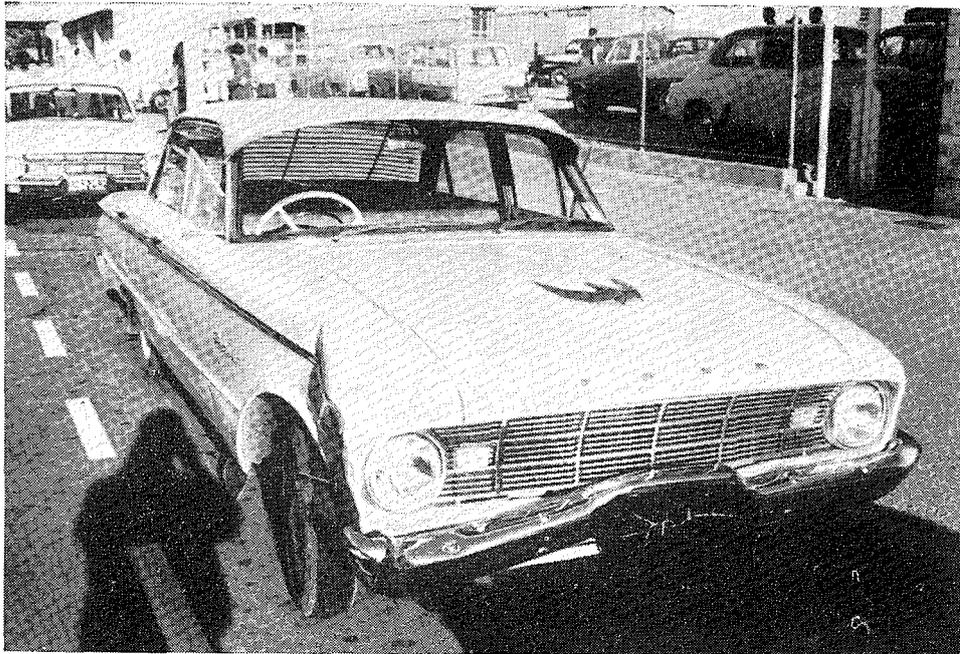
Fig. 3.9—Minor overall damage

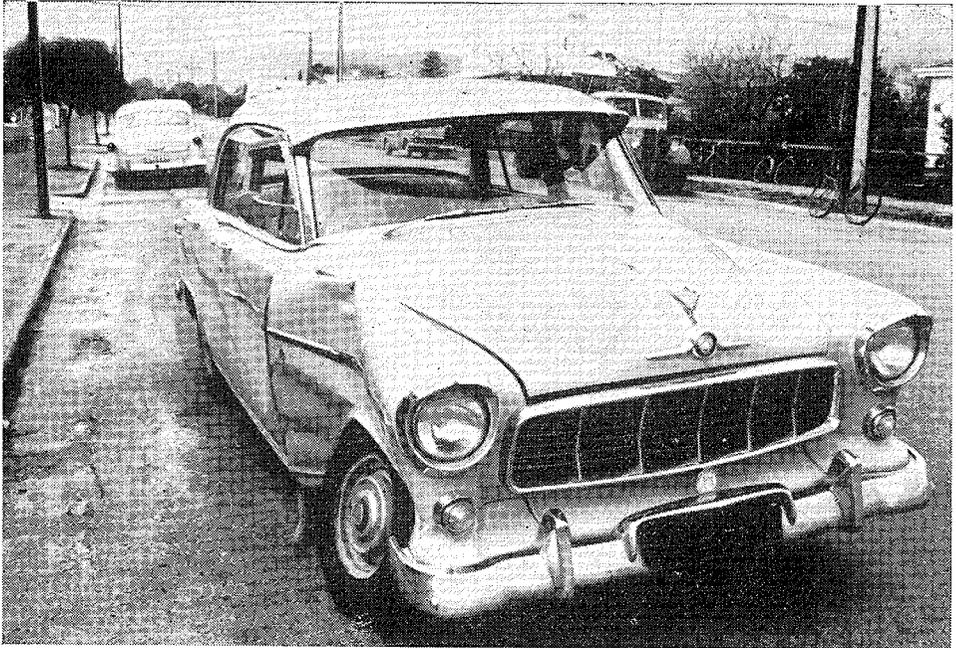
Fig. 3.10—Moderate overall damage

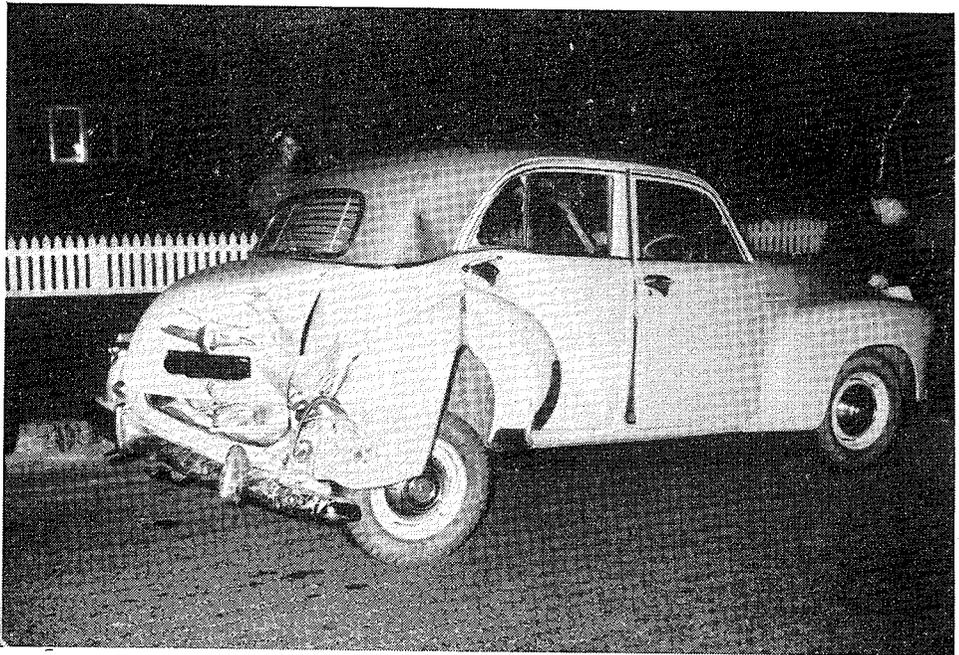
Fig. 3.11—Severe overall damage

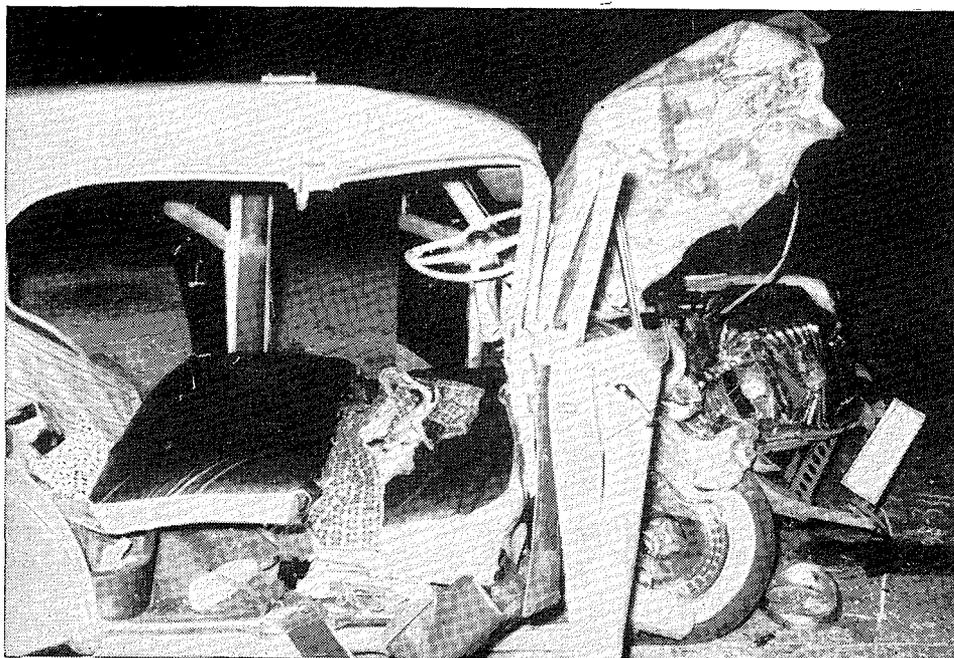
Fig. 3.12—Extremely severe overall damage

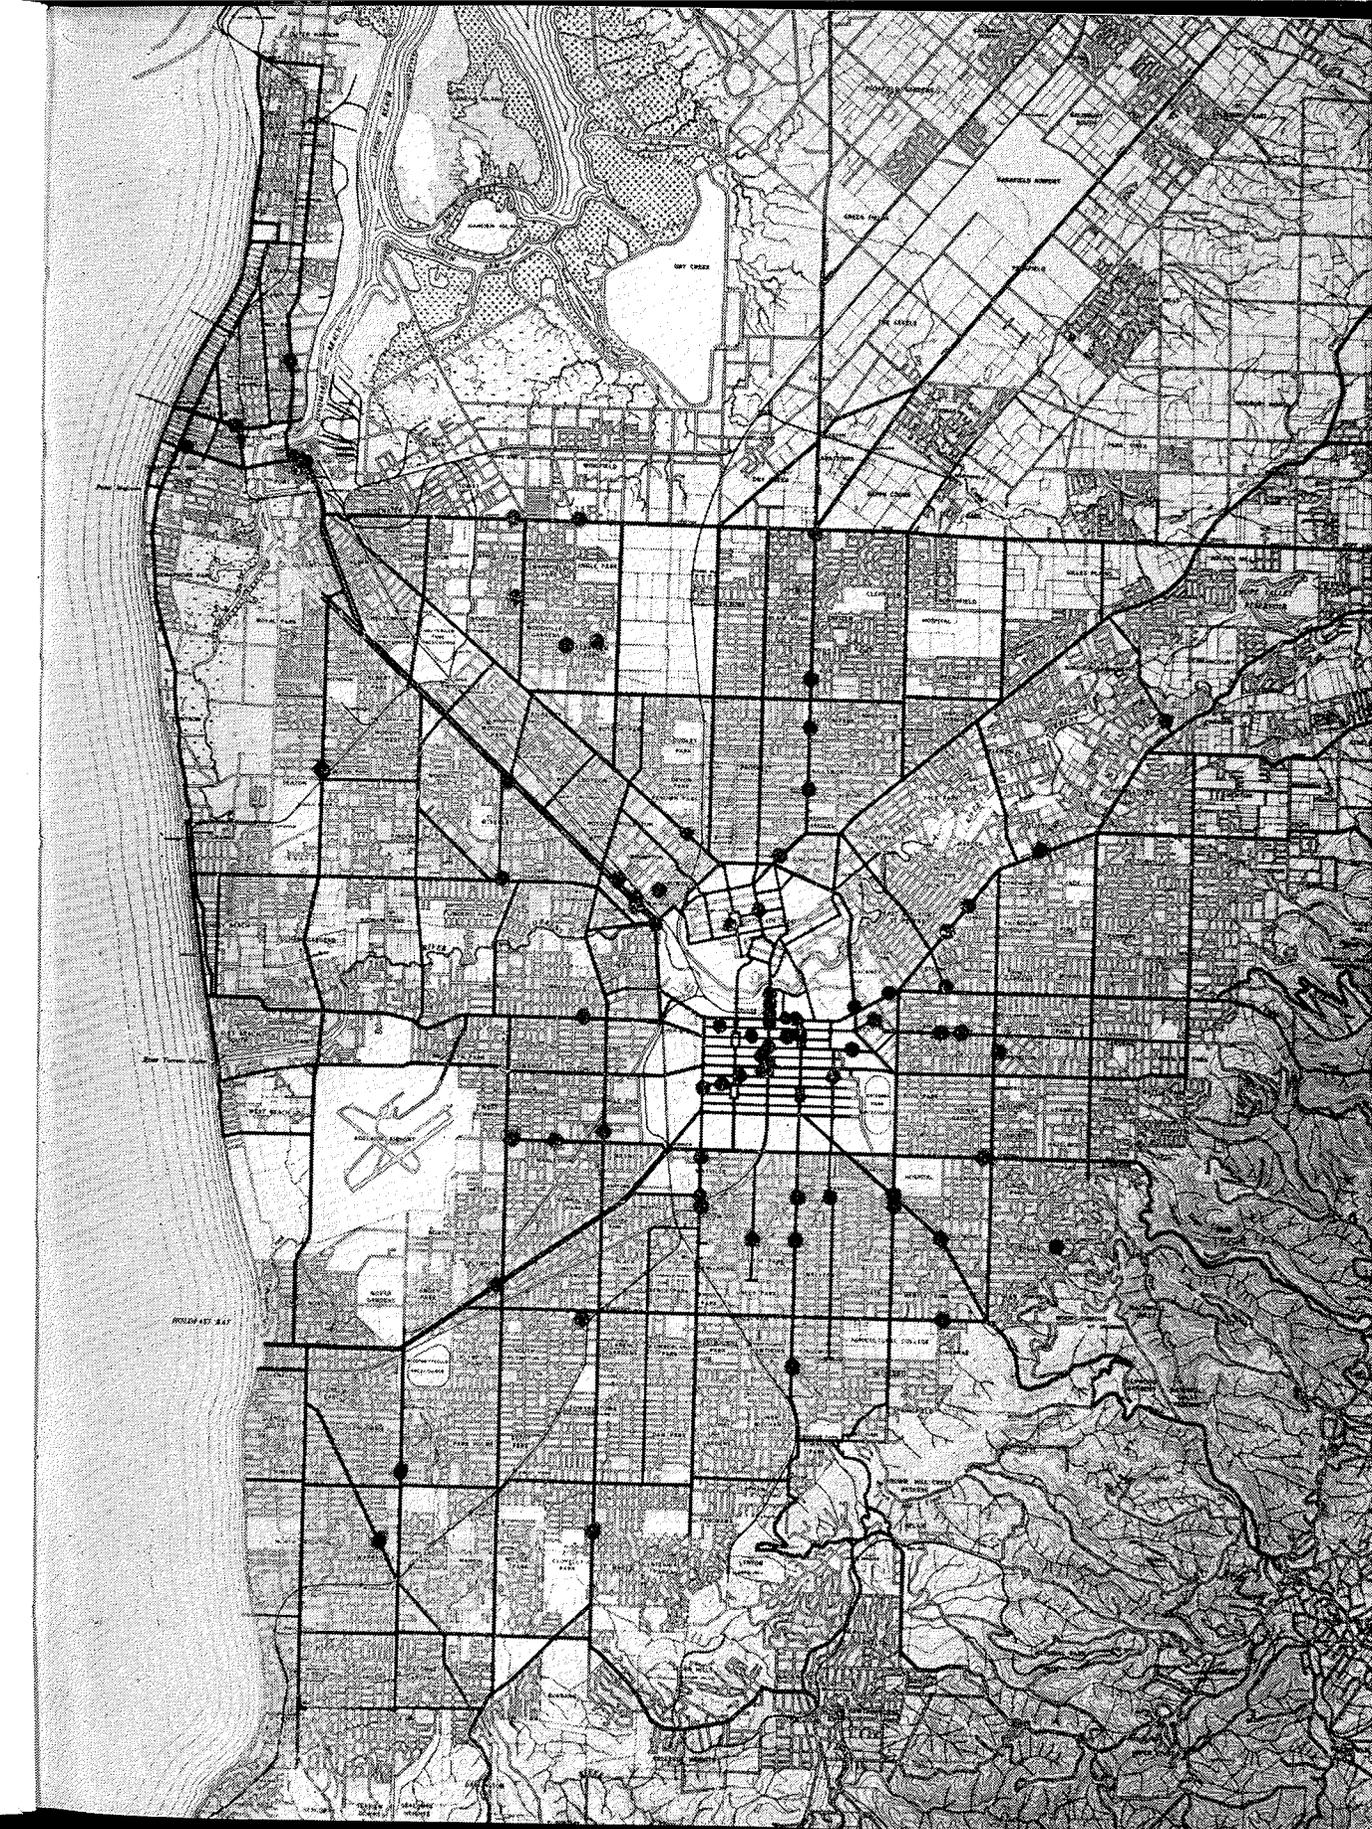
Fig. 4.10—79 pedestrian accidents (Traffic Accident Research Unit survey, 1963-64)

4.52 The locations of our pedestrian accidents are shown in Fig. 4.10. Almost all occurred on busy roads. In fact 72 of a total of 79 occurred on roads carrying more than 5,000 vehicles in 12 hours; the remainder occurred on minor side streets.

4.1 An accident involving a pedestrian (hereafter called a 'pedestrian accident') is perhaps the simplest kind of traffic accident: a naked and relatively uncomplicated encounter between man and the machine. All cities swarm with pedestrians, who wish to and need to cross streets thickly populated with moving vehicles. It is noteworthy that almost all the pedestrian accidents in our sample occurred on roads classified as 'busy' in respect of vehicular movement (see *Fig. 4.10* and para. 4.52).

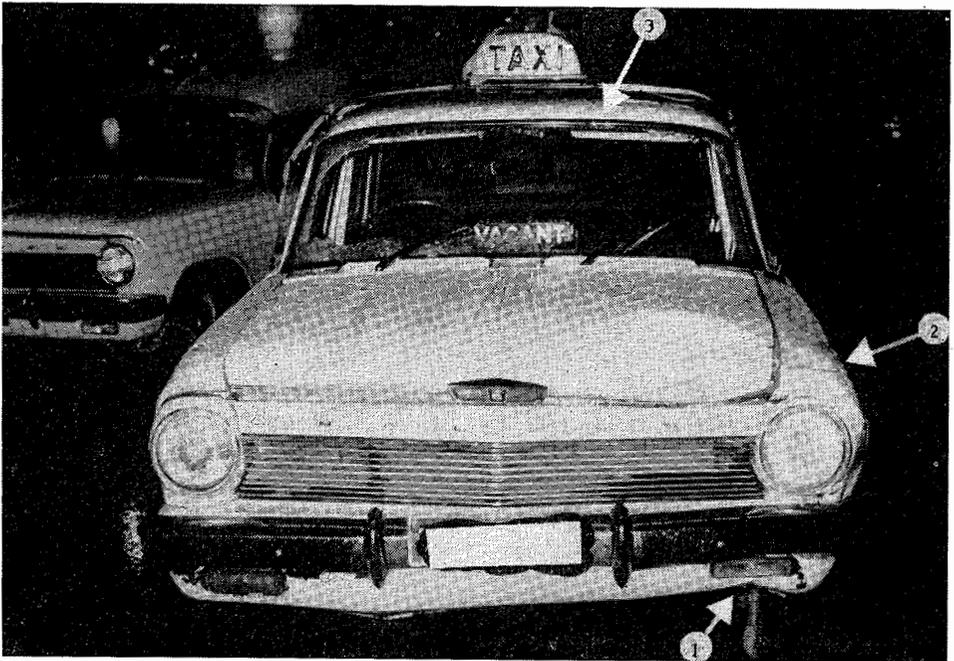
Fig. 4.20—Case 0105: Holden EJ versus pedestrian.

- Note: 1. (First impact) smear on bumper, dent in metal beneath bumper
 2. (Second impact) dents in edge of bonnet and headlight
 3. (Third impact) broken windscreen, small dent in surround

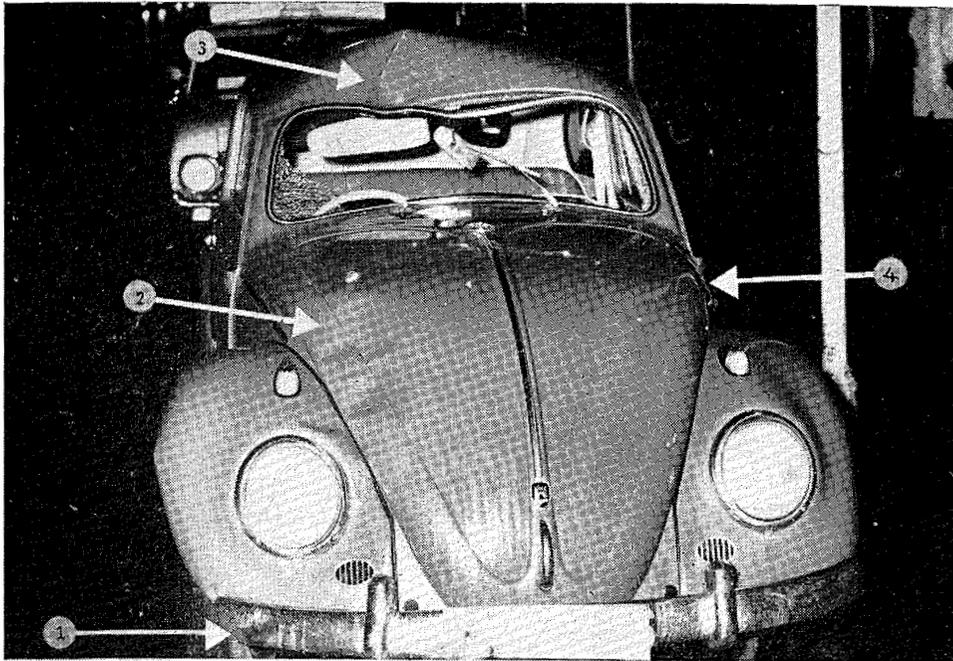
Fig. 4.21—Case 0414: Volkswagen versus pedestrian
 Note: 1. Smears on bumper, which is pushed back against mudguard
 2. Dent in bonnet and mudguard caused by pedestrian's hip
 3. Dent in roof and broken windscreen caused by pedestrian's head
 4. Radio aerial pushed forwards as pedestrians slid off roof onto road

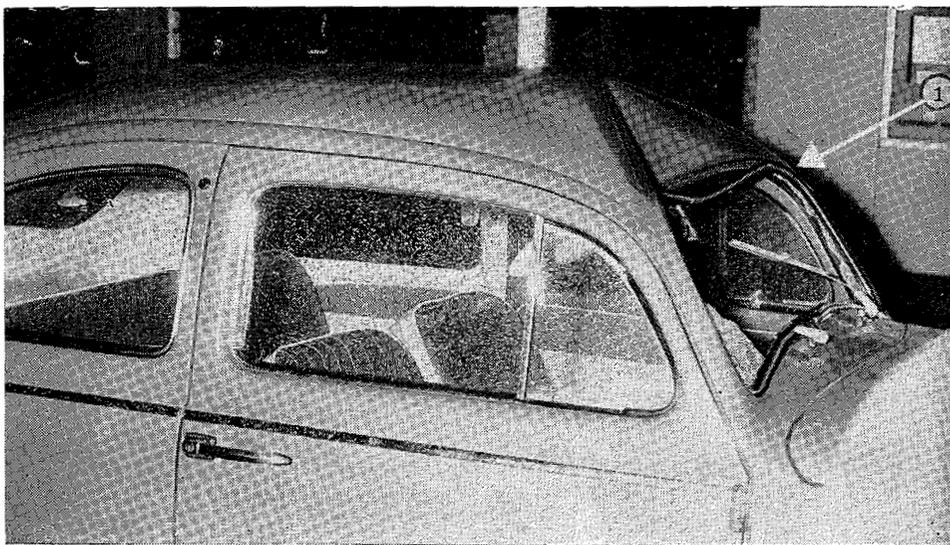
Fig. 4.22—Case 0414: Volkswagen versus pedestrian. Arrow shows dent 5 in. deep in roof, produced by the impact of the pedestrian's legs (fourth impact point)

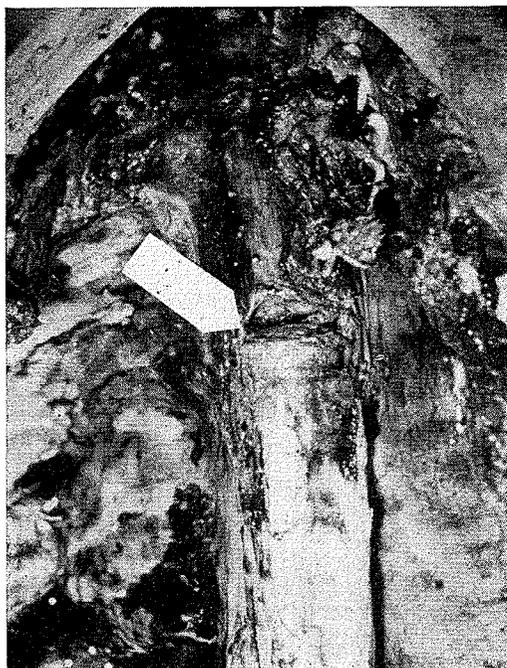
Fig. 4.29—Case 0234: disruption of the inter-vertebral disc between the third and fourth thoracic vertebrae

intervertebral disc between T3/4 (Fig. 4.29) and one case of crush fracture of the body of T10. Both of these pedestrians also sustained many severe injuries to all body areas.

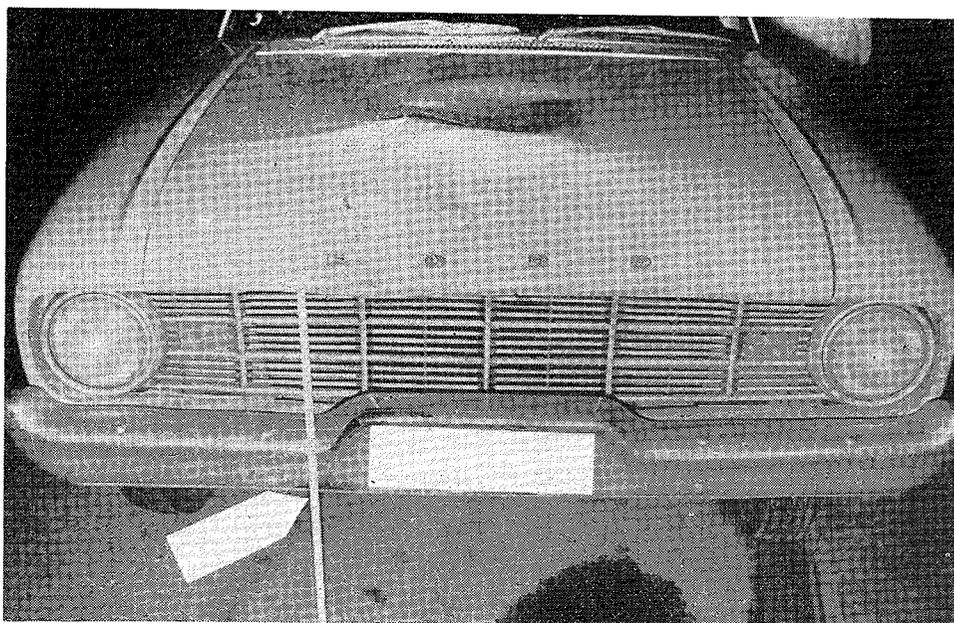
Fig. 4.30—Case 0131: brush marks on bumper bar (arrow) from impact with pedestrian's legs. Dents in bonnet produced by pedestrian's head and trunk

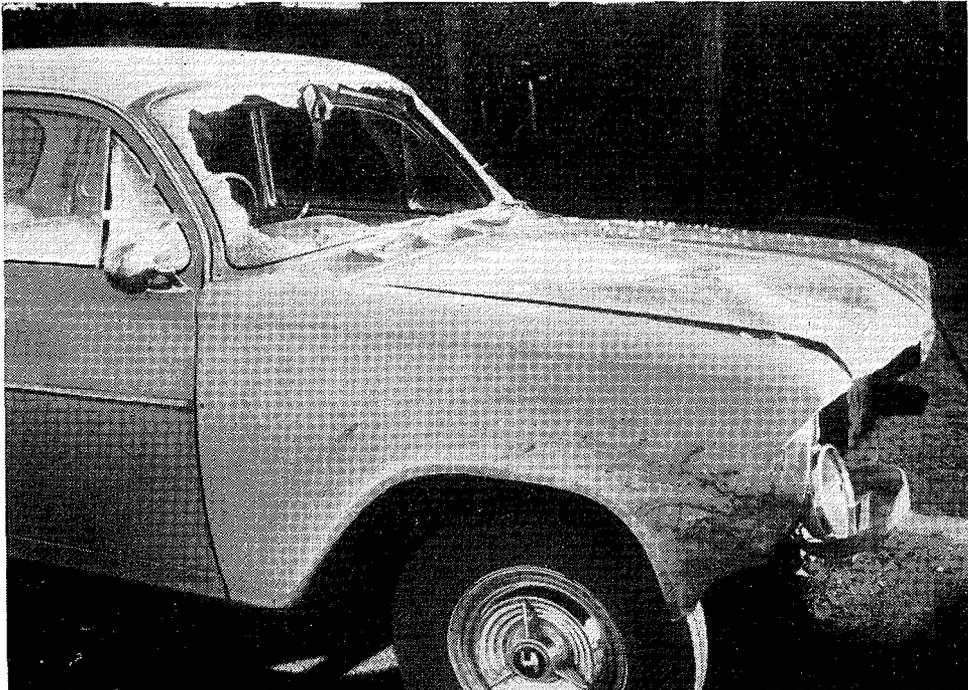
Fig. 5.7—Case 0367: rider of bicycle made dent in top of bonnet, broke the windscreen and slid along the roof (bumper and grille had been removed before the accident)

The soft tissue injuries were all in the lumbar region and over the sacrum. The subcutaneous emphysema occupied the right lower quadrant of the anterior abdominal wall. This was case 0367 where a 12-year old boy was struck by the front of the bonnet of an EJ Holden as he crossed in front of it (Fig. 5.7, 5.8 and 5.9). He suffered a laceration of the anterior wall of the rectum, associated with separation of the pubic symphysis and both sacroiliac

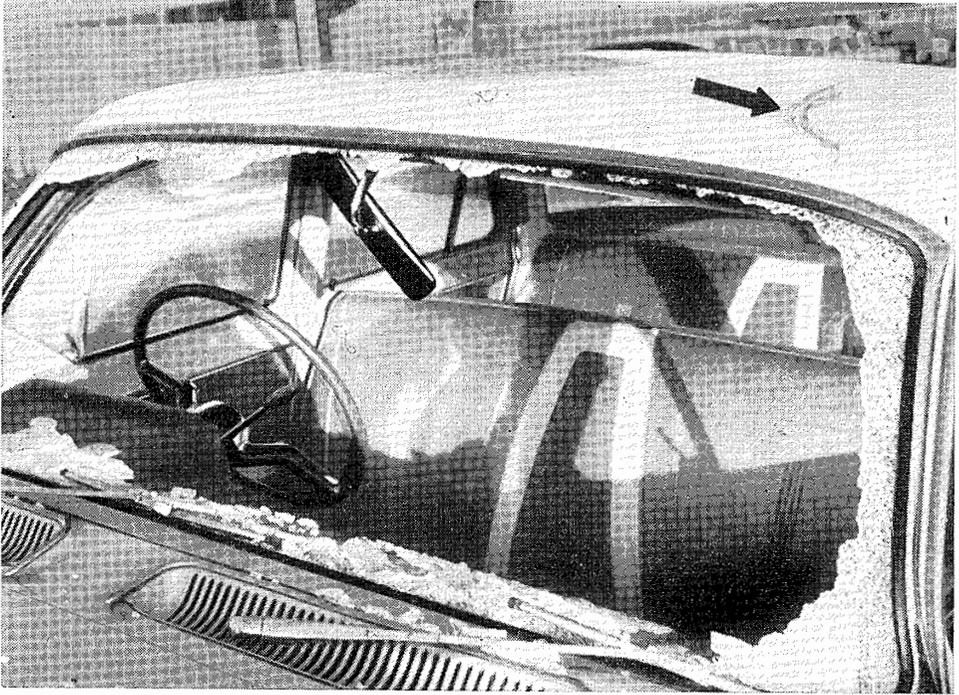
Fig. 5.8—Case 0367: blood smears on roof of car

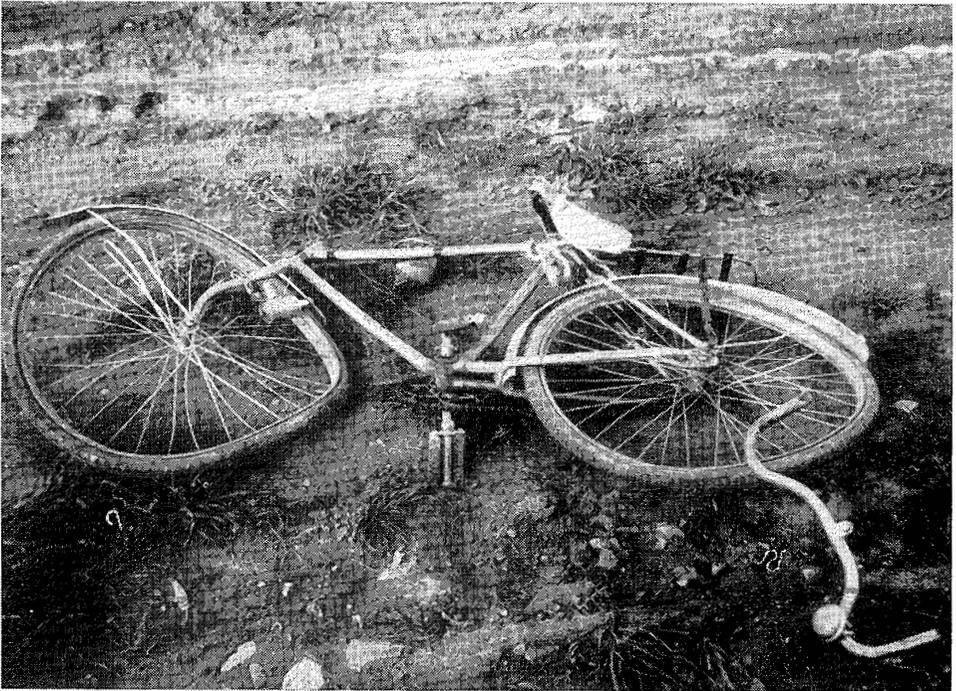
Fig. 5.9—Case 0367: bicycle which was struck by the car shown in Fig. 5.6

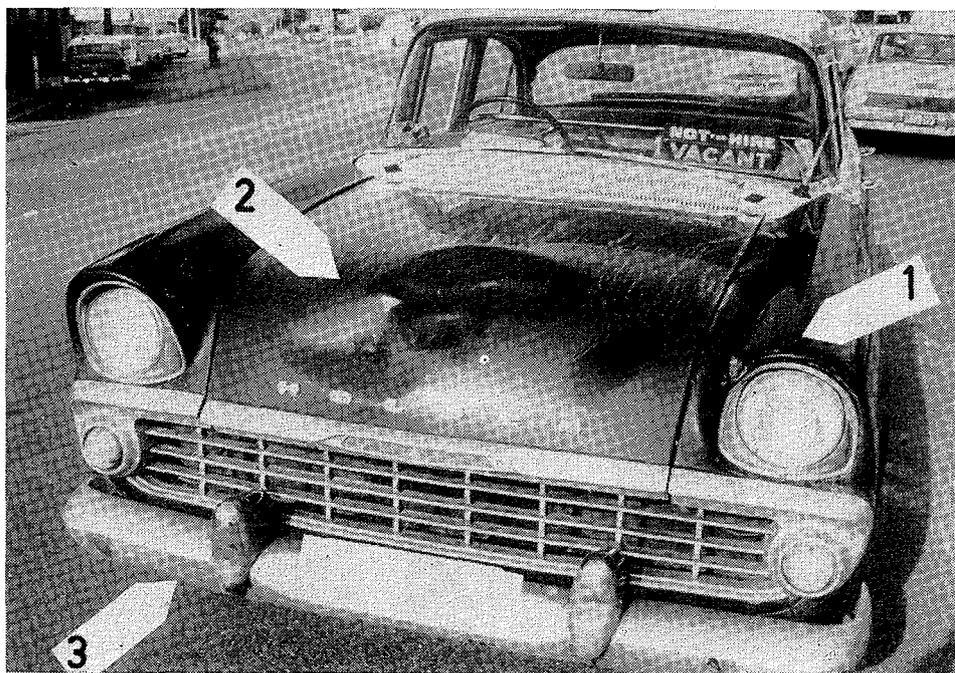
Fig. 5.11—Case 0160: impact of front of car with side of bicycle. Arrows indicate marks made by:
(1) handlebar on left headlight of car.
(2) the seat of the bicycle on the rider's hip on the top of the bonnet.
(3) the rear axle of the bicycle on the right bumper overridden.

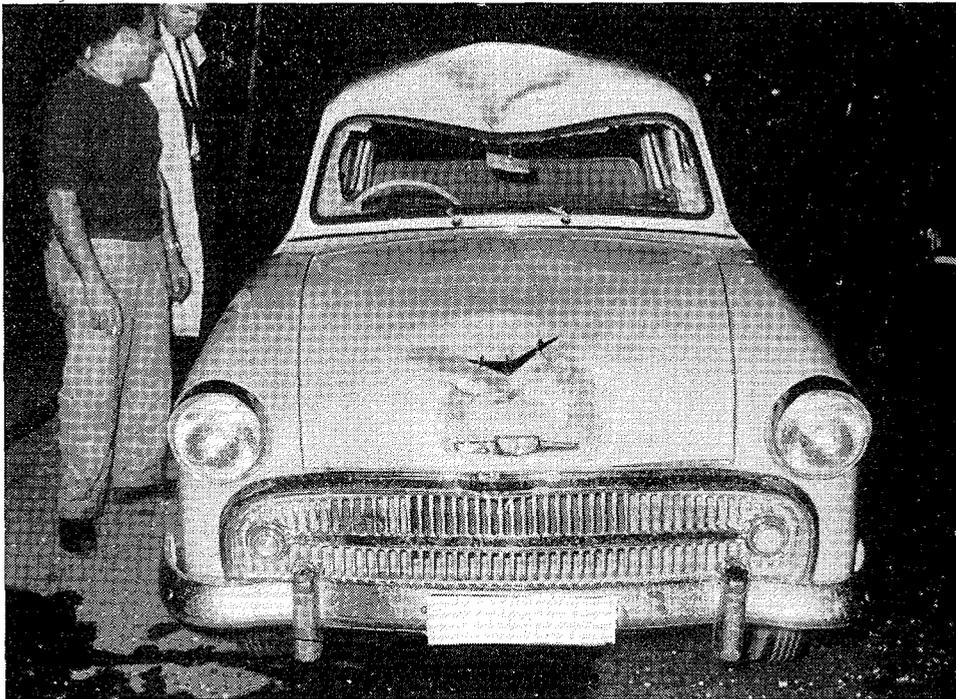
5.35 There were three collisions that were head-on or close to head-on. In one of these the rider struck the centre of the front of the car and then broke the windscreen and dented the roof with his head (Fig. 5.13 and 5.14). In the other two

Fig. 5.13—Head-on collision between car and bicycle (dent in roof made by rider's head)

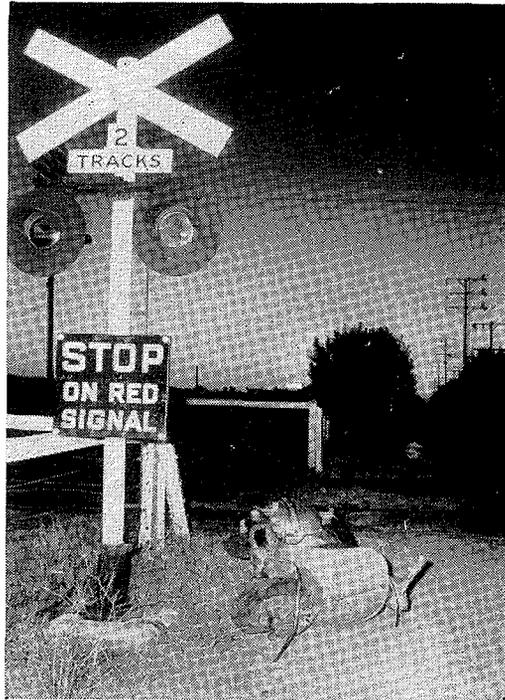
to go past on the track farthest away from him. He then moved on to the closer track and was struck by a diesel railcar travelling in the opposite direction, as he tried to push his machine back off the track (Fig. 6.8). The warning signals were operating at the time. The front left corner of the railcar struck the right side of the rider's head causing extensive fracturing of skull, maxilla, and mandible, also extensive brain lacerations and transection of the brainstem below the pons (Fig. 6.9). His other injuries were abrasions to his right shoulder and left leg.

Fig. 6.8—Scooter stopped alongside these lights, then moved forward and was struck, from the right, by the train shown in Fig. 6.9

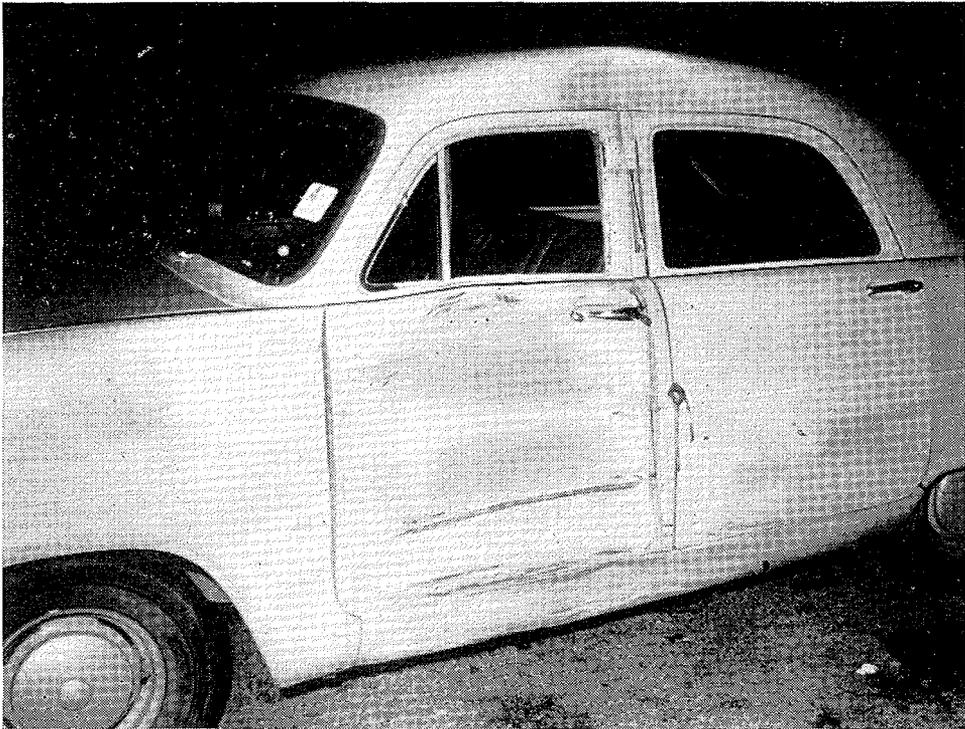
Fig. 6.11—Case 0087: motor-scooter struck left door of car. Damage around centre post caused by impact of rider's head

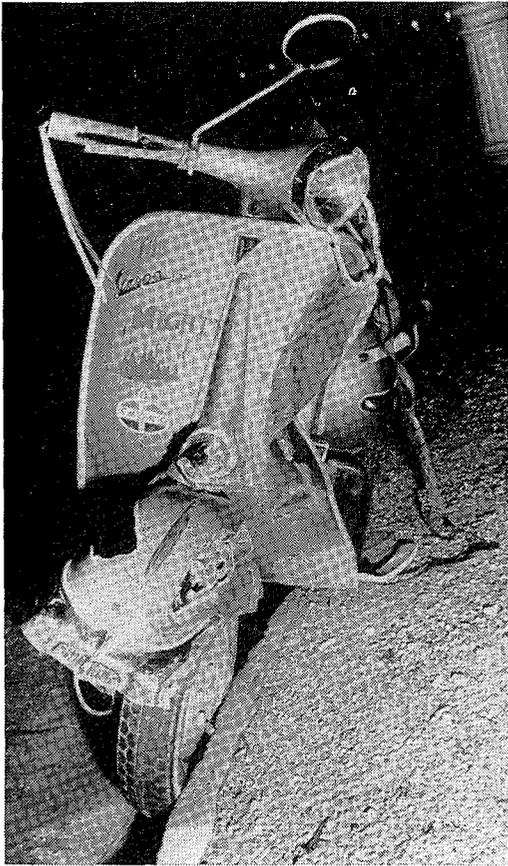
Fig. 6.12—Case 0087: Motor-scooter struck car shown in Fig. 6.11

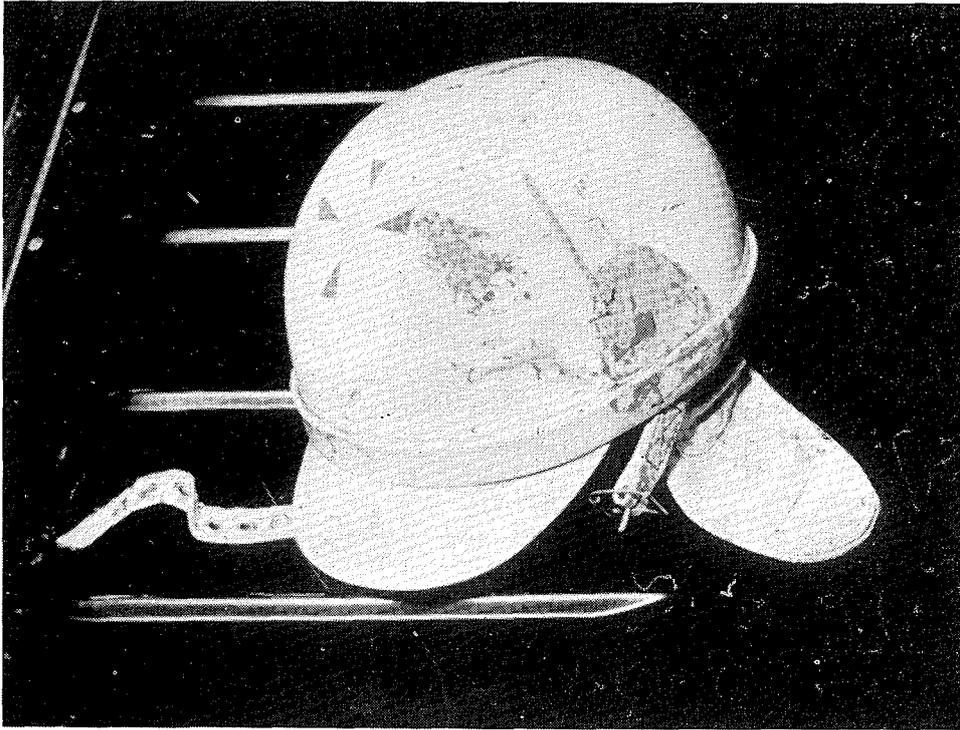
Fig. 6.15—Case 0087: helmet worn by motor-scooter rider (note abrasions of paint)

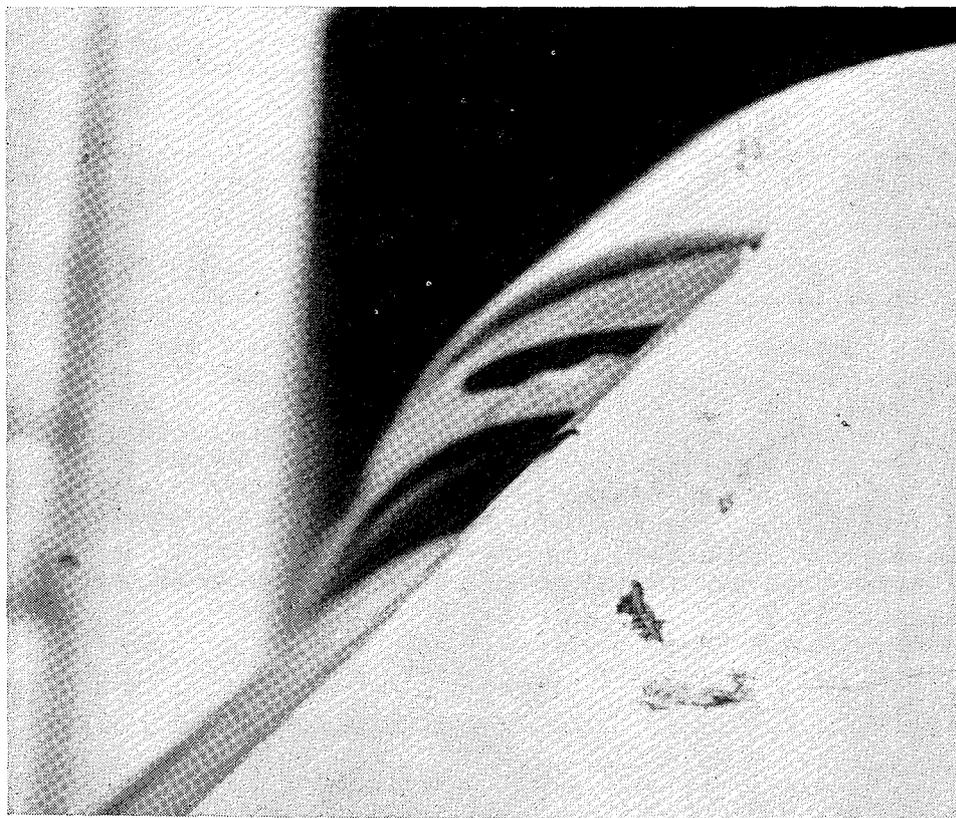
Fig. 6.19—Case 0418: teeth marks made by motor-scooter rider

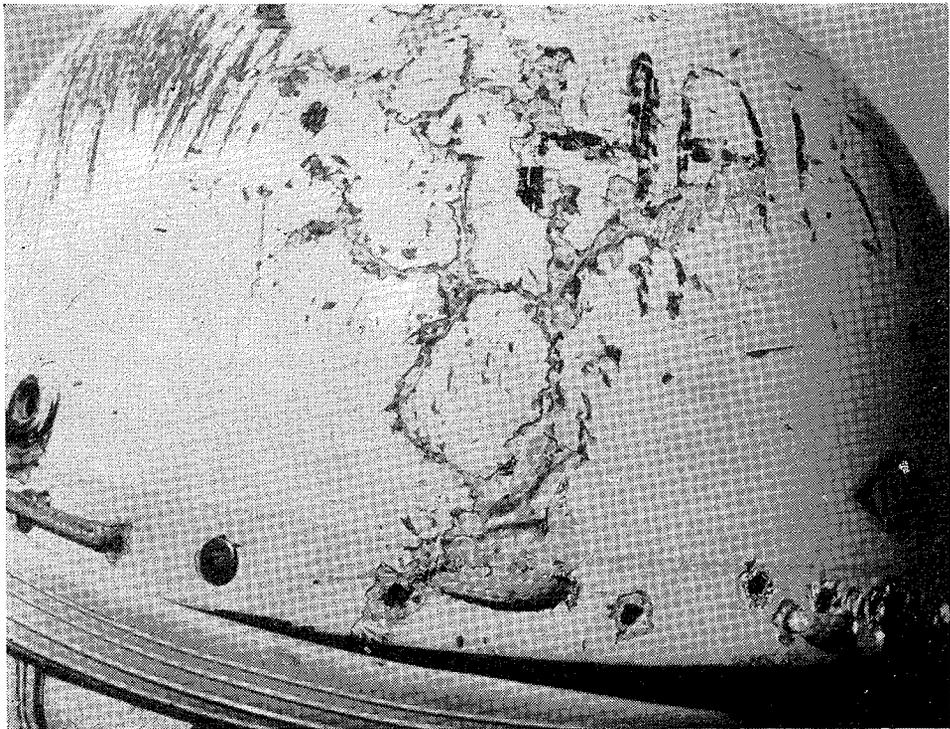
Fig. 6.24—Note fracture through shell of helmet

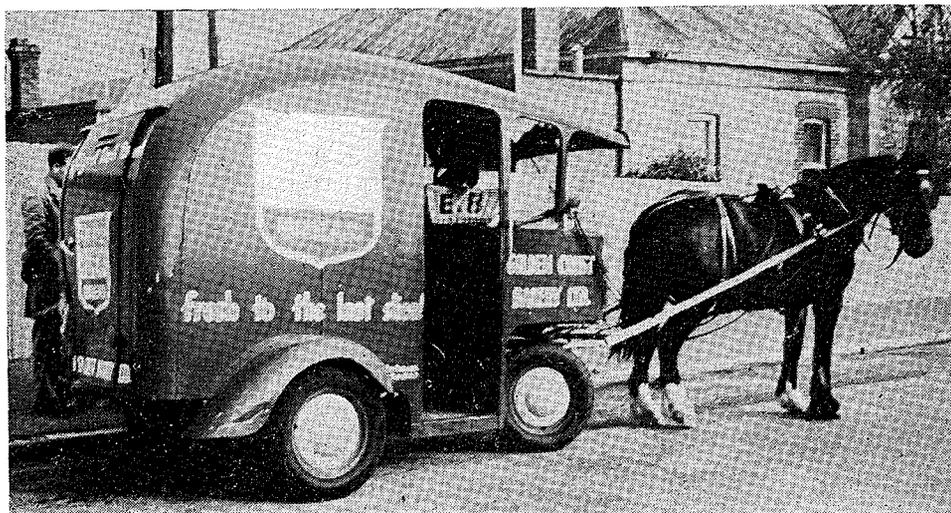
Fig. 7.5—This baker's cart was struck from the rear by a truck. The horse was obviously ill at ease when the photograph was taken soon after the accident

and 0417 are the familiar type of chain collisions. In accident 0395 it was, of course, the truck that ran into the back of the horse and cart (*Fig. 7.5*). The truck then skidded to the left and hit a parked car.

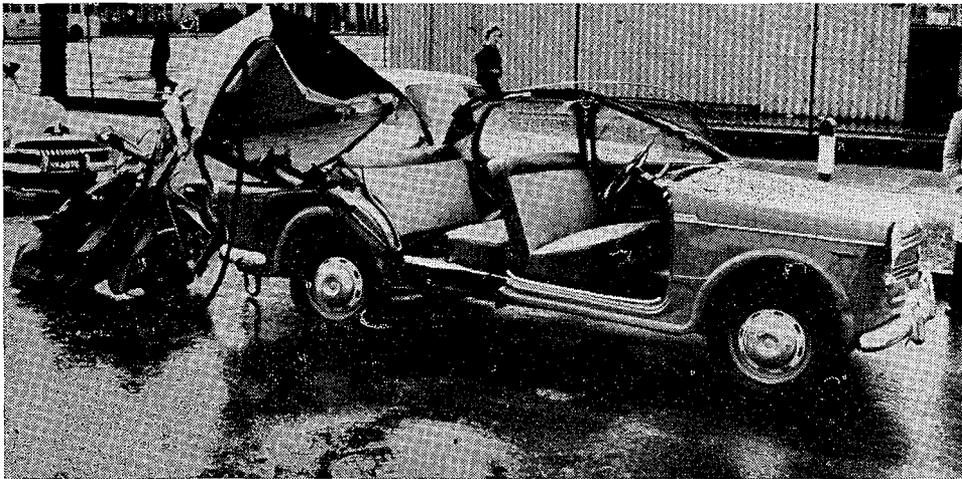
Fig. 7.6—This Fiat 1100 sedan had its roof torn off when it ran under the overhanging tray of a truck

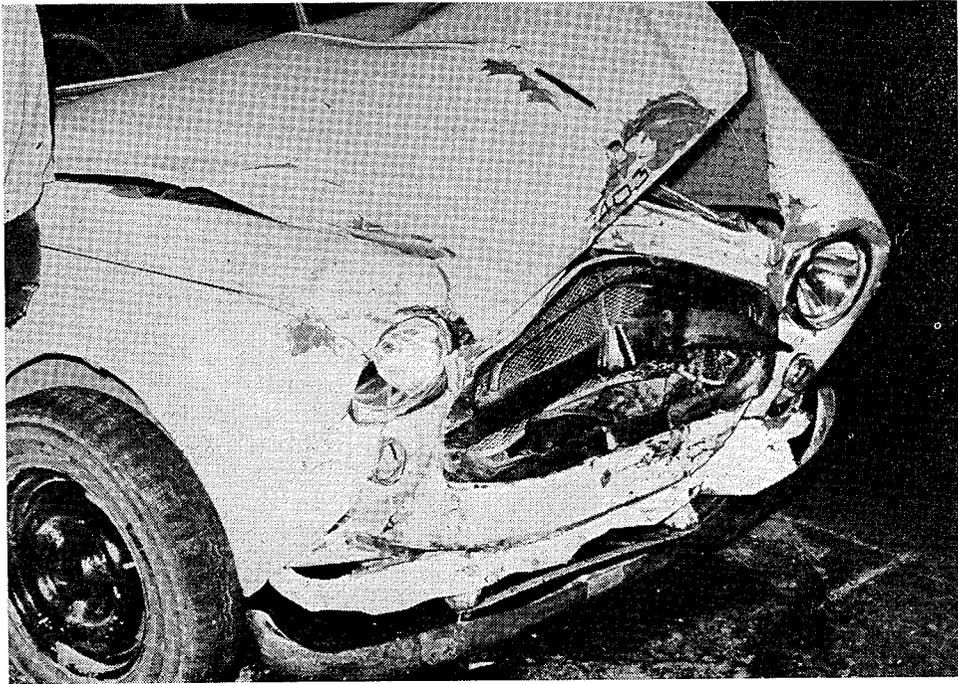
The front of a Peugeot (Fig. 8.2) struck the left side of a Ford Zephyr (Fig. 8.3) at a traffic light controlled intersection. The Zephyr was spun anti-clockwise through 270° and came to rest against the front of a Simca which had just moved off with the green light. The first collision resulted in injury to the driver of the Peugeot and to a rear seat passenger of the Zephyr. The collision with the Simca caused almost no damage to the cars, and no injury to the occupants.

Fig. 8.2—1958 Peugeot 403, after colliding with the Ford Zephyr shown in Fig. 8.3

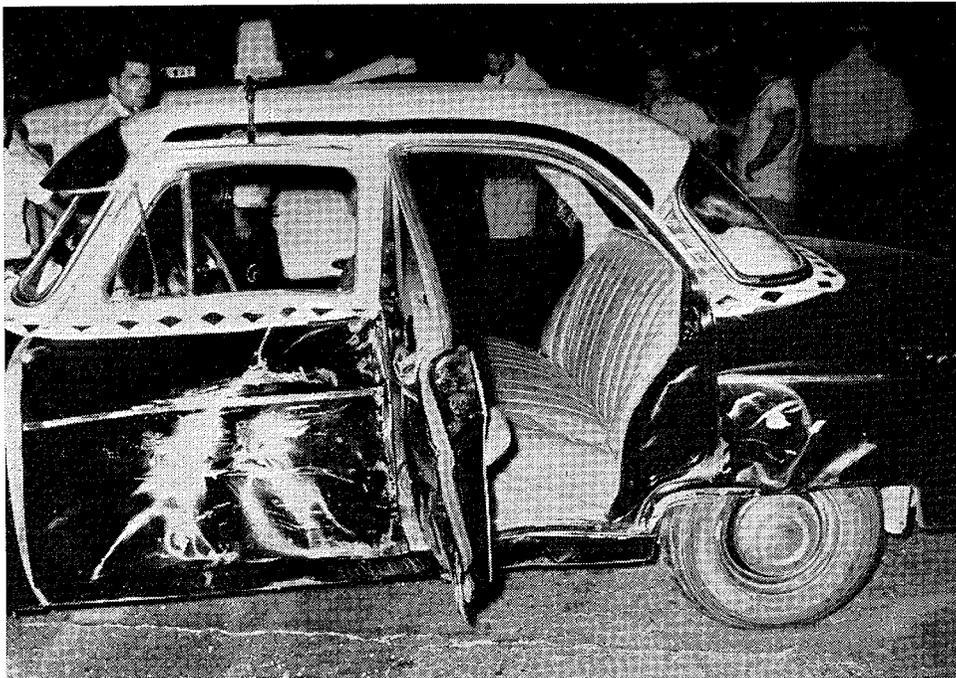
Fig. 8.3—1959 Ford Zephyr, struck by the Peugeot shown in Fig. 8.2. Note that the rear door has come open

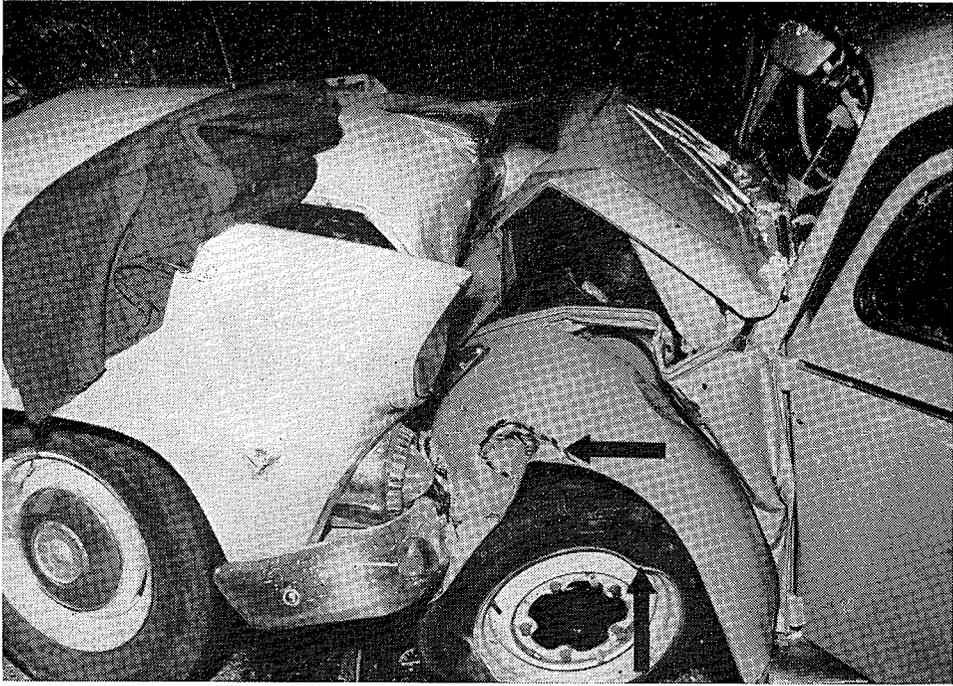
Fig. 8.6—Case 0046: arrows indicate the damage due to the initial collision between the Volkswagen and a Ford

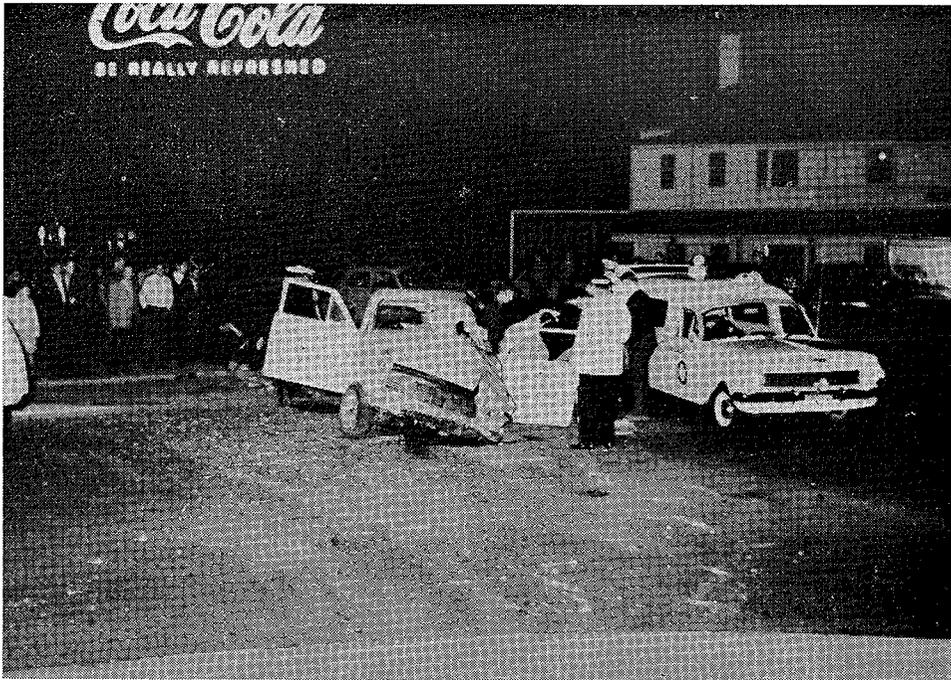
Fig. 8.18—1957 FE Holden after a collision with the roundabout shown in Fig. 8.17
