TRAFFIC ACCIDENTS IN ADELAIDE, SOUTH AUSTRALIA

AUSTRALIAN ROAD RESEARCH BOARD

SPECIAL REPORT No. 1, JULY, 1966

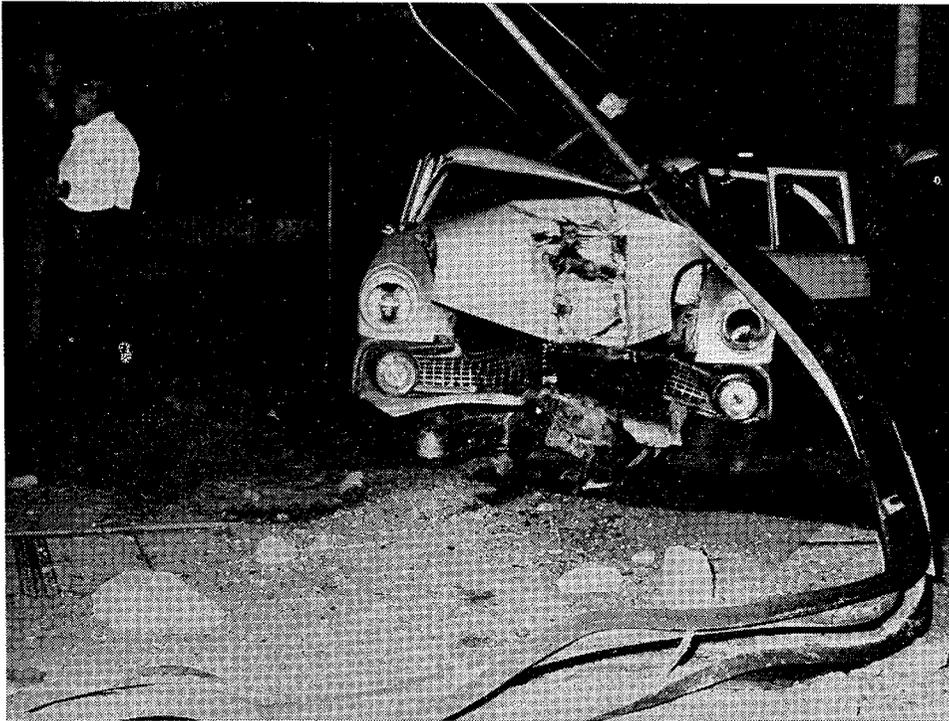
Fig. 8.20—1955 Ford Customline, after colliding with a steel and concrete utility pole. The base of the pole is in the bottom left corner. The car approached from the left (see also Fig. 9.31)

1.109 A collision with a utility pole can result in severe damage to the vehicle and severe injury to the occupants. Poles can be modified to minimize the damage to a vehicle which hits one, and the value of introducing such modified poles could be considered.

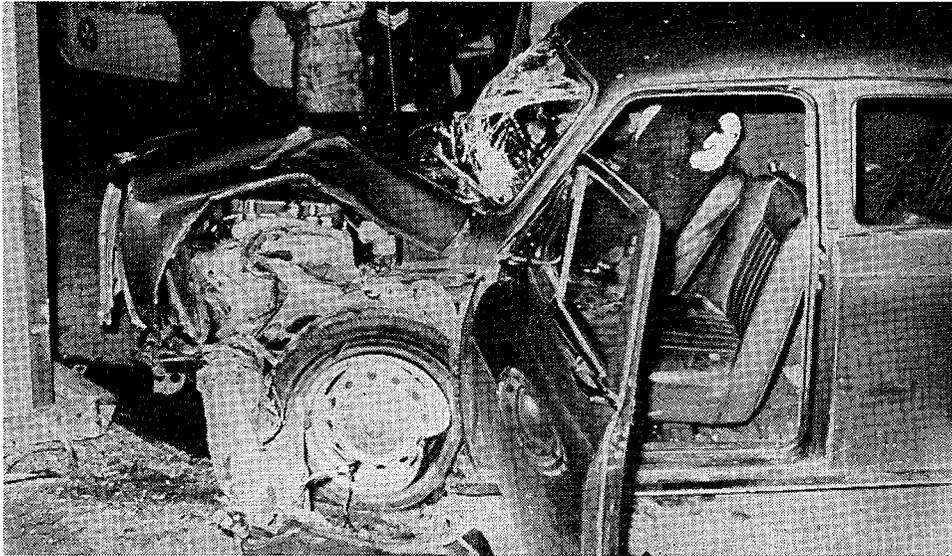
Fig. 8.22—1954 M.G. Magnette after colliding with the utility pole shown (see also Fig. 9.29, 11.7 and 11.17)

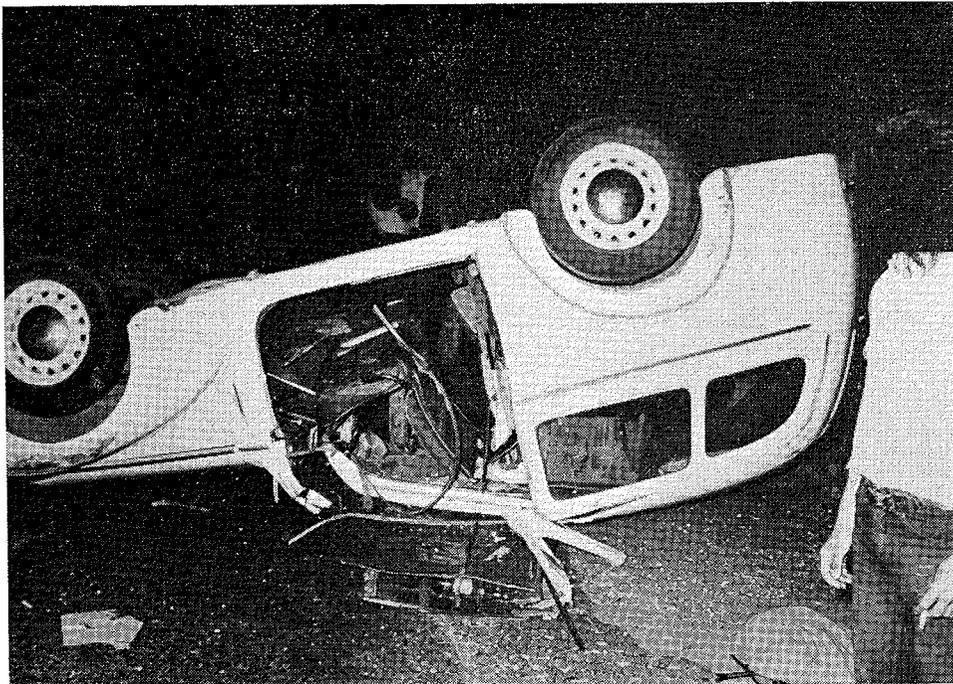
Fig. 8.23—This Skoda rolled over after swerving from one side to the other on a straight road

young drivers may drive older and therefore cheaper cars. The other point, and one which is directly related to vehicle design, is that five of these 12 cars had independent rear suspension of the swing-axle type. These cars were two Volkswagen 1200 sedans, two Skoda sedans (*Fig. 8.23*), and one Renault Dauphine (*Fig. 10.6*). The drivers of these cars had mostly been driving for more than five years. One driver in fact claimed 45 years' driving experience.

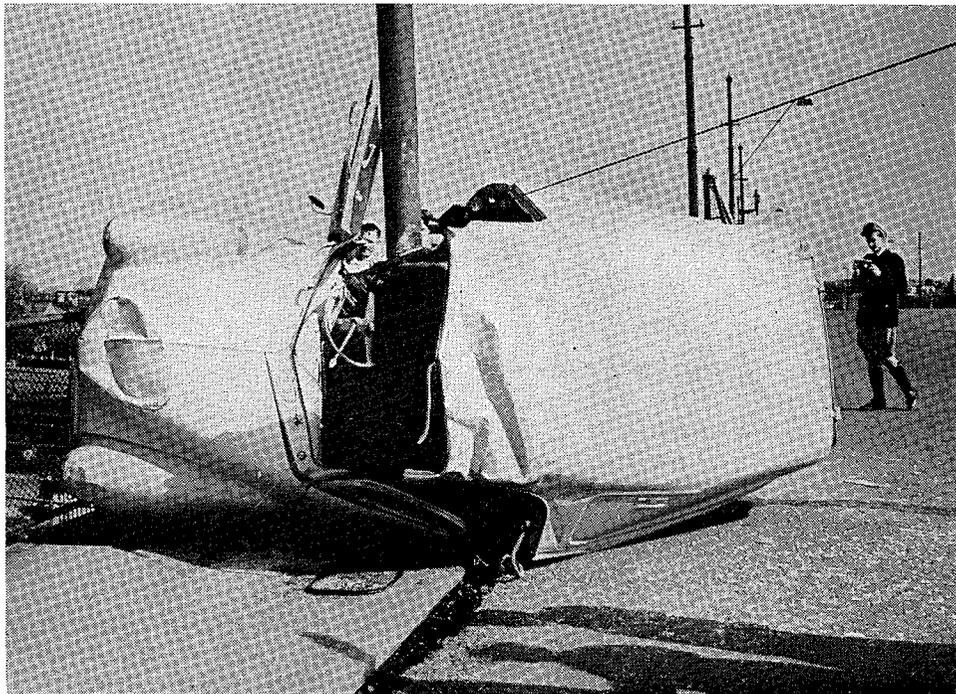
Fig. 8.25—This 1955 FJ Holden panel van rolled over and struck a steel utility pole. The front corner posts and the steering wheel were cut to extricate the driver from the damaged car

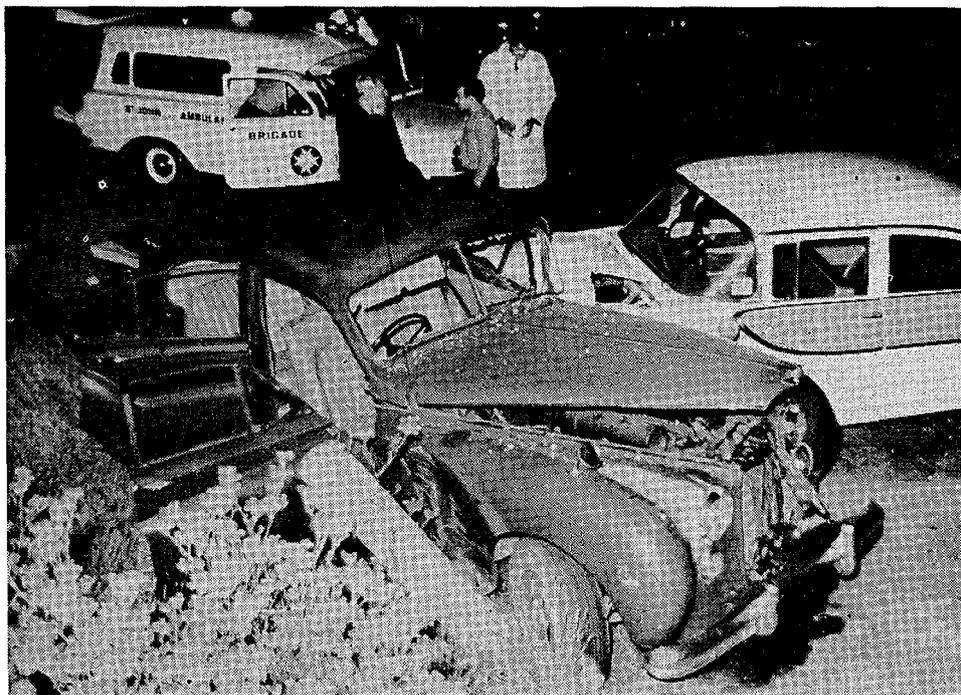
Fig. 9.3 — Two-car collision

Fig. 9.43—The damaged FB Holden, shown in Fig. 9.3, stripped for repairs

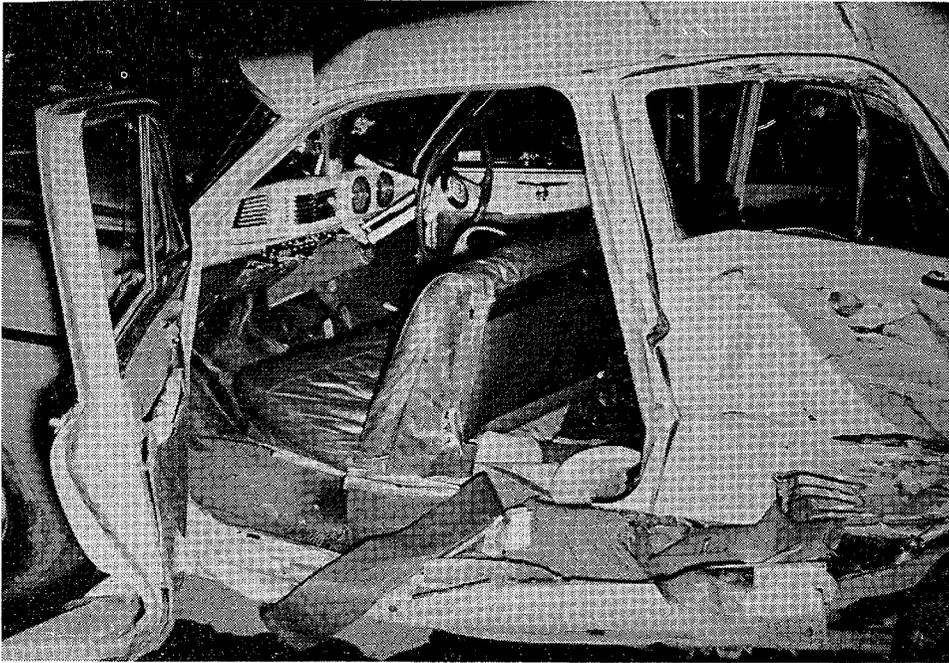
Fig. 9.9 — Impact on the side of the passenger compartment of a 1954 Vauxhall Wyvern

the reason, the fact remains that many of these impacts are on the side of the case car, including the sides of the passenger compartment. This has particular significance for both vehicle designers and for traffic engineers.

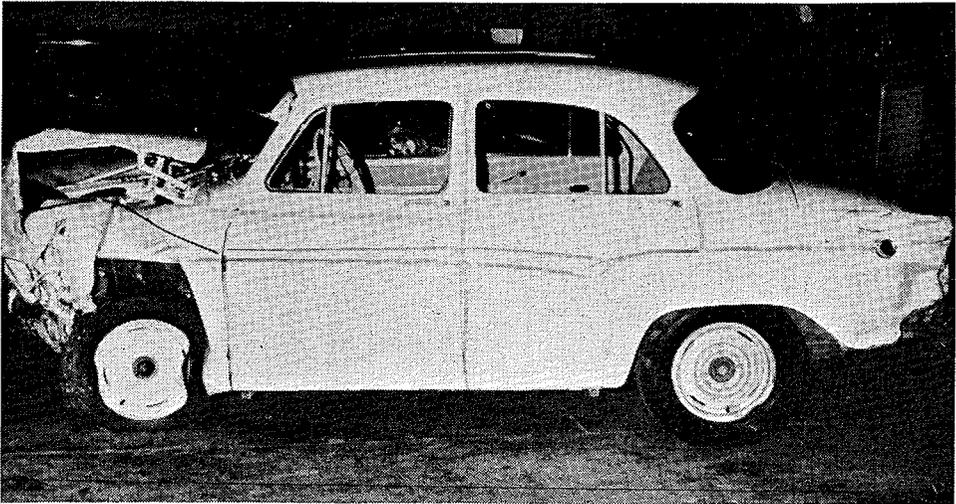
Fig. 9.10 — The damage to the rear of this Simca was caused by the initial collision with another car. The frontal damage resulted from a subsequent collision with the side of a hotel

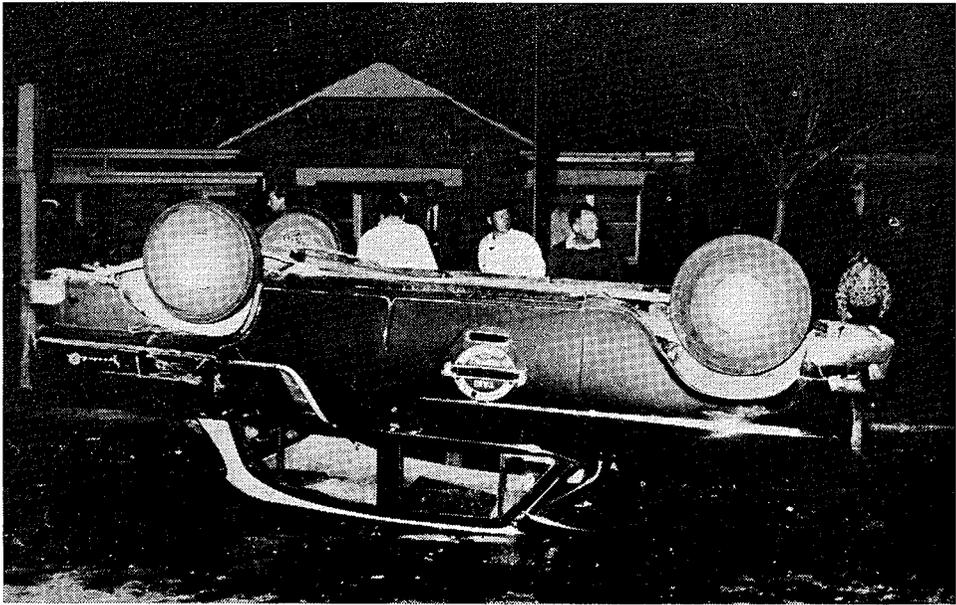
Fig. 9.11—This FC Holden taxi rolled over after being struck on the left side, behind the rear wheel, by the Holden shown in Fig. 9.12

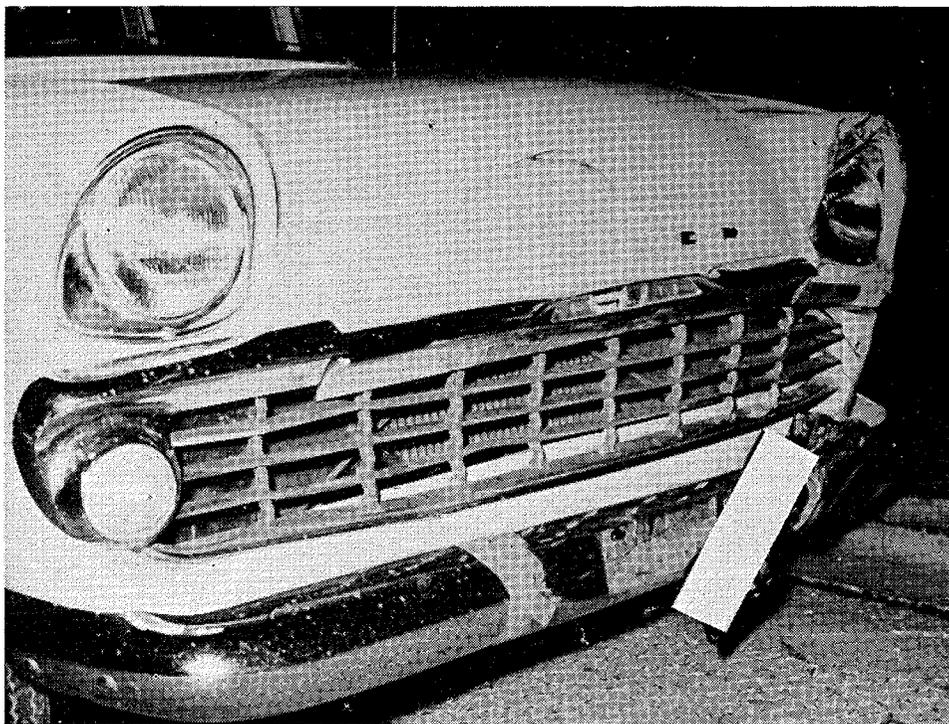
Fig. 9.12—Note the relatively small amount of damage to this car. The struck car (see *Fig. 9.11*) was spun anti-clockwise by the impact and rolled over

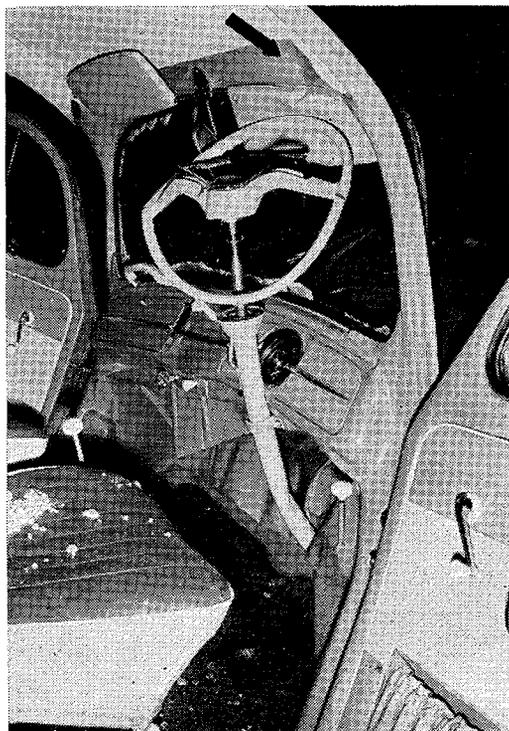
Fig. 9.15 — 1962 Volkswagen 1200 steering column forced back in a head-on collision with another car. Note also the dent in the header strip made by the driver's head, and the shoe trapped by the pedals

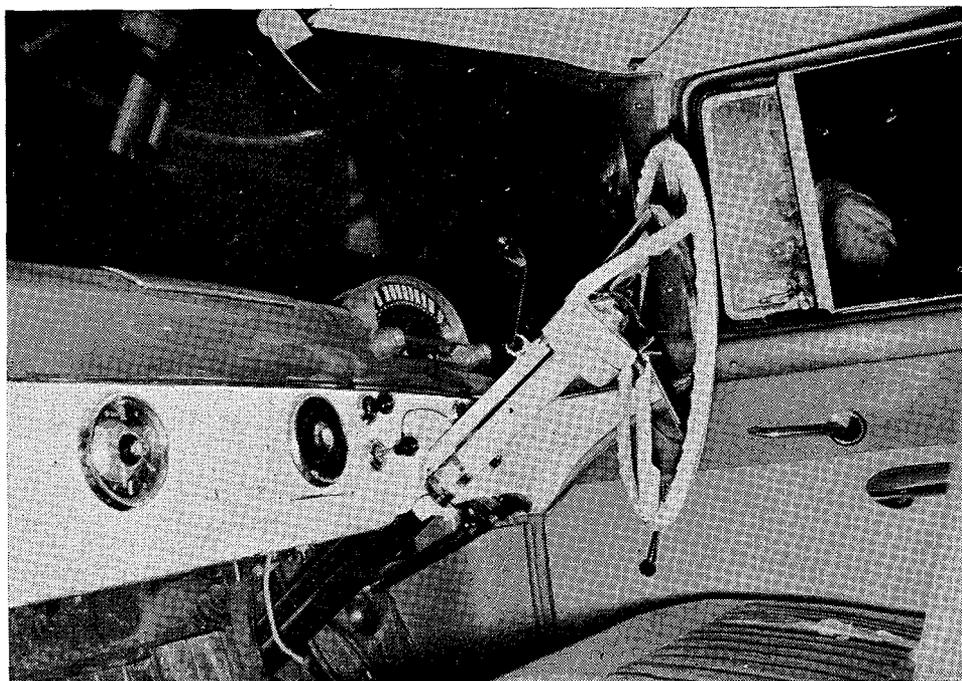
Fig. 9.17 — Three-spoke 'dished' wheel of a 1957 Ford Customline, damaged by the driver being thrown against it in a head-on collision with another car

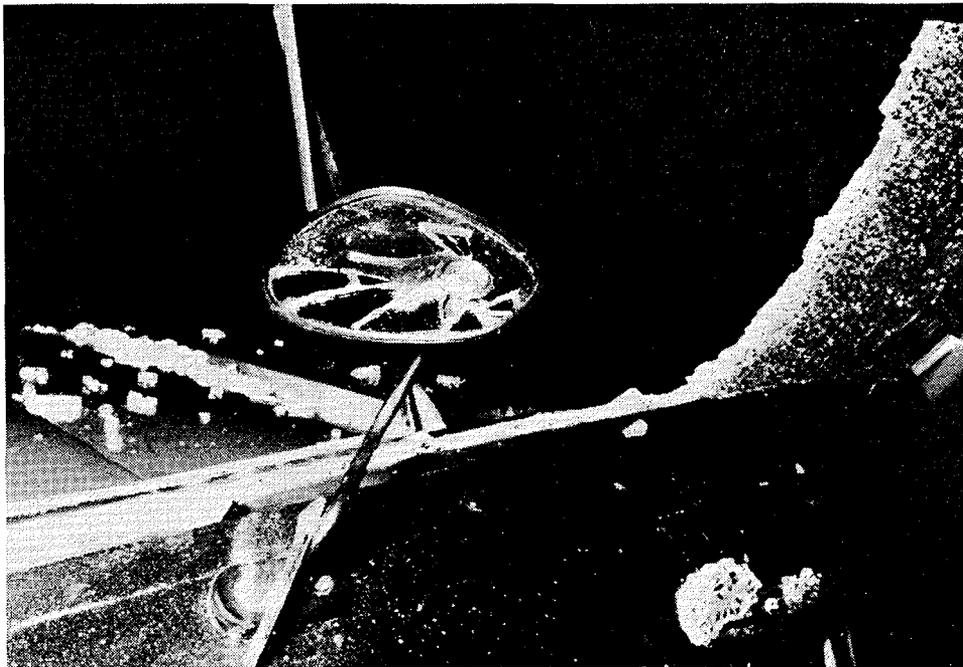
Fig. 9.21 — Rear vision mirror of a 1963 Renault R4, broken when struck by an occupant

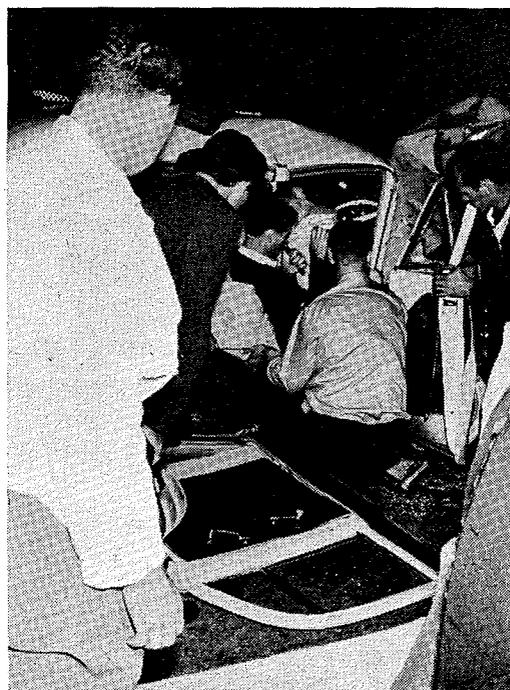
Fig. 9.22 — Driver trapped in an FX Holden by the front seat, which moved forward in the collision

9.53 Failure of the seat mountings, whether it is failure of the adjustment catch or complete failure of the mountings, means that the front seat occupants are forced by the front seat up against the instrument panel and steering wheel in a frontal impact. This additional force alone is bad enough, but in some cases, particularly with the 'bench' seat, the seat may become jammed, wedging the occupants up against the instrument panel. Fig. 9.22 shows ambulance

men, police and tow truck drivers working to release a driver who has been trapped in this way. The seat had come forwards and the damaged adjustment (Fig. 9.23) prevented it from being pushed back. The driver, who had a severe compound fracture

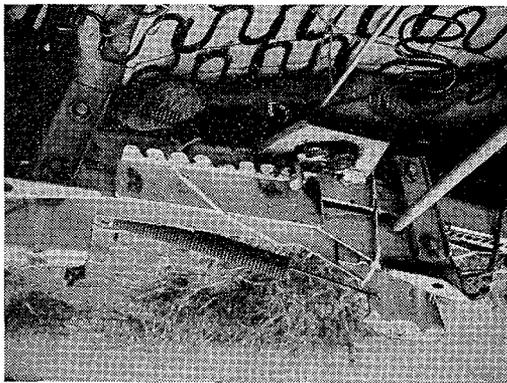
Fig. 9.23—Seat adjustment locking mechanism (passenger's side) of the 1952 FX Holden shown in Fig. 9.22

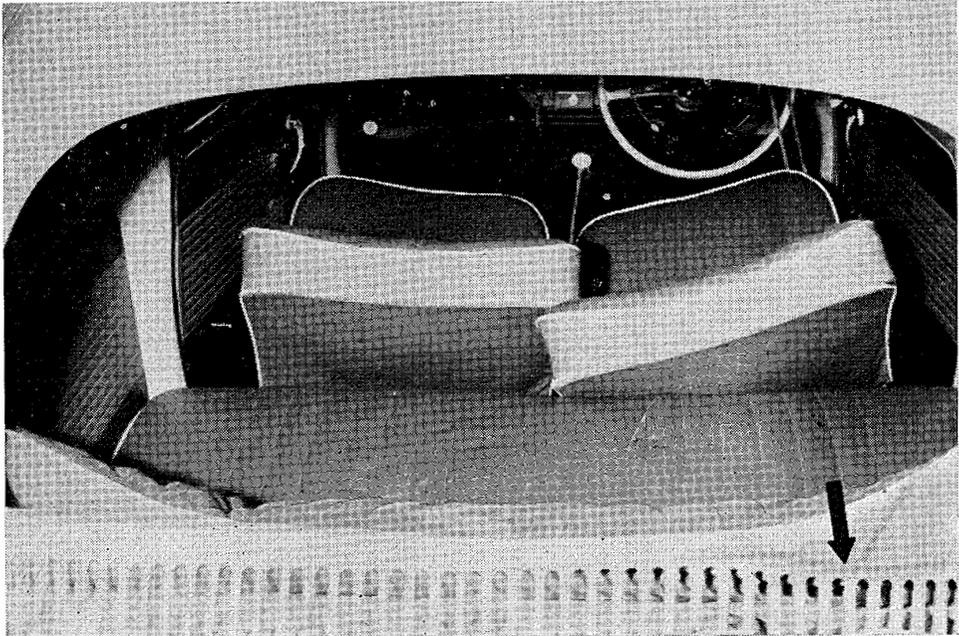
Fig. 9.25 — The front seat mountings of this 1960 Volkswagen failed when it was hit from the rear by another car. Note the damage to the back of the rear seat, and the dent (indicated by arrow) below the rear window, which was made by the driver's head

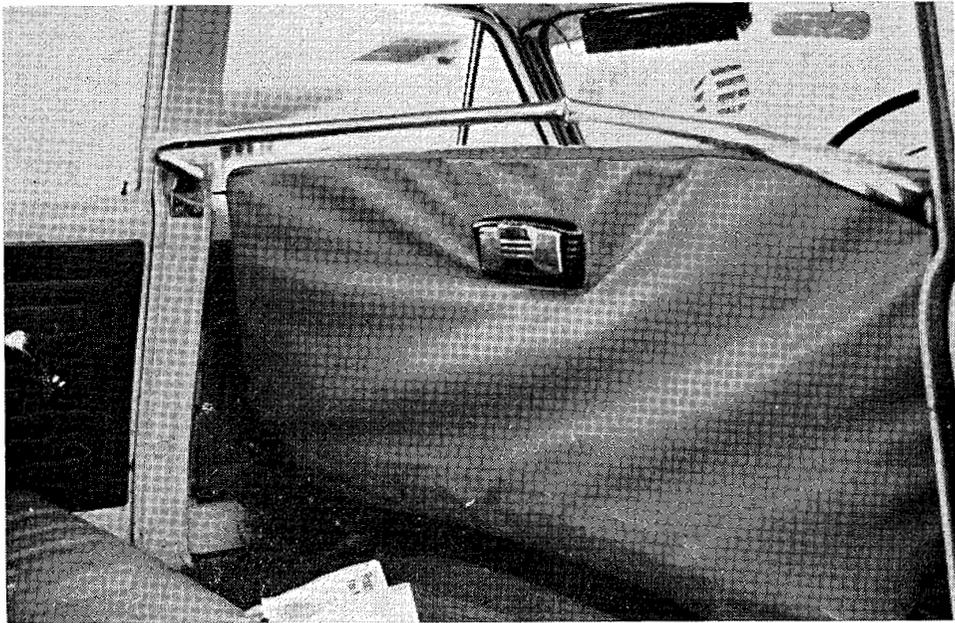
Fig. 9.26 — Handrail of a 1959 Holden taxi, struck by a rear seat passenger

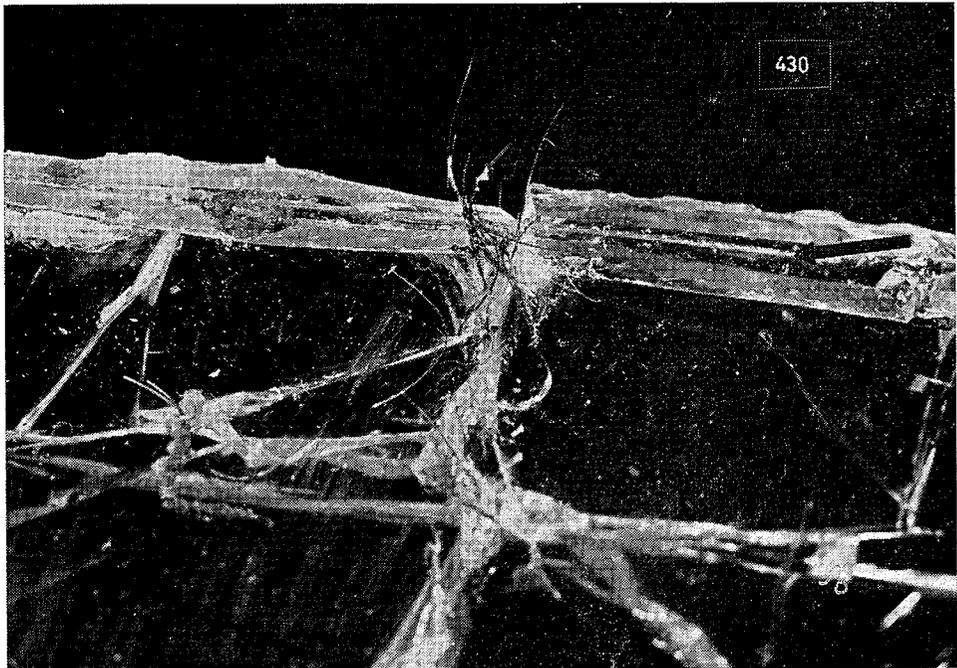
Fig. 9.29 — Laminated glass windscreen of a 1954 MG Magnette saloon, broken by the passenger's head; note hairs caught on sharp edges. Arrow indicates the interlayer between the two sheets of glass

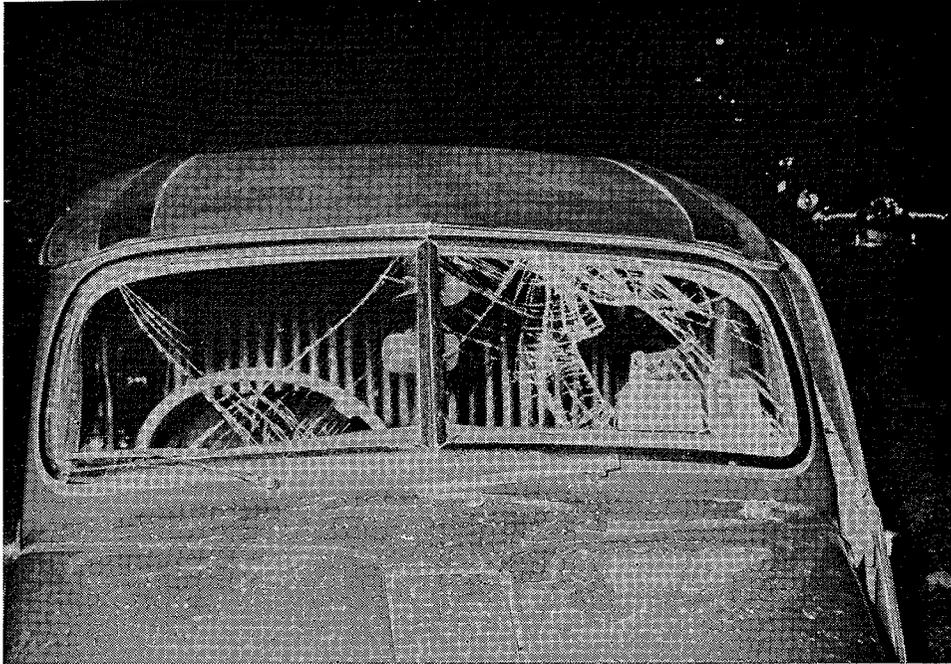
Fig. 9.30 — Laminated glass windscreen of a 1952 Riley. The fractures on the driver's side are due to deformation of the frame. Both driver and passenger struck the other half of the screen

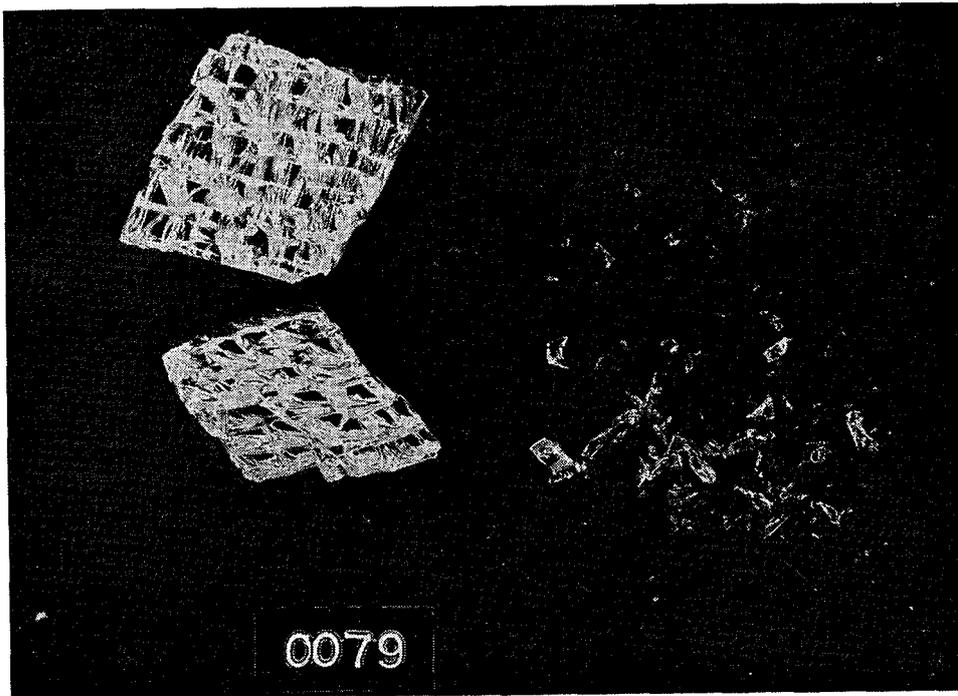
Fig. 9.32—Fragments of toughened glass from the shattered windscreen of a 1961 Volkswagen (Scale: 1.2 x full size)

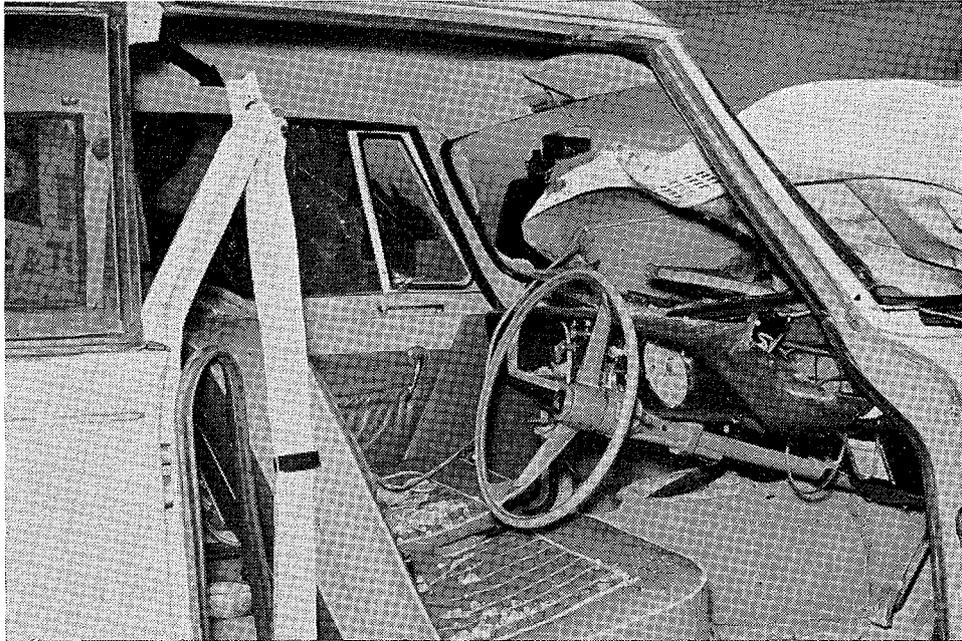
Fig. 9.33—Failure of seat belt mounting (arrow) on a 1960 Triumph Herald. Distortion of the mounting on the passenger's side is also indicated. This vehicle is also shown in Fig. 7.8

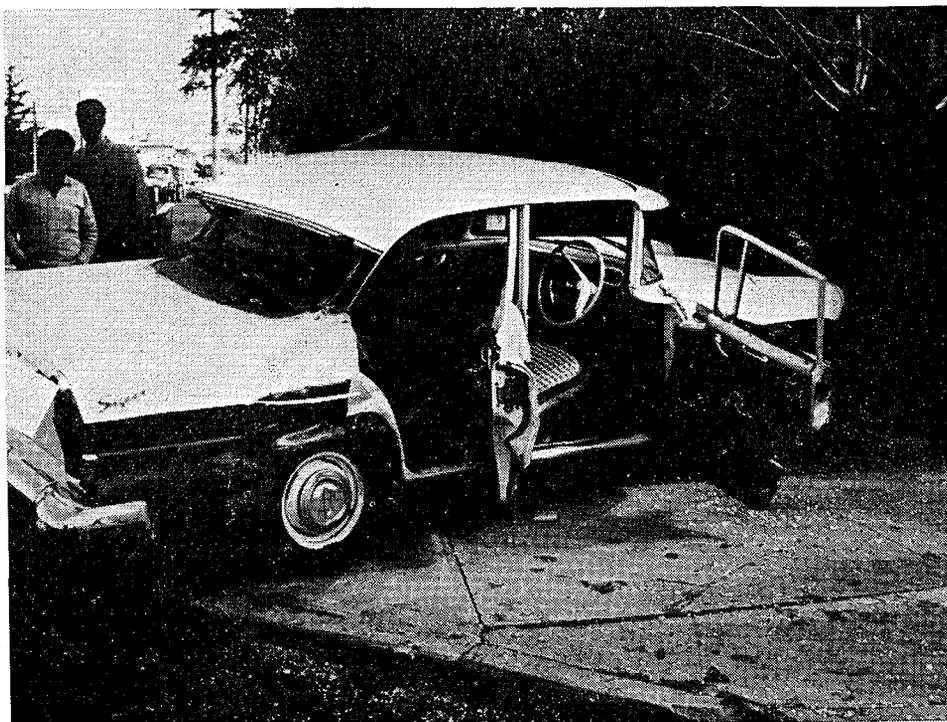
Fig. 9.34—1960 Vauxhall Victor, struck on the right side by another car at an intersection. Both doors on the right side were sprung open

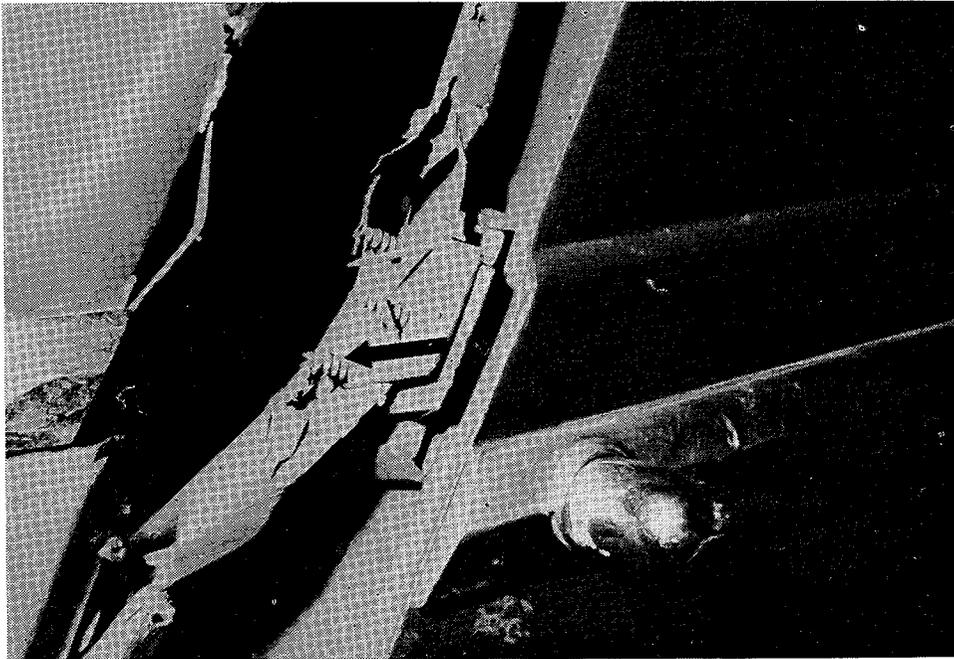
Fig. 9.39—Door lock failure on a 1952 Riley Saloon. Arrow indicates one of three wood-screws used to mount the striker plate to the body of the car

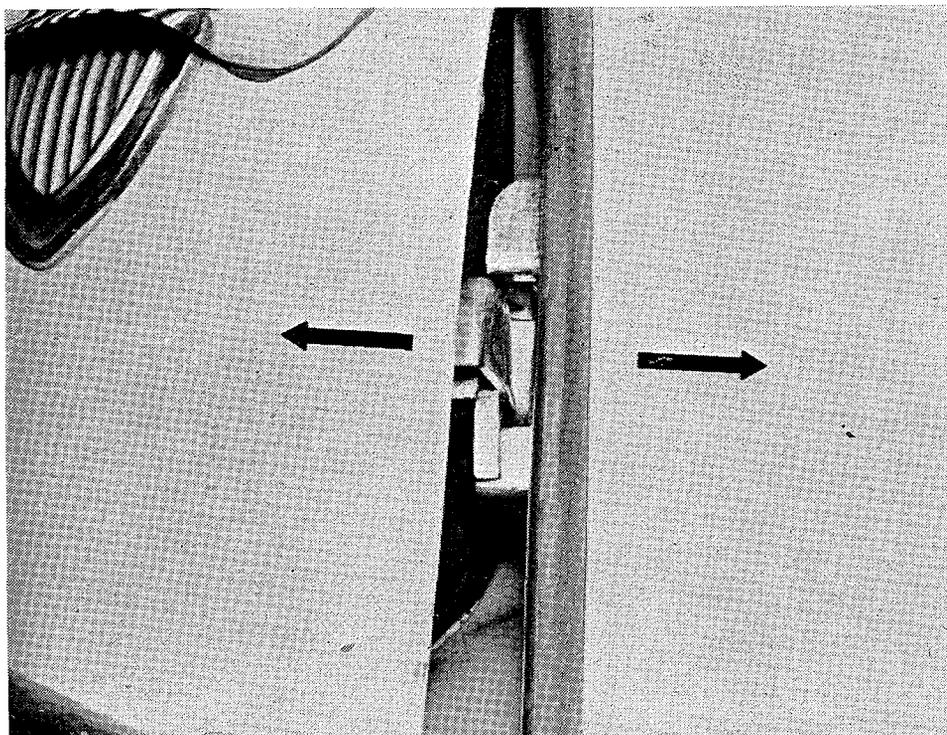
Fig. 9.41—1960 FB Holden door latch. The flange is bent, as in Fig. 9.40, but the latch is still engaged with the striker plate and the door has not opened. The forces on the lock, due to the distortion of the body frame of the car, are in the directions shown by the arrows.

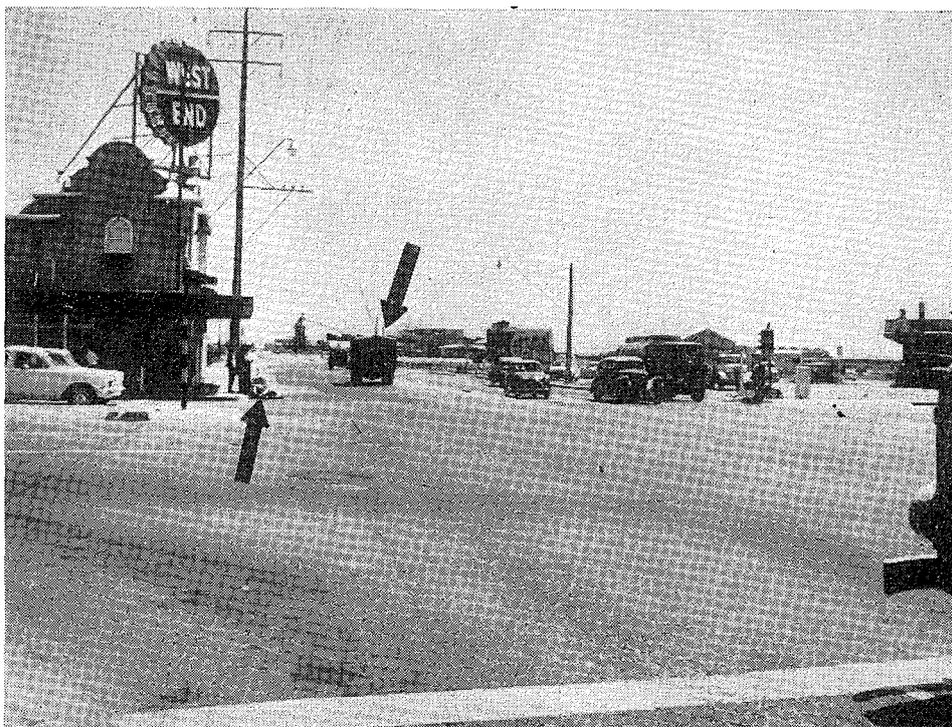
A truck carrying a load of peaches, total weight 8 tons, was travelling west along Grand Junction Road at about 20 m.p.h. After entering the intersection the lights changed to amber and then to red. A motor-scooter moved off from the southern leg of M.R.2 (see Fig. 10.5). Although it was mid-day the rider could not see this truck because there was another truck alongside him on his right on M.R.2. The scooter hit under the left side of the tray of the truck and was run over by the rear wheels. The rider, a 32-year old man, received a fractured rib and multiple abrasions. His pillion passenger, a 30-year old woman, received abrasions and a deep laceration to the right knee. They were both wearing safety helmets. The driver of the truck was not injured. The truck was immobilized in what was rather a 'David and Goliath' sequence.

Fig. 10.5—Gepps Cross: view looking west along Grand Junction Road. Arrows indicate wrecked motor-scooter and immobilized truck (accident 0239).

10.27 It is, of course, true to say that had the motorists been more observant and taken greater care these accidents may not have happened. But a similar remark applies to those responsible for the phasing of these lights. Unfortunately serious under-

staffing of this section of the Highways Department means that the work of contractors who install traffic lights very often cannot be checked for some months or even years.

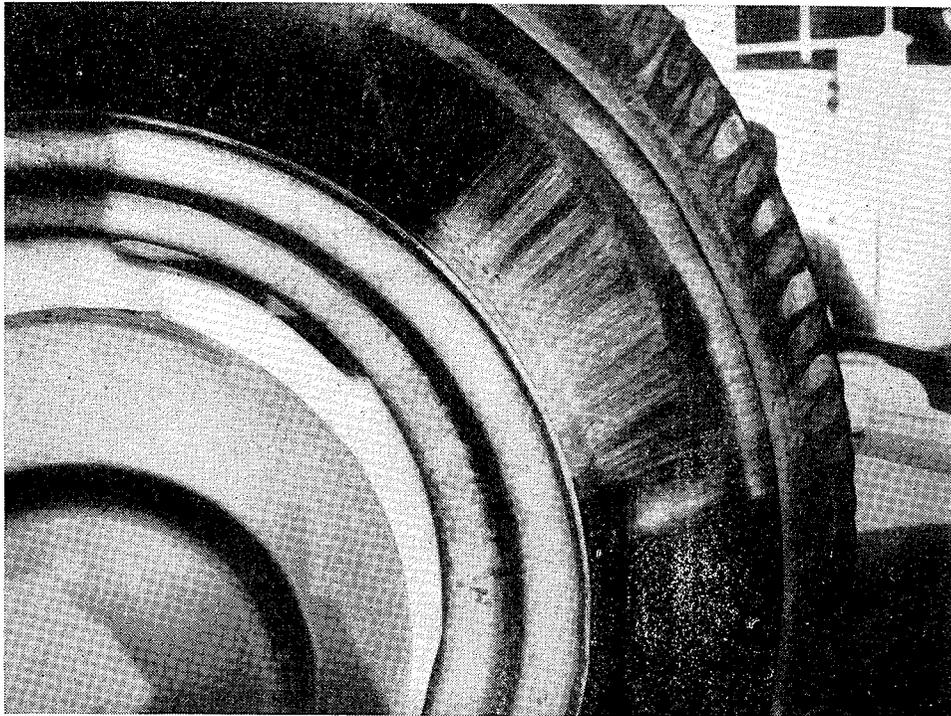
Fig. 10.9—Abraded wall of tyre which made the skid mark shown in Fig. 10.8

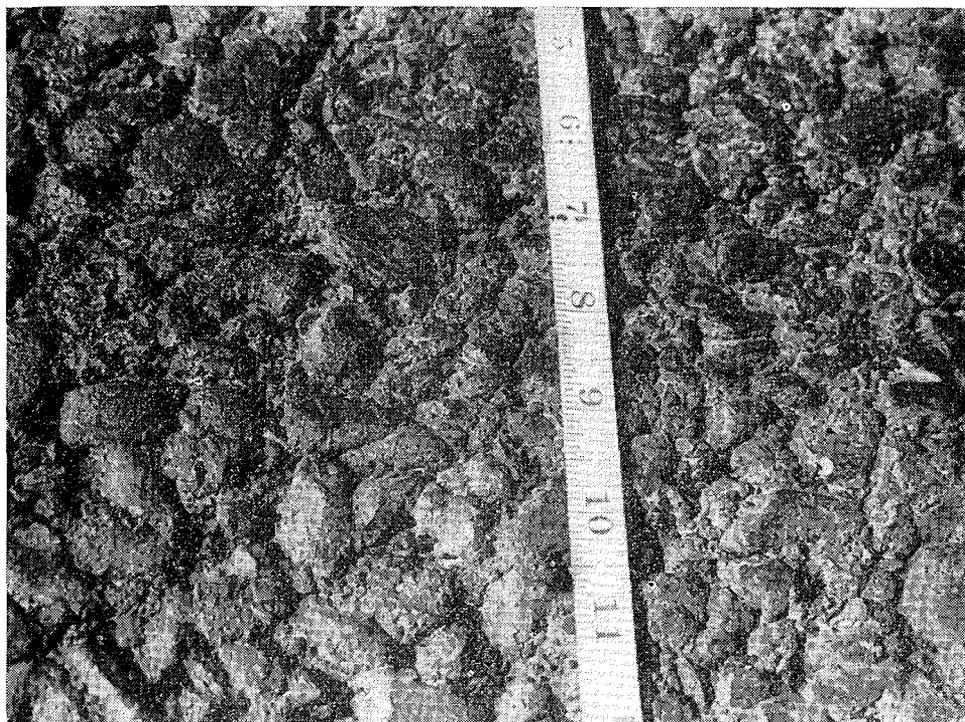
Fig. 10.13—Detailed view of the skid mark and road surface shown in Fig. 10.12. The tape measure shows inches

10.34 A stopping distance of 22 yards from 30 m.p.h. on a dry, clean bitumen surface is most surprising. The particular surface is shown in Fig. 10.12 and 10.13. The poor skid resistance is apparently due to the large aggregate being coated with bitumen, which is melted by the heat generated by the tyre sliding over it. The resulting skid mark is a molten tar mark and not an abraded rubber mark. The vehicle is in fact sliding on molten tar. We understand that this surface is a basecourse for the final layer of hot mix. As there often seems to be a delay of some months before the final layer is applied we suggest that signs be displayed warning motorists of the slippery surface.

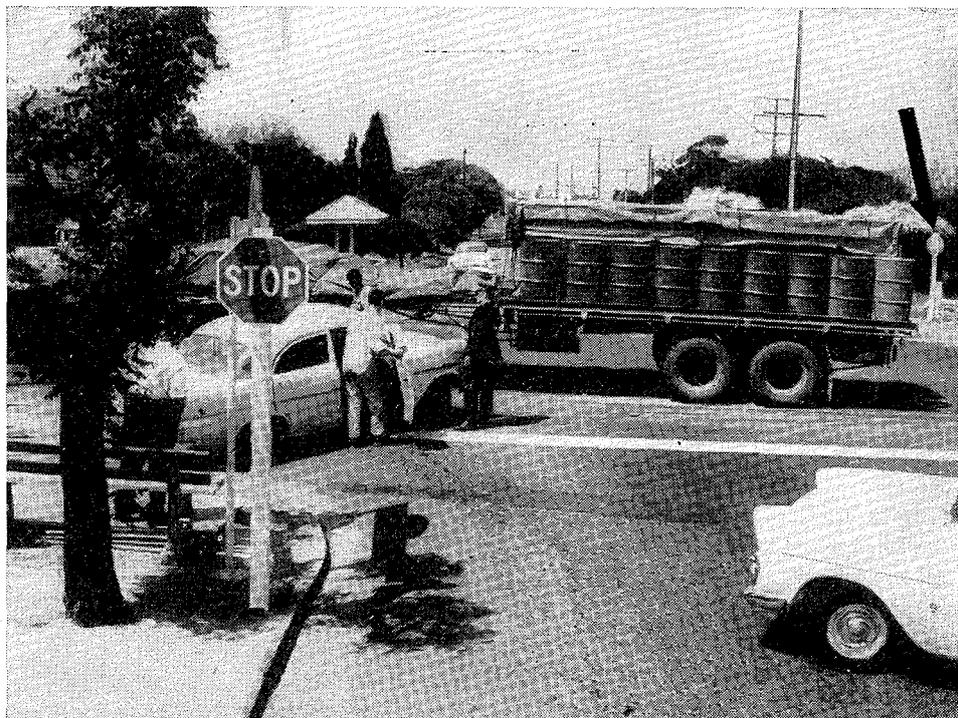
Fig. 10.16—Stop signs: this semi-trailer was unable to slow down sufficiently to avoid hitting the car which had moved off from the stop sign (arrow) on the far side

10.55 Nine vehicles that had stopped as required at a stop sign collided with a vehicle on the intersecting road. This vehicle was approaching from the right in five cases, and from the left in the other four cases. There are two points to mention here. One is the role of a third vehicle which creates a 'blind spot' for the driver moving off from the stop sign. Either these drivers did not realize that a vehicle might be hid-

den behind the third car or they decided, foolishly, to take a chance that the road was clear. The other point is that some drivers do not seem to appreciate that, if they move off suddenly from a stop sign, approaching traffic may not be able to stop in time to avoid a collision.

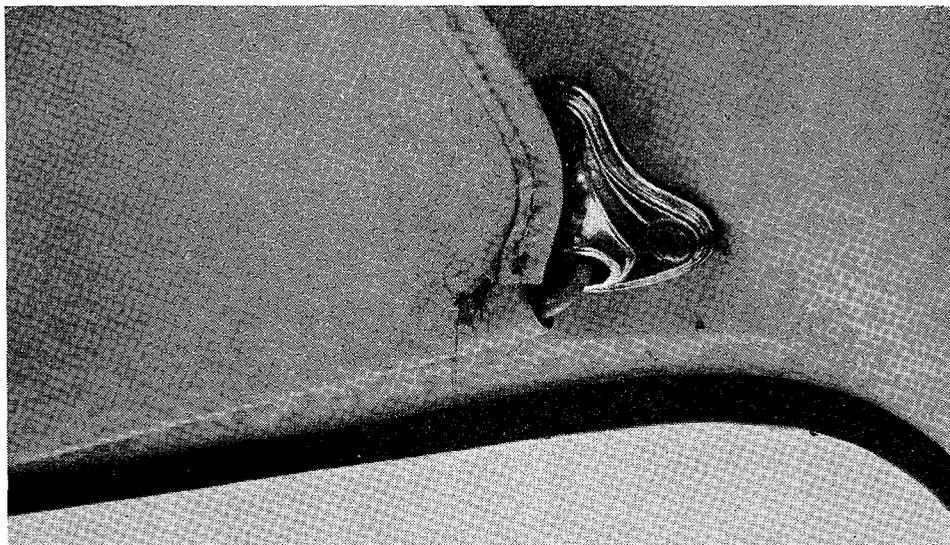
Fig. 11.2—Sunvisor hinge: note skin and hair caught in lining

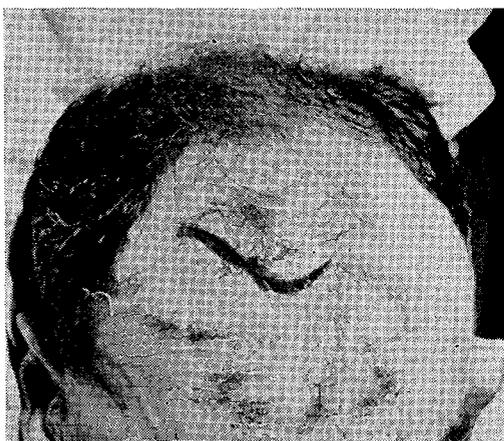
Fig. 11.3—Laceration in driver's forehead, produced by sunvisor hinge shown in *Fig. 11.2*

11.8 There are some characteristic lacerations produced by certain structures inside the car. Sunvisor hinges (Fig. 11.2) cause a 'U' shaped laceration, at or above the hairline (Fig. 11.3). The rear vision mirror is usually struck by the forehead, nose and upper cheek, producing a series of small lacerations as the plate glass shatters into fragments (Fig. 11.4). When a car occupant strikes a tempered glass windscreen with sufficient force to break it, he usually receives small shallow lacerations from the small fragments of glass. If his head, after the initial impact which breaks the glass, travels downwards towards the lower edge of the windscreen, he breaks out the glass fragments remaining in the frame,

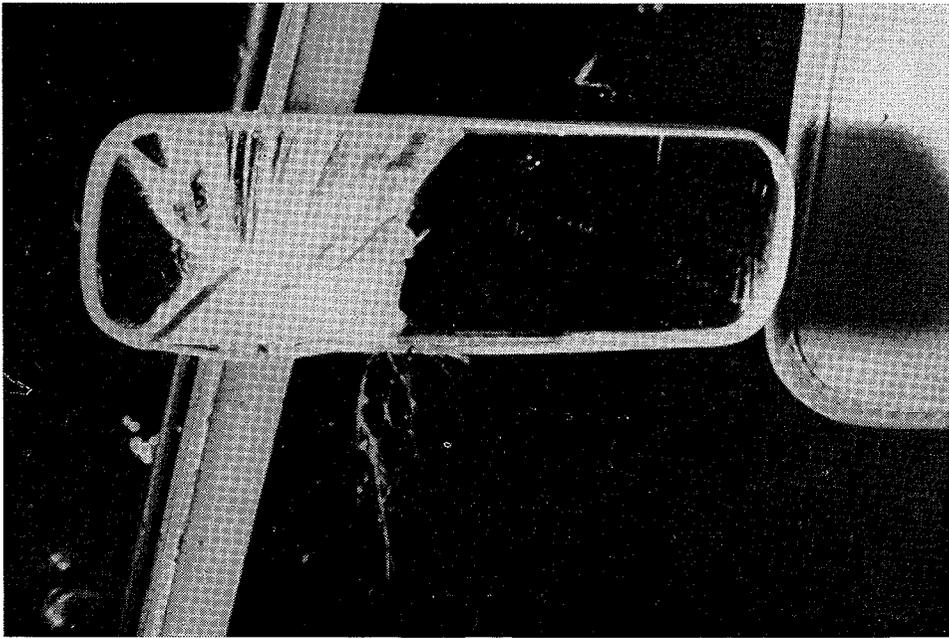
Fig. 11.4—Rear vision mirror struck by face of front seat passenger. Note characteristic fracture of glass and hairs and skin adhering to frame

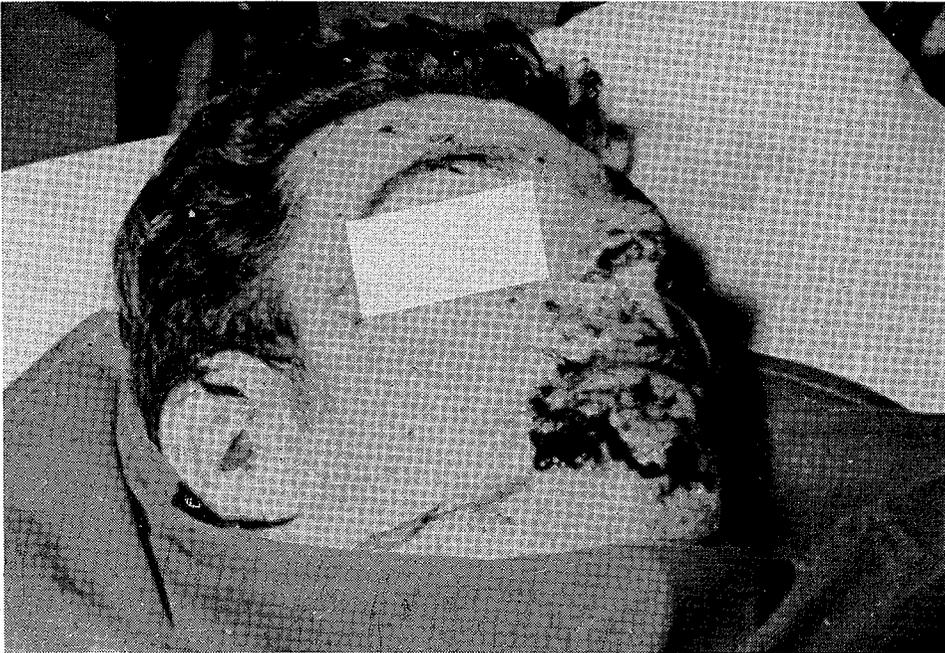
Fig. 11.5—Lacerations to chin and right ear produced by impact with tempered windscreen

producing lacerations to the lower surface of the chin (*Fig. 11.5*) and a characteristic shape to the hole in the windscreen (*Fig. 11.6*).

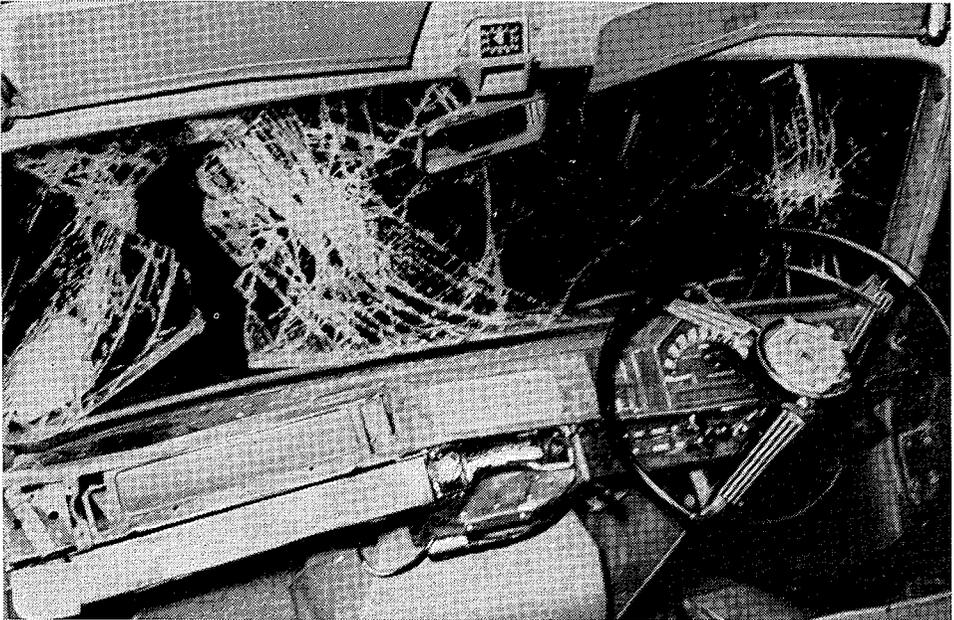
Fig. 11.7—Case 0430: laminated glass windshield penetrated by passenger's head, resulting in severe lacerations of forehead

11.9 Impact with a laminated glass windscreen seems to produce severe lacerations if the glass is penetrated by the head (*Fig. 11.7*), the face being cut by the sharp edges exposed. If the laminated glass is not pene-

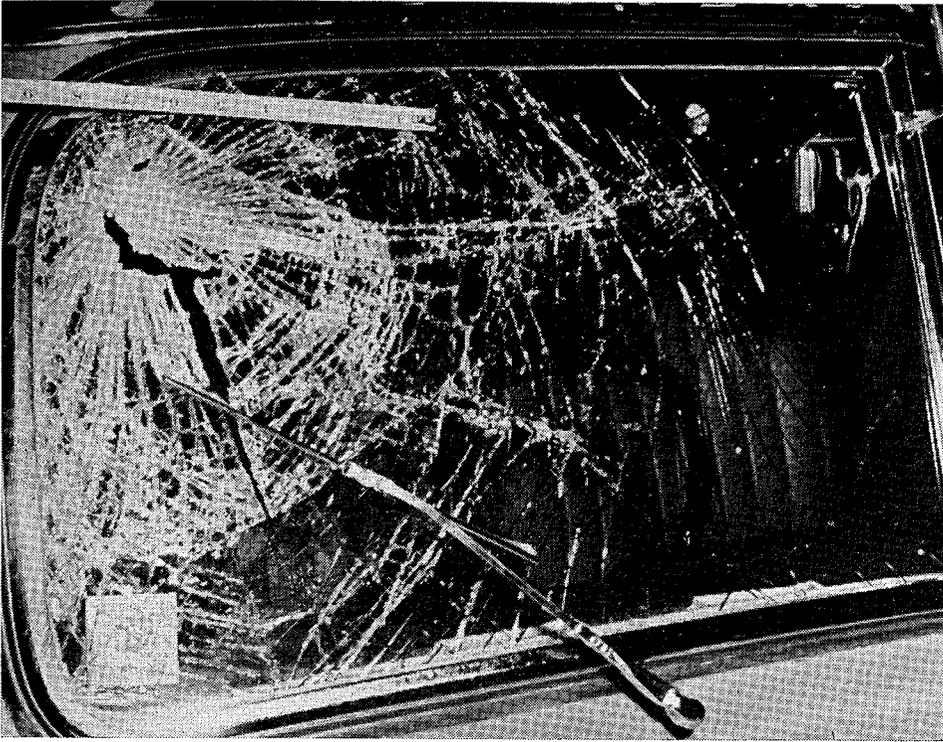
Fig. 11.8—Laminated glass windscreen not penetrated by occupant's head; minor lacerations of the face resulted

trated (*Fig. 11.8*) the lacerations are smaller and less severe. The three cases of lacerations to the face from laminated glass all involved the eyebrow and forehead, an important area cosmetically. There were few fractures of the facial bones. The worst was in a woman who was struck on the face by the hub of the steering wheel (*Fig. 11.9*). This produced severe lacerations of the forehead, nose, cheek, mouth and chin, with a depressed fracture of the right maxilla (*Fig. 11.10*). Another girl fractured her lower jaw in several places, again on striking the steering wheel hub.

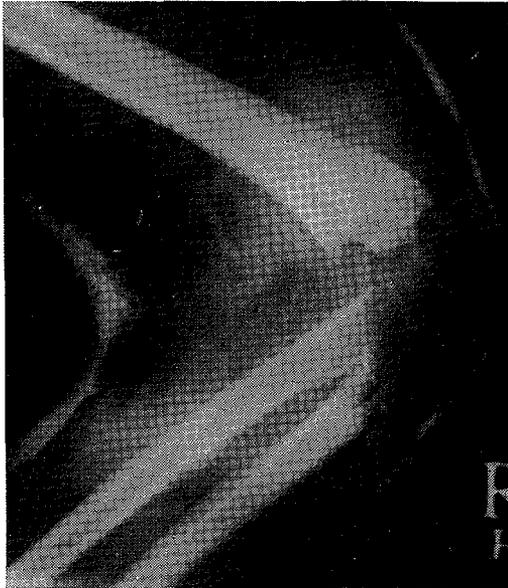
Fig. 11.12—Compound fracture of right elbow, with complete loss of bone and joint, after impact with tray of truck

11.22 In case 0294 the 50-year old driver of a car suffered a compound fracture when his elbow, which was resting on the window sill and protruding from the car, struck the tray of a truck travelling in the opposite direction. There was complete loss of the lower end of the humerus and the upper end of the radius and ulna (*Fig. 11.12*). The other case of fracture of the elbow involved a 41-year old woman driver who put out her left arm to prevent her daughter from striking the windscreen as her car hit a tree. The daughter carried her mother's
