TRAFFIC ACCIDENTS IN ADELAIDE, SOUTH AUSTRALIA

AUSTRALIAN ROAD RESEARCH BOARD

SPECIAL REPORT No. 1, JULY, 1966

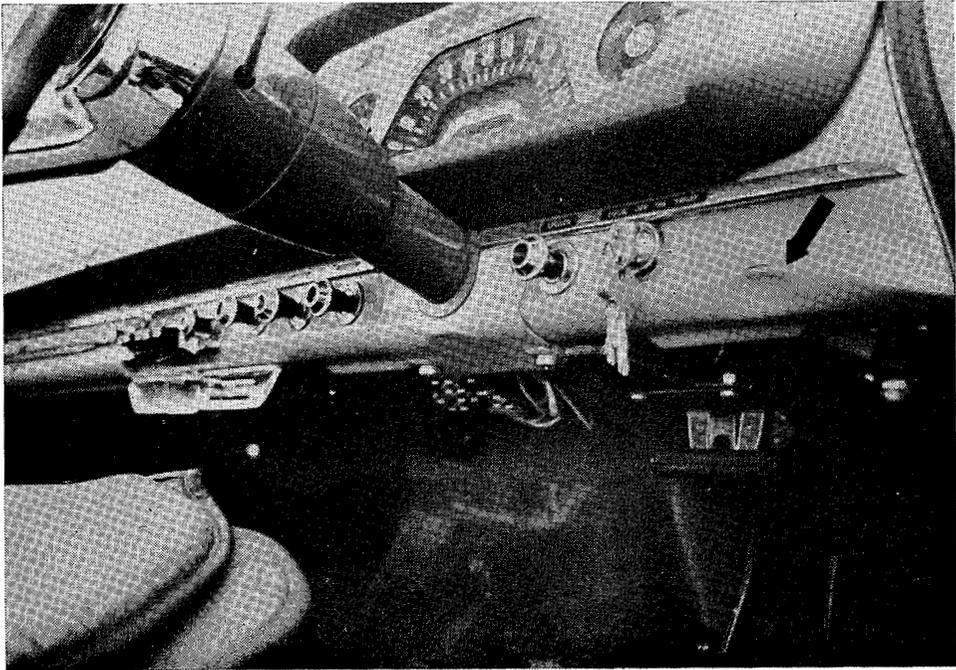
Fig. 11.13—Frontal impact: note dent in lower edge of instrument panel (arrow), produced by impact with driver's knee

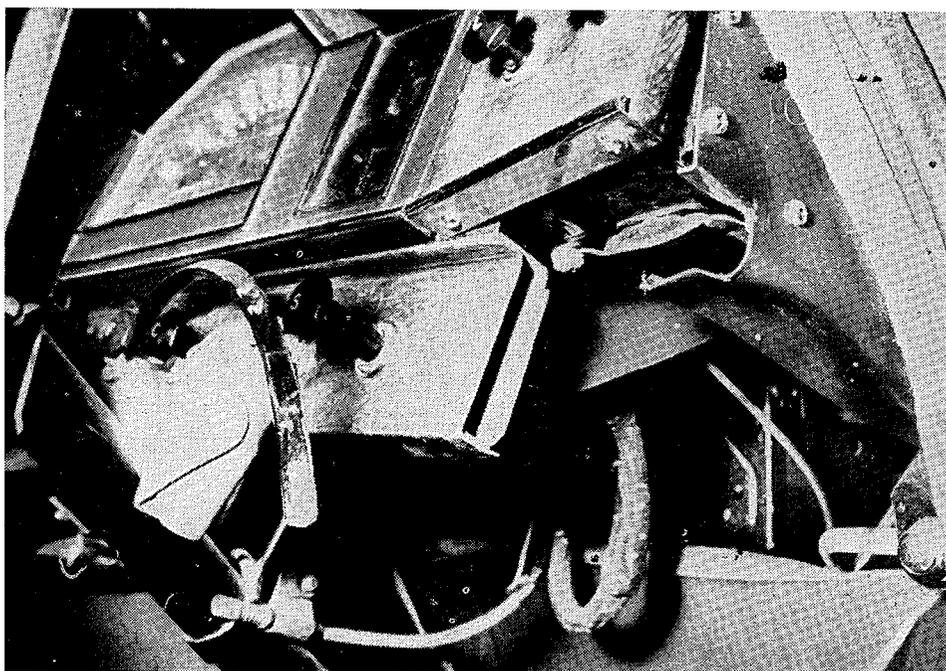
Fig. 11.17—Case 0430: frontal impact. Note many sharp metal edges under instrument panel.

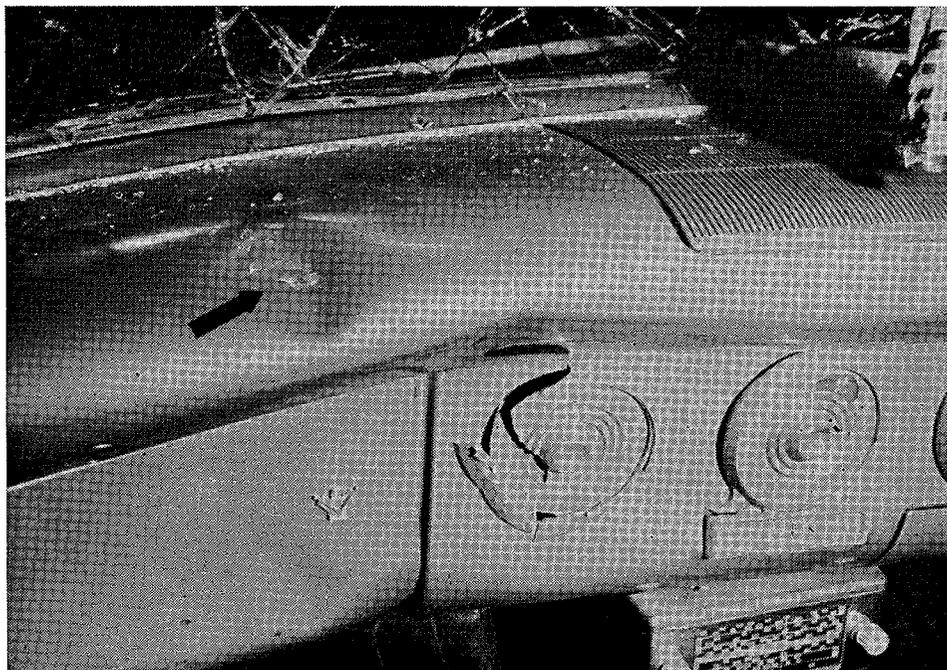
Fig. 11.18—Case 0046: frontal impact. Passenger's knee struck face of instrument panel, and his face and teeth struck top of instrument panel (arrow). Note teeth marks

The passenger compartment of the Ford was relatively undamaged (Fig. 9.18). The driver suffered a fracture of the right knee cap when his knee hit a knob on the instrument panel. The left front seat passenger struck the windscreen and the top of the instrument panel with her face, fracturing her front teeth (Fig. 11.18).

upper half of the windscreen and the header area. This is where evidence of head impacts is found: on the sunvisor hinges (*Fig. 11.2*), the rear vision mirror (*Fig. 11.4*) and the windscreen. From here the head and trunk must fall downward because the windscreen glass is broken out downwards (*Fig. 11.6*), and teeth are broken on the top of the instrument panel (*Fig. 11.18*).

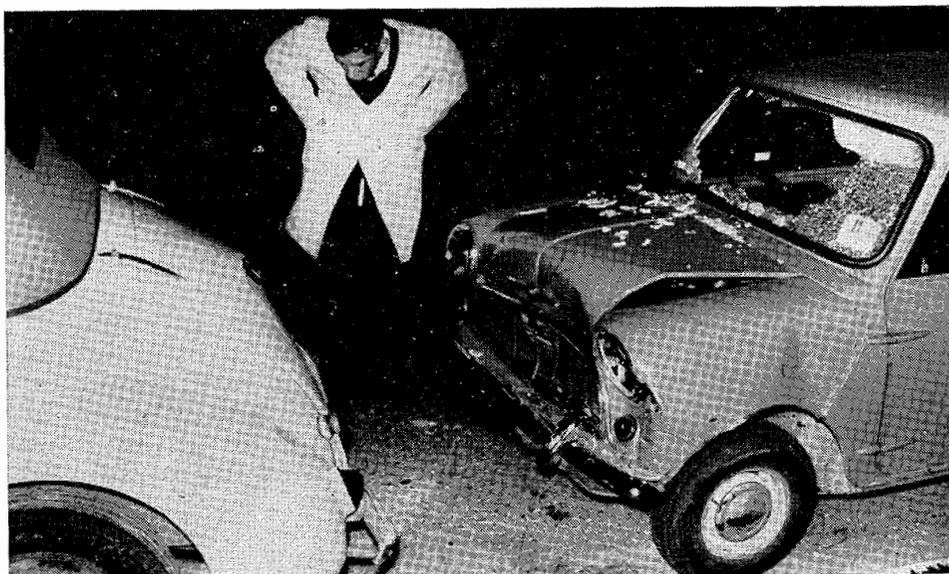
Fig. 11.21—Mini Minor struck stationary car. The driver, not wearing a seat belt, broke the windscreen with his head

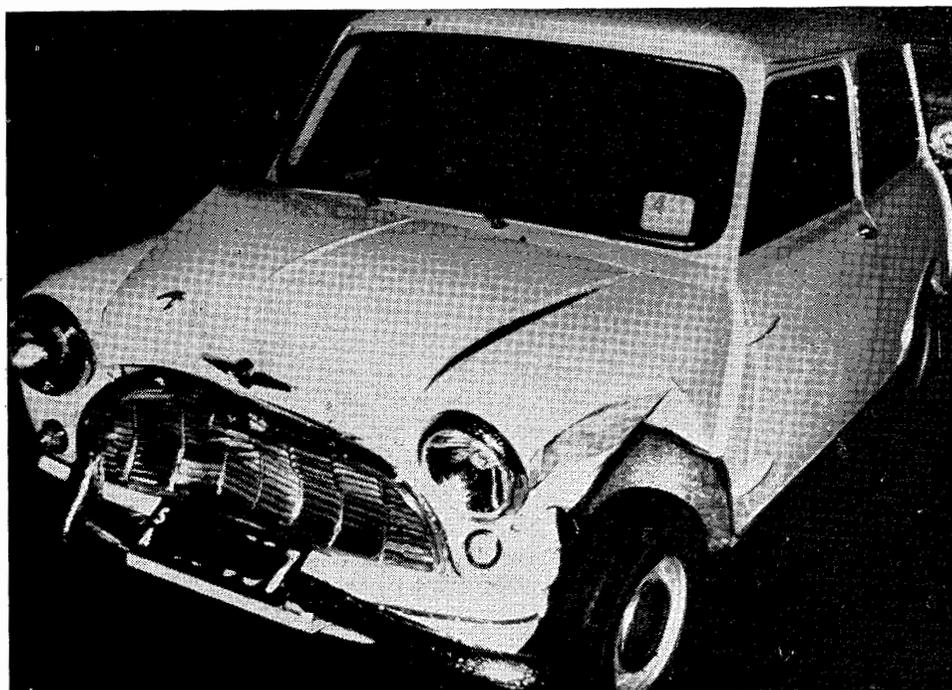
Fig. 11.22—Mini Minor struck stationary car. Damage was similar to that shown in Fig. 11.21. The driver, who was wearing a seat belt, was not injured

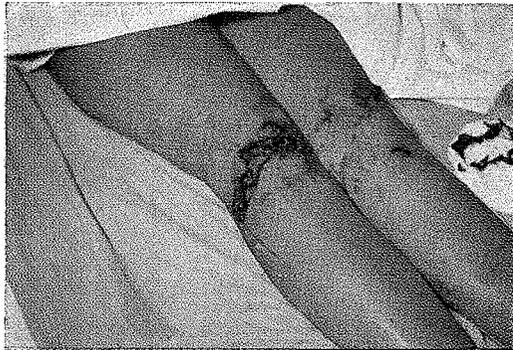
Fig. 9.20—Injuries caused by striking the instrument panel shown in Fig. 9.19 (see also p. 200)

9.41 One hundred and thirty-six or 35 per cent of these 390 cars had the instrument panels damaged by the occupants being thrown against them. The panels of 100 cars received minor damage (bent knobs, etc.) and 36 were severely damaged (large dents). The bent control knob shown in *Fig. 9.18* is an example of minor damage. *Fig. 9.19* (Appendix B) illustrates severe damage to an instrument panel, and *Fig. 9.20* (Appendix B) the consequent injury.
