Performance of bull bars in pedestrian impact  
tests

RWG Anderson, AL van den Berg, G Ponte,  
LD Streeter, AJ McLean

CASR Report Series  
CASR020  
2006

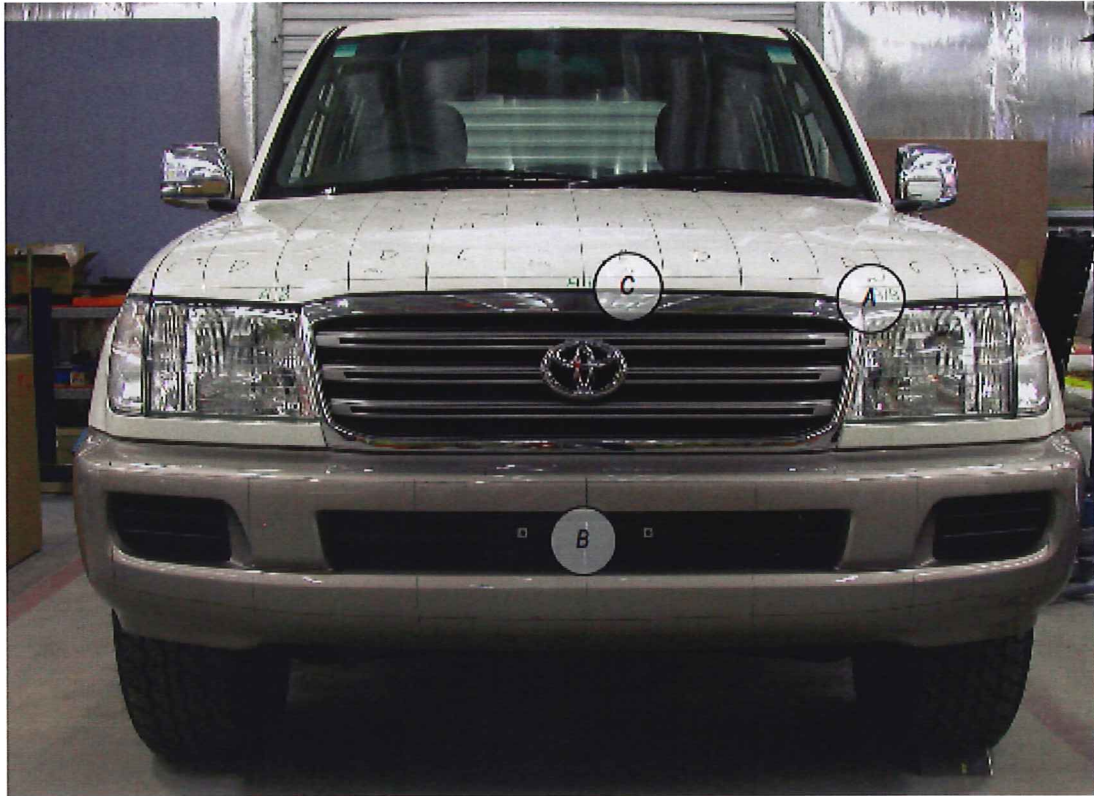
Figure 3.1  
Toyota Landcruiser test locations. Letters correspond to test locations for Part A, B and C tests

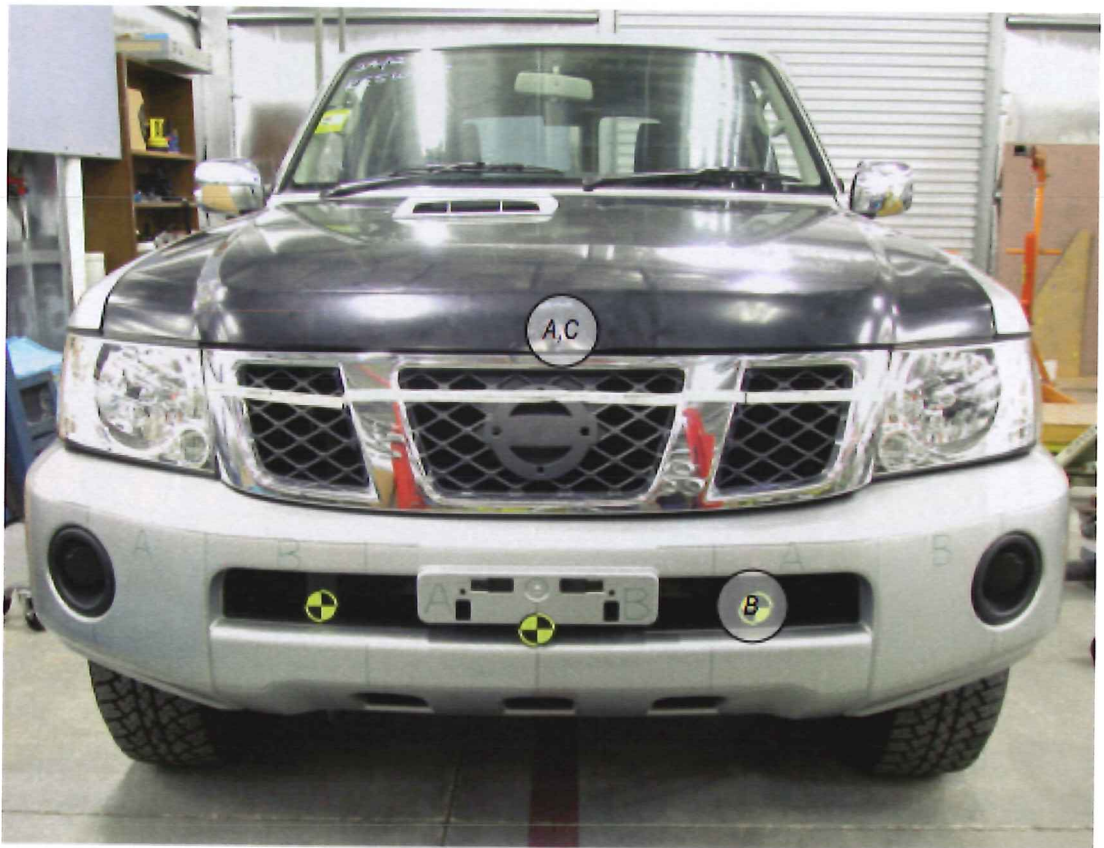
Figure 3.4  
Nissan Patrol test locations. Letters correspond to test locations for Part A, B and C tests

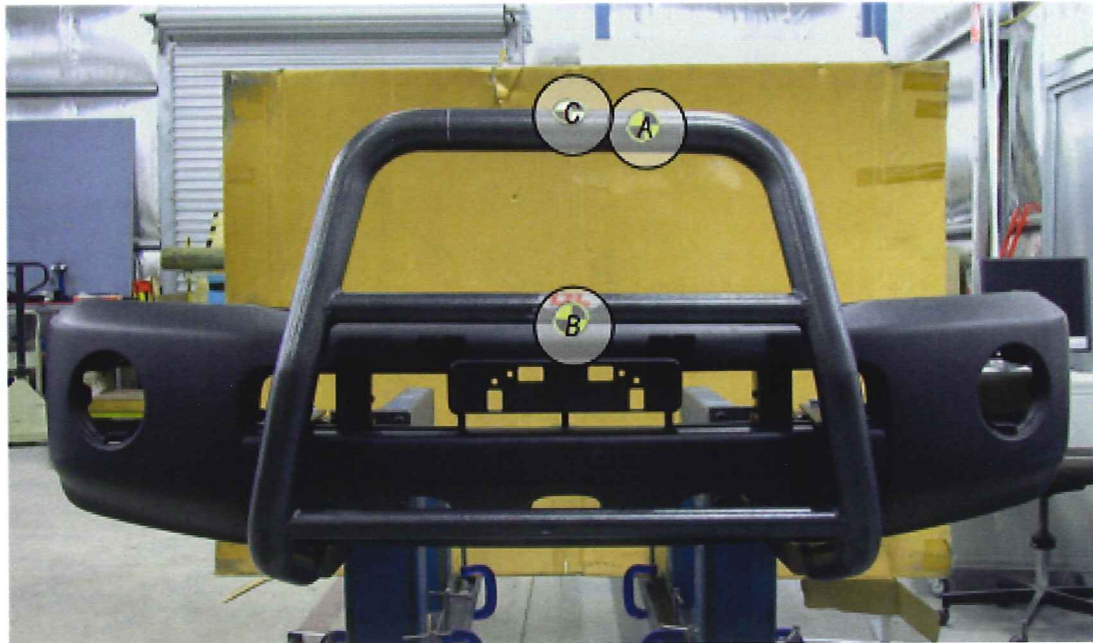
Figure 3.5  
Nissan Patrol aftermarket alloy / aluminium nudge bar test locations.  
Letters correspond to test locations for Part A, B and C tests

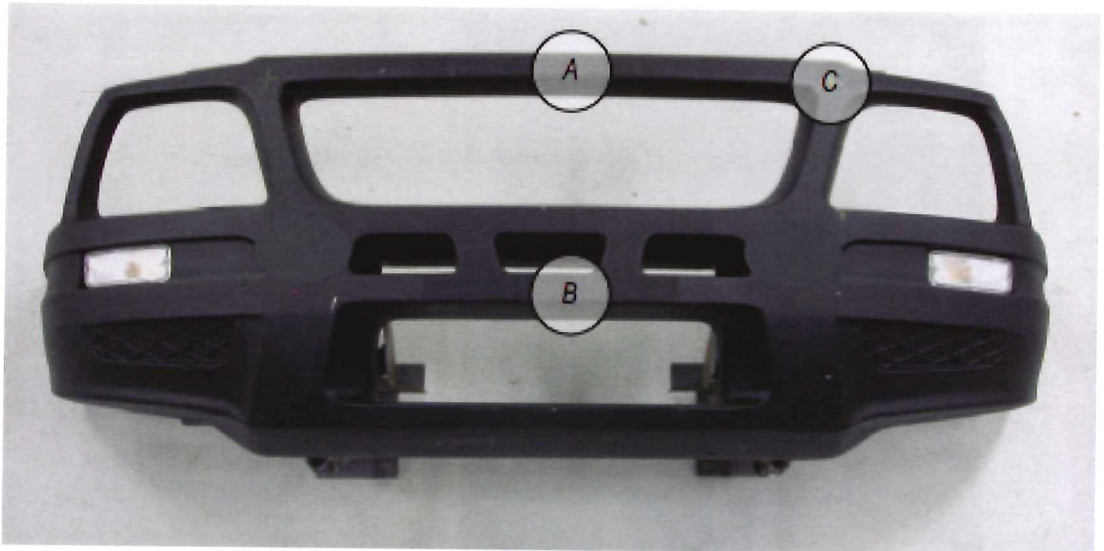
Figure 3.7  
Nissan Patrol aftermarket polymer bull bar test locations.  
Letters correspond to test locations for Part A, B and C tests

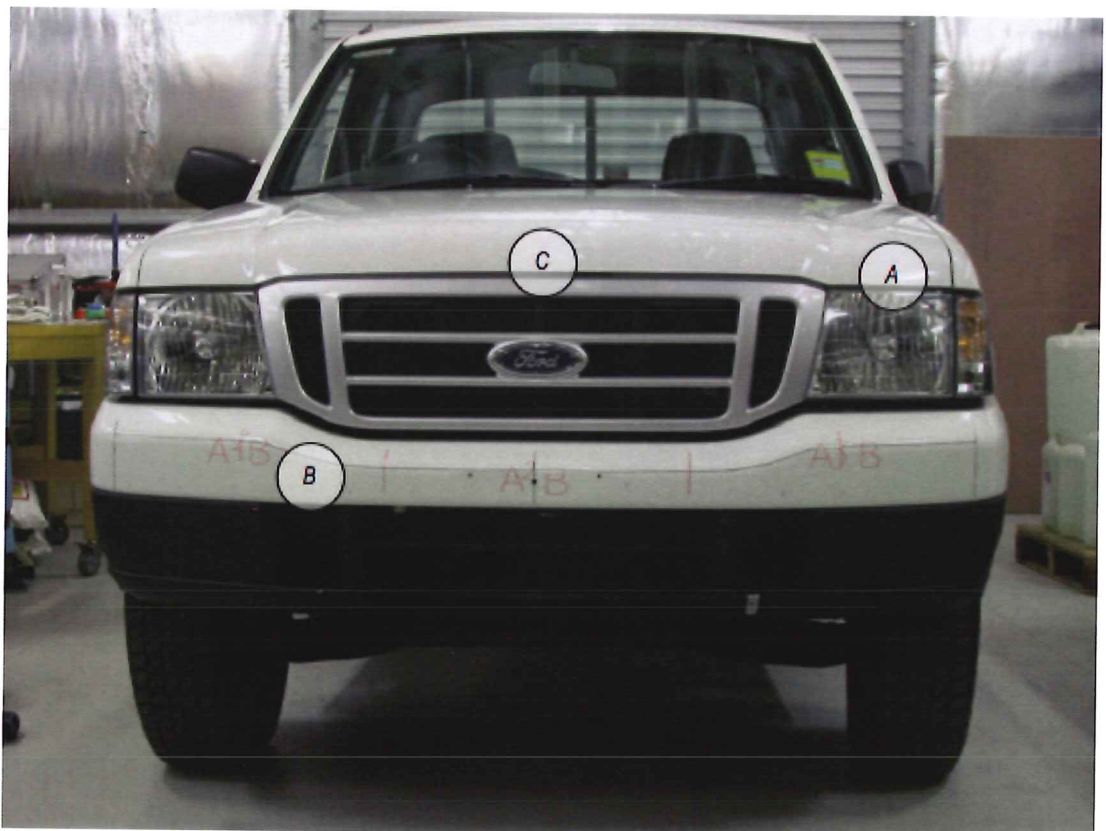
Figure 3.8  
Ford Courier test locations. Letters correspond to test locations for Part A, B and C tests

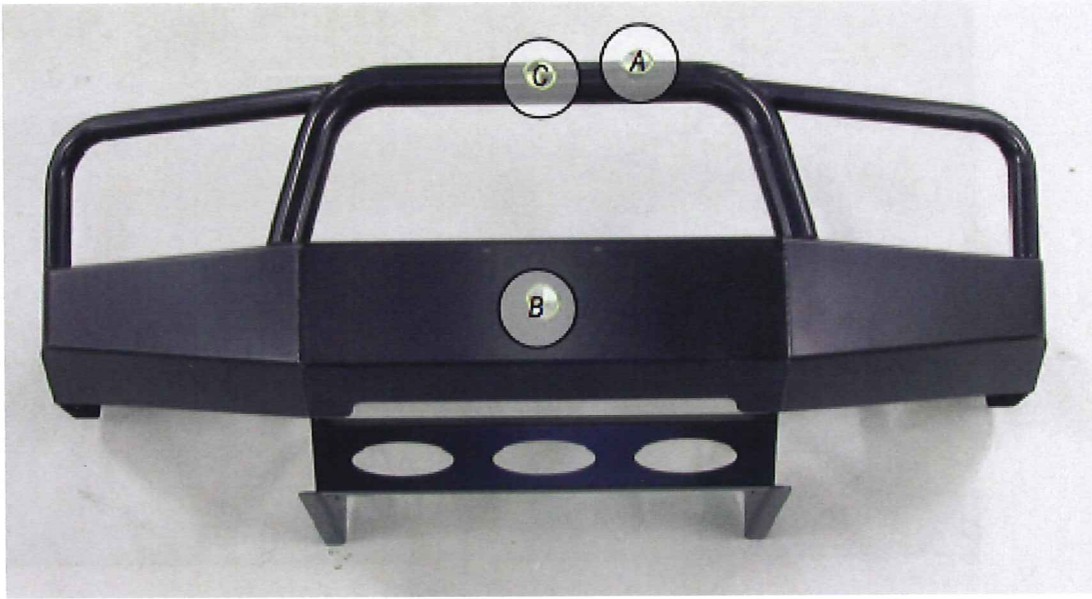
Figure 3.9  
Ford Courier aftermarket steel bull bar test locations.  
Letters correspond to test locations for Part A, B and C tests

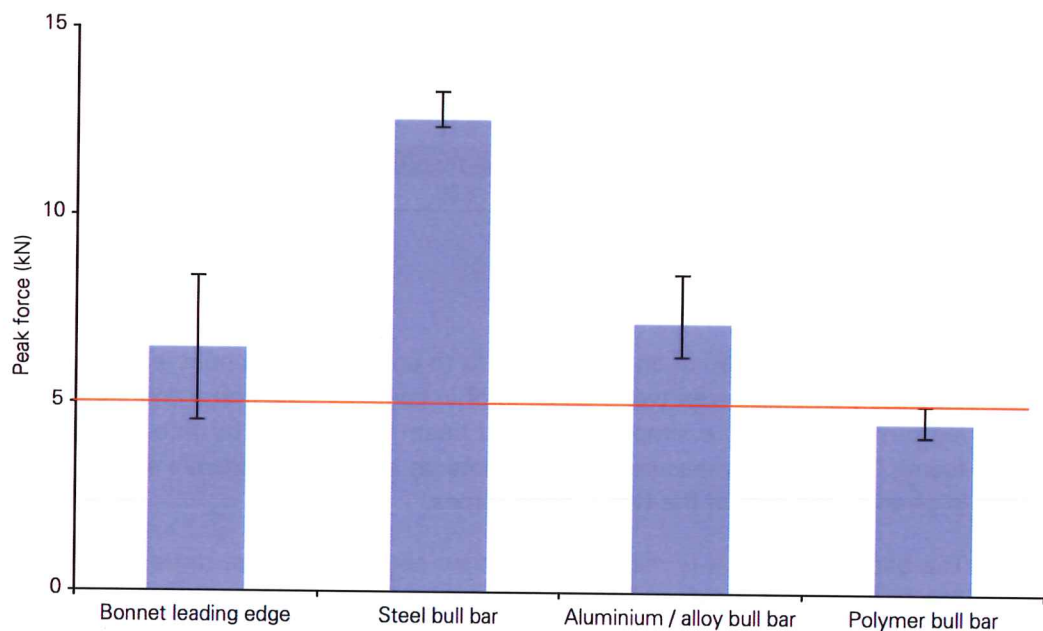
**Figure 4.1**  
Average peak force values from Part A tests on the bonnet leading edge and the top rail of the specified types of bull bar. The range of values measured in the tests is shown. The red line indicates the injury tolerance limit of 5 kN.

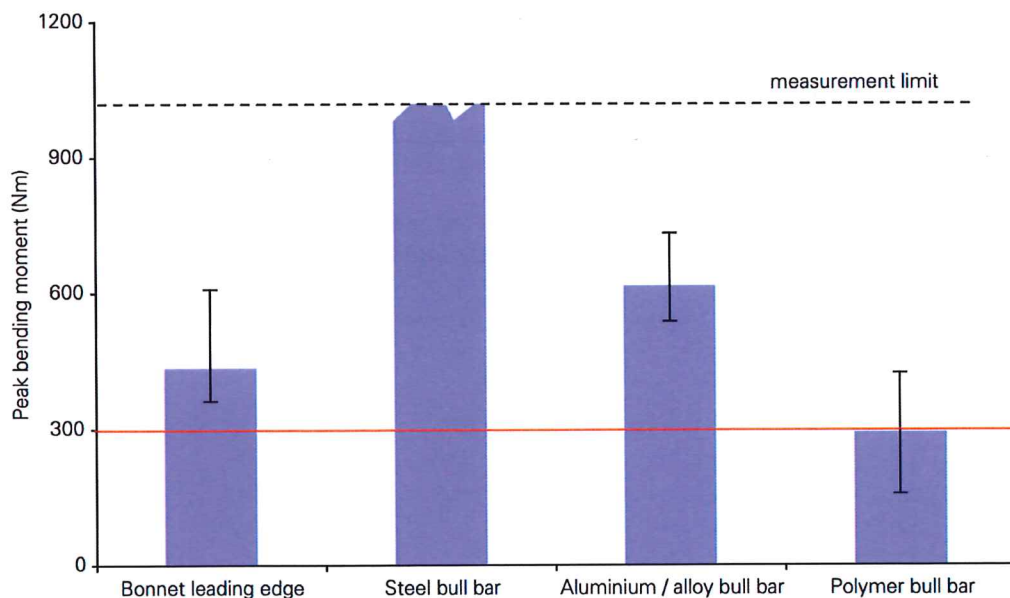
**Figure 4.2**  
Average peak bending moment values from Part A tests on the vehicles' leading edges and the top rails different types of bull bars. The error bars indicate the range of values measured in the tests on each type of bull bar. The red line indicates the injury tolerance limit of 300 Nm.

The tests also produced measures of the bending moment across the legform. The Euro NCAP limit for bending is 300 Nm. The bending moment results of the upper legform tests are shown in Table 4.3, and the average values in Figure 4.2. The polymer bull bars produced the lowest bending moments and were, on average, better performing than the front of the vehicle.

The polymer bull bars produced, on average, bending moments less than the Euro NCAP injury threshold, but (as noted previously) at a lower impact speed than that which would be specified by the Euro NCAP protocol.

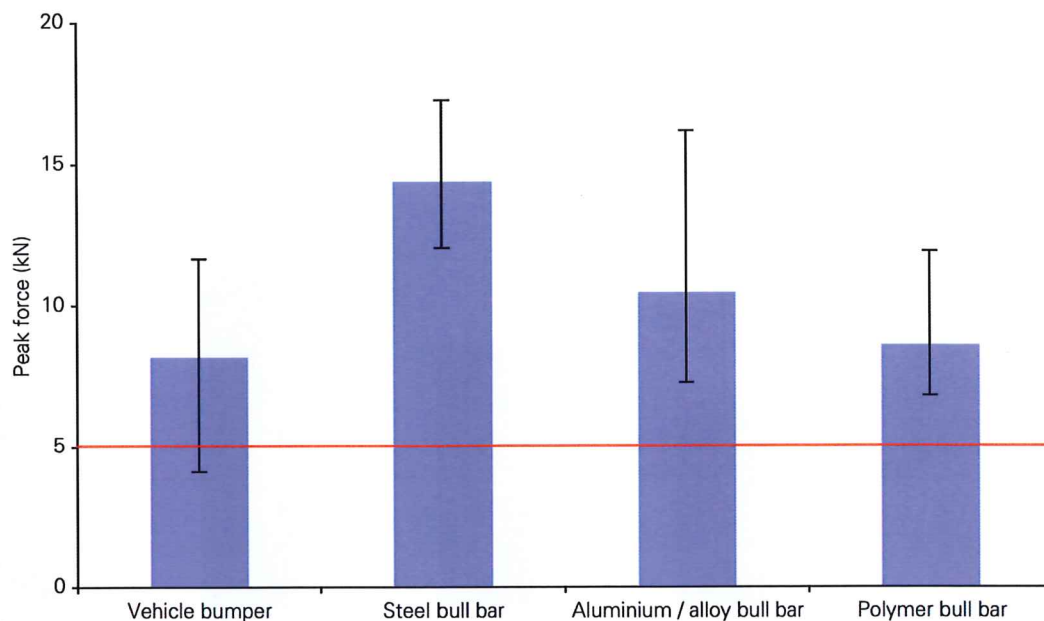
Figure 4.3  
Average peak force values from Part B tests on the vehicle bumper and the bumper areas of the specified types of bull bar. The range of values measured in the tests is shown. The red line indicates the injury tolerance limit of 5 kN.

It may be noted that, according to the bending moment produced in these tests, the bull bars performed similarly to or often only slightly worse than the vehicle itself. However, the peak impact force produced by the bumper sections of the steel bull bars and two of the aluminium/alloy bars was considerably higher than that for the vehicle bumper. The bumper section of the bull bar presents a broad, flat surface to the impactor, and hence bending across the impactor is not as pronounced as in tests with the top rail of the bull bar. However, the stiffness and mass of the bumper sections is such that the impact force produced is higher than in the tests of the top rails of the bull bars.

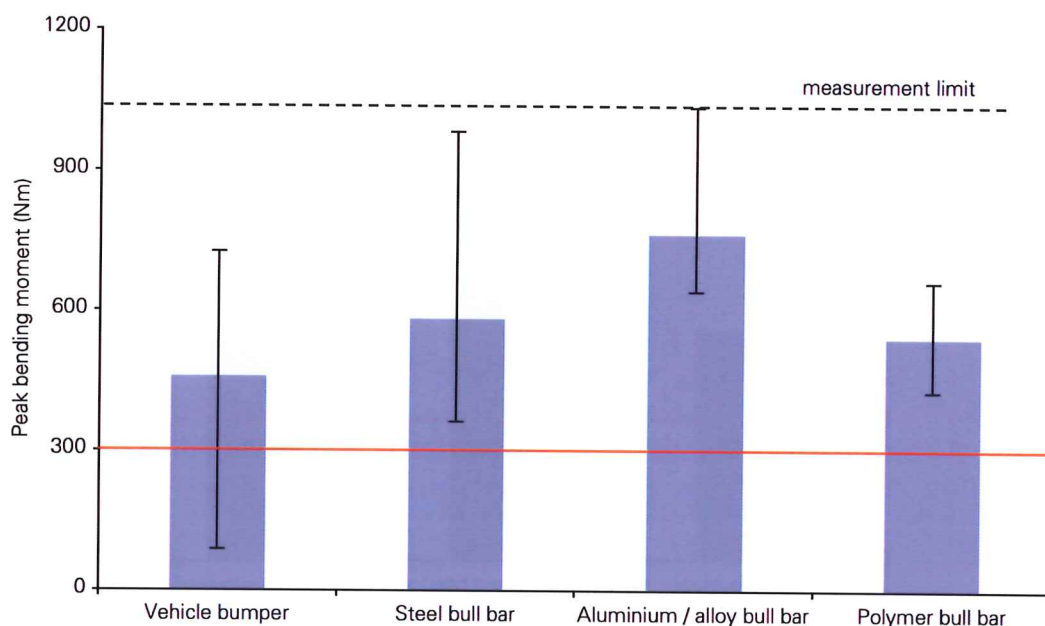
Figure 4.4 Average peak bending moment values from Part B tests on the vehicle bumper and the bumper areas of different types of bull bar. The range of values measured in the tests is shown. The red line indicates the injury tolerance limit of 300 Nm.
