Video capture and analysis of cyclists using infrastructure in the ACT through machine learning

JRR Mackenzie, G Ponte

CASR202

September 2022

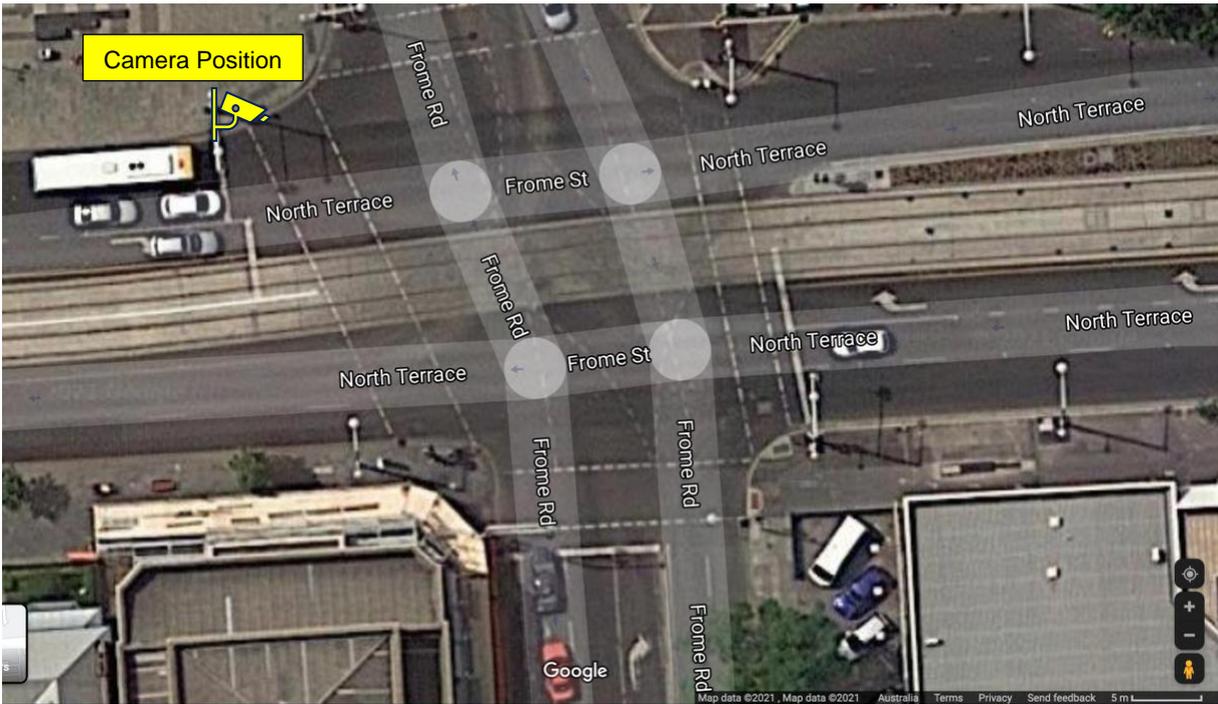
Figure 2.1
Aerial view of Frome Road and North Terrace, showing the intersection layout and camera position

The camera was trialled for a day at one of the busier intersections in Adelaide, the intersection of Frome Road and North Terrace. An aerial view from Google maps is presented in Figure 2.1 which also shows the camera was mounted on a traffic pole approximately 3 metres above ground level. Figure 2.2 shows the 135-degree field of view captured by the camera with subsequent processed by machine learning software correctly identifying two cyclists within the traffic scene.

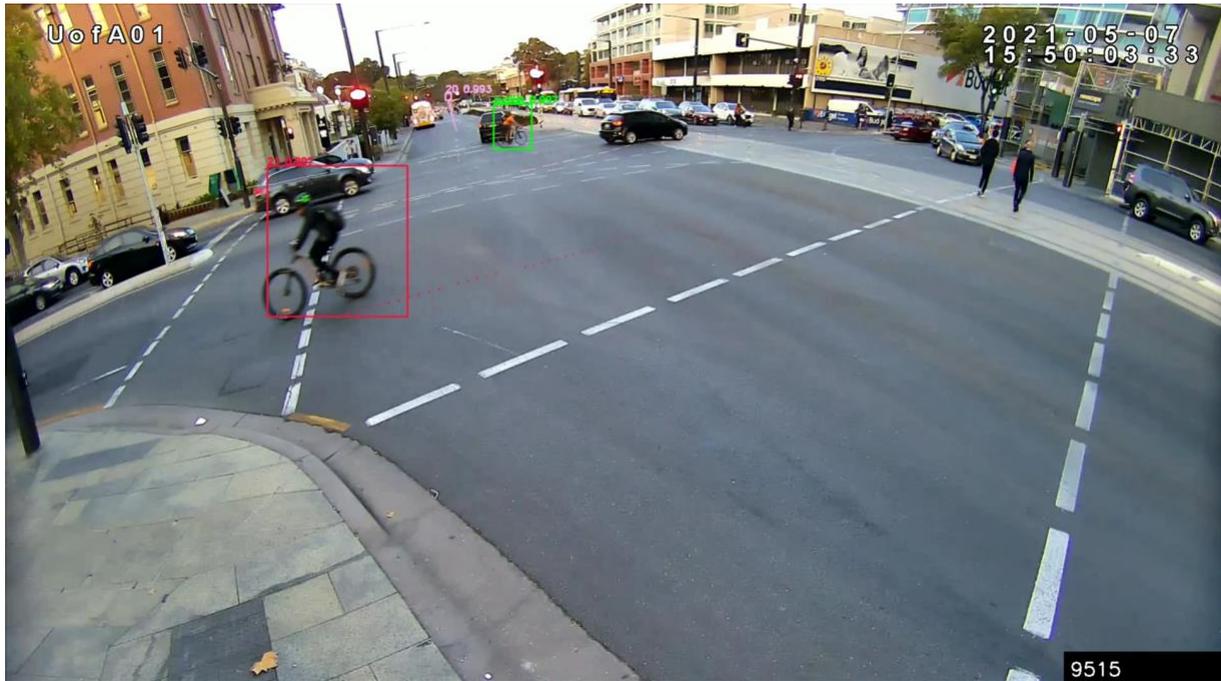
Figure 2.2
Captured camera field of view of traffic on Frome Road and North Terrace, with two cyclists being correctly identified by the machine learning software

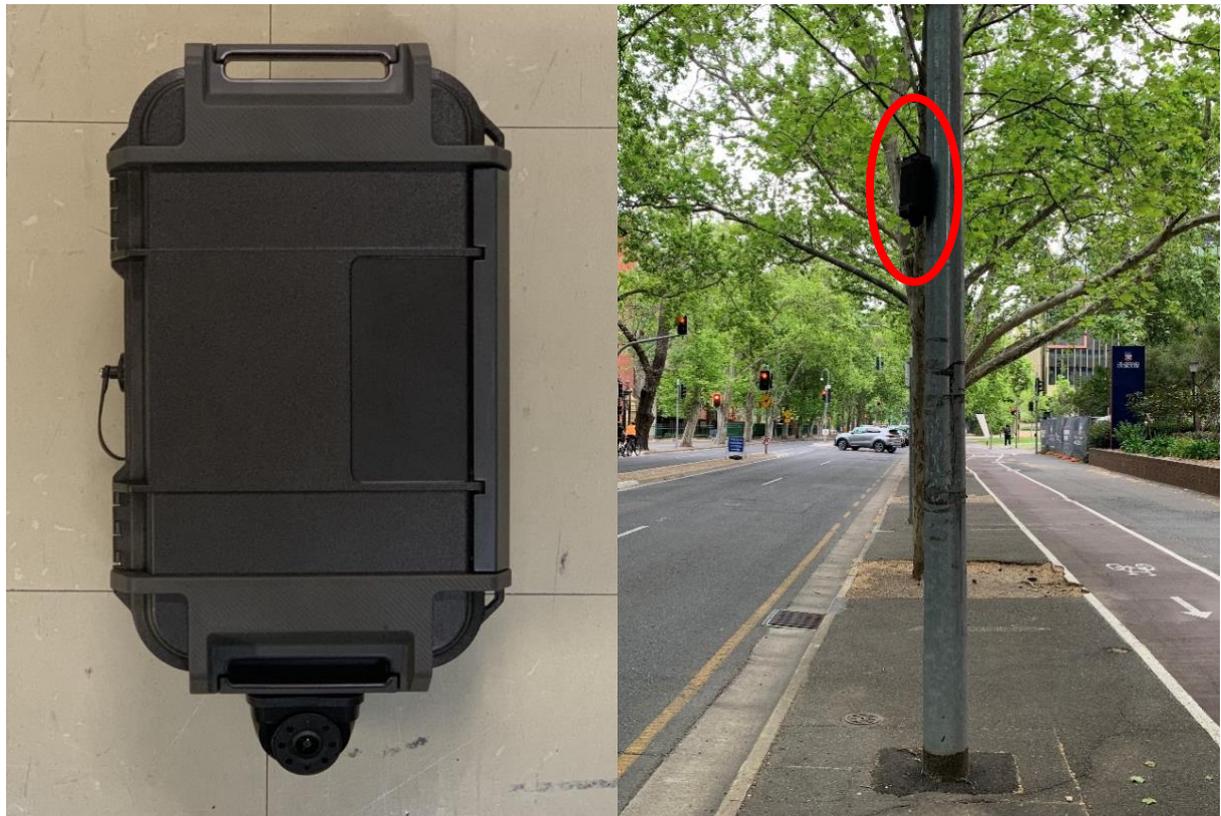
Figure 2.3
Surveytech 130-hour modular traffic surveillance camera system

The Surveytech unit consists of a camera, digital video recorder (DVR), and battery built into a weather-proof enclosure (rated at IP68) that features pole mounting attachment points. The unit can be connected to a computer or smartphone via WiFi and a live view can be observed. The video camera system can be set to record at specific hours of the day and can be powered down automatically between scheduled recording times to conserve battery life. The quality of the video is 1920 x 1080 pixels and the bitrate can be adjusted from 600 to 8000 Mbps, while the frame rate can be adjusted from 5 frames per second (fps) up to 30 fps.

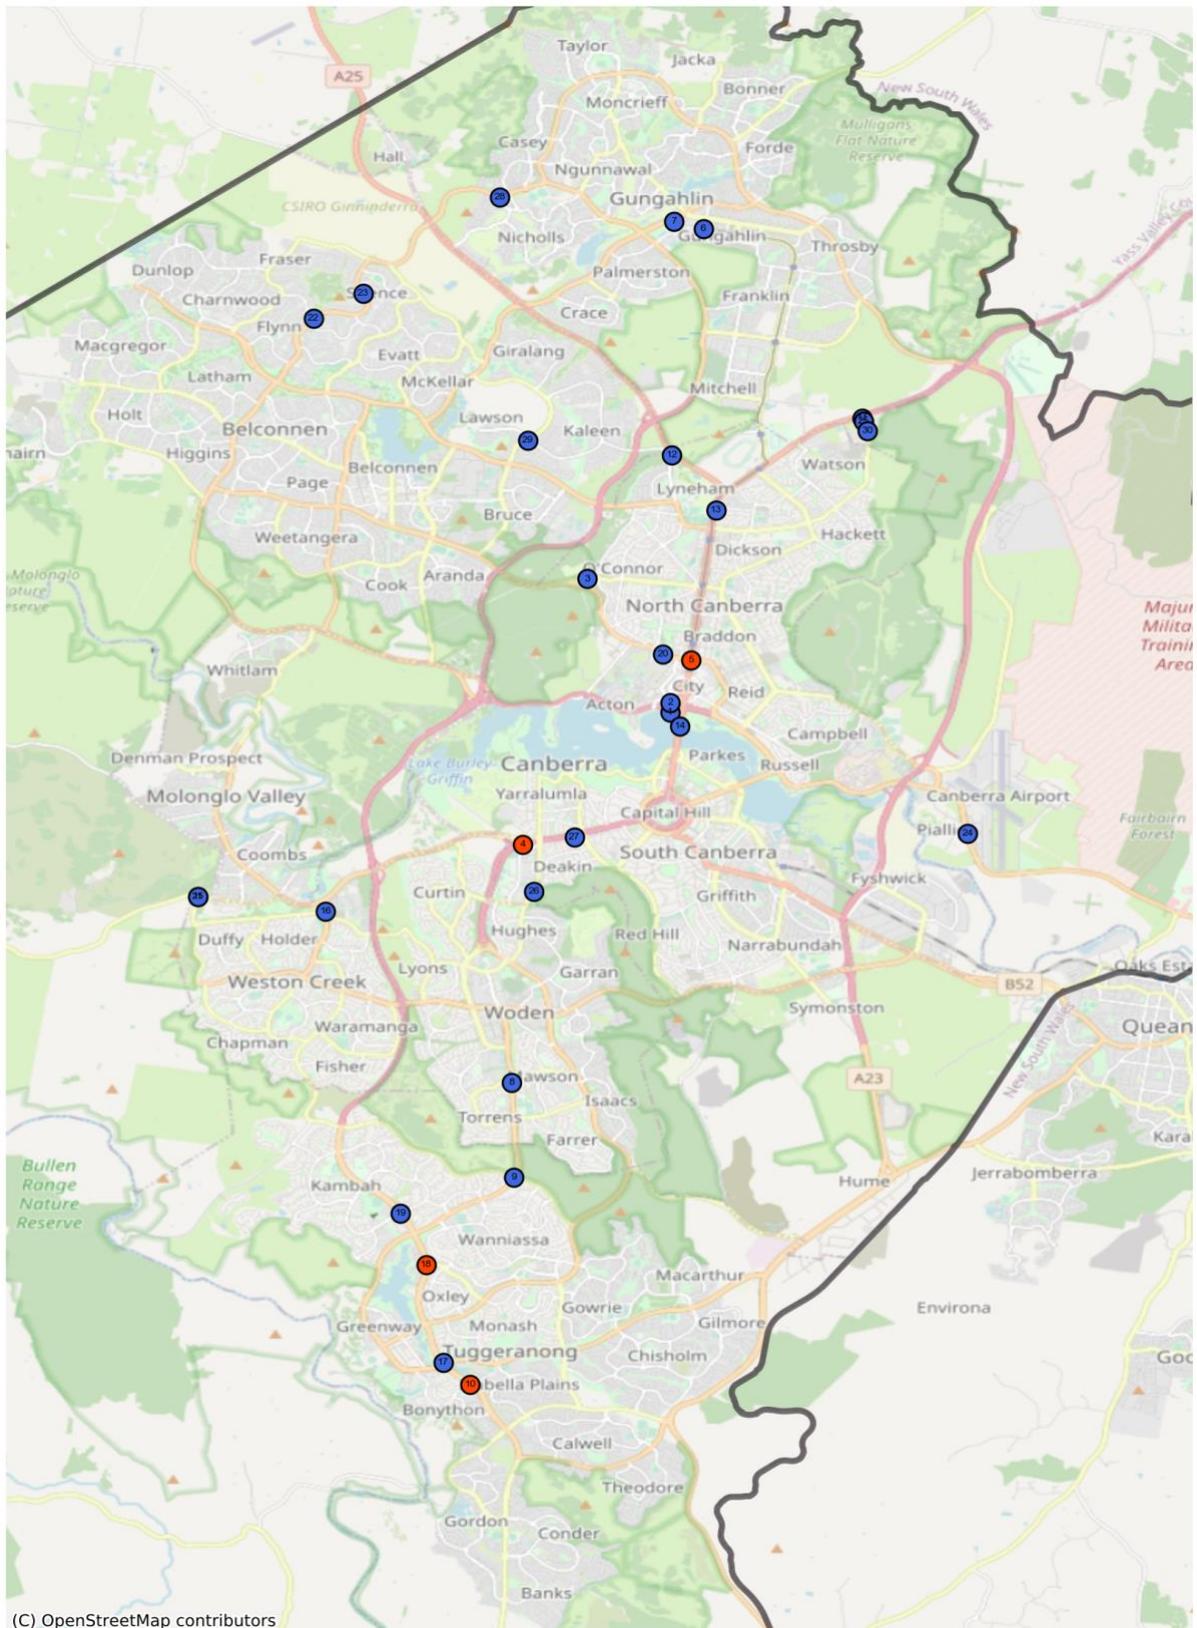
Figure 3.1
 Stakeholder recommended locations for surveillance of cyclists' use of infrastructure
 (selected locations shown in orange)

Responses were received from two stakeholders and together they recommended 30 locations, listed in Table 3.1 and shown in Figure 3.1 below.

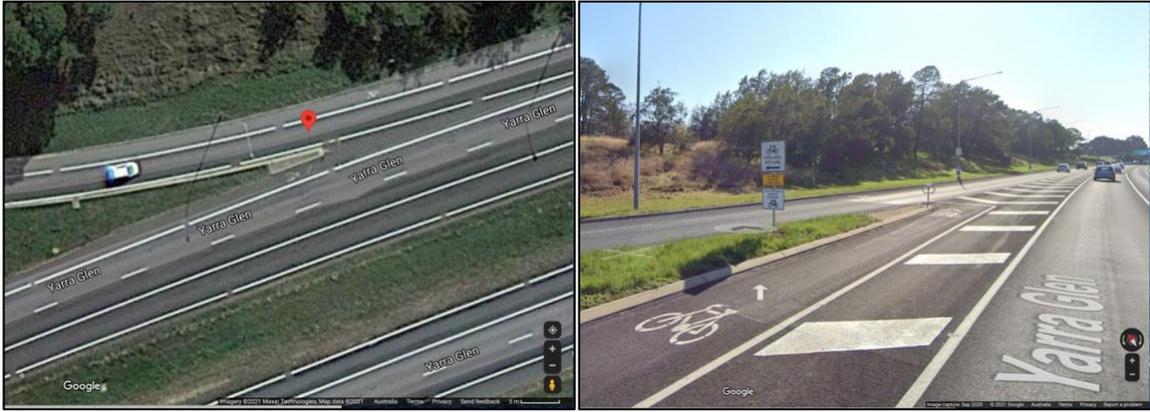
Figure 3.2
Birds-eye view and street view (Google Maps) of location 4, referred to as Site A

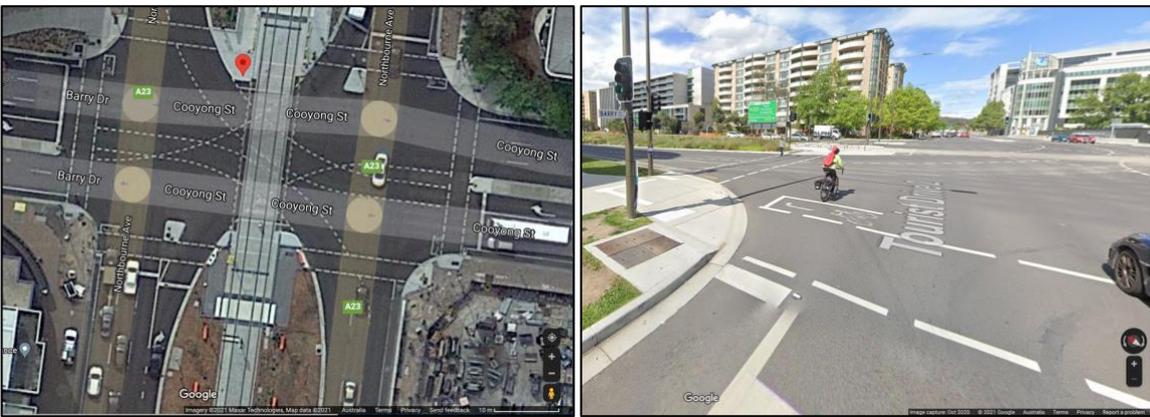
Figure 3.3
Birds-eye view and street view (Google Maps) of location 5, referred to as Site B

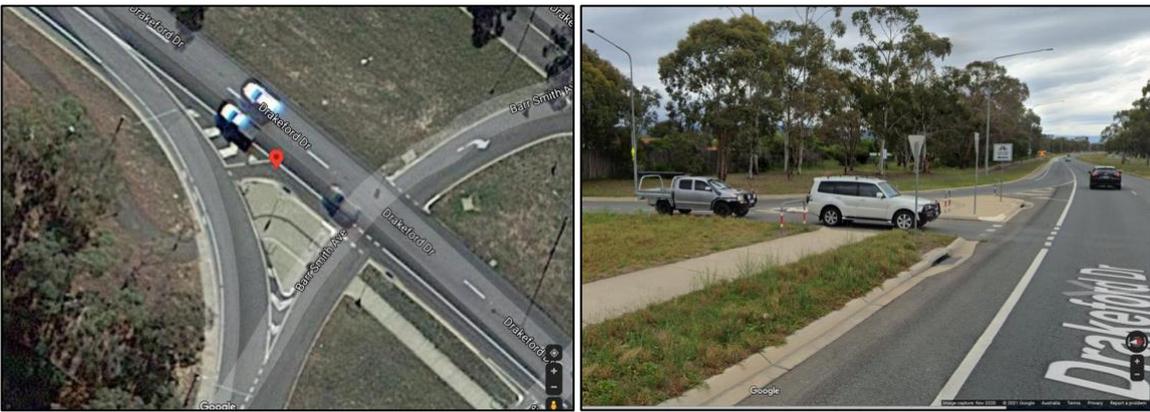
Figure 3.4
Birds-eye view and street view (Google Maps) of location 10, referred to as Site C

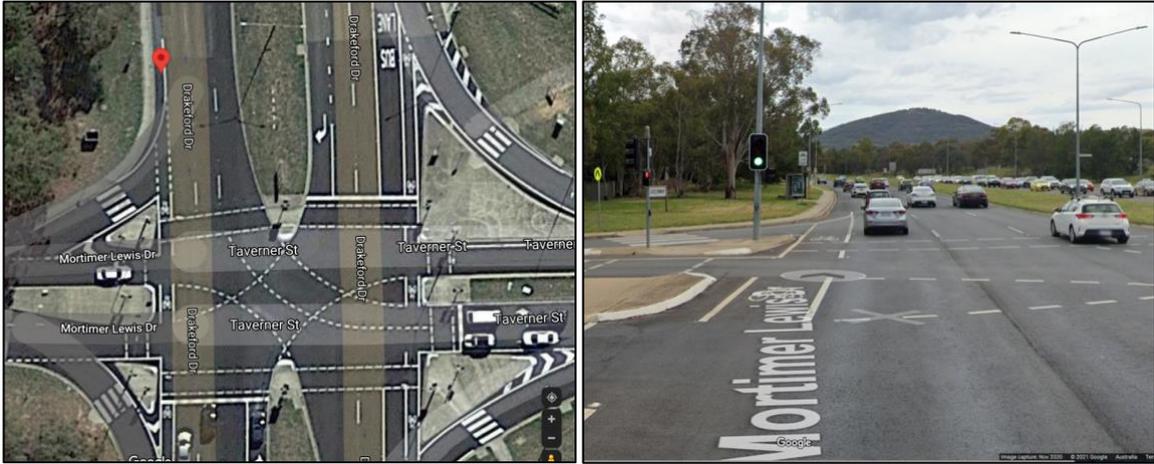
Figure 3.5
Birds-eye view and street view (Google Maps) of location 18, referred to as Site D

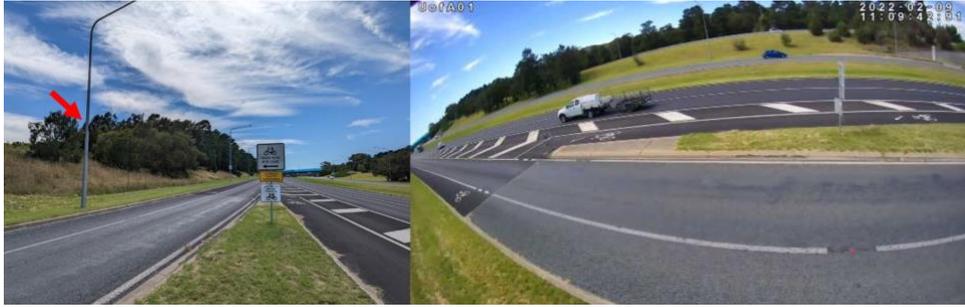
Figure 4.1

Position of camera (marked with arrow) and the actual camera view of the bike lane and road for Site A

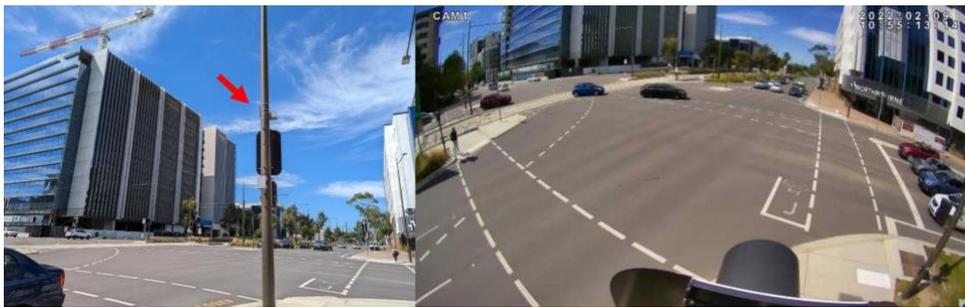
Figure 4.2

Position of camera (marked with arrow) and the actual camera view of the bike lane and road for Site B

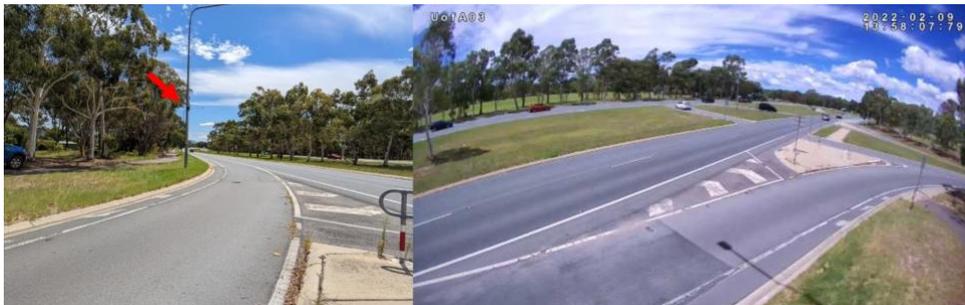
Figure 4.3

Position of camera (marked with arrow) and the actual camera view of the bike lane and road for Site C

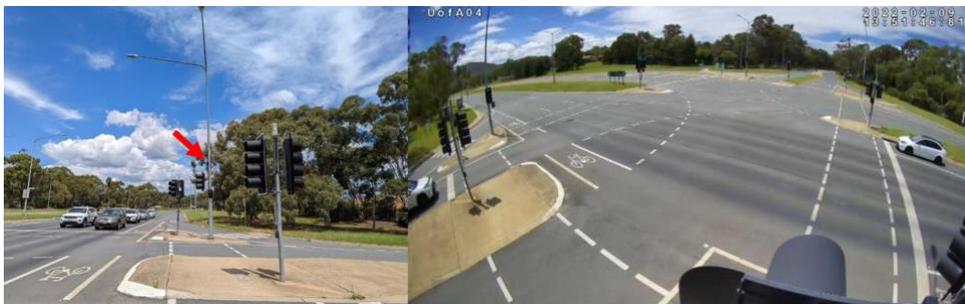
Figure 4.4

Position of camera (marked with arrow) and the actual camera view of the bike lane and road for Site D

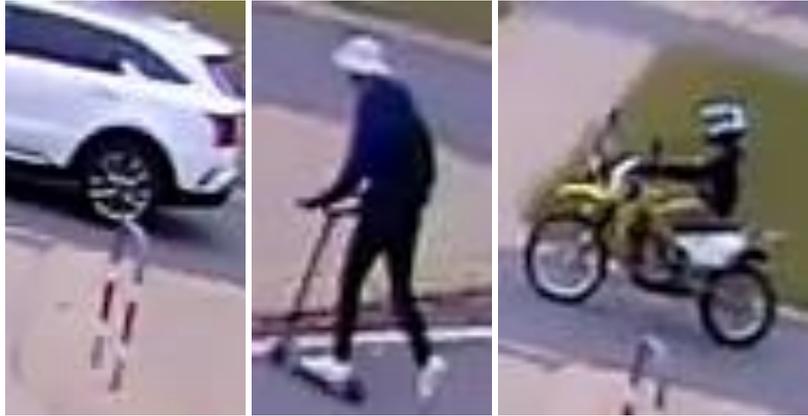
Figure 5.1

Examples of erroneous detections: pedestrian handrail and vehicle wheel combination, kick-scooter rider, and motorcyclist

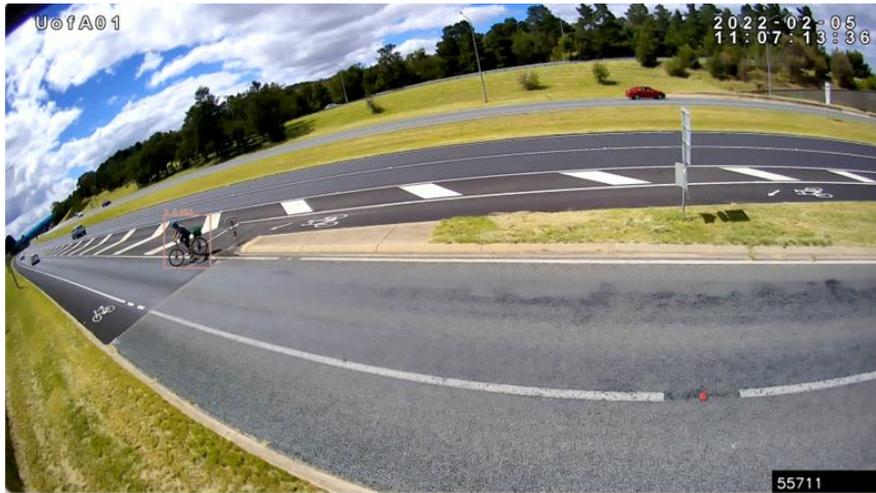
Figure 6.1
Example of an appropriate merge behaviour (using the designated crossing infrastructure) at Site A

At Site A it was observed that few cyclists (10.8%) used the designated infrastructure to travel across the merging road. This is likely to be due to the angle on the painted infrastructure, which would require cyclists to slow considerably (or stop). This may be considered unfavourable to many cyclists who might want to maintain their speed when merging across a motor-vehicle traffic lane. Despite the low rate of usage for the infrastructure, most cyclists did choose to merge shortly after the designated cross point, when there was still a reasonable painted buffer area. Concerningly, over a fifth of cyclists merged late, exposing themselves to potential risk with less buffer area between themselves and vehicle traffic. Less

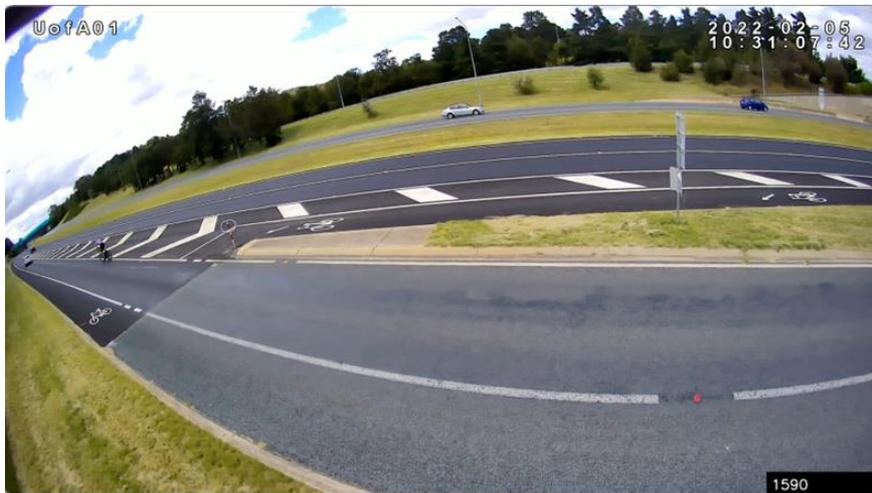
Figure 6.2
Example of an early merge behaviour at Site A

merge, where the cyclist passed the designated crossing point then merged across the traffic lane into the bicycle lane prior to the second marked road chevron; and (3) a late merge, where the cyclist travelled beyond the second painted chevron marking then merged across the traffic lane into the bicycle lane at some later point. Examples of each of these merging behaviours are shown in Figures 6.1 – 6.3 below. It was noted that cyclists who crossed later had less protective buffer from vehicles on either side.

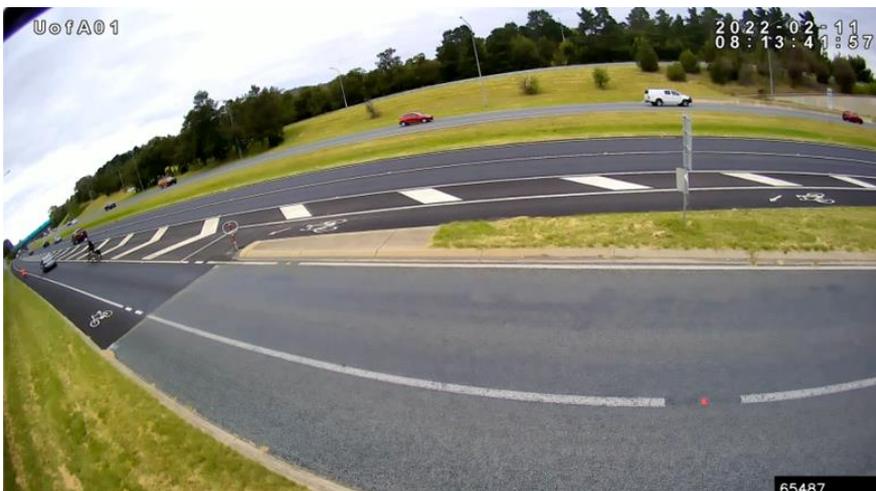
Figure 6.3
Example of a late merge behaviour at Site A

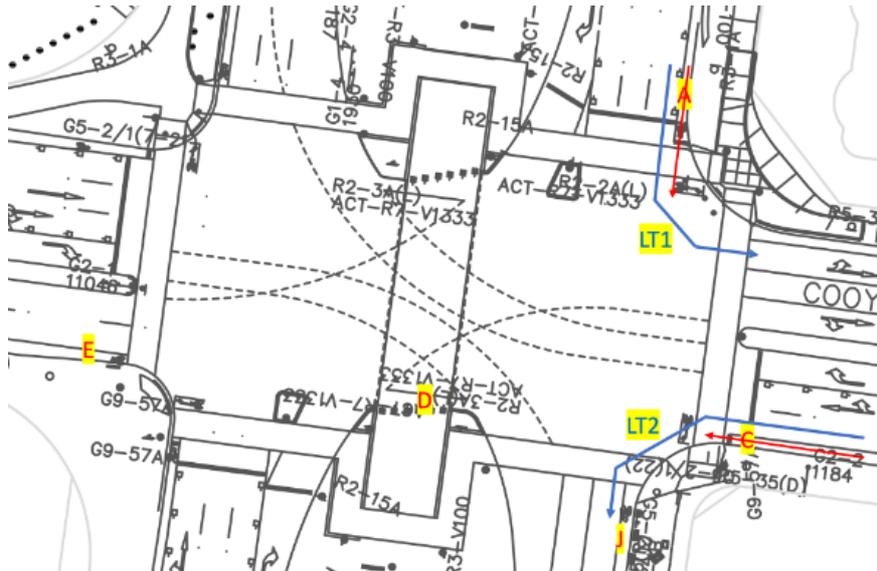
Figure 6.7

Observable left turn interactions between motor-vehicles and cyclists

Site B was a complex intersection and cyclists were observed undertaking more than 200 different routes through the scene. When focussing on the routes of interest, it was found that motor-vehicle left turns were occasionally problematic for cyclists, particularly during a green cycle, and some risky left turns were observed. Some close passes were noted as a result of the light rail corridor which offset the bike lane towards the traffic lane slightly. Some cyclists appeared to avoid the offset bike lane and diverted to use the pedestrian crossing infrastructure instead. The bike boxes appeared to be under-utilised, with greater numbers of cyclists choosing to turn right from the traffic lanes.

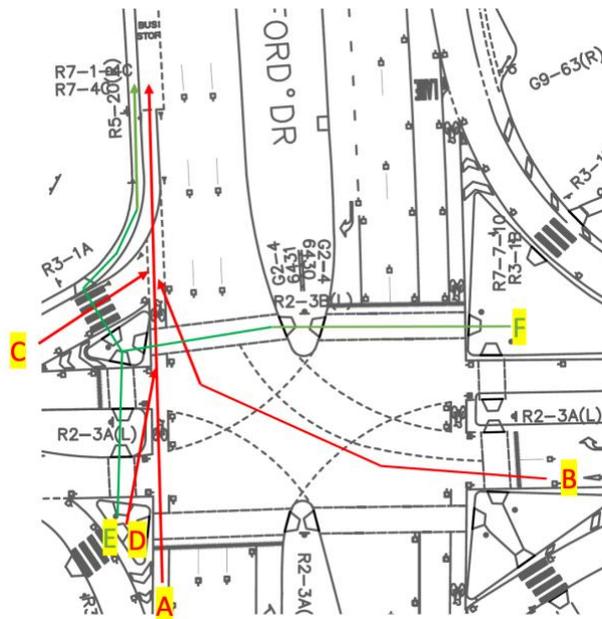
Figure 6.10
Cyclist routes observed at Site D

Relatively few cyclists were observed at this site over the seven-day monitoring period. The routes taken by the observed cyclists are shown in Figure 6.10, and the frequency of cyclists using those routes is shown in Table 6.7. There were only 27 cyclists observed initially travelling along the bike lane on Drakeford Drive and proceeding through the intersection with Mortimer Lewis Drive (route A). Additionally, there were five cyclists who joined the terminating bike lane from routes B, C, and D and two cyclists who used the footpath parallel to the bike path (routes E and F).
