Older pedestrians hit by motor vehicles in the Australian Capital Territory

REPORT NO.	DATE	PAGES	ISBN	ISSN
CASR205	November 2022	34	978 1 925971 40 8	1449-2237

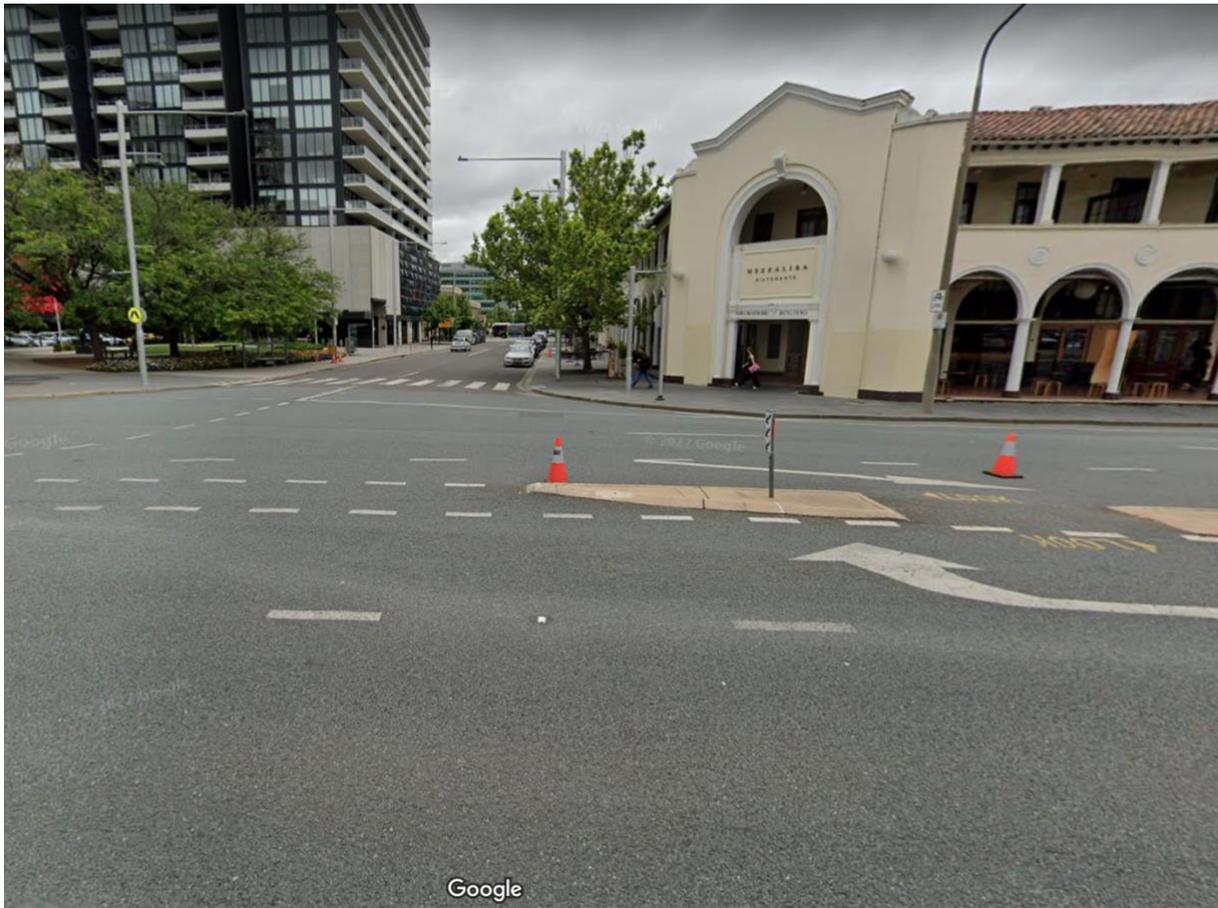
The issue of inner-metropolitan spaces that have a high level of pedestrian activity but are not designed in a way that prioritises the movement, needs, and safety of pedestrians (as opposed to prioritising vehicles) is demonstrated when a couple of the crashes are examined in detail. Figure 3.8 is a Google Maps screen shot of a location where an older pedestrian was hit by a vehicle and admitted to hospital as a result. It is the T-intersection of London Circuit and West Row, in the central business district of Canberra near hotels, restaurants and shops. The pedestrian was attempting to cross London Circuit (a busy road with three lanes in each direction) from north to south (heading towards the camera). Behind the camera (out of view of the screen shot) is a large car park and many pedestrians would cross at this location to access the car park. There is a zebra crossing across the neck of the T-intersection (to cross West Row) but there is no pedestrian-prioritised protection or infrastructure at this location, or in the near vicinity, for pedestrians to use to cross London Circuit. It can be seen in Figure 3.8 that there is a narrow pedestrian refuge built into the median but it has no protection (e.g., concrete bollards). Interestingly, written on the road at the refuge is the word “look” accompanied by an arrow, which instructs pedestrians to look in the appropriate direction for cars. The pedestrian in this case thought the road was clear, started crossing and could not understand how the driver of the vehicle did not see them. This location would benefit from redevelopment with the needs and safety of pedestrians as the priority. One option is to have a signalised intersection to provide pedestrian signals. If there is a wish to avoid having a signalised intersection here, another option is to provide a raised zebra crossing further east on London Circuit, so that it is not too close to West Row.

Location of a serious older pedestrian collision with a motor vehicle at the T-intersection of London Circuit and West Row. Pedestrian was crossing London Circuit towards the camera through the narrow pedestrian refuge

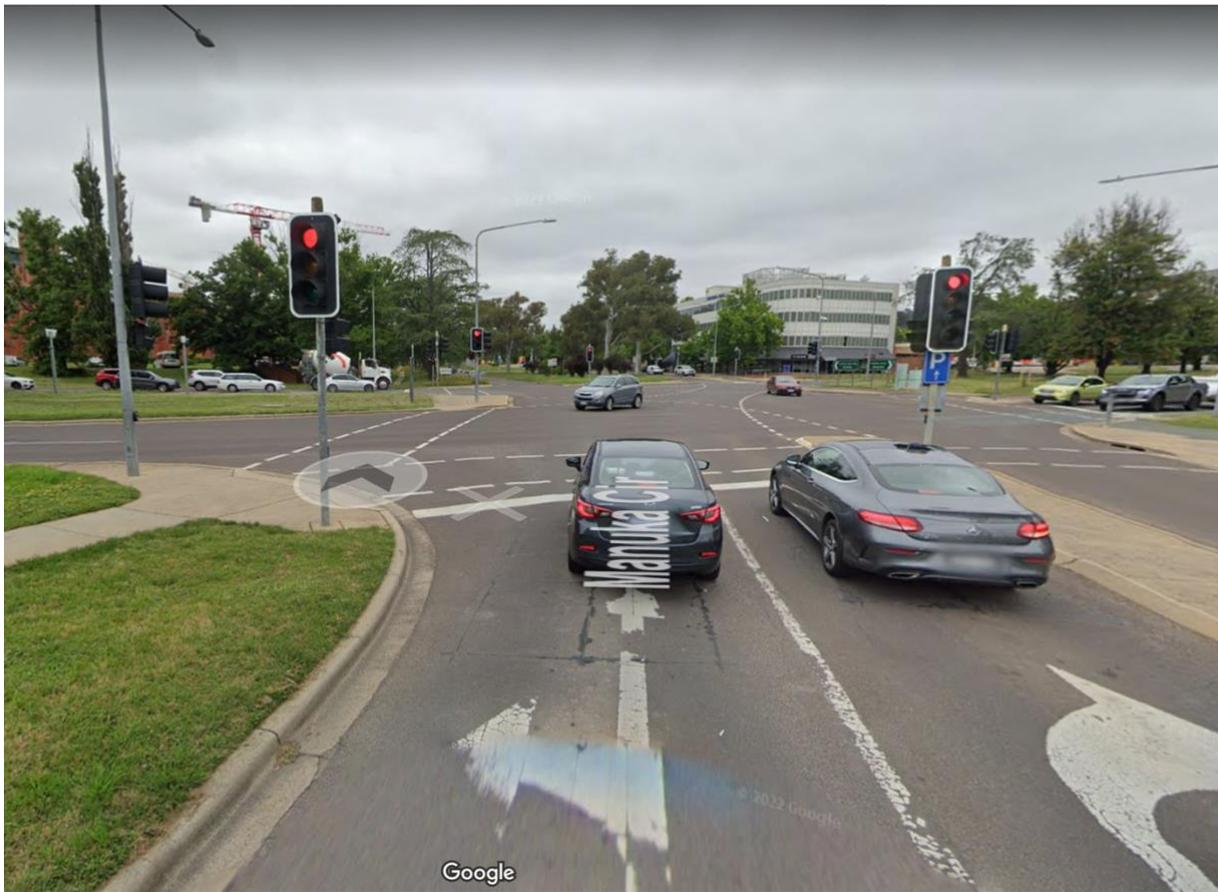
In another Canberra CBD crash, an older pedestrian was fatally injured when struck by a bus. The pedestrian was waiting at the signalised intersection of Manuka Circuit and Canberra Avenue to cross the east bound lanes of Canberra Avenue walking in a southerly direction. The bus had travelled south on Manuka Circuit and was intending to turn left at the traffic lights to travel east on Canberra Avenue. The screen shot in Figure 3.10 shows the intersection from the perspective of both the pedestrian and the bus. The traffic light and pedestrian signal turned green, and the pedestrian started walking. The bus had to give way to the pedestrian but was focussed on a bicyclist coming from the opposite direction and did not see the pedestrian. The bus turned left and hit the pedestrian. This demonstrates that pedestrian collisions can occur even when the pedestrian is using a signalised crossing if the crossing is not appropriately designed with the safety of the pedestrian in mind. The screen shot demonstrates that there are no left turning arrows for traffic from the direction of the bus. This collision may have been avoided if there had been a red arrow that required the bus to continue to wait while the pedestrian started walking.

Location of a fatal older pedestrian collision with a bus at the intersection of Manuka Circuit and Canberra Avenue. Pedestrian was walking straight ahead at the lights and the bus was turning left at the lights

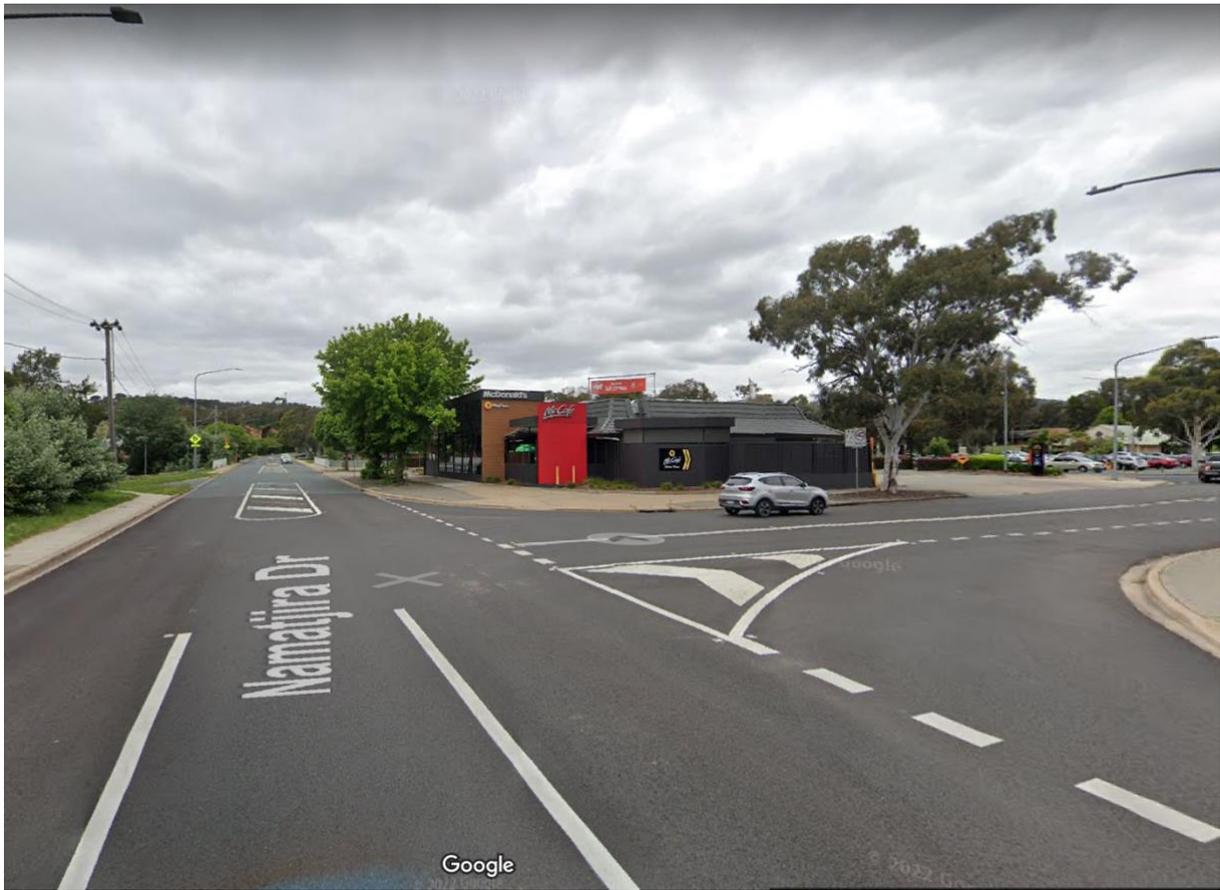
It is useful to examine two of the suburban serious older pedestrian crashes in more detail as they demonstrate how the provision of a pedestrian crossing could have prevented the collision. Figure 3.11 shows the T-intersection of Namatjira Drive and Macnally Street in Weston. An older pedestrian was crossing Macnally Street (neck of the T-intersection) east towards the MacDonalds restaurant about 5 metres south of the Give Way line and was hit by a vehicle turning left off Namatjira Drive and fatally injured. Many pedestrians would cross at this location to access the MacDonalds restaurant. This location would benefit from either the intersection being signalised with pedestrian lights or a raised zebra crossing further south on Macnally Street.

Location of a fatal older pedestrian collision at the intersection of Namatjira Drive and Macnally Street, Weston. Pedestrian was crossing Macnally Street to the MacDonalads, and the vehicle turned left off Namatjira Drive onto Macnally Street

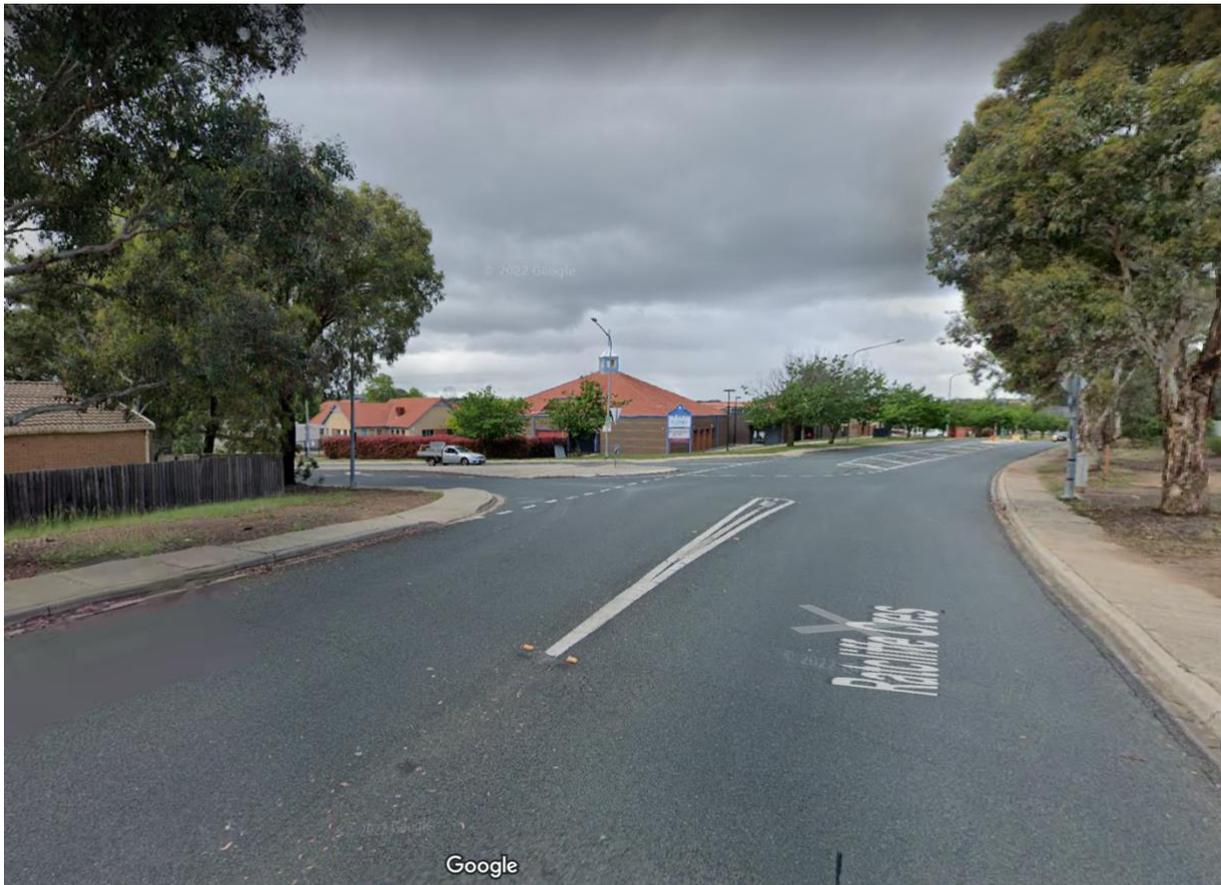
Figure 3.12

Similarly, an older pedestrian was admitted to hospital after they were hit by a vehicle at the intersection of Ratcliffe Crescent and Krefft Street in Florey (Figure 3.12). The pedestrian was crossing Krefft Street (the neck of the T-intersection), but it is not clear in which direction they were walking. The vehicle had turned right off Ratcliffe Crescent onto Krefft Street to travel north. Many children and parents/caregivers would cross Krefft Street at this location to access the Primary School on the corner, and their safety would be improved by either the intersection being signalised with pedestrian lights or raised zebra crossings further north on Krefft Street and further east on Ratcliffe Crescent.

Location of a serious older pedestrian collision at the intersection of Ratcliffe Crescent and Krefft Street, Florey. Pedestrian was crossing Krefft Street (neck of T-intersection), and the vehicle turned right off Ratcliffe Crescent onto Krefft Street
