# **Driver behaviour preceding crashes at stop or give way sign-controlled intersections**

CASR223

**Centre for Automotive Safety Research**

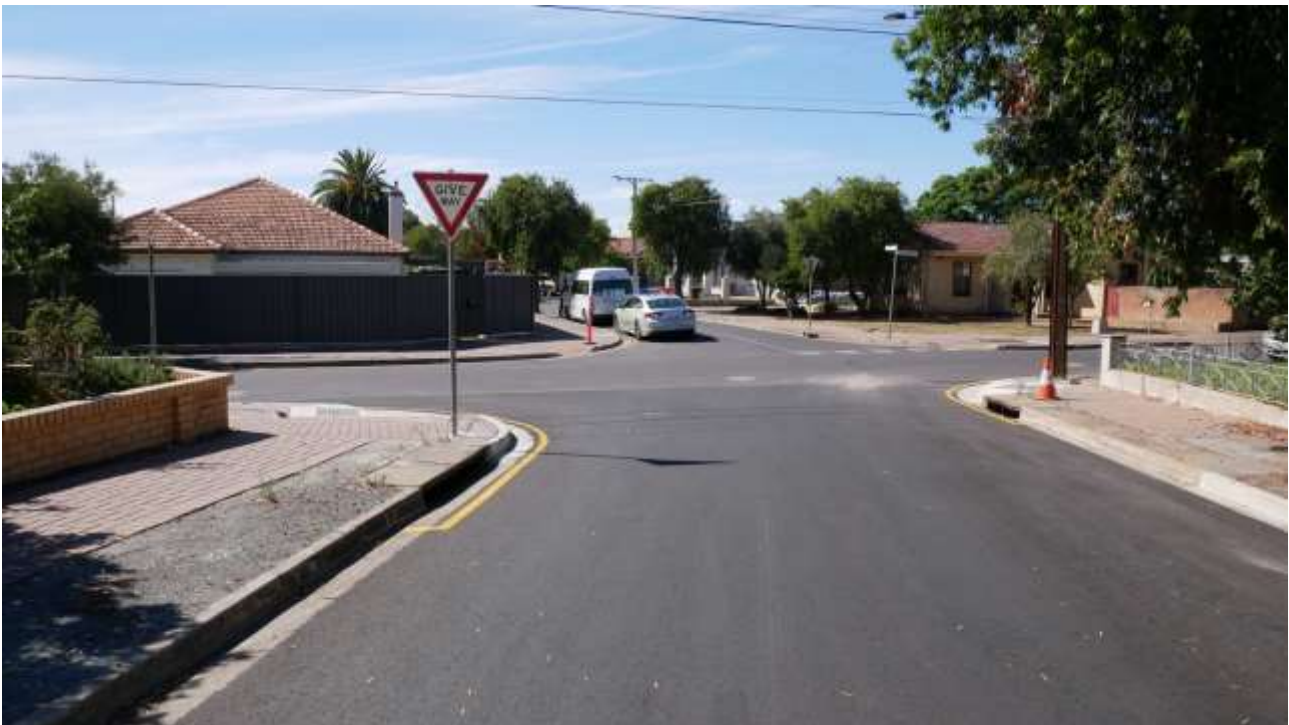
Figure 3.1

Intersection in which the non-priority road had recently been resurfaced but a give way line had not been repainted. A driver approaching the intersection from this direction travelled straight through without realising they were required to give way and collided with another vehicle.

Not surprisingly, the driver was unfamiliar with the road in 11 of the 12 run-through crashes. There was not enough information about the driver in the twelfth crash to determine whether they were familiar with the road or not. The second most common circumstance was that the crash occurred in dark lighting conditions that made it difficult for the driver to see the intersection or the stop/give way sign. Inclement weather contributed to three crashes for the same reason. In four crashes, the stop/give way line at the intersection was faded or not present. The road had recently been resurfaced in one crash, but a give way line had not been painted on the new surface and the driver noted that this contributed to them not being aware that they had to give way at the intersection (Figure 3.1).

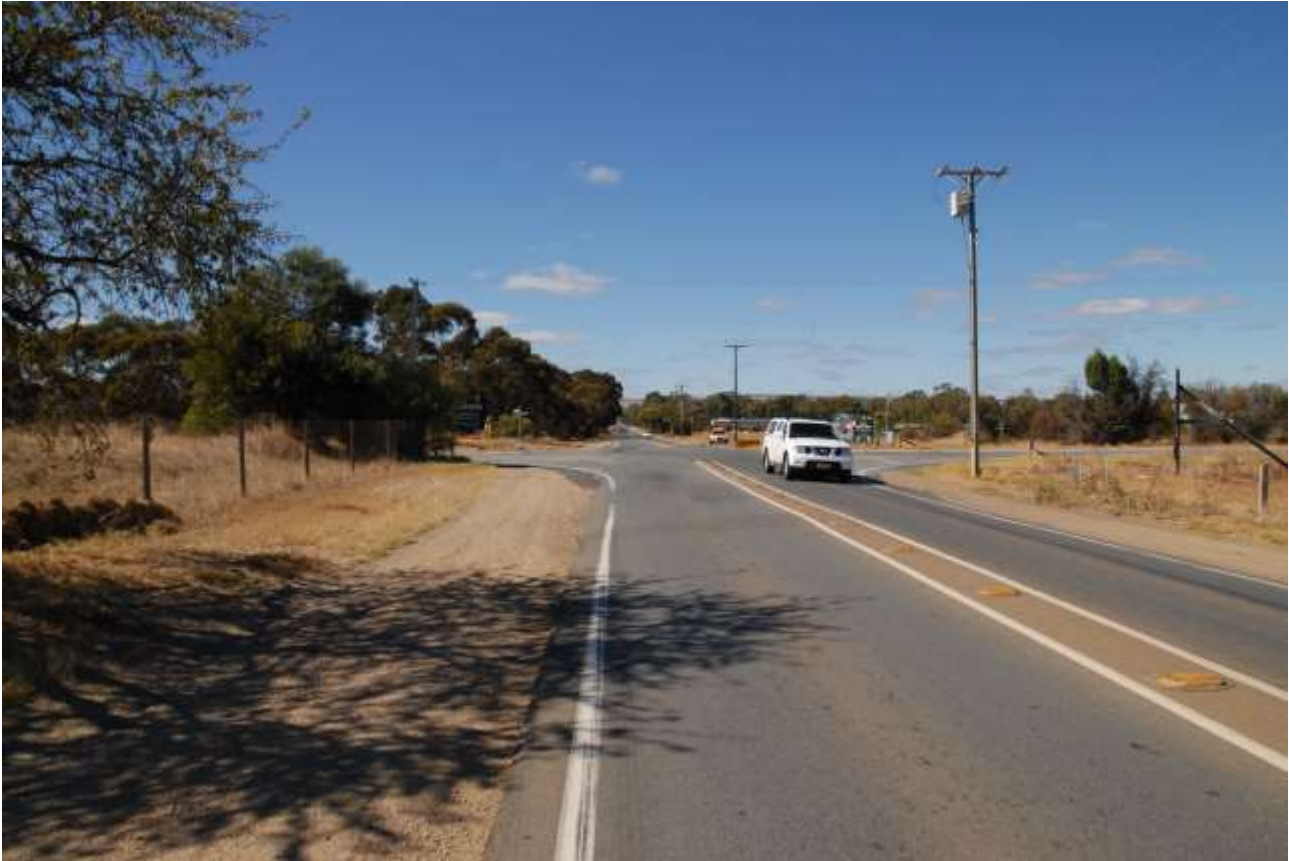
Figure 3.3

Typical intersection in the peri-urban area of Angle Vale, Virginia, and Two Wells. Three crashes were investigated by CASR at this location (Section 3.3.1) and more than 20 crashes occurred here over a ten-year period (Section 3.3.2).

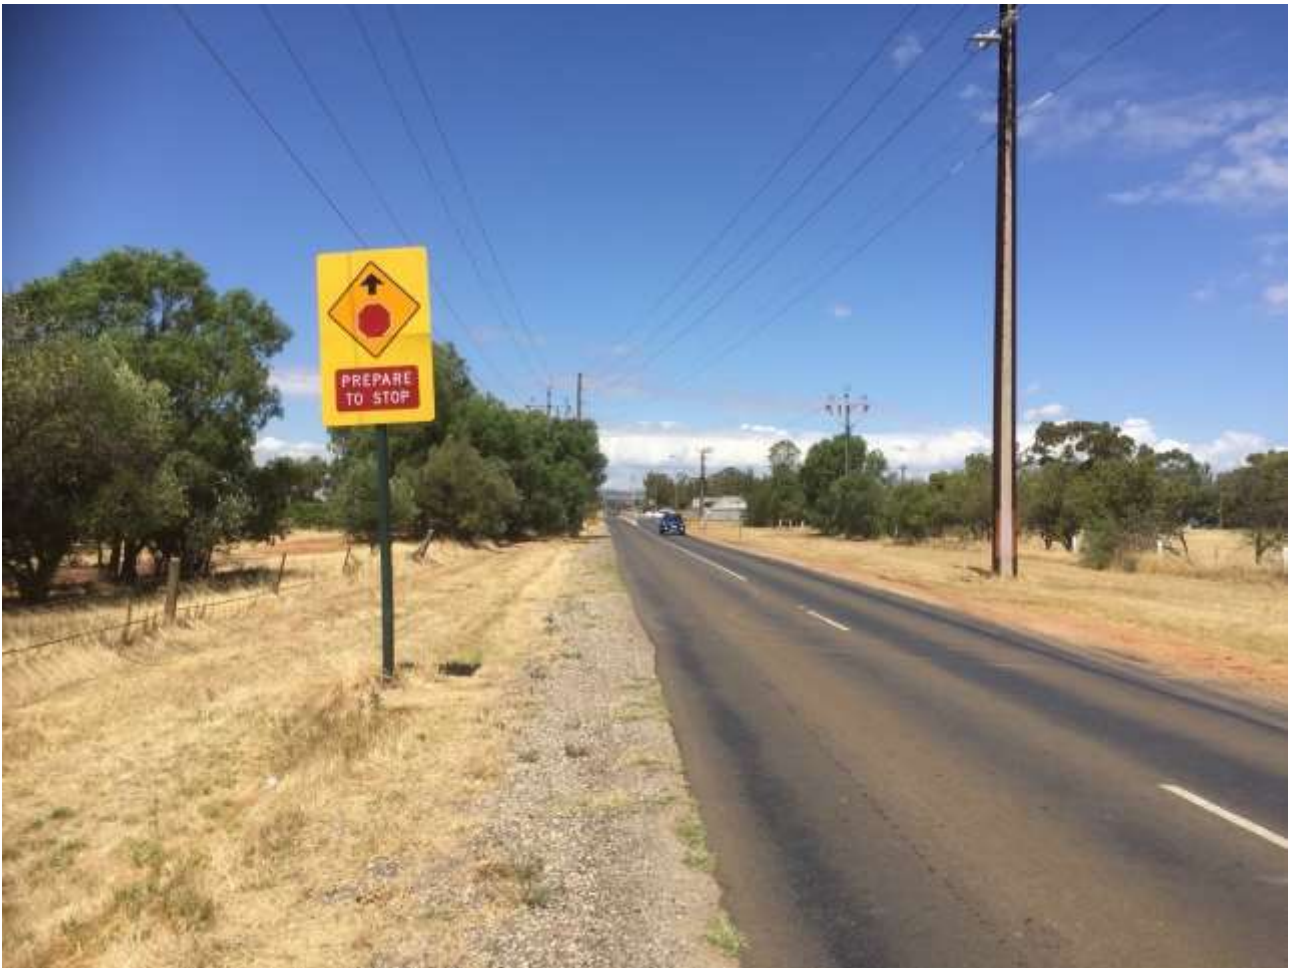
Figure 3.4

Advanced warning sign that was missed by a driver who travelled straight into the intersection

In 12 of the 19 run-through crashes, there were advanced warning signs on the approach. This is interesting because the driver must have missed these clearly visible warning signs that have been installed, in addition to the standard stop or give ways signs, for the express purpose of increasing the awareness of drivers that they are approaching an intersection at which they are required to give way. Further to this, the intersections had additional treatments to further improve driver awareness in several of the 12 crashes. In one, the words “prepare to stop” were written on the advanced sign (Figure 3.4), and the two stop signs at the intersection (one on each side of the road) were bordered by a yellow/orange colour to further improve conspicuity. The single stop sign at the intersection was again bordered by yellow/orange in another crash, while one crash had two advanced warning signs (one on each side of the road), warning delineation on the approach and two give way signs at the intersection (one on each side of the road) that were bordered by yellow/orange. The non-priority road (on which drivers were required to give way) was off-set through the intersection in two crashes. The intention of off-set intersections is that the non-priority road does not continue in a straight line through the intersection. This serves as a visual indication to the driver that they are not on a priority road and must give way. One of these off-set intersections included a bi-directional chevron sign at the termination of the non-priority road from the perspective of the at-fault driver (Figure 3.5). However, despite these additional treatments designed to increase driver awareness, the drivers in these crashes managed to drive straight into the intersections without slowing or stopping.

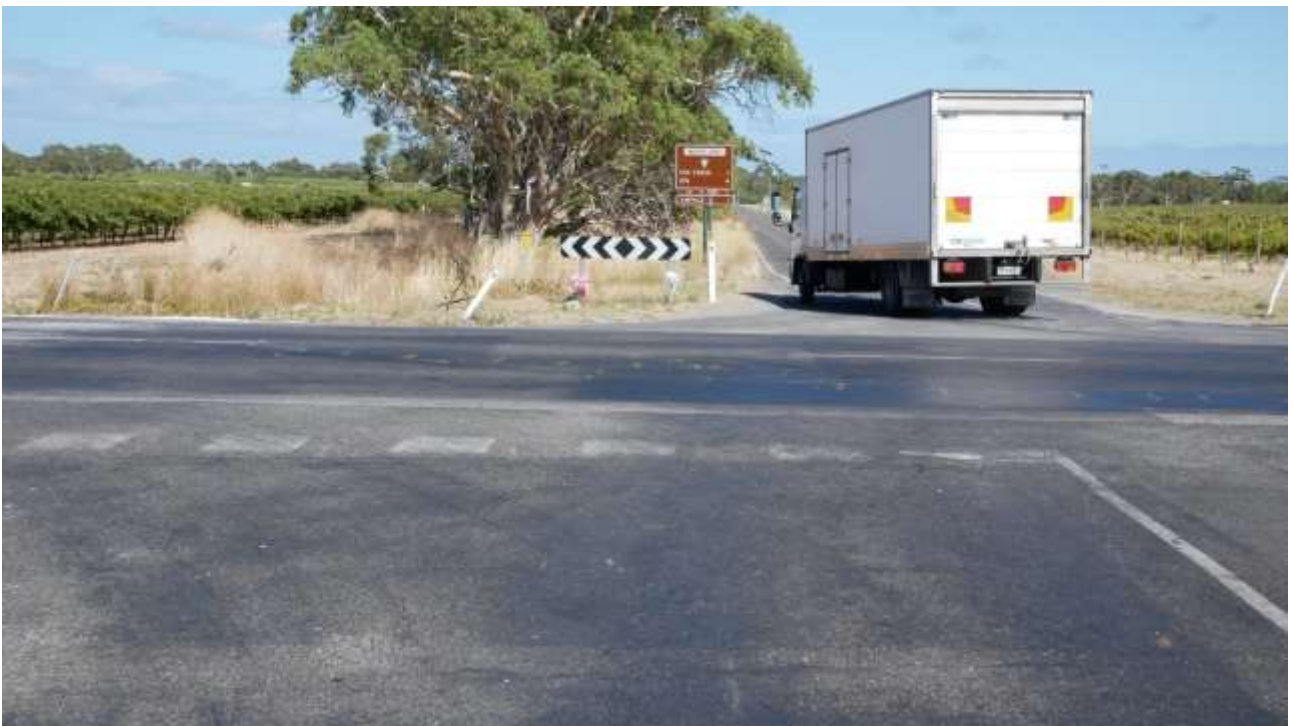
Figure 3.5

Bi-directional chevron sign in the path of an off-set non-priority road through an intersection

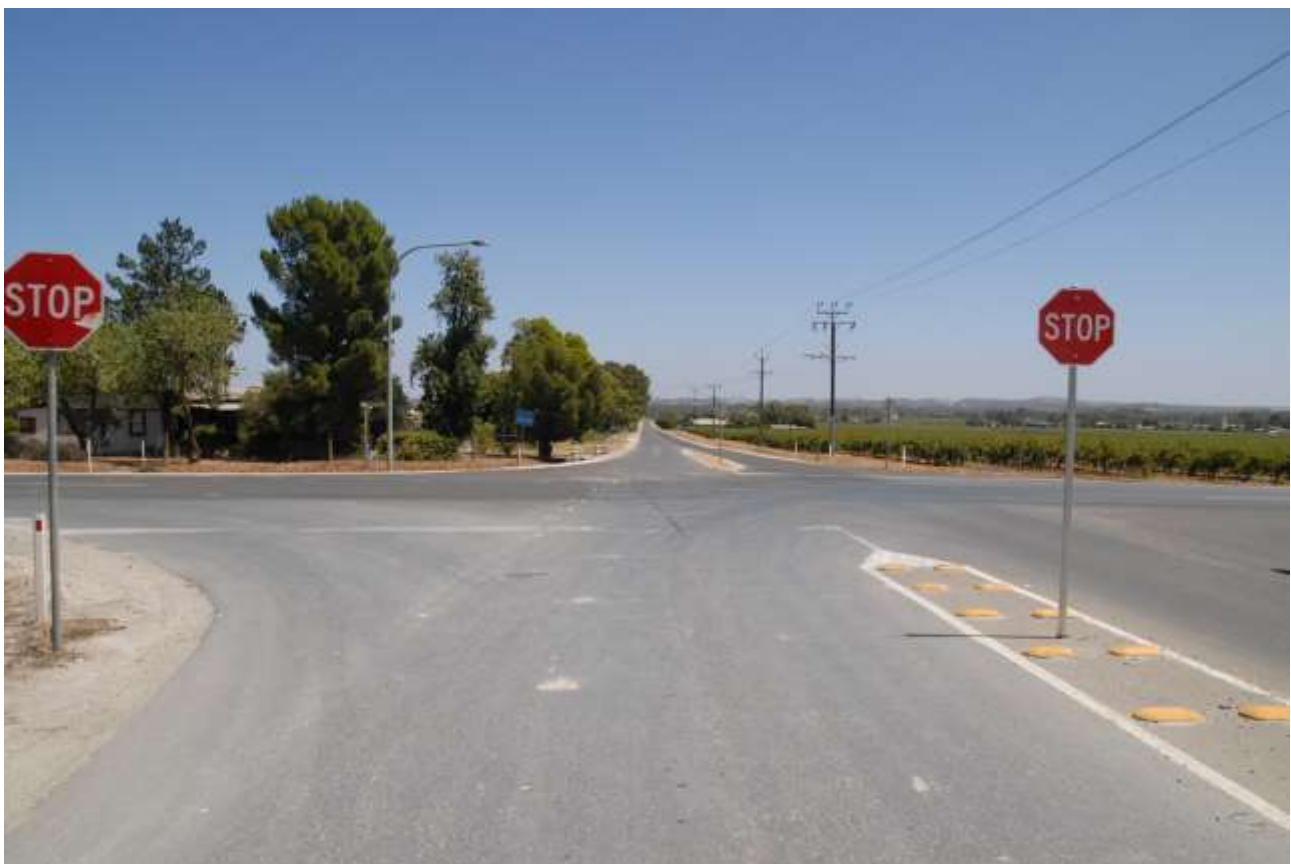
Figure 3.7  
Penrice Road through the intersection with Stockwell Road in Light Pass in 2018,  
facing west from the eastern side of the intersection

Two crashes were investigated at the crossroad intersection of Penrice and Stockwell Roads in Light Pass, in the Barossa Valley. The first occurred in 2018 and the second four-and-a-half years later in 2022. In the first, a work utility was heading north on Stockwell Road and a two-axle truck was heading west on Penrice Road. The intersection was controlled by stop signs for both directions on Penrice Road. The truck driver stopped at the intersection and gave way to a B-double truck heading north on Stockwell Road. The driver's view further down the road was blocked, however, by a rise in Stockwell Road on the approach to the intersection for traffic travelling north, and possibly by a large tree on the south-east corner of the intersection. He drove across the intersection in front of the utility. In the second crash, a B-double truck was heading north on Stockwell Road and a dual-cab utility was heading east on Penrice Road (opposite direction from the truck in the first crash). The utility driver drove straight through the intersection without slowing or stopping and checking for traffic. The driver stated that he was not aware that he had to stop due to never having driven through the intersection before. Also, the sun glare reflecting off the wet road and the rainy and overcast conditions contributed to his failing to notice the signs. The speed limit through the intersection for both roads is 80 km/h. The highest level of injury for the first crash was hospital treatment and for the second it was hospital admission. Interestingly, in the four-and-a-half years between the two crashes, the intersection had been identified as a black spot and several treatments were applied to improve driver awareness on Penrice Road that they must stop and look for traffic. In 2018, both directions of Penrice Road had an advanced warning sign and two stop signs at the intersection (Figure 3.7). In 2022, delineation, a tear-drop median, and a 'keep left' sign had been added to off-set Penrice Road (Figure 3.8). Despite these treatments, the driver in the latter crash drove straight through.

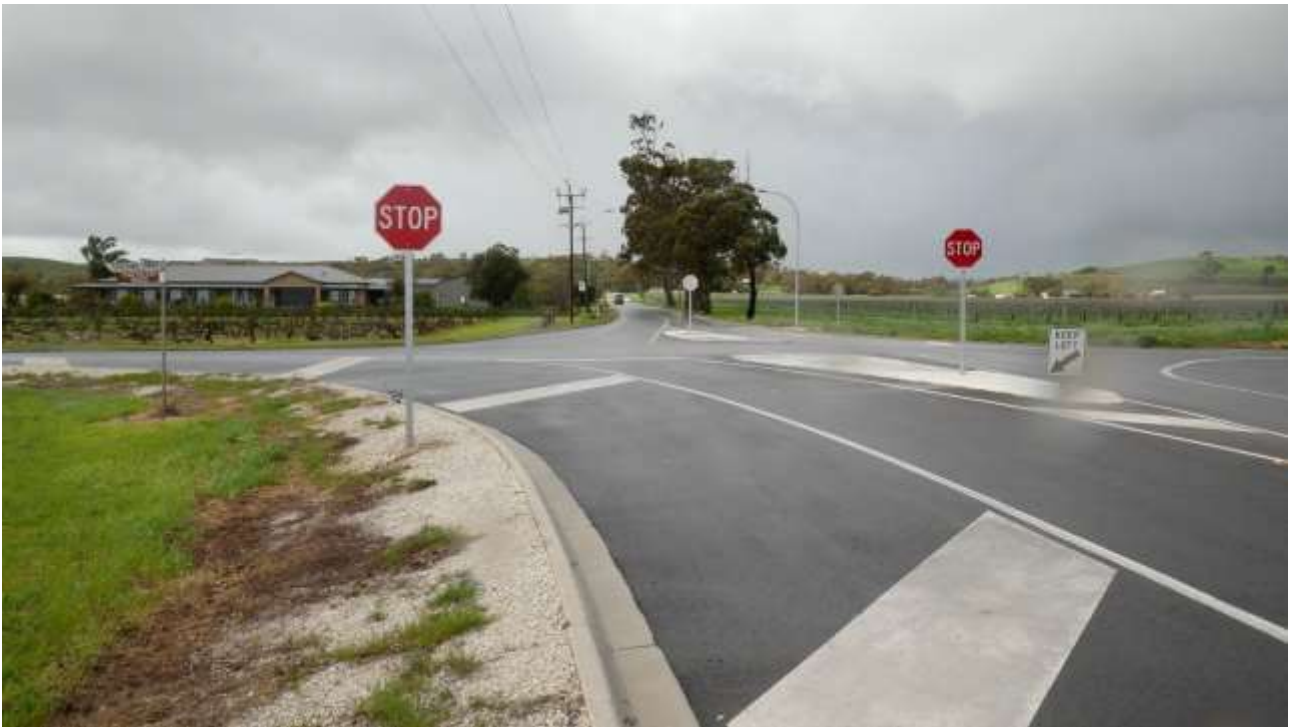
Figure 3.8

Penrice Road through the intersection with Stockwell Road in 2022, facing east from the western side of the intersection

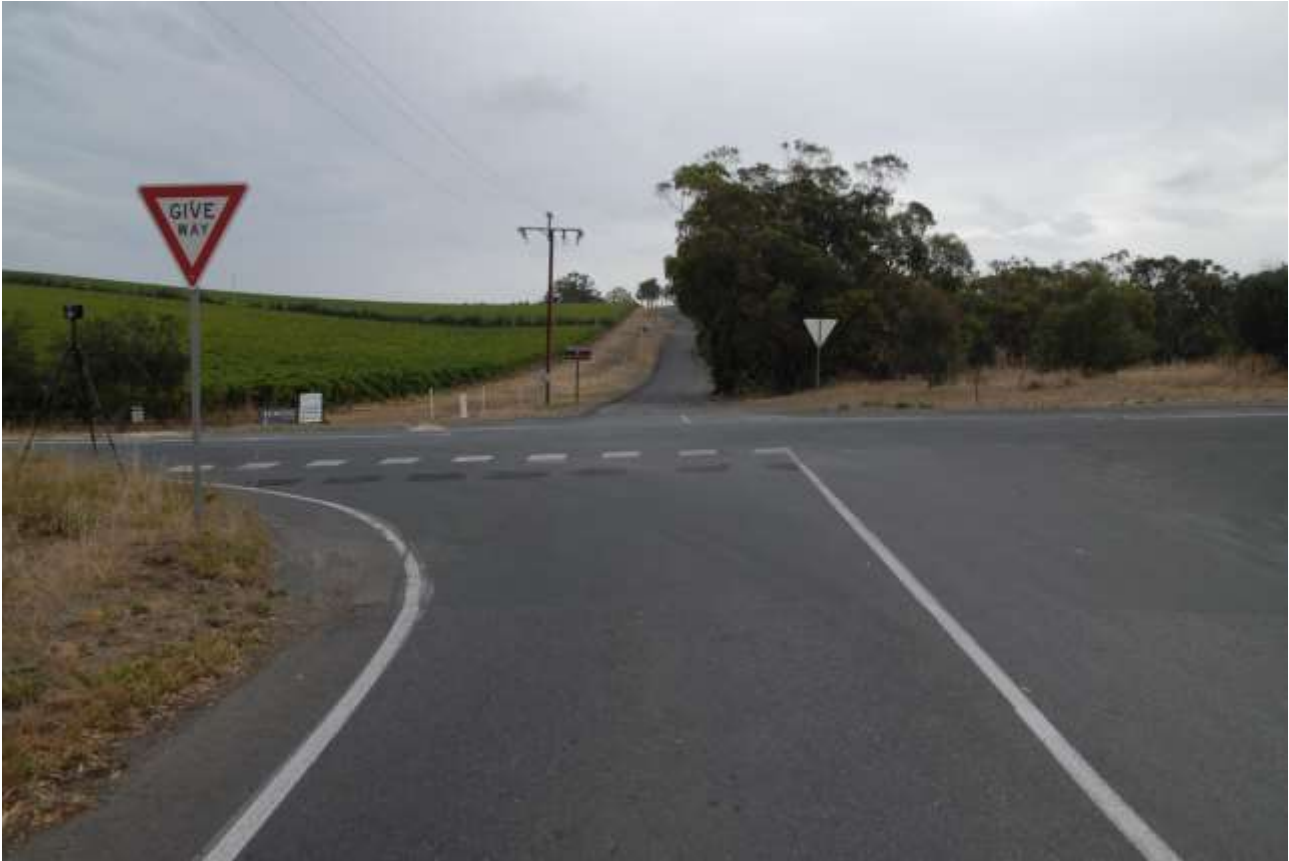
Figure 3.9

Olivers Road through the intersection with Seaview Road in 2019, facing north from the southern side of the intersection

Two crashes were investigated at the crossroad intersection of Seaview and Olivers/Coppermine Roads in McLaren Vale. The first occurred in 2019 and the second four years later in 2023. In both, one vehicle (a 3-axle truck in the second crash) was heading west on Seaview Road and another was heading north on Olivers Road. The vehicles on Olivers Road in both crashes went straight through the intersection without slowing or stopping. In the first crash, the driver on Olivers Road who went straight through the intersection was an international traveller who had been in Australia for less than 24 hours and was unfamiliar with the intersection. The driver had driven through two previous intersections on Olivers Road for which he had right of way (priority road) and, therefore, thought he also had right of way at the intersection with Seaview Road (despite an advanced warning give way ahead sign). It is not known why the driver in the second crash drove straight through the intersection. The speed limit for both roads is 80 km/h. The highest level of injury for the first crash was hospital treatment and for the second crash was hospital admission. Once again, in the period between the two crashes several treatments were applied to the intersection. At the time of the first crash, there was one warning give way ahead sign on the approach and one give way sign at the intersection for vehicles on Olivers Road (Figure 3.9). At the time of the second crash, there were two warning give way ahead signs (one on either side of the road) with the distance to the intersection displayed (Figure 3.10). There was also delineation on the bitumen within the approaching lane to further draw the driver's attention to the intersection ahead and two give way signs at the intersection (one on either side of the road) that were bordered by a yellow/orange colour to increase conspicuity. These additional treatments did not stop the driver in the second crash travelling straight through without stopping.

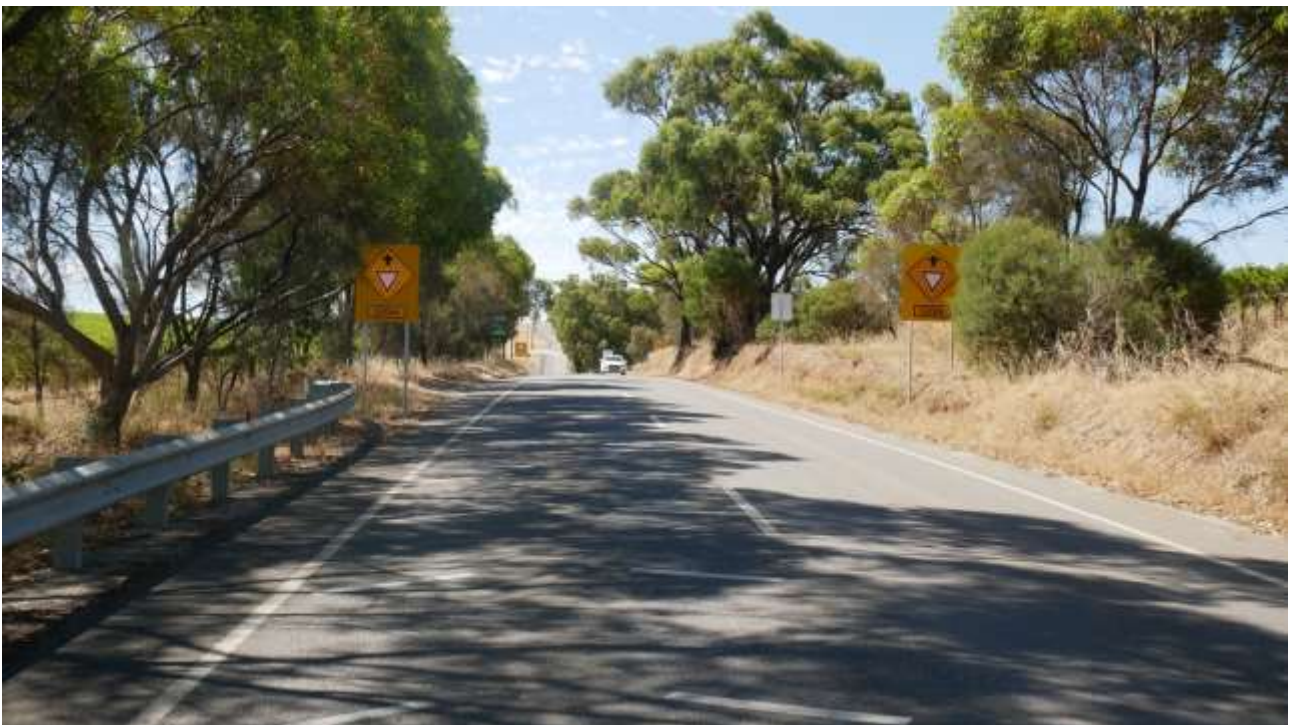
Figure 3.10

Olivers Road through the intersection with Seaview Road in 2019, facing north from the southern side of the intersection

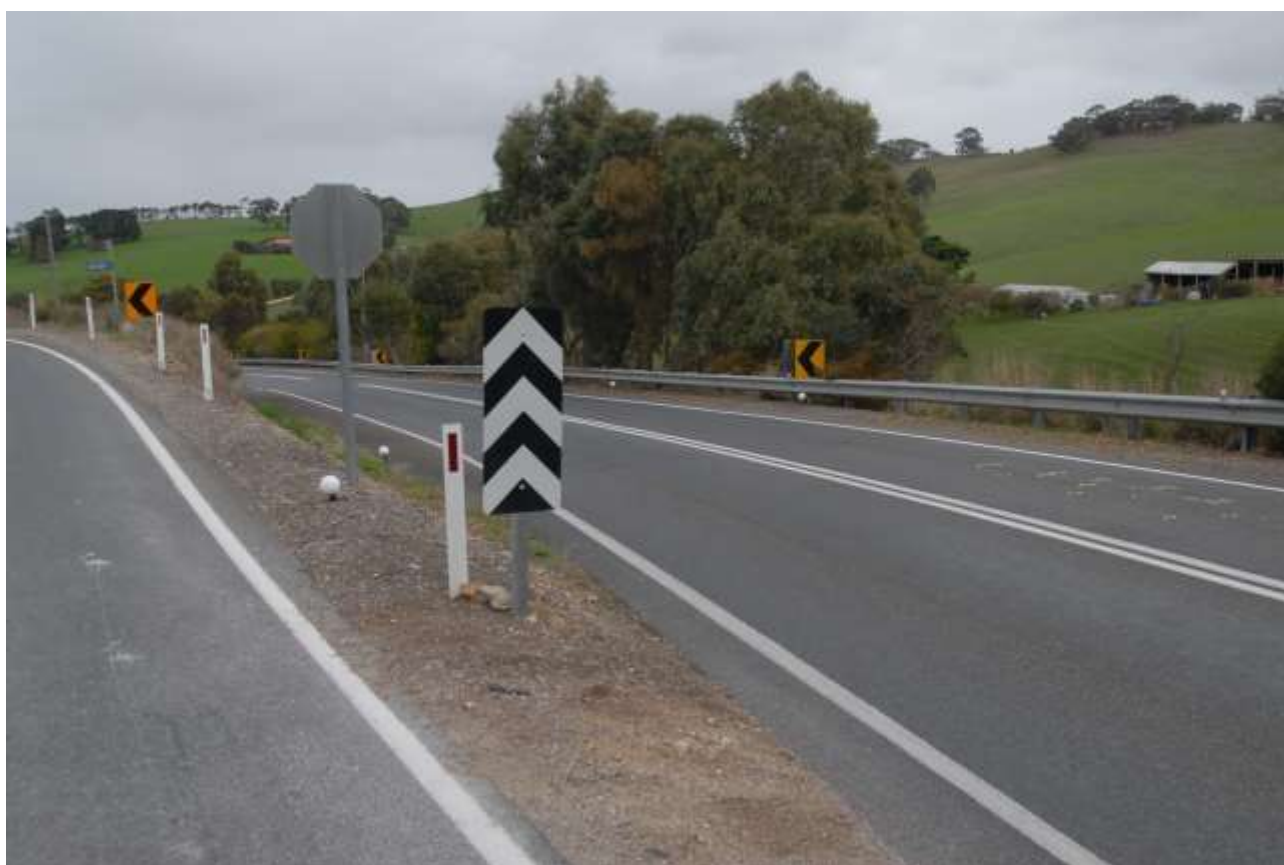
View of traffic travelling north on Bull Creek Road from the perspective of a road user at the stop sign at the termination of Paris Creek Road

Several T-intersections in this research, and the crashes investigated at them, are worthy of further mention as their design and layout are particularly difficult or complex for the driver on the terminating road (required to give way) to negotiate. Firstly, a crash occurred at the intersection of Bull Creek and Paris Creek Roads in the rural area or Paris Creek. Figure 3.11 shows the intersection layout. A car was turning right from Paris Creek Road to travel north on Bull Creek Road. The driver had stopped for the stop sign and was looking left and right for approaching traffic; however, it was particularly difficult to look for traffic approaching from the left due to the acute angle of Bull Creek Road leading into the intersection (driver required to look backwards rather than just to the left). Bull Creek Road also comes up a steep incline from a low gradient and around an embankment from that direction which restricts vision of fast-moving vehicles on this road (80 km/h speed limit). Figure 3.12 shows the view to the left from the driver's perspective (to check for traffic travelling north on Bull Creek Road). The driver was slowly moving out to get a better view and was prioritising the need to check for traffic from the left as it was so difficult to see but failed to adequately check for traffic from the right and moved into the path of a motorcycle travelling south on Bull Creek Road. The rider was admitted to hospital due to colliding with the car, being ejected from the motorcycle, and hitting the road. The car driver reported travelling through the intersection regularly and noted how difficult it is to navigate due to the restricted vision.

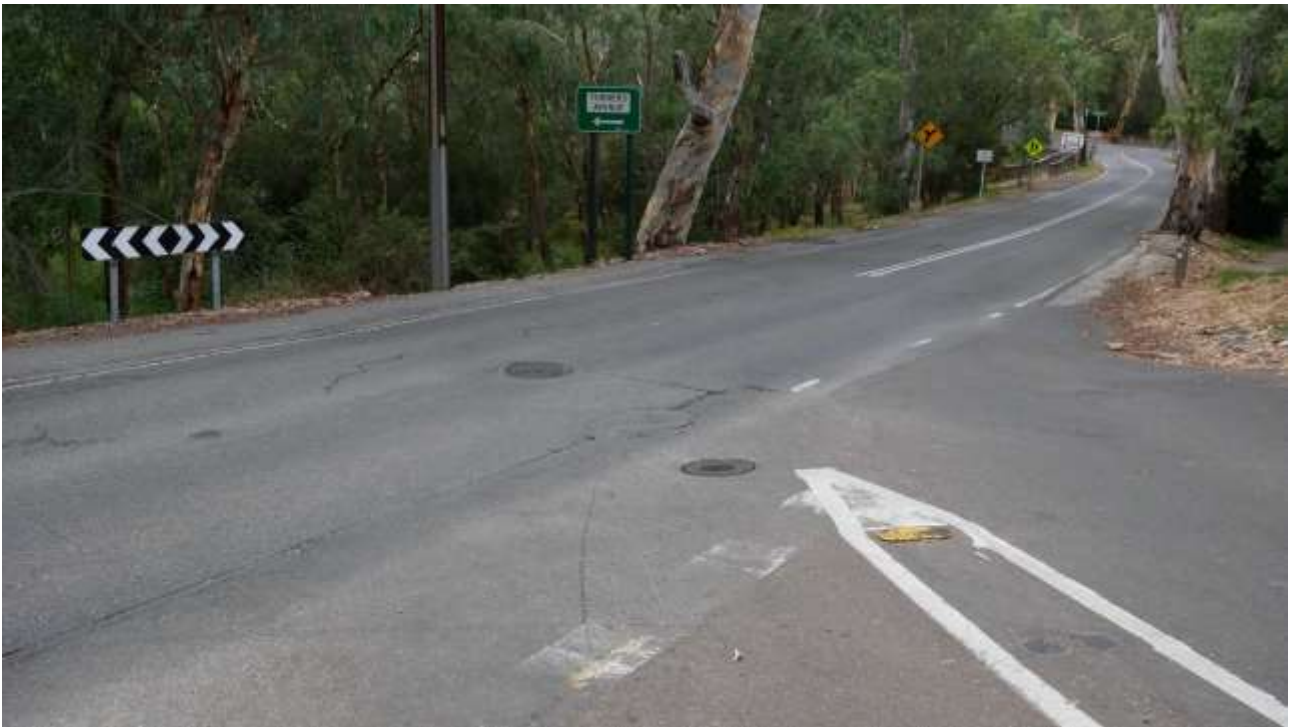
Figure 3.14

View right from the perspective of a road user at the give way sign at the termination of Red Road

driver stopped at the give way sign where Red Road terminates and was looking for traffic. However, visibility was very poor in both directions due to the acute angle of Main Road to the left of Red Road and trees and embankments in both directions (Figures 3.13, 3.14 and 3.15). Also Red Road terminates at the bottom of a steep decline and traffic is busy on Main Road. The driver was concentrating so much on checking for traffic from the left and right that they failed to recognise a vehicle directly in front of them in the middle of the intersection that was turning right from Main Road to travel west on Red Road. Both vehicles turned at the same time. They were travelling slowly (60 km/h speed limit; both vehicles turning), so the collision was minor and only one vehicle occupant (an infant) required a precautionary check-up at the hospital. The driver on Red Road was very familiar with the intersection and noted how difficult it is to negotiate.

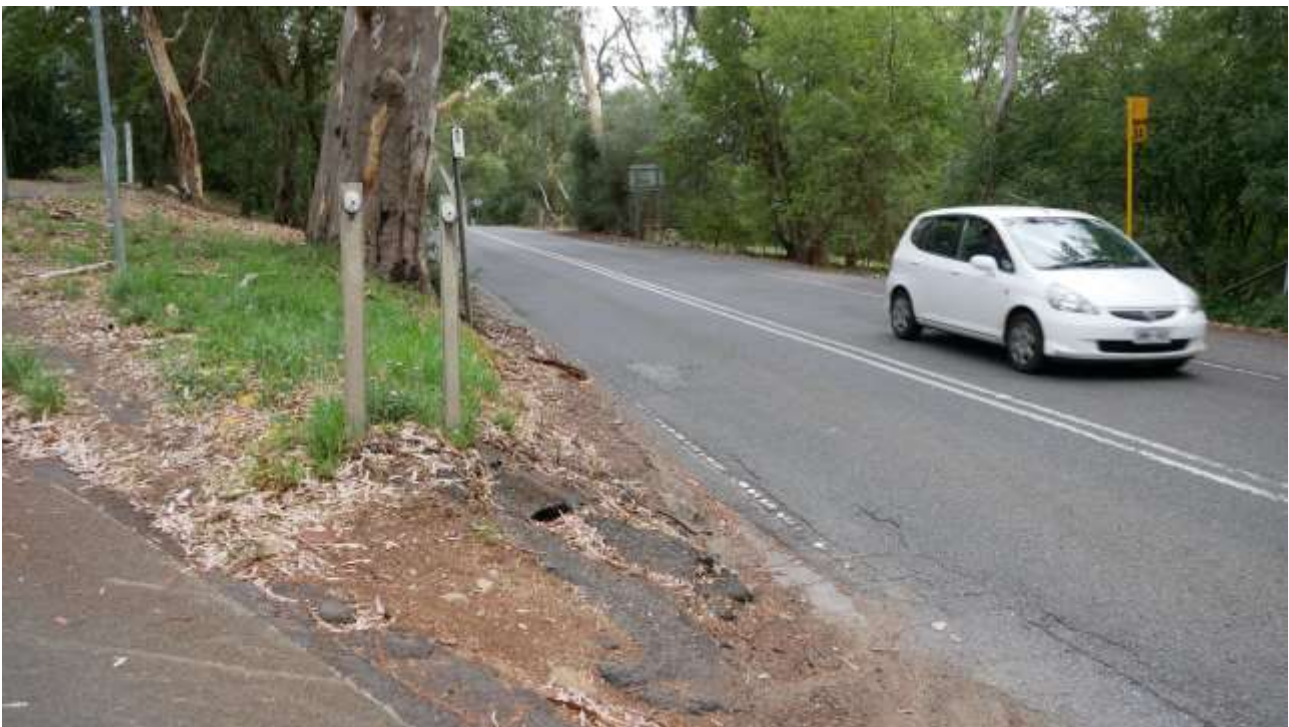
Figure 3.15

View left from the perspective of a road user at the give way sign at the termination of Red Road

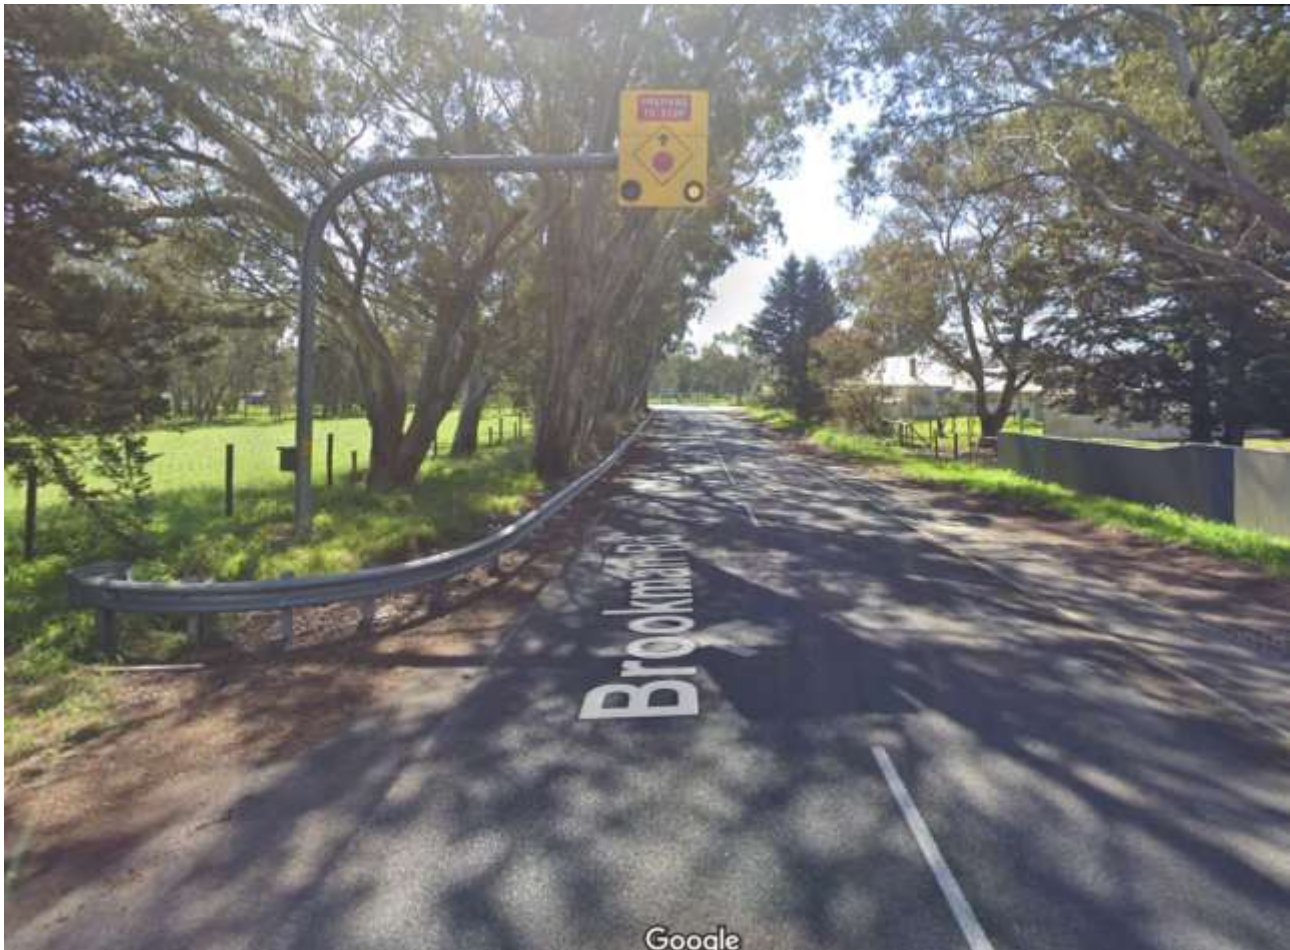
Overhead warning sign on Brookman Road, Meadows, South Australia

Other innovative efforts attempt to increase the effectiveness of advanced warning signage and/or signage at the intersection by making the signs bigger and more visible, for example, an arch-type overhead sign that has flashing lights. However, these are subject to practical restraints, such as the cost to install and the power source requirements. Srinivasan (2008) studied crashes at stop sign-controlled intersections in North and South Carolina, USA before and after the installation of overhead flashing beacons. They found a 12% reduction in angle crashes. Similarly, Murphy and Hammer (2007) also conducted a before and after evaluation of overhead flashing beacons at four-leg, two-way stop sign-controlled intersections in North Carolina and found a 12% decrease in total crashes, a 9% decrease in injury crashes, a 40% decrease in severe injury crashes, and a 26% reduction in 'ran stop-sign' crashes. Other before and after evaluations of overhead flashing beacons in the USA have also demonstrated crash reductions (Brewer and Fitzpatrick, 2004; Stackhouse & Cassidy, 1996). Research by Pant, Park, Neti, and Hossain (2007) in Ohio found that overhead flashing beacons led to reduced vehicle speeds in the major directions of traffic at rural stop sign-controlled intersections, particularly at intersections with inadequate stopping sight distance. However, the beacons had little effect on accepted or rejected gaps and were ineffective in reducing stop sign violations. They also found no statistically significant reduction in crashes. Figure 5.1 shows an example of an overhead warning sign in use currently on Brookman Road in Meadows SA. However, such overhead signs are not commonly in use in SA.
