ENGINEERING ASPECTS

TRAFFIC ACCIDENTS

ADELAIDE, SOUTH AUSTRALIA.

A thesis presented for the degree of Master of Engineering of
the University of Adelaide, based on work in the Traffic Accident
Research Unit of the Department of Pathology of the University
of Adelaide.

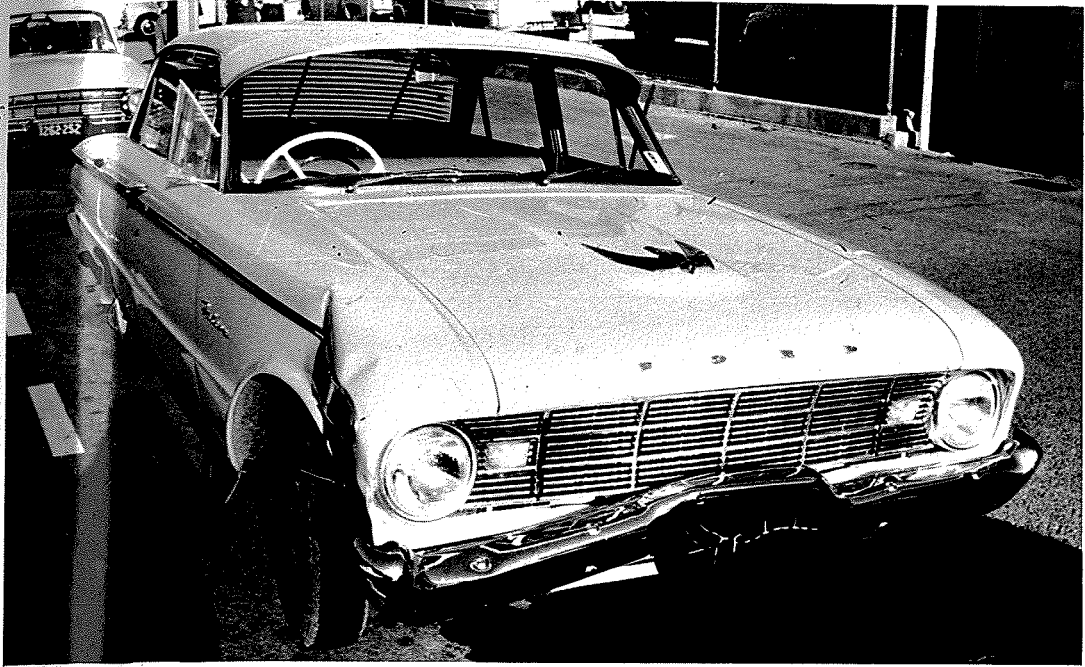
Fig. 3.10
Minor overall damage.

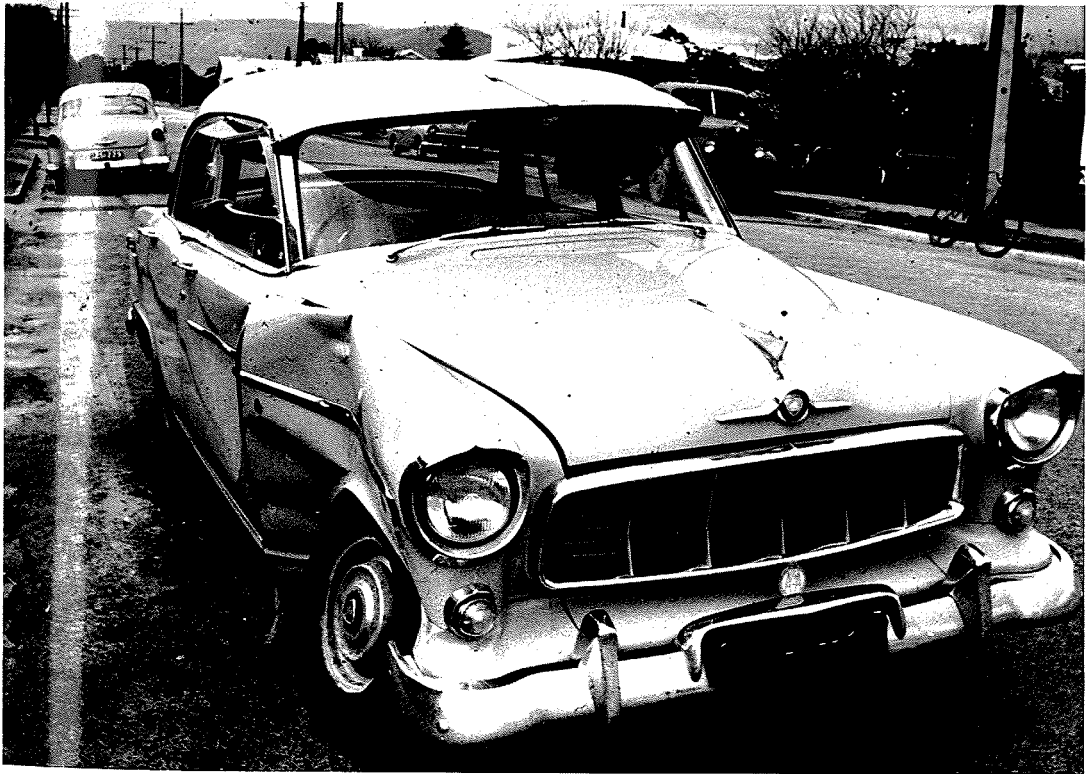
Fig. 3.11
Moderate overall damage.

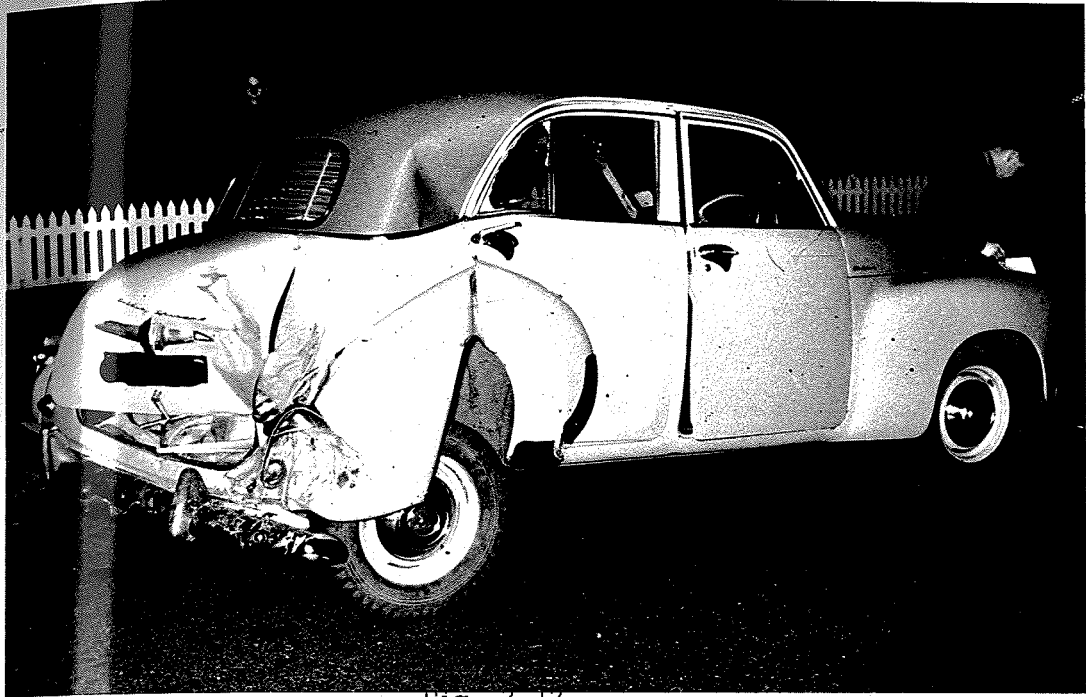
Fig. 3.12
Severe overall damage.

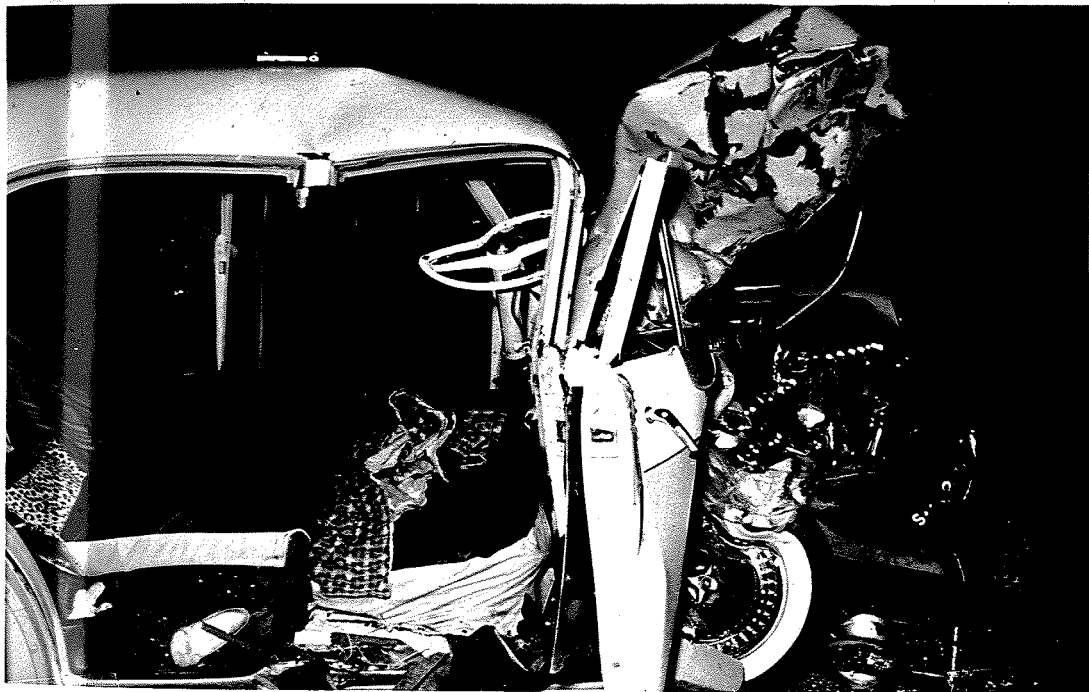
Fig. 3.13
Extremely severe overall damage.

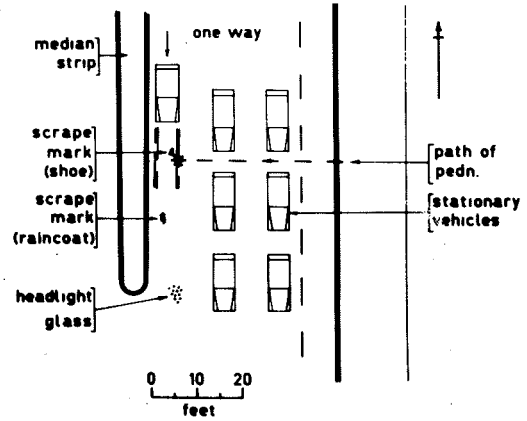
Fig. 4.8
Case 0317.

0317 A 33 year old female pedestrian ran between stationary cars in the two left traffic lanes and was struck by a 1958 Ford Zephyr travelling down the outside lane. The pedestrian suffered a fracture of the right side of the pelvis and a fracture of the mid-shaft of the right tibia. (Fig. 4.8.)

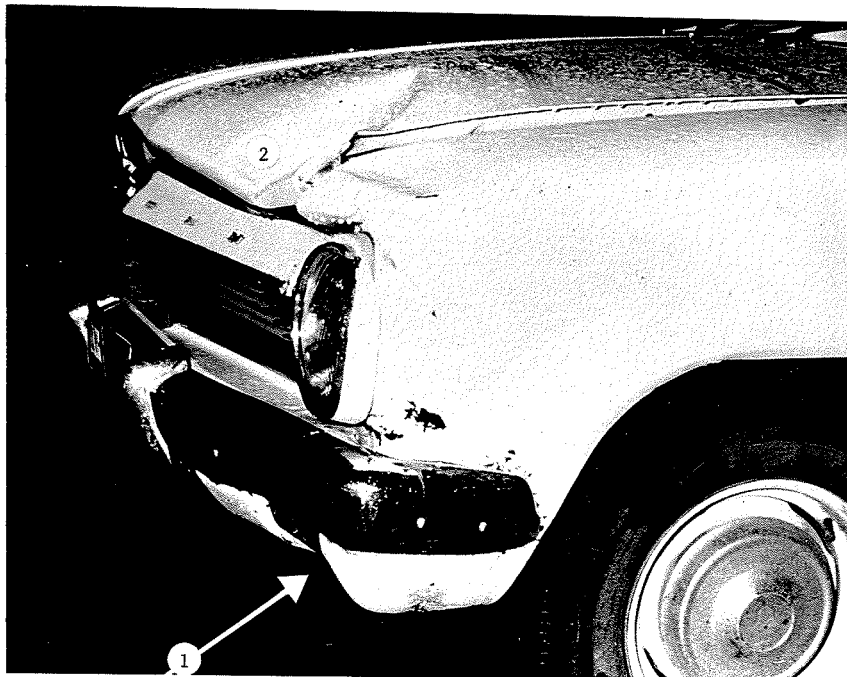
Fig. 4.18

Case 0105: Holden EJ versus pedestrian. Numbers show first and second impact points.

4.90 The sequence of events when a car strikes a pedestrian is as follows: (Assuming the pedestrian is an adult and standing with one side towards the car): (Figs. 4.16, 4.17) The initial impact is from the bumper bar which strikes the lower leg. The effects of this impact for a given vehicle speed depend partly on the amount of body weight this limb is supporting at impact, and partly on the limb's own inertia. Almost at the same instant, but slightly later, the leading edge of the bonnet (hood) of the car will strike the hip of the pedestrian. The pedestrian then rotates about this secondary impact point until his head and chest strike the bonnet, windscreen and/or the windscreen surround. The higher the impact speed the further back along the car this third impact point will be (Figs. 4.18 to 4.21).

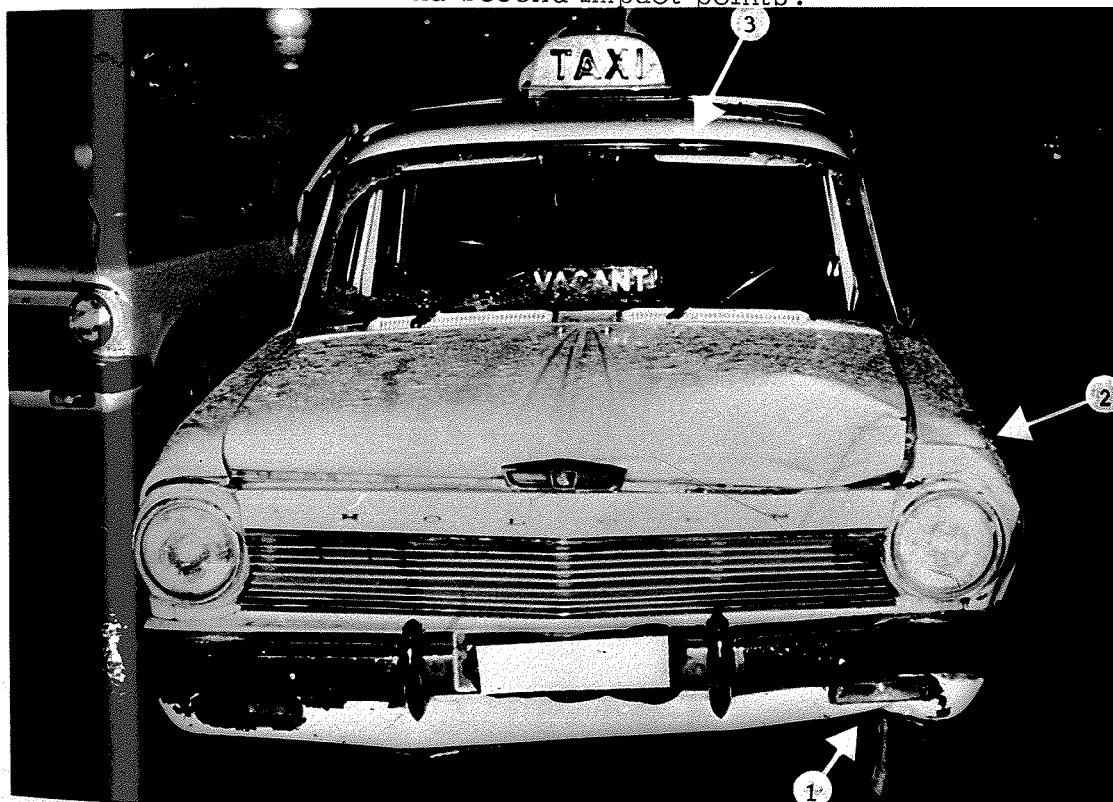
Fig. 4.19

Case 0105: Holden EJ versus pedestrian

2 (Second impact) dents in edge of bonnet and headlight.

3 (Third impact) broken windscreen, small dent in surround.

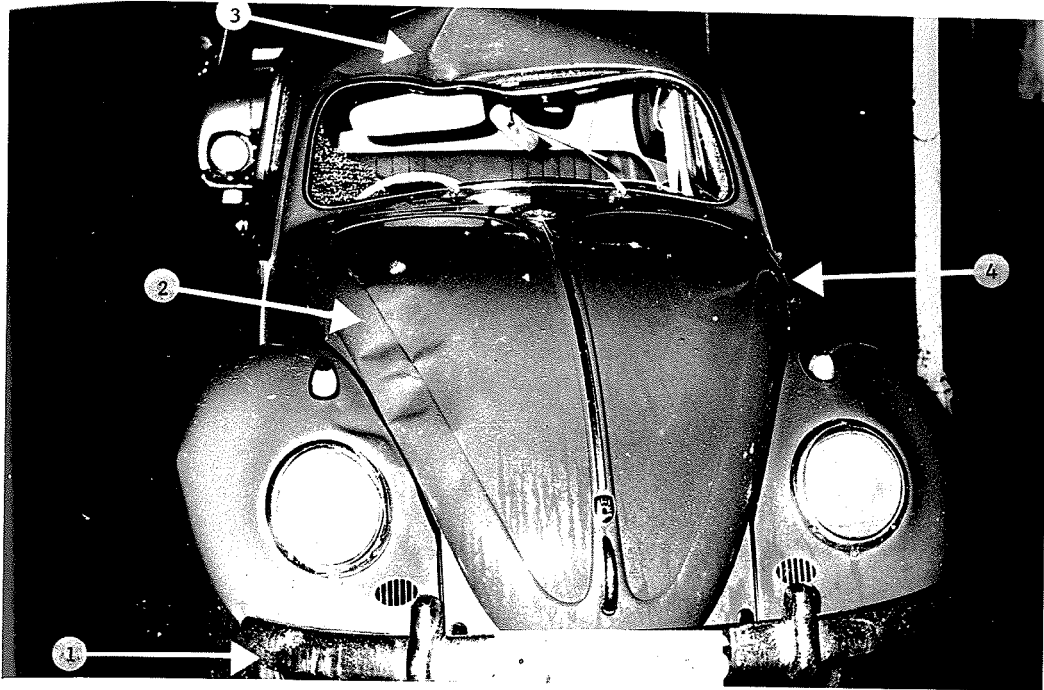
Fig. 4.20
Case 0414: Volkswagen versus pedestrian (See notes below).

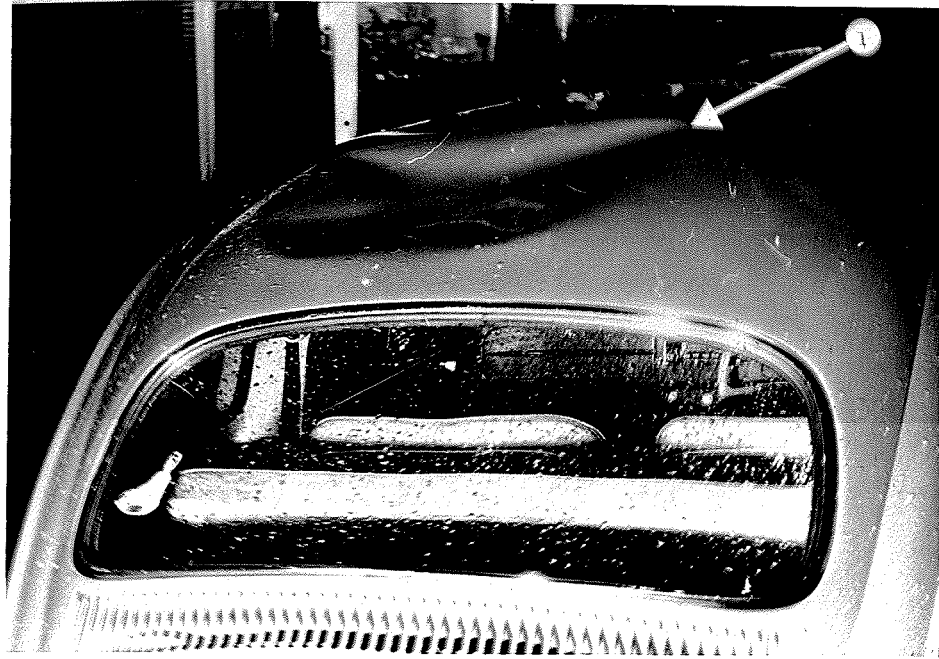
Fig. 4.22
Case 0414: Volkswagen versus pedestrian. Dent in rear of roof was probably produced by impact of pedestrian's legs (fourth impact point).

not slow down, the pedestrian, who is now travelling almost at the speed of the car, will fall to the road, either behind or on one side of the car (Fig. 4.22).

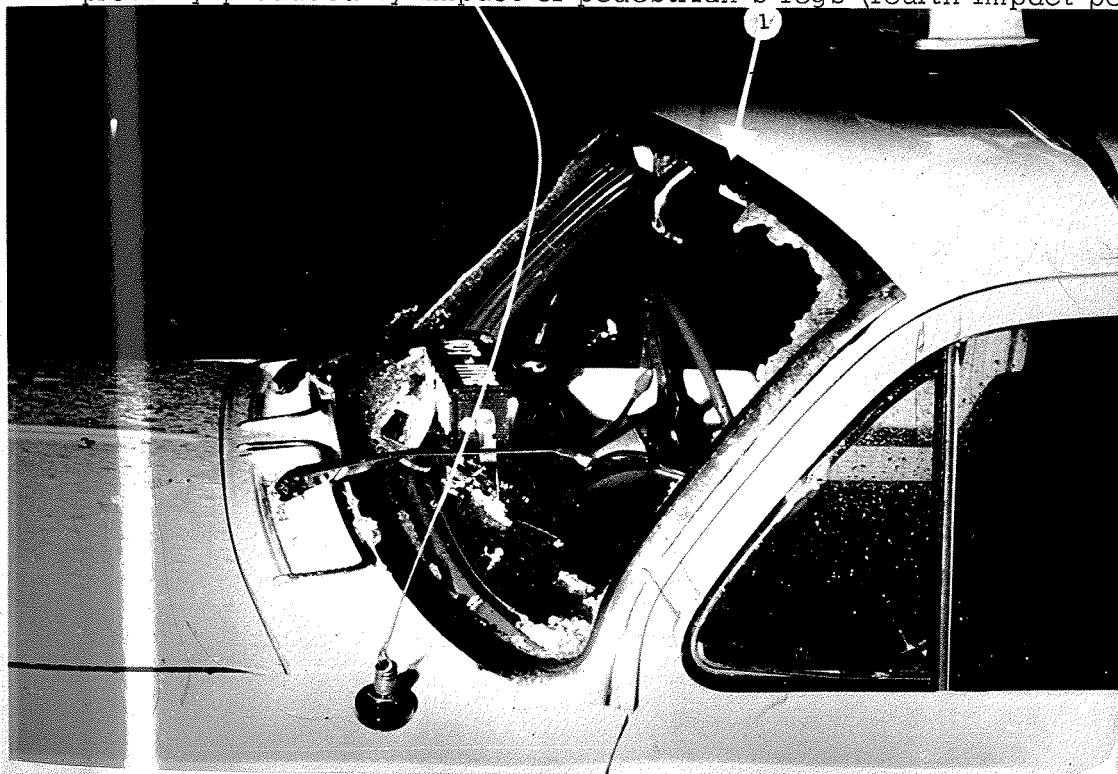
Fig. 4.23
Case 0105: Holden EJ versus pedestrian. Arrow shows third impact point.

4.94 This sequence of multiple impacts was worked out by observing characteristic marks on the car made by the pedestrian during his passage over it. There are dents, or brush marks in the dust on the bumper, headlight rims, and the edge of the bonnet. These often correspond with the injuries on the pedestrian's legs and hips. Dents, brush marks and scratches on the top of the bonnet indicate where the trunk and head hit. There may be grease marks from the head on the windscreen and surrounds; or if the windscreen is broken, there may be hair and skin on the jagged glass fragments retained in the frame. (Figs. 4.23; 4.29.)

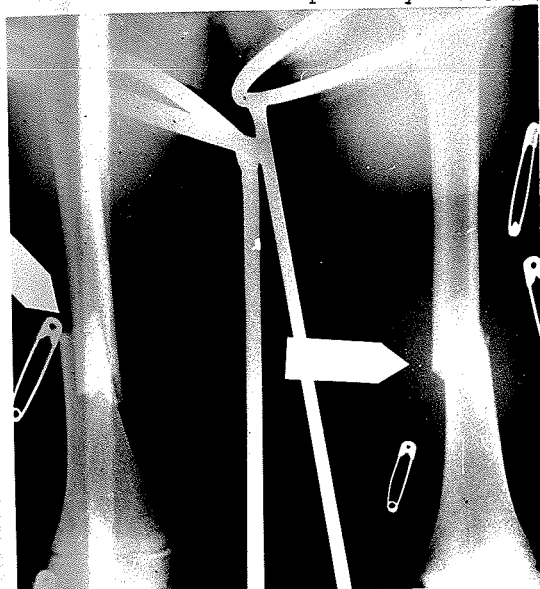
Fig. 4.27
Case 0131: X-ray showing fractures of both femurs.

a pedestrian. Figure 4.30 shows a 1962 Ford Falcon sedan which struck a nine year old boy at a speed of over forty miles per hour. The boy sustained fractures of both femurs. (Fig. 4.27.) The shape of the bumper bar was changed on later models of this car. (Figure 4.32.) The car shown in this figure struck an elderly man. The smaller radius of the leading edge of the bumper bar on this model very nearly severed the legs of the pedestrian (Figure 4.31).

4.109 The X-rays shown in Figures 4.27 and 4.28 show clearly the nature of the fractures to the legs of two pedestrians. It was found that it was possible to predict, from the known circumstances of the accident, the nature of these fractures to a fairly high degree of certainty. Similarly a careful study of such fractures affords a considerable amount of information regarding the direction of the impact. This can be extremely useful in

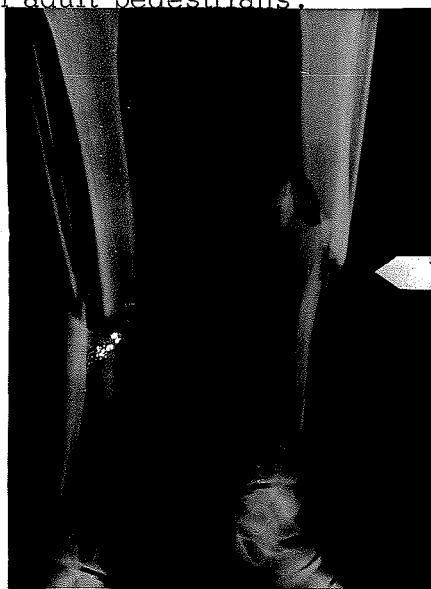
Fig. 4.28
Case 0276: X-ray showing fractures of both tibiae.

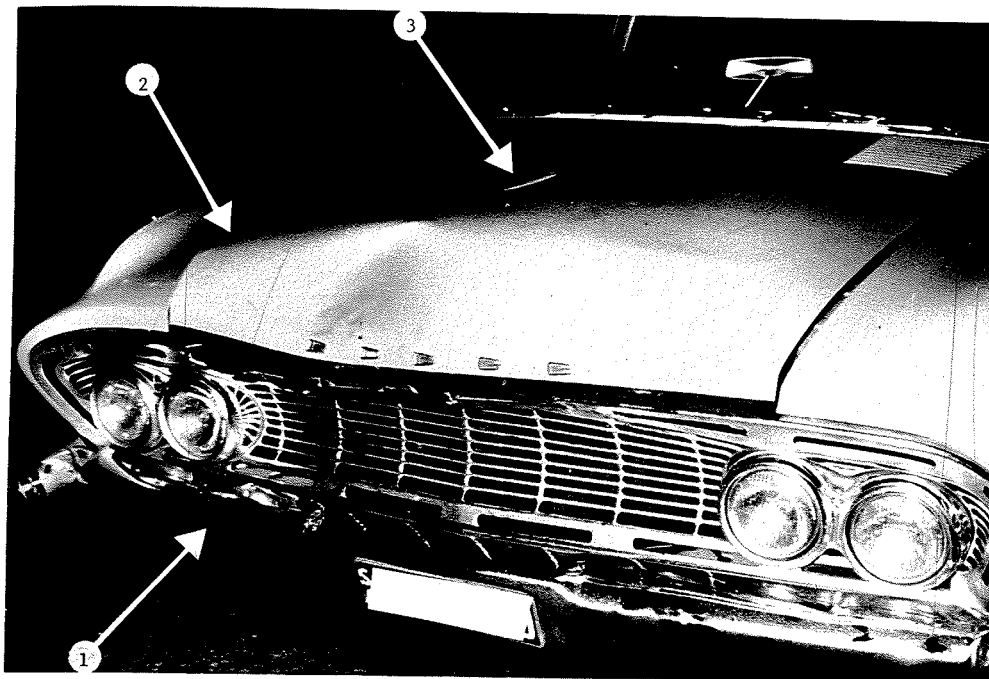
Fig. 4.29

Case 0316: Dodge versus pedestrian

3 (Third impact) dent in centre of bonnet produced by the impact of the

pedestrian's elbow.

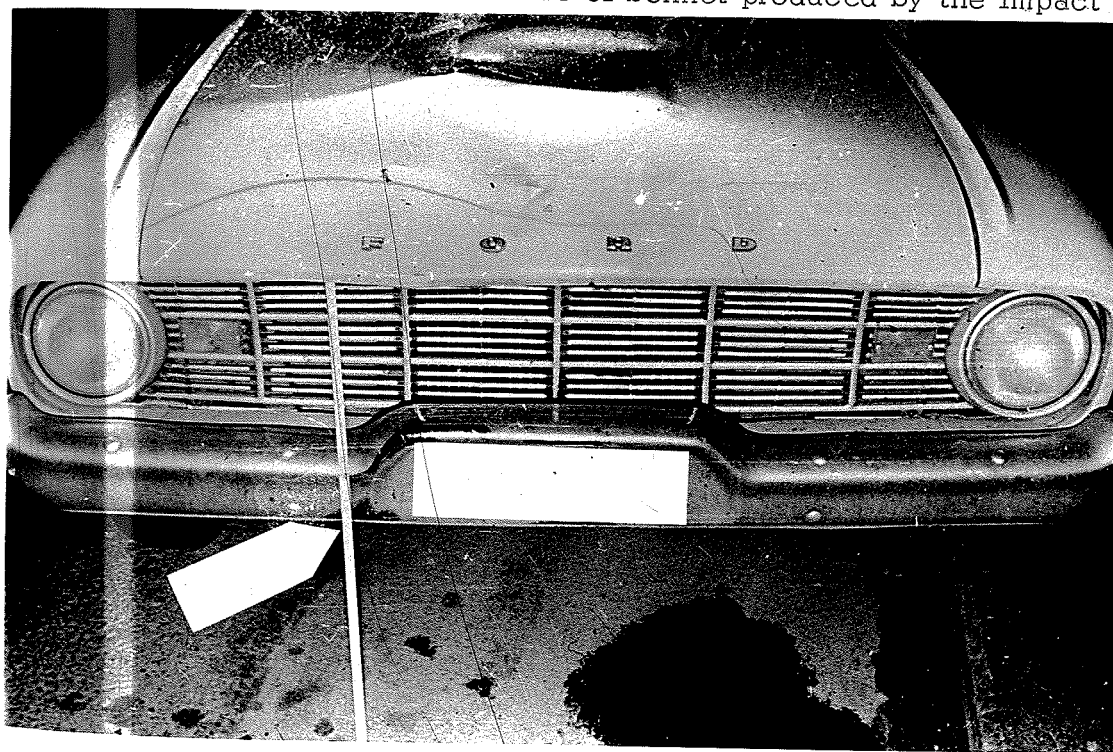
Fig. 4.30

Case 0131: Brush marks on bumper bar (arrow) from impact with pedestrian's legs. Dents in bonnet produced by pedestrian's head and trunk.

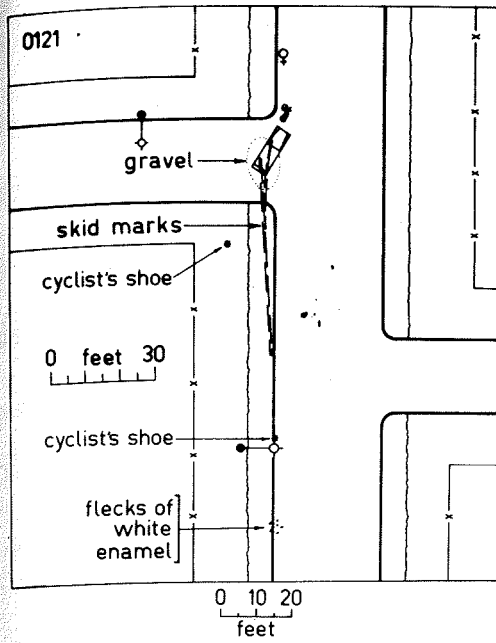
Fig. 5.4
Case 0121.

5.8 There were five accidents where the cyclist was struck from the rear while riding on the left side of the road, i.e. the driver did not see the cycle. Four of these occurred at night, e.g. case 0121 (Fig. 5.4).

0121 A 15 year old girl riding a bicycle was struck from behind by a Holden F.E. panel van. She was thrown up on to the bonnet of the car, striking the windscreen. Some threads of green wool from the cyclist's cardigan were found caught on the ends of some lengths of wood which were carried on the roof rack and projected forwards over the bonnet.

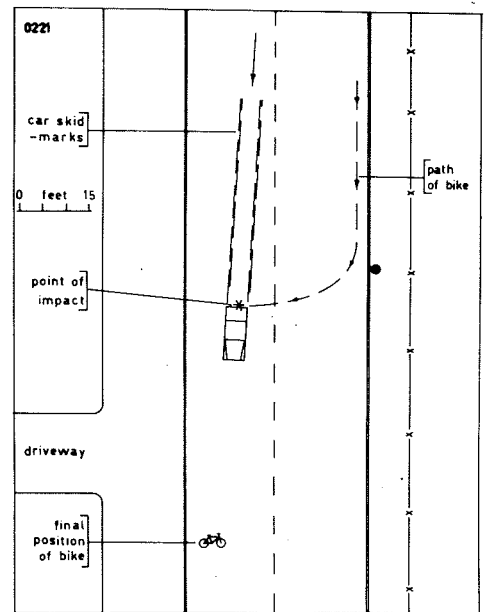
Fig. 5.5
Case 0221.

0221 A 13 year old boy cyclist turned right from the left hand kerb and crossed the path of a Morris Elite sedan which was travelling in the same direction. The driver of the car said that he was travelling at 30 - 35 m.p.h. when he saw the bicycle come from the left side of the road. He

swerved to the right and braked, but the bicycle kept turning in front of him. The car then struck the bicycle on the centre of the right side of the latter. The windscreen of the car was broken. The rider of the bicycle sustained concussion and abrasions and a small laceration to his chin.

The car skidded for 20 yards which, in this case, indicated a speed of more than 40 m.p.h. before the driver started braking (Fig. 5.5).

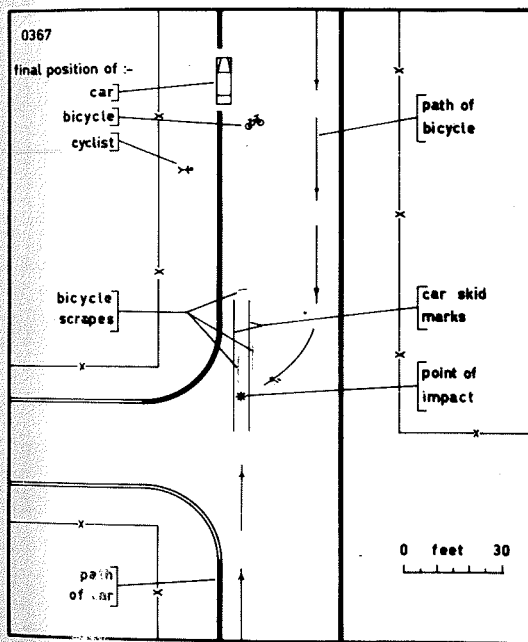
Fig. 5.6
Case 0367

- 0367 A 12 year old boy cyclist turned right from a main road into a side street. He was struck by a Holden EJ sedan which was travelling in the opposite direction along the main road. The Holden was being repaired and had most of the front grille and bumper bar removed. The speed at impact was between 30 and 40 m.p.h. The cyclist sustained a compound fracture of the left tibia caused by the impact from the front edge of the bonnet, separation of the pubic symphysis and sacro-iliac joints and a laceration of the anterior wall of his rectum. The cause of these injuries is obscure. He sustained concussion and abrasions to the left side of his face, possibly from striking and breaking the windscreen of the car. His legs swung upwards as his head hit the windscreen and he slid along the roof of the car and then fell to the ground, in soft mud at the roadside, as the car braked to a halt. (Figs. 5.6, 5.8, 5.9.)

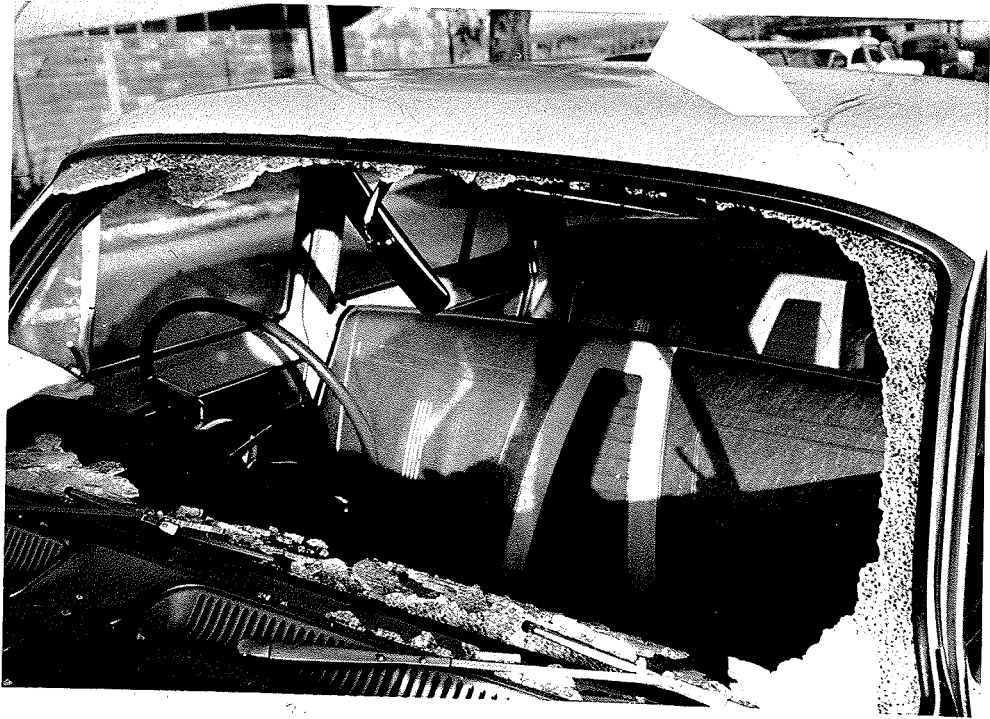
Fig. 5.8
Case 0367: blood smears on roof of car.

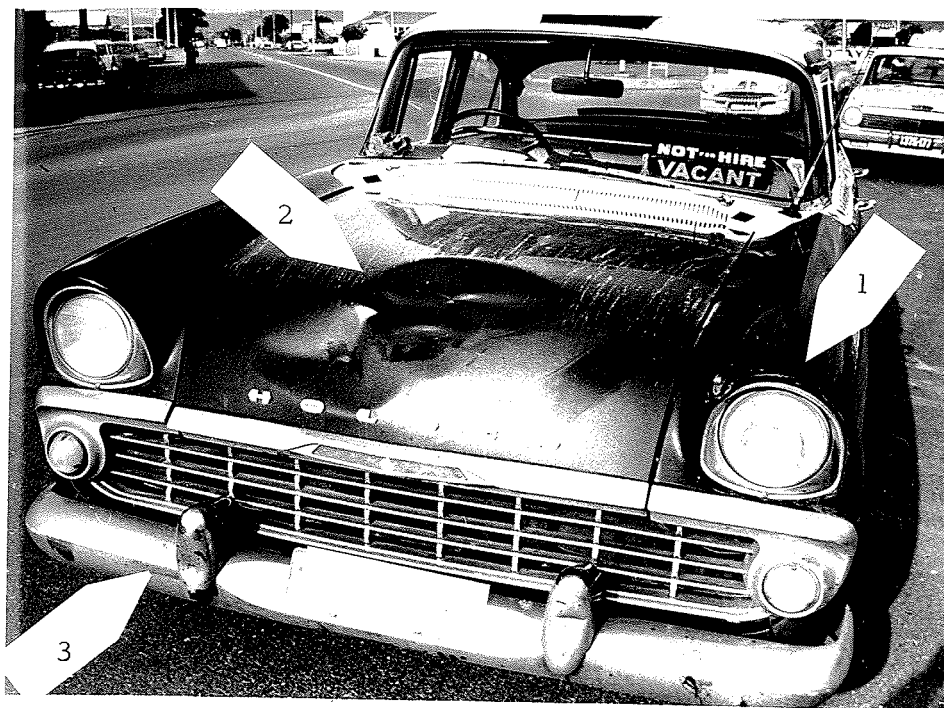
Fig. 5.10
Case 0160: impact of front of car with side of bicycle. Arrows indicate marks made by (1) handlebar on left headlight of car, (2) the seat of the bicycle and the rider's hip on the top of the bonnet, (3) the rear axle of the bicycle on the right bumper overrider.

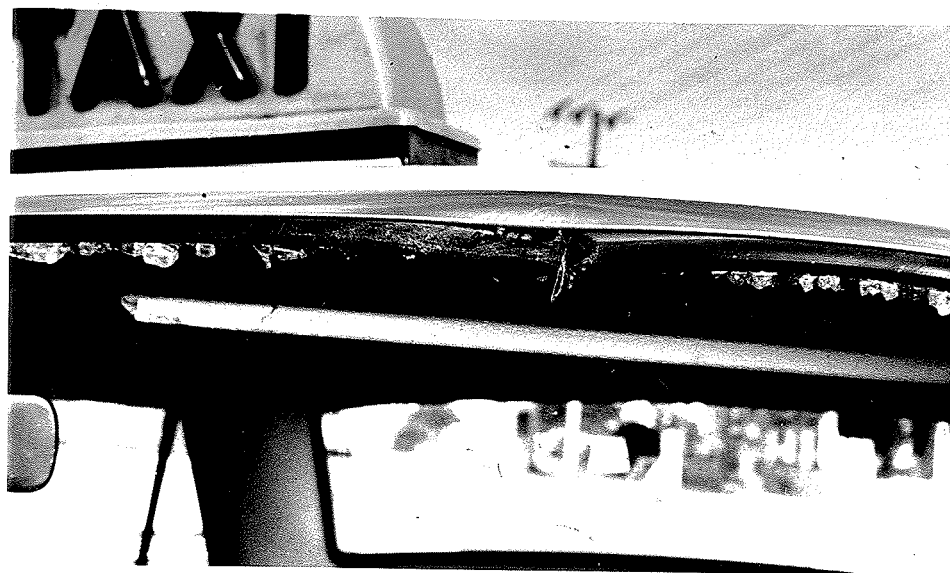
Fig. 5.11
Dent in roof of car made by bicyclist's head. Note hair stuck to chrome strip.

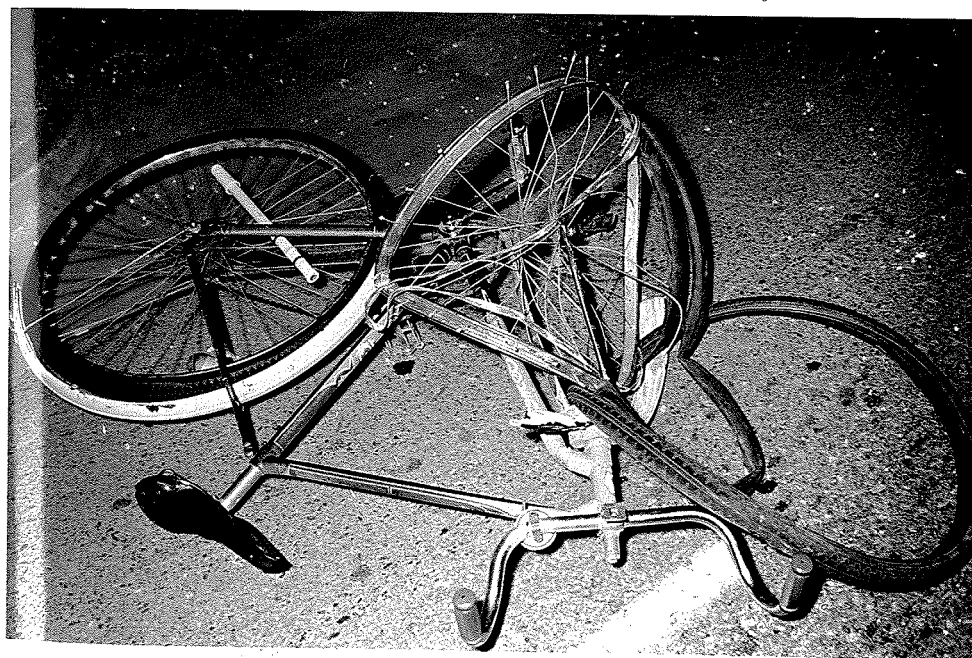
Fig. 5.13
Bicycle which collided with the car shown in Figure 5.12.

with the windscreen area (Figs. 5.12; 5.13). Because the cyclist usually travels at a much lower speed than that of the striking vehicle, the relative speed on impact is of the same order for both types of collisions.

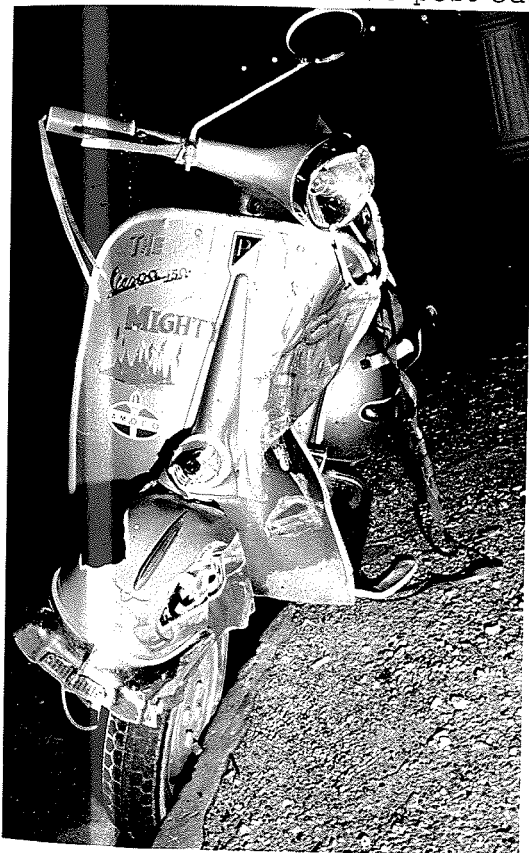
Fig. 6.8

Case 0087: motor-scooter struck car shown in Figure 6.7.

0087 This accident happened in the city just before dusk on a fine clear day. A youth on a motorscooter struck the left side of a car which had been coming towards him and had turned right, across his path, at a traffic-light-controlled intersection (Fig. 6.10). The scooter rider's head struck and shattered the glass of the left front door of the car (Figs. 6.7, 8, 9). The jagged edges of the glass remaining in the frame caused extensive lacerations of the left side of the base of his neck and left shoulder. The impact with the centre post fractured his lower jaw and left collar bone. A safety helmet protected his scalp from abrasions, but he was concussed. The elderly male driver of the car received only small lacerations from fragments of glass from the broken window.

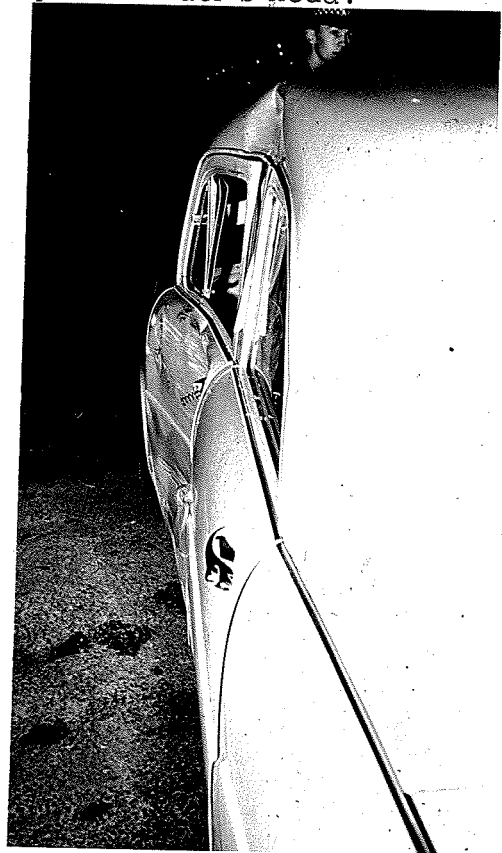
Fig. 6.9

Case 0087: deformation of car produced by the impact of motor-scooter and rider.

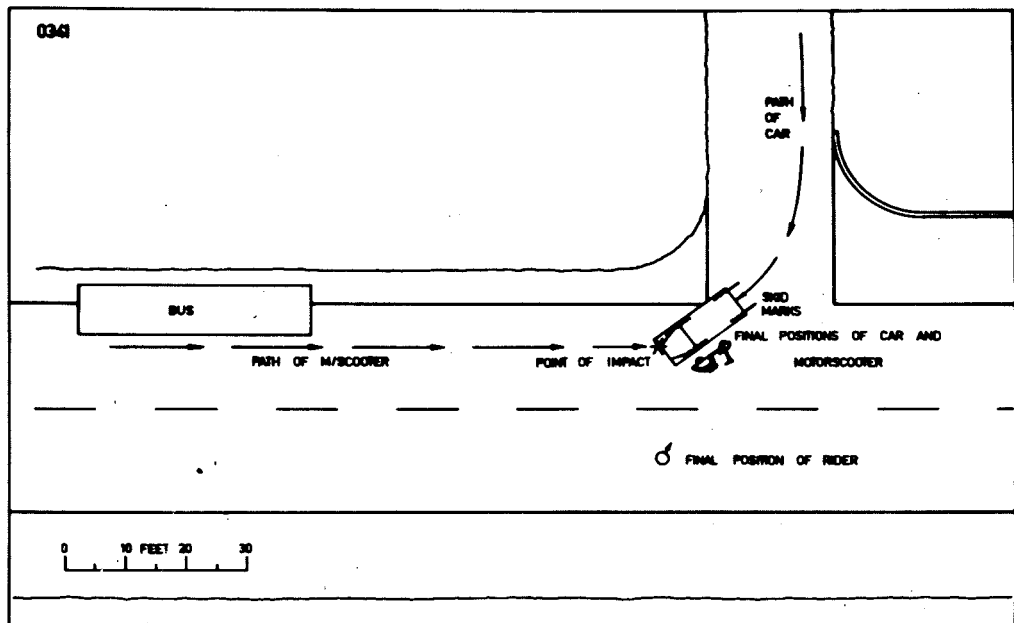
Fig. 6.11
Case 0341.

0341 The middle-aged male driver of a car proceeded with a right hand turn from a side street, despite the fact that his view to his right was obscured by a bus which was taking on passengers. A motorscooter suddenly came past the bus from his right and struck the right front corner of the car (Fig. 6.11). The rider of the scooter said he saw the car appear from behind the bus with the driver looking to his left. Although he tried to stop he was unable to avoid the collision with the car. He sustained a fracture of his left tibia. He was wearing a safety helmet.

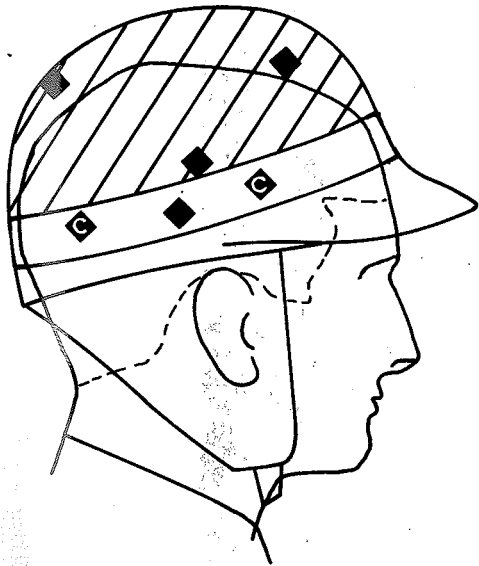
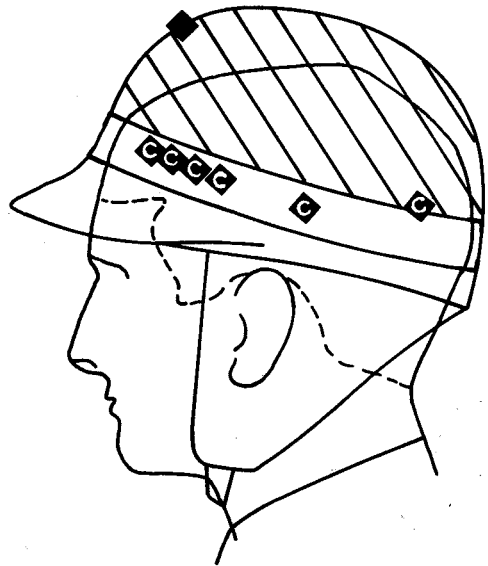
Cases in which a helmet was worn, showing the position of impacts in relation to the shell of the helmet and the protective padding. The cross-hatched area indicates the extent of the padding. 'C' indicates an impact causing concussion.

injury in each relevant case among these motorcyclists suggested two factors that are not adequately allowed for in the present Standard for safety helmets (Ref. 35). The points of impact in those cases in which helmets were worn are shown in Figures 6.15 and 6.16. Those impacts which caused concussion are marked with a 'C'. The energy-absorbing lining of a helmet made to the above Standard is shown by the cross-hatching.

6.55 It can be seen that very nearly all of the impacts which caused concussion were in fact located below the energy-absorbing lining. This obviously defeats one of the main purposes of these helmets, to absorb the energy of the impact before it reaches the brain. A more demanding Standard, that for racing motorcyclists' helmets (Ref. 36), does specify a more enveloping helmet covering the ears and lined throughout with energy-absorbing material. The second factor to appear is also related to the speed at impact. B.S. 2001 demands a test impact equivalent to that of a 10 lb. mass falling through a distance of 9 feet. The head weighs about 10 lbs. and so this test is roughly equivalent to a direct head impact resulting from a fall from a height of 9 feet, neglecting the weight of the remainder of the body. Most of the impacts shown in Figures 6.15 and 6.16 were at speeds greater than 20 m.p.h. But an impact at even 20 m.p.h. is equivalent to a 'free fall' impact from a height of 14 feet, far beyond the test height of 9 feet.

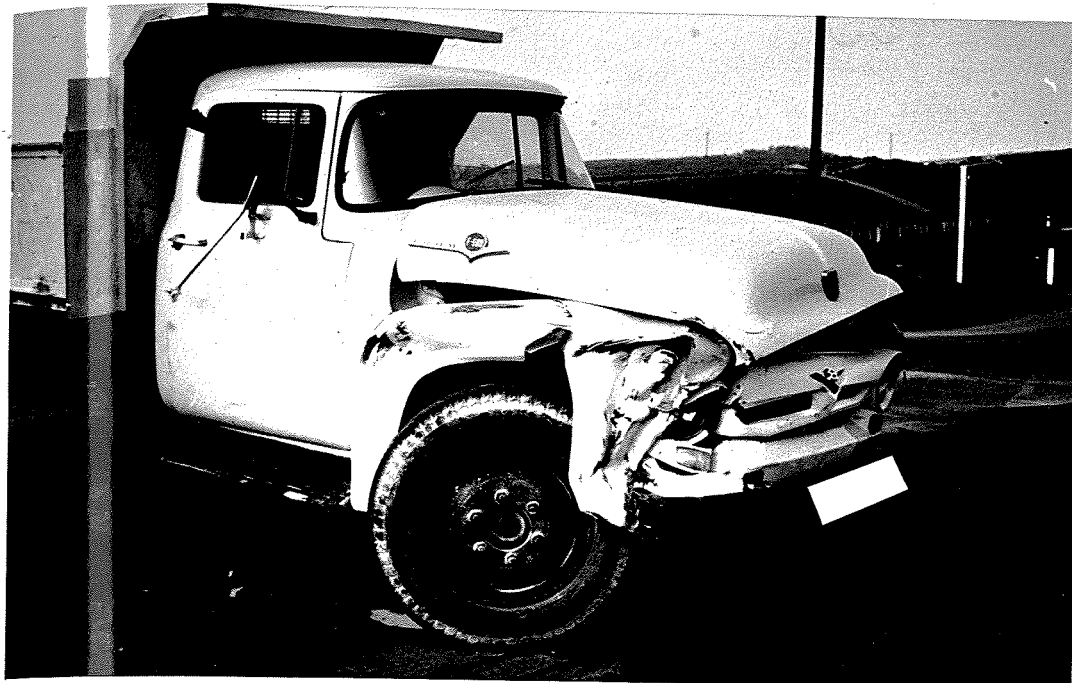
Fig. 7.8

Truck 1 (Fig. 7.5). The driver was ejected through the door shown.

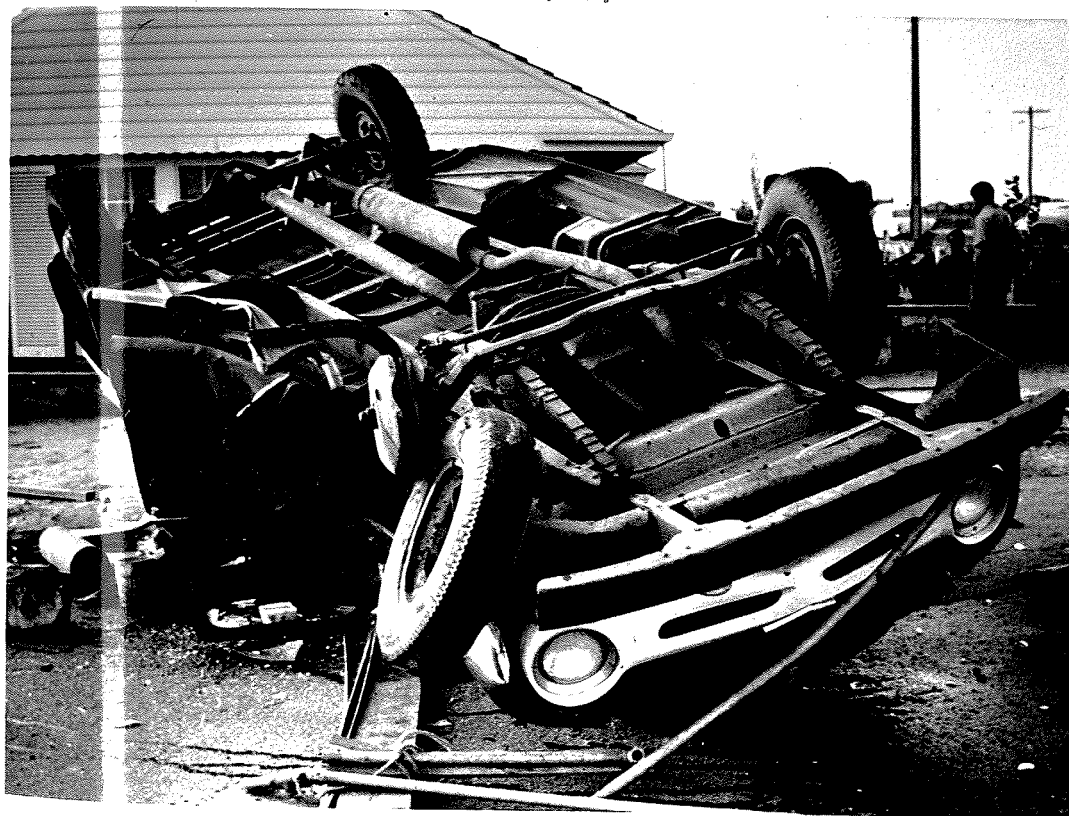
Fig. 7.9

Truck 2 (Fig. 7.5). Note that the rim of the left front wheel has separated from the centre of the wheel.

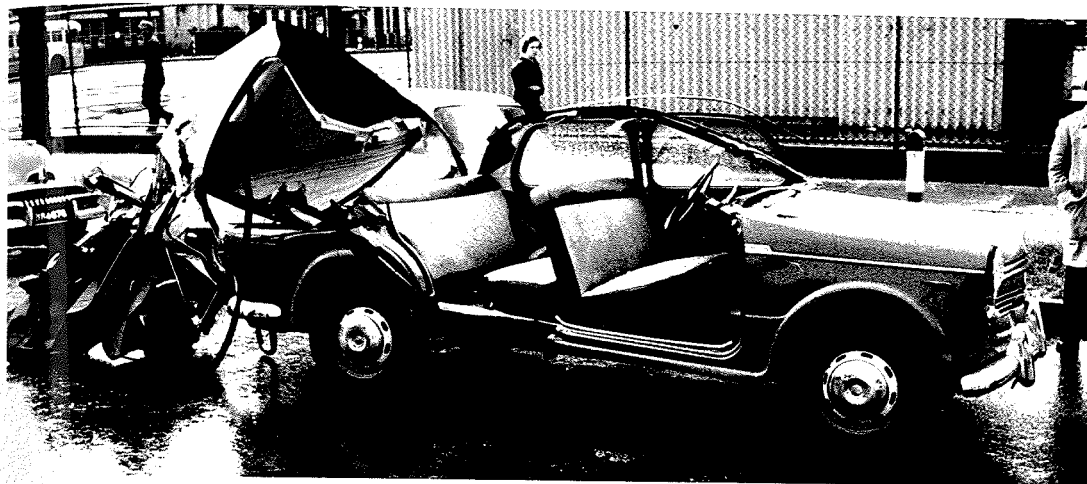
Fig. 7.10
This Fiat 1100 Sedan had its roof torn off when it ran under the overhanging tray of a truck.

him he had to brake suddenly to attempt to avoid a collision. He was unsuccessful (Fig. 7.10). The point of impact on the car was on the right side of the roof, which hit the overhanging tray of the truck (see also paragraph 7.15).

7.15 It would be desirable, with regard to such collisions, for trucks to be fitted with barriers below the tray at the rear and the sides. Such barriers, if designed to take the main force of any collision with another vehicle, would reduce the injury potential of this type of accident. A careful study comparing the cost of these modifications to an estimate of the value of possible benefits should be the first step in any further consideration of this suggestion. (See also paragraph 7.29 and Fig. 7.10.)

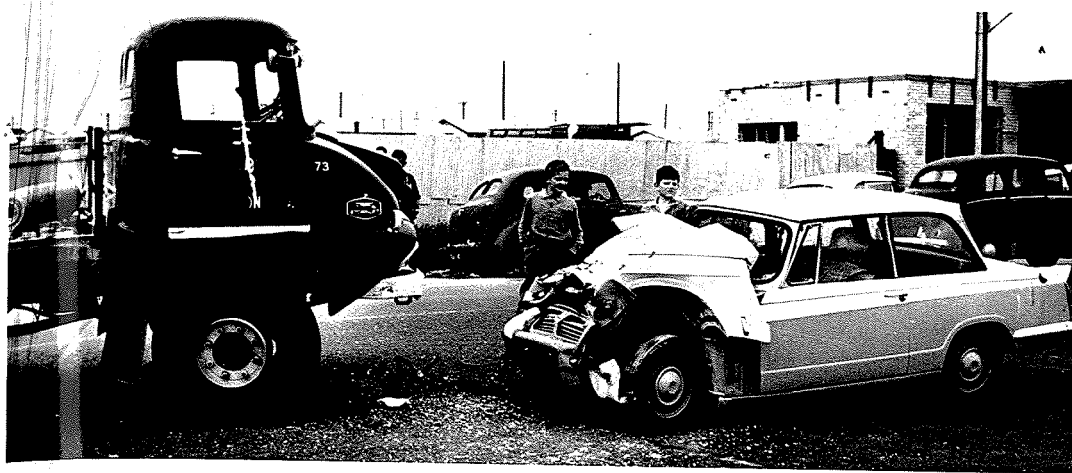
Fig. 7.12
The truck was turning across the path of the car. (It had been backed off the car when this photograph was taken.)

truck was turning to enter a private driveway (Fig. 7.12). The remaining case involved a heavy vehicle of considerable length turning right from the leg of a 'T' junction into a busier road. This truck was struck by a car which approached from his right. The average speed of cars along this particular stretch of road is high, around 40 to 45 m.p.h. It is possible that the truck driver did not make sufficient allowance for the high traffic speed at this location.

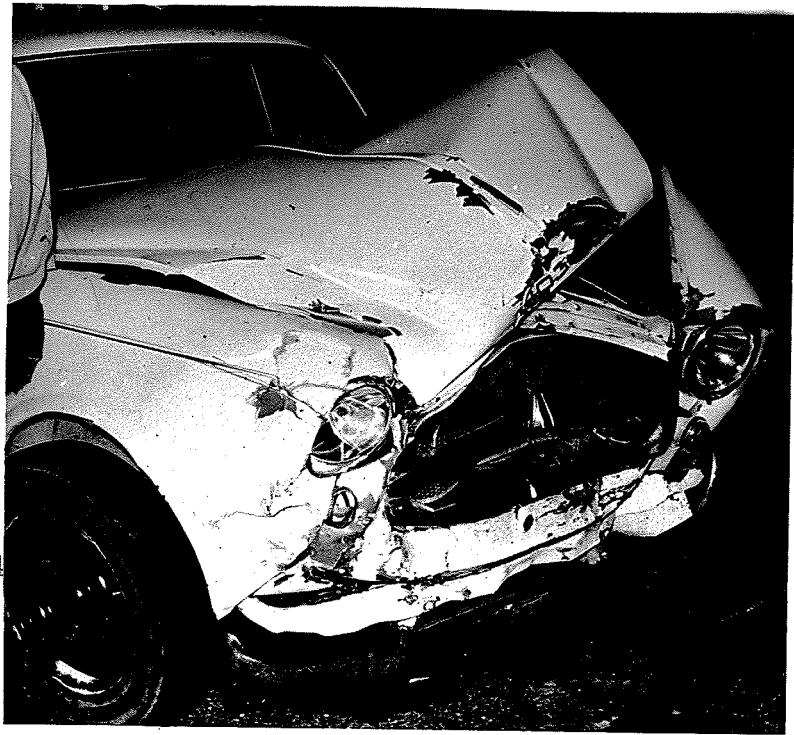
0244 The front of a Peugeot (Fig. 8.3) struck the left side of a Ford Zephyr (Fig. 8.4) at a traffic light controlled intersection. The Zephyr was spun anti-clockwise through 270° and came to rest against the front of a Simca which had just moved off with the green light. The first collision resulted in injury to the driver of the Peugeot and to a rear seat passenger of the Zephyr. The collision with the Simca caused almost no damage to the cars, and no injury to the occupants.

Fig. 8.4
1959 Ford Zephyr, struck by the Peugeot shown in Figure 8.3.
Note that the rear door has come open.

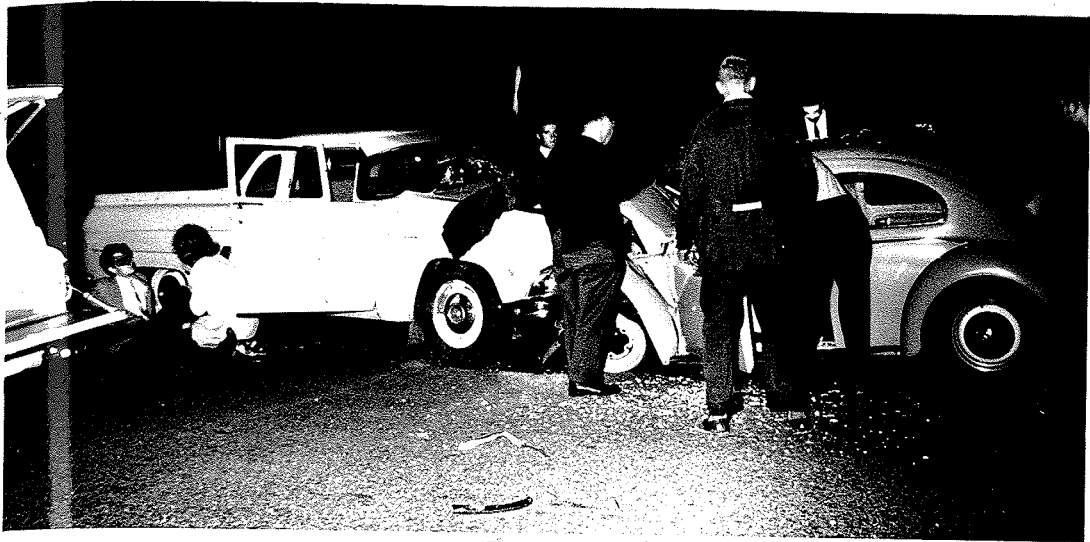
Fig. 8.5

0046 A Volkswagen saloon, while overtaking a Humber Super Snipe saloon, lightly struck the right rear corner of the Humber with the left front wheel. The Volkswagen then veered across to the opposite side of the road where it struck a Ford Mainline utility head-on (Fig. 8.5). The damage to the Volkswagen was more severe than the damage to the Ford (Fig. 8.6). The driver of

Case 0046: collision between a 1955 Ford Mainline Utility and a 1962 Volkswagen. The driver and passenger of the utility are on the road beside their vehicle. The driver of the Volkswagen is still inside his car.

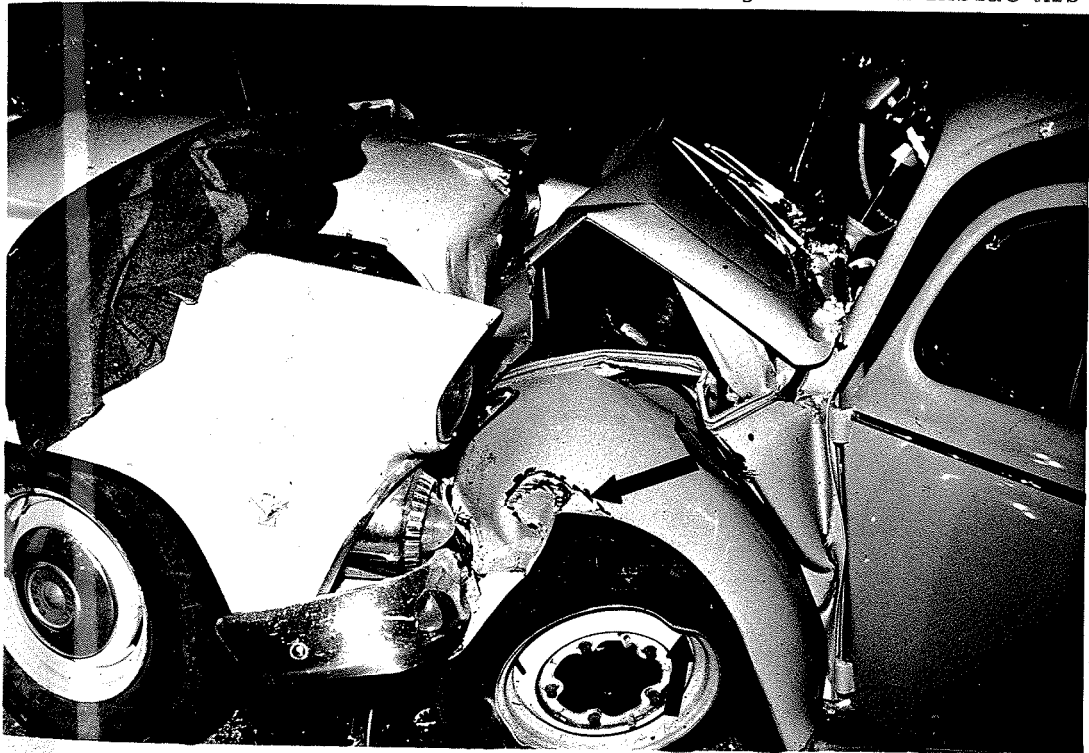
Fig. 8.6

Case 0046: arrows indicate the damage due to the initial collision between the Volkswagen and a Humber.
