ENGINEERING ASPECTS

TRAFFIC ACCIDENTS

ADELAIDE, SOUTH AUSTRALIA.

A thesis presented for the degree of Master of Engineering of
the University of Adelaide, based on work in the Traffic Accident
Research Unit of the Department of Pathology of the University
of Adelaide.

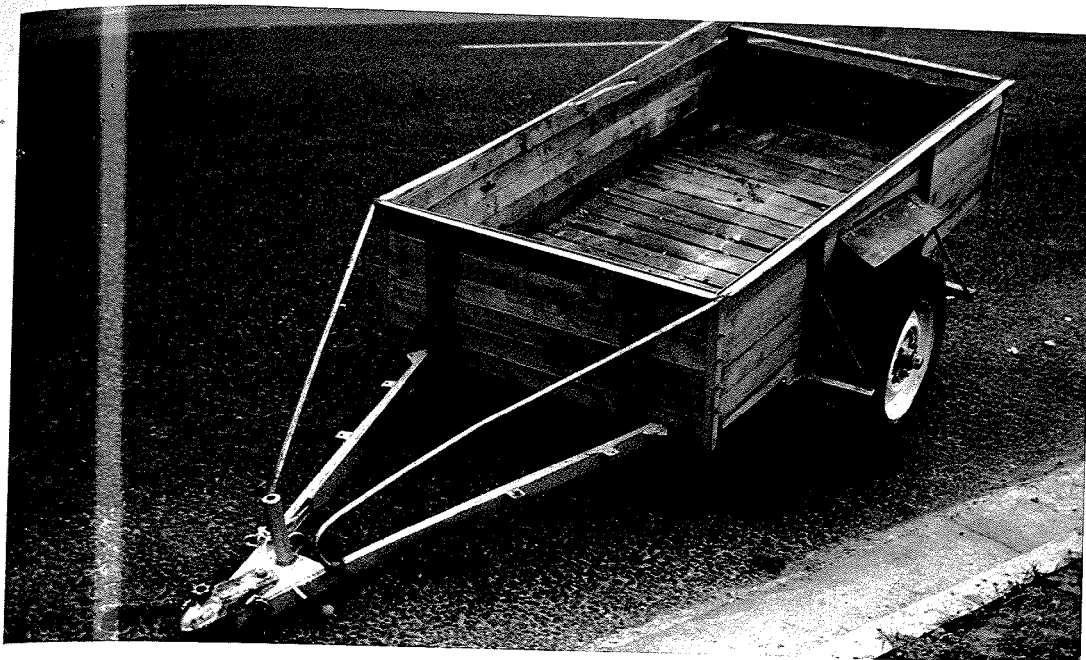
Fig. 8.11

This trailer broke loose and crashed into a parked car.

8.12 Forty-four of the 408 accidents in this survey were essentially single car accidents. Included in this group are 13 cases of cars running into parked vehicles, and two cases of trailers coming loose and hitting cars. The various types of accidents in this group are listed in paragraph 8.5. Some of these accidents had obvious and specific causes. In two cases the driver collapsed at the wheel and each of the cars swerved off the roadway and hit a tree. Two other cases appeared to have been deliberate attempts to crash a car; in each case the motive may have been to win the sympathy or attention of another party. One driver lost control of a Volkswagen 1200 when a small child pushed the back of the driver's seat forwards (Fig. 8.12). Another driver mistook first gear for reverse and, instead of backing out of an off-street parking area, bounced forwards over a low concrete kerb, crossed a roadway and crashed into the side of a parked car. Two drivers claimed that they were distracted, one by a hat falling to the floor, the other by a moth flying into his eye. They both drove into the rear of parked cars. Finally there were the two accidents mentioned earlier which were caused by trailers breaking loose from their towing vehicle and colliding with other cars.

each of these trailers points to the need for specifications for both the strength of such chains and the method of attaching them to both the trailer and the vehicle. It may also be desirable to make it an offence to tow a trailer which is not fitted with chains which meet such a specification. The condition of such chain is important. Thus Fig. 8.13 shows the chain from a trailer (Fig. 8.11) in one of the accidents listed above. Notice that one link has been replaced with thin wire, and that the other links are almost worn through.

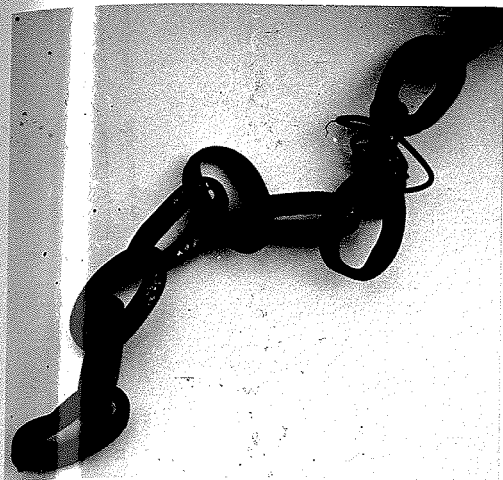
Fig. 8.13
Safety chain, from the trailer
shown in Figure 8.11.

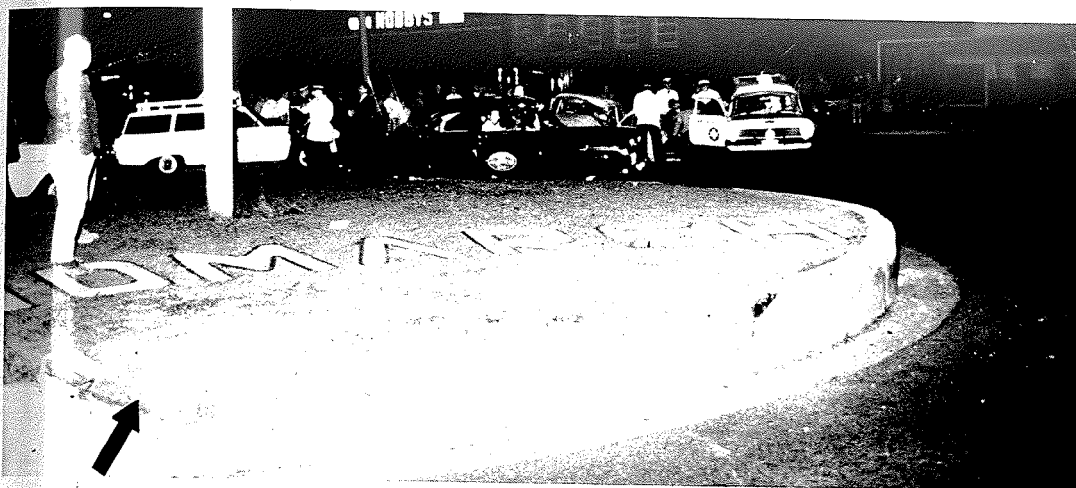
Fig. 8.14
Roundabout struck by the car shown
in Figure 8.15. Arrow shows point
and direction of impact.

8.18 The collision with a roundabout was a mysterious case. There was no indication of any attempt having been made to avoid a collision, such as skid marks due to braking, etc. The car struck the 18 inch high edge of the roundabout and rolled end over end. Once again the driver was concussed and unable to give any coherent explanation for the collision. A sloping rather than a vertical edge (Fig. 8.14) to the roundabout would certainly have reduced the damage to the vehicle and possibly the injuries to the driver. The existing vertical edging did not prevent the car from crashing onto the roadway on the far side of the roundabout, which is over 12 yards in diameter (Fig. 8.15).

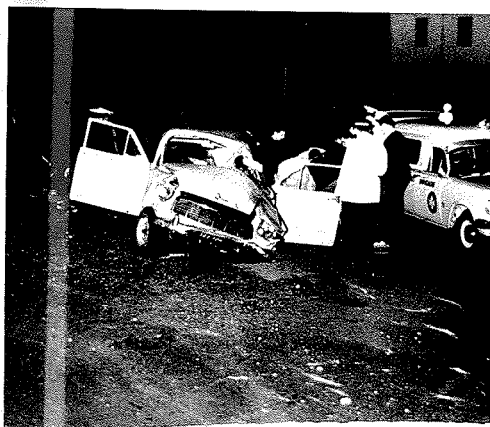
Fig. 8.15
1957 FE Holden after colliding with the
roundabout shown in Figure 8.14.

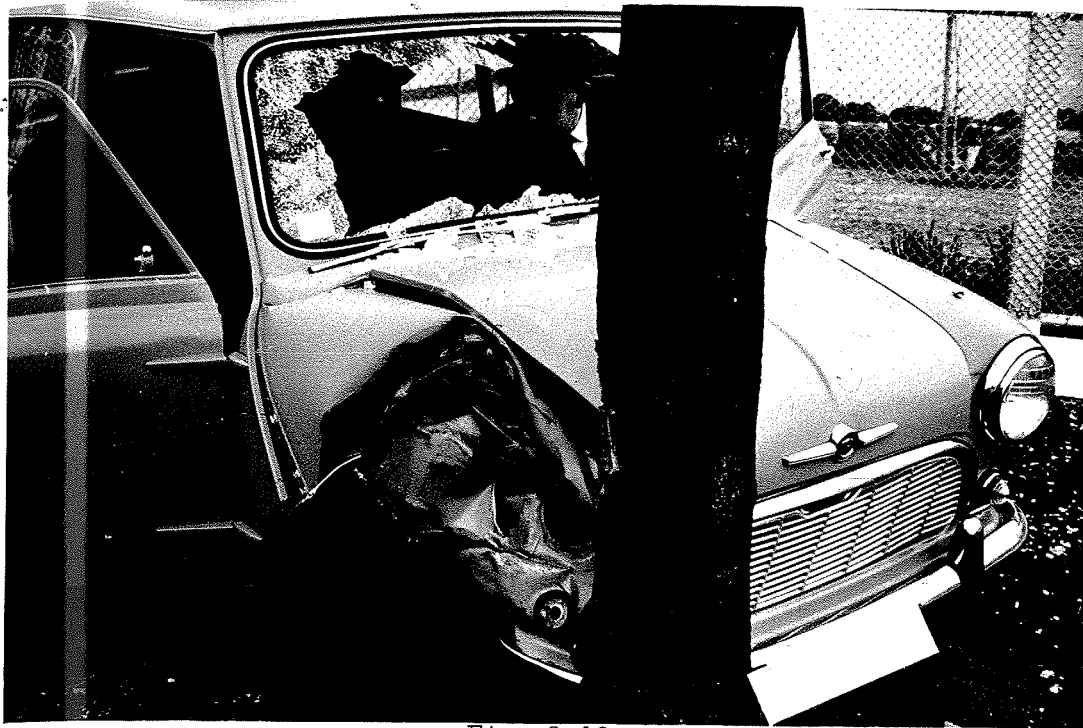
Fig. 8.16

The driver of the Morris 850 braked and swerved to the left to avoid hitting a dog. The car mounted the footpath and collided with this tree.

8.20 The collisions with trees call for little comment. Obviously if a car runs off the road it is likely that it may hit either a tree (Fig. 8.16) or a utility pole. If we were to choose further to denude our streets of trees, and to place all our power lines underground, the risk of this type of collision would be reduced, at the expense of damage to fences, etc. and possibly to pedestrians. A collision with a pole can result in severe damage to the vehicle and serious injuries to the occupants (Fig. 8.17). Utility poles can be modified to minimize the damage to a car which hits one (Ref. 36). One accident in this series, 0430, was partly due to an irregularity in the road alignment resulting in a line of utility poles being in the path of approaching traffic (Fig. 8.18). More effective street lighting and/or clearly visible markings on the poles may reduce the risk of collisions such as this one.

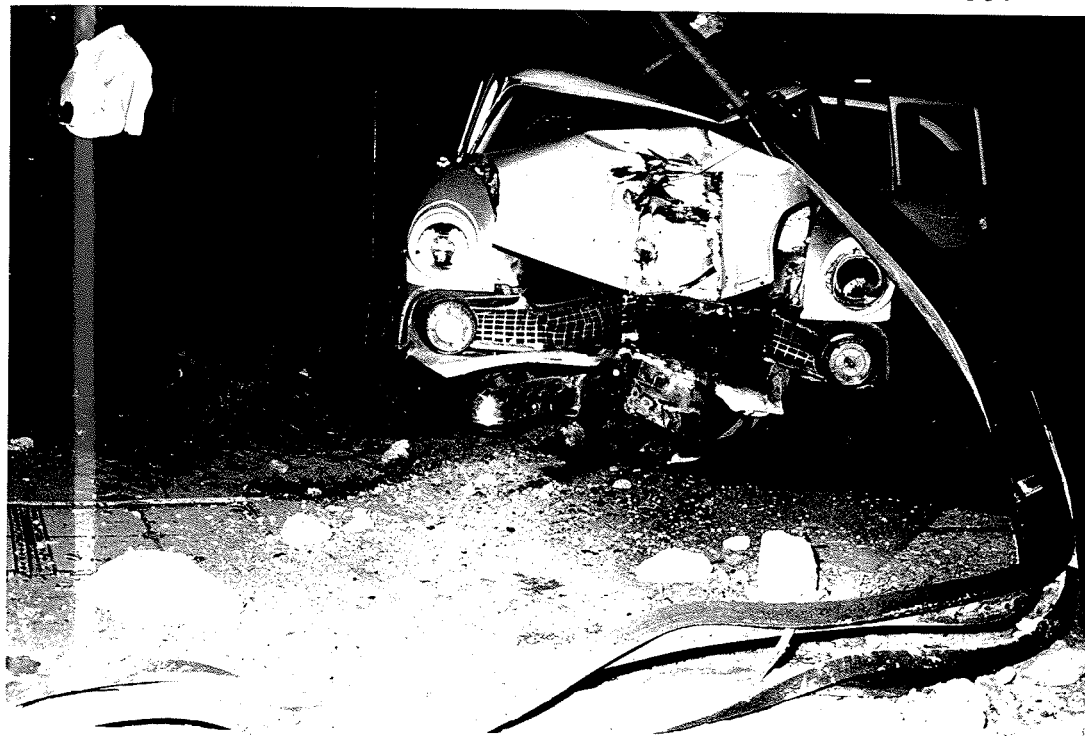
Fig. 8.17

1955 Ford Customline, after colliding with a steel and concrete utility pole. The base of the pole is in the bottom left corner. The car approached from the left.

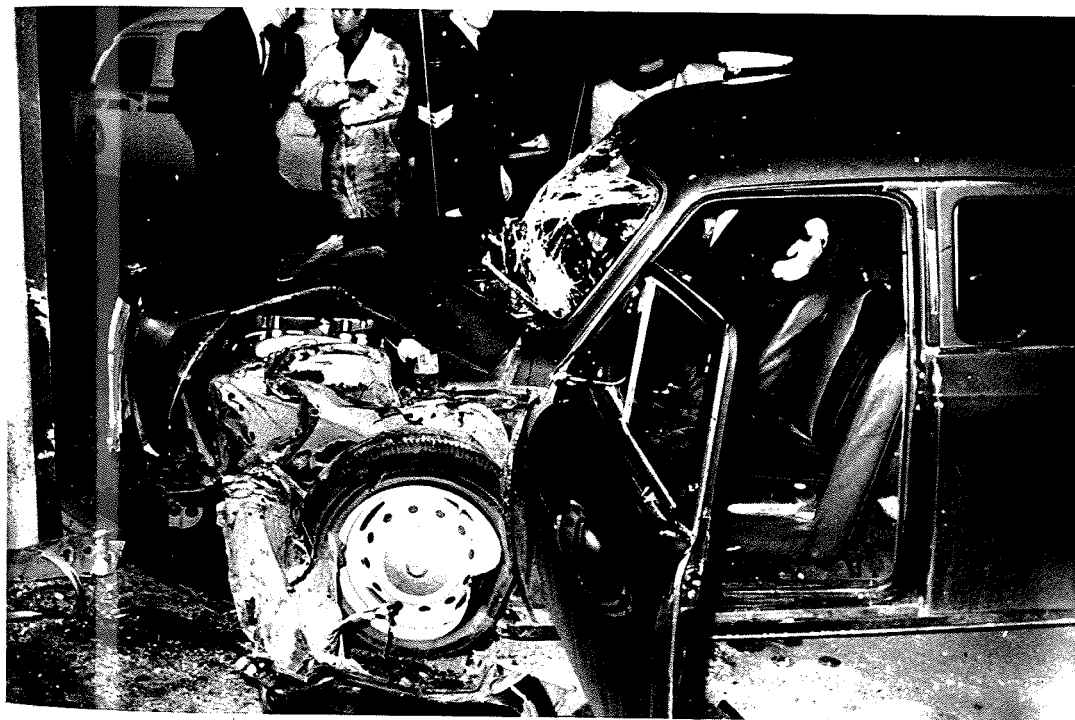
0430 An M.G. Magnette saloon struck a utility pole with the front left corner (Fig. 8.19). Both occupants were affected by alcohol. The driver, a male aged 19 years, sustained concussion, lacerations to the bridge of his nose from the windscreen, an abrasion over his sternum from the steering wheel, and a deep laceration over his right knee and bruising of his left knee (instrument panel). The left front seat passenger a male aged 26 years, sustained concussion and a deep laceration involving his left eyebrow and left forehead

Fig. 8.19
1954 M.G. Magnette, after colliding with a utility pole (see Fig. 8.18).

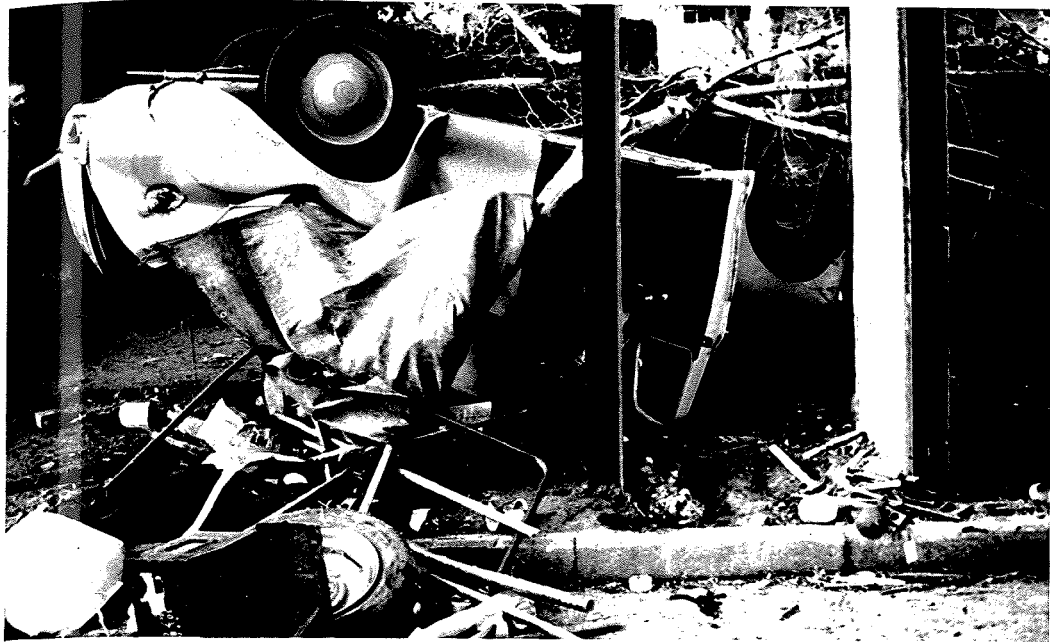
Fig. 8.20

A passenger in the back of this 1951 Austin A40 Utility was killed when it overturned and struck a tree.

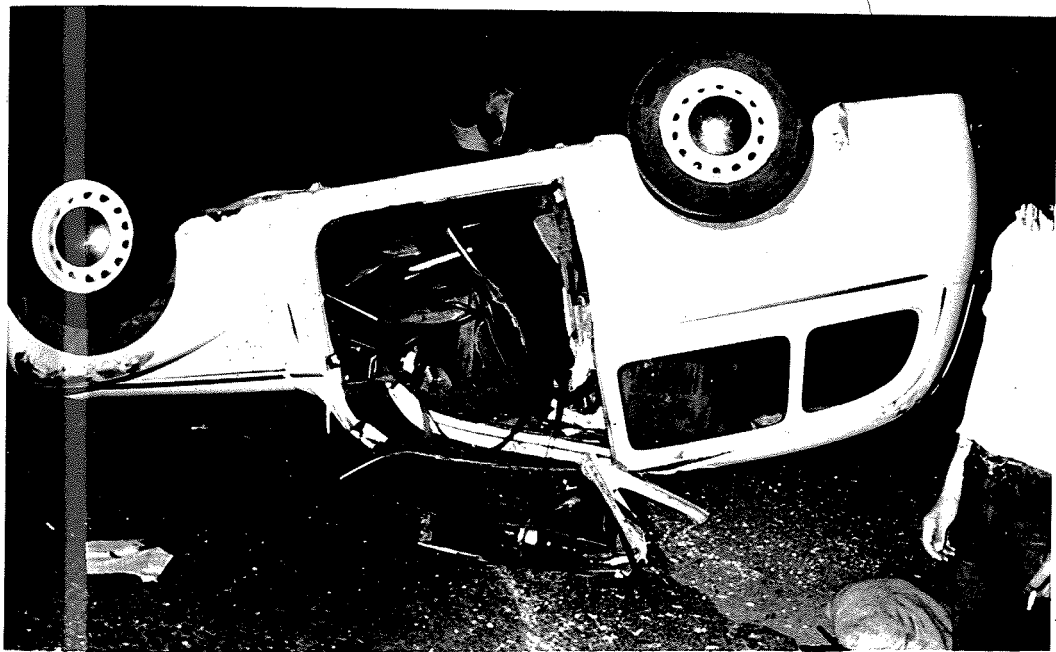
Fig. 8.21

This 1950 Skoda rolled over after swerving from one side to the other on a straight road.

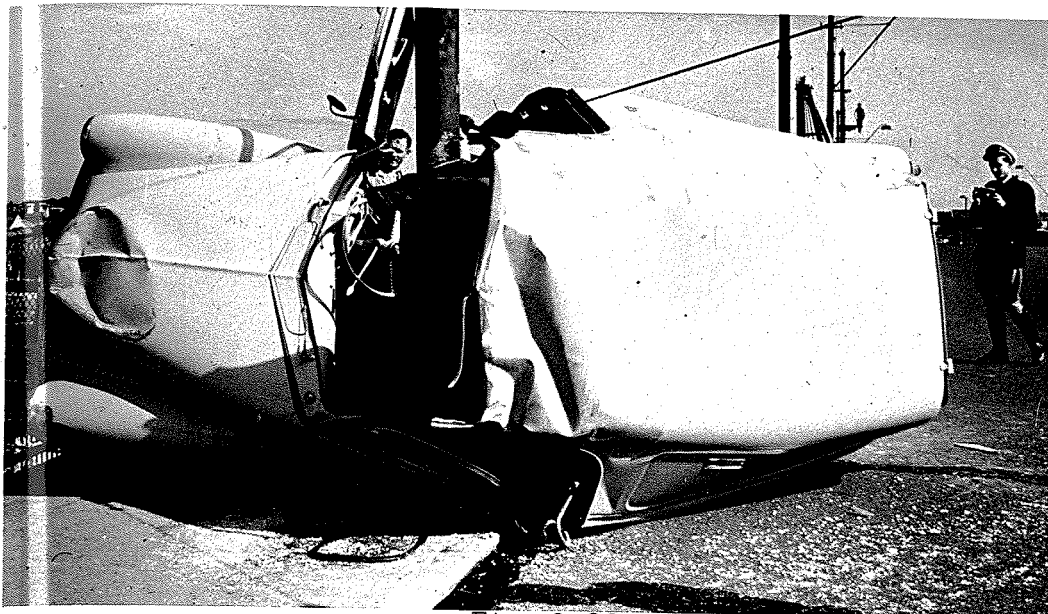
Fig. 8.22

This 1955 FJ Holden Panel Van rolled over and struck a steel utility pole. The front corner posts and the steering wheel were cut to extricate the driver from the damaged car.

0314 A 1955 FJ Holden panel van approached a bridge on a gradual left curve at a speed which may have been in the range 40 to 50 m.p.h. A slight bump in the road surface caused the vehicle to slew to the left. The driver was unable to bring the car back to the straight ahead position and it rolled over to the right. It continued to roll until it hit a steel utility pole with the underbody of the car (Fig. 8.22). The deformation of the car at this point was 24 in. (Fig. 8.23). The driver, an 18 year old girl, was trapped by the legs between the under-surface of the instrument panel and the bottom of the seat (Fig. 8.24). She was not released from the car until the front corner posts had been sawn through, the steering wheel cut away, and the dash and instrument panel forced apart using portable hydraulic jacks. She suffered concussion, a minor fracture of one vertebra of the neck, and bruises and abrasions to both thighs.

The right rear tyre had a pressure of 10 p.s.i. The left rear was 20, the right front 24 and the left front 25 p.s.i. The low pressure in the right rear tyre may have been one of the main factors which resulted in this vehicle's rolling over. This was a commercial vehicle and it seems that this was one accident in which neglected maintenance cost a firm a vehicle and also injured an employee.

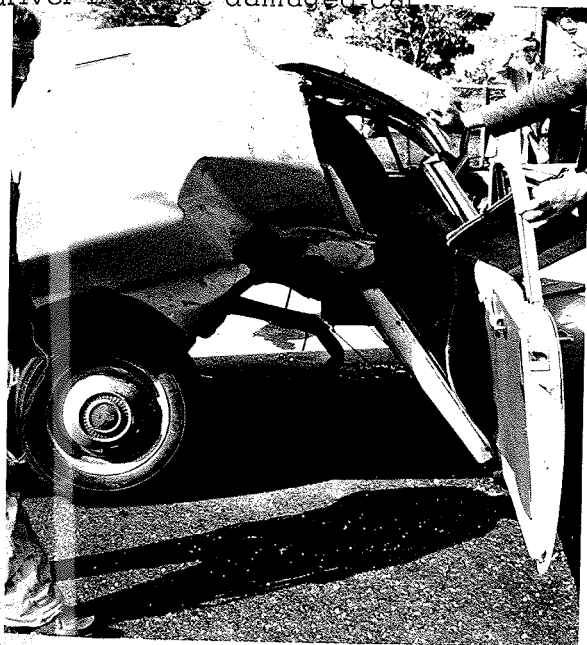
Fig. 8.23

The Holden Panel Van shown in Figure 22.

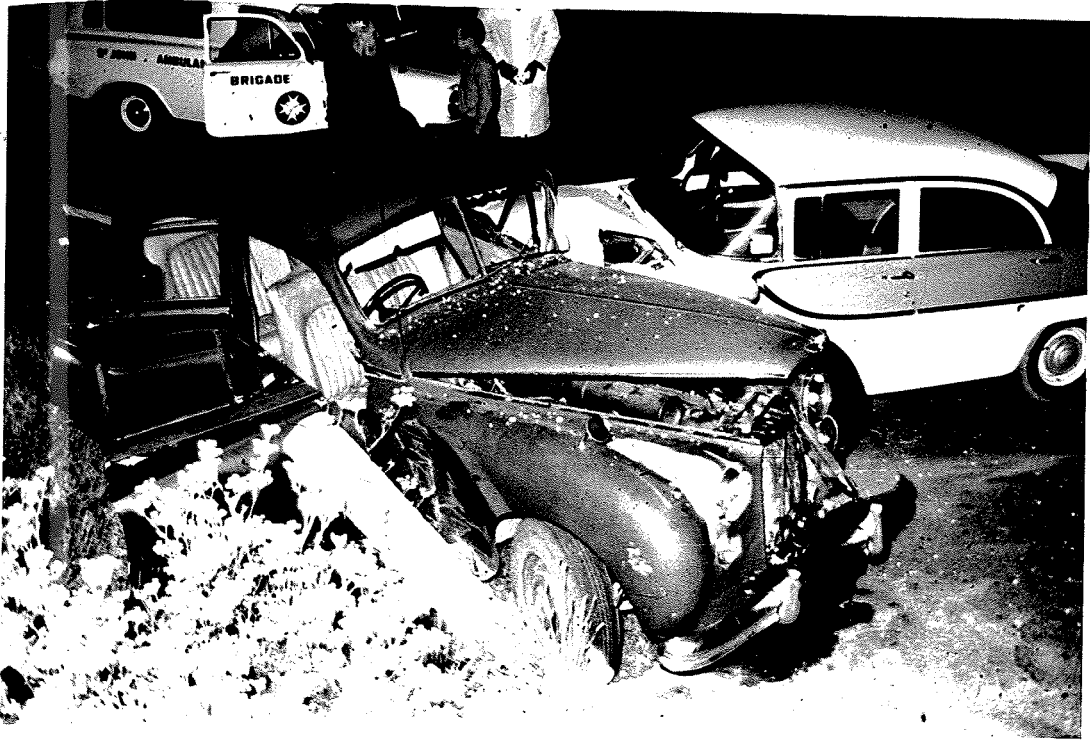
Fig. 8.25
Collision between a Jaguar and an FB Holden.

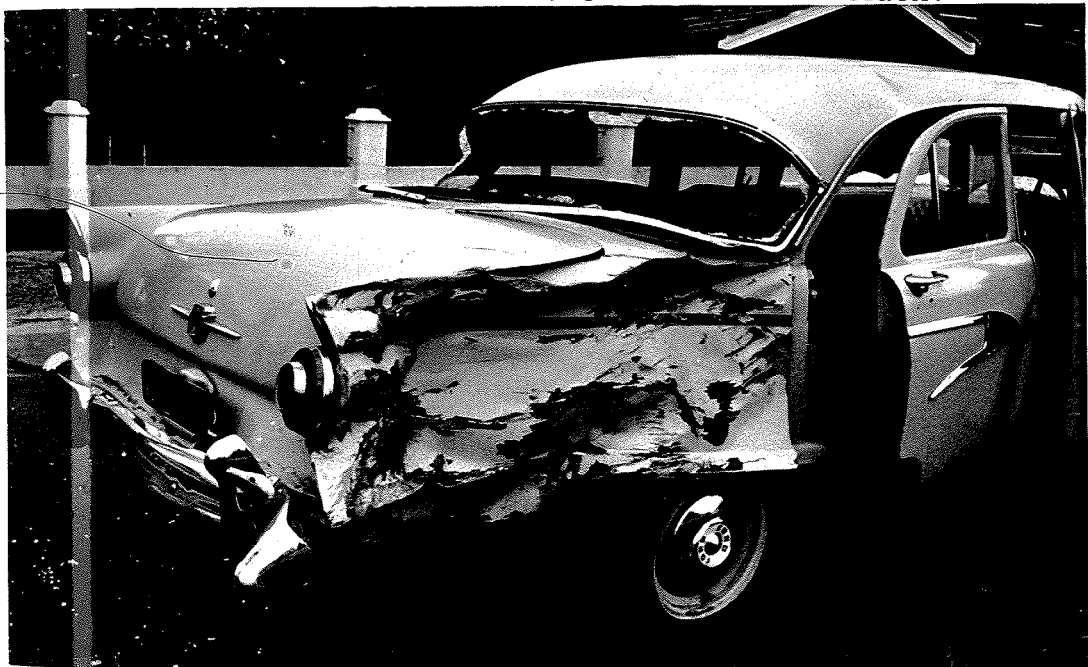
Fig. 8.26
The doors of this Ford Customline came open during the accident shown
in Figure 8.28.

The impact on the side of the Customline caused it to spin sideways and also sprung open the doors on the opposite side. This sequence then set the stage for the ejection of the occupants which took place when the car stopped spinning, as it struck the other car.

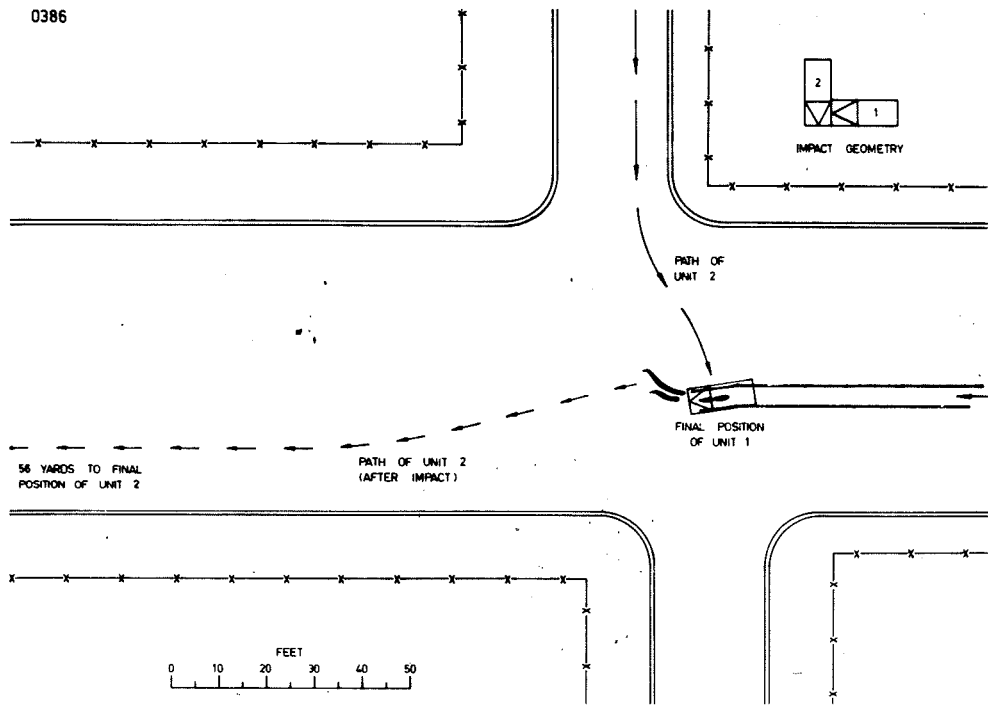
8.32 Accident 0386 (Fig. 8.27) is an example of a collision between two cars. It is significant that the driver of the Holden looked only in one

Fig. 8.27
Case 0386.

direction (right) before entering the intersection.

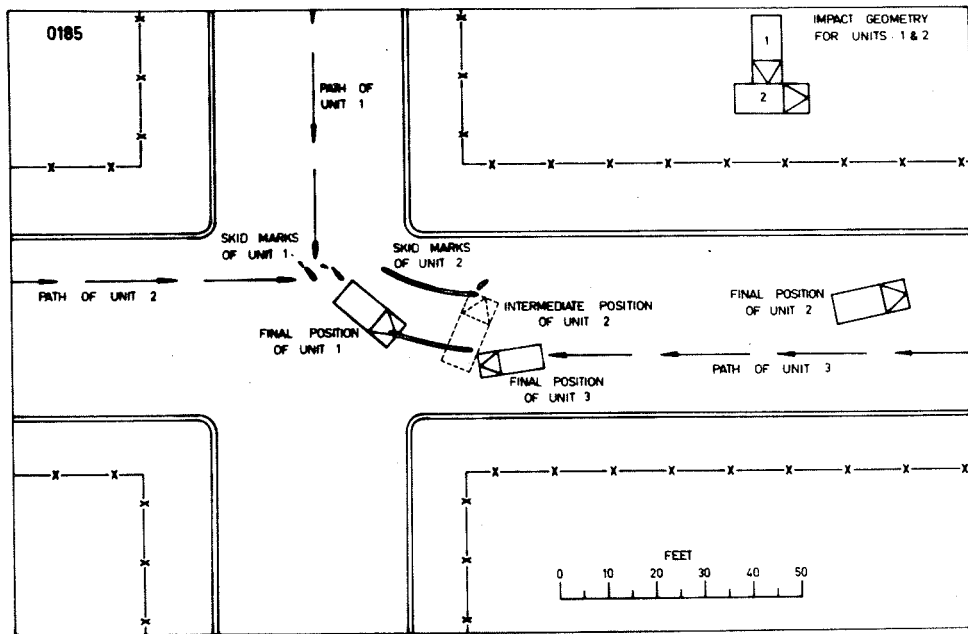
Fig. 8.28
Case 0185 (see also Fig. 8.26).

0185 At a right-angled intersection with a good sight distance a Ford Customline was struck on the centre of its left side by the front of a Standard Vanguard II. The Customline spun 90° anti-clockwise, and struck an Austin A40 which was approaching the intersection from the opposite direction. The original impact caused the right side doors of the Customline to come open and then the impact of the right rear corner with the Austin stopped the Customline's rotary motion, causing the two occupants to be ejected, one through the front door and one through the rear door (Fig. 8.26). The Customline then spun 90° clockwise, coming to rest facing its original direction. The driver of the Vanguard could not remember the impact or events immediately preceding the collision. He had a small abrasion on his right forehead. The driver of the Customline was concussed and had abrasions to his right shoulder, right buttocks, right hand and right knee, and his right forehead. He could not remember anything except the very start of the trip. The passenger of the Ford was seated in the centre of the rear seat. He sustained abrasions and small lacerations to the right side of his face, a fracture of his

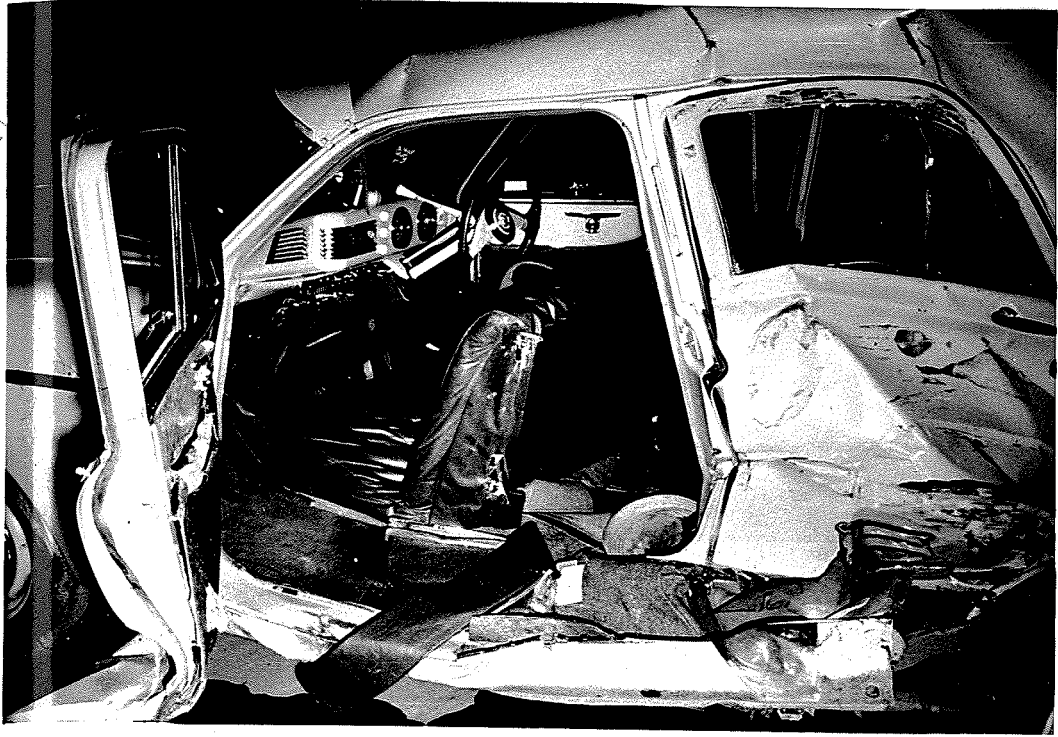
Fig. 8.34

Impact on the side of the passenger compartment of a 1954 Vauxhall Wyvern.

8.43 The sides and top of the passenger compartment are probably the most vulnerable parts of the structure of a car, as far as deformation of the passenger compartment is concerned (Fig. 8.34). The ends of the compartment are protected by the front and rear sections of the car,

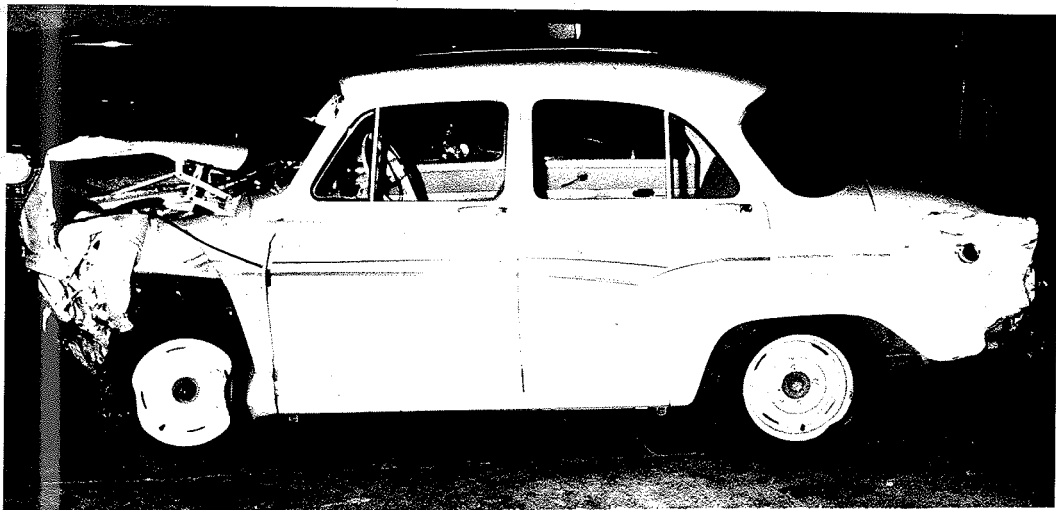
Fig. 8.35

The damage to the rear of this Simca was caused by the initial collision with another car. The frontal damage resulted from a subsequent collision with the side of a hotel.

0096 A 1961 Simca sedan had almost completed a right turn at a light-controlled five way intersection when it was struck on the left rear corner by a Vauxhall Velox sedan. The resulting damage from this impact was moderate to both cars. The Simca, however, was spun clockwise and crashed into the side of an hotel (Fig. 8.35). This subsequent impact resulted in severe damage to the car. The occupants sustained lacerations and abrasions.

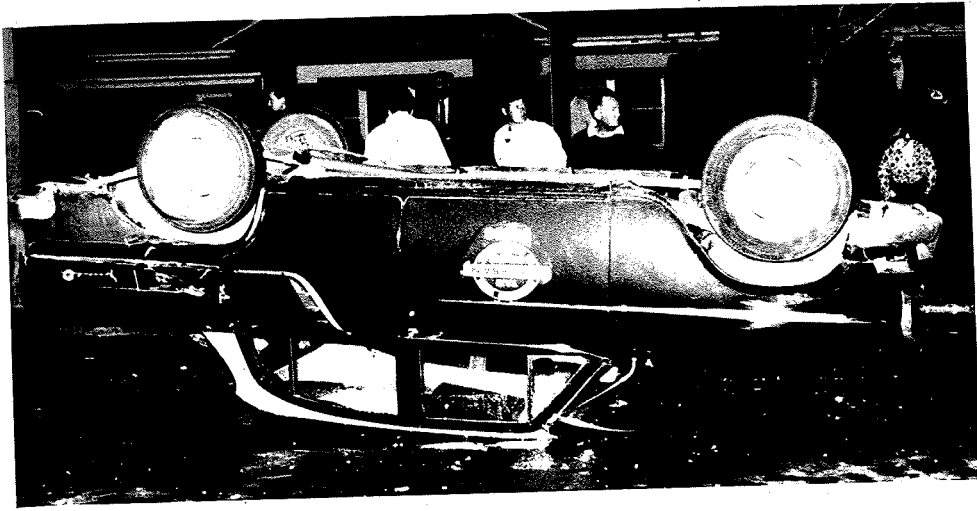
Fig. 8.36

This FC Holden taxi rolled over after being struck on the left side, behind the rear wheel, by the Holden shown in Figure 8.37.

0412 An FC Holden taxi (Fig. 8.36) was struck on the left rear corner by an EK Holden sedan (Fig. 8.37). Although the damage resulting to both cars from this impact was not great, the taxi was spun anticlockwise and rolled over (Fig. 8.38). It then struck a utility pole and spun round again to face in its original direction, but upside down. The driver and one rear seat passenger of the taxi suffered bruises. The other rear seat passenger was concussed. The two occupants of the other car were not injured.

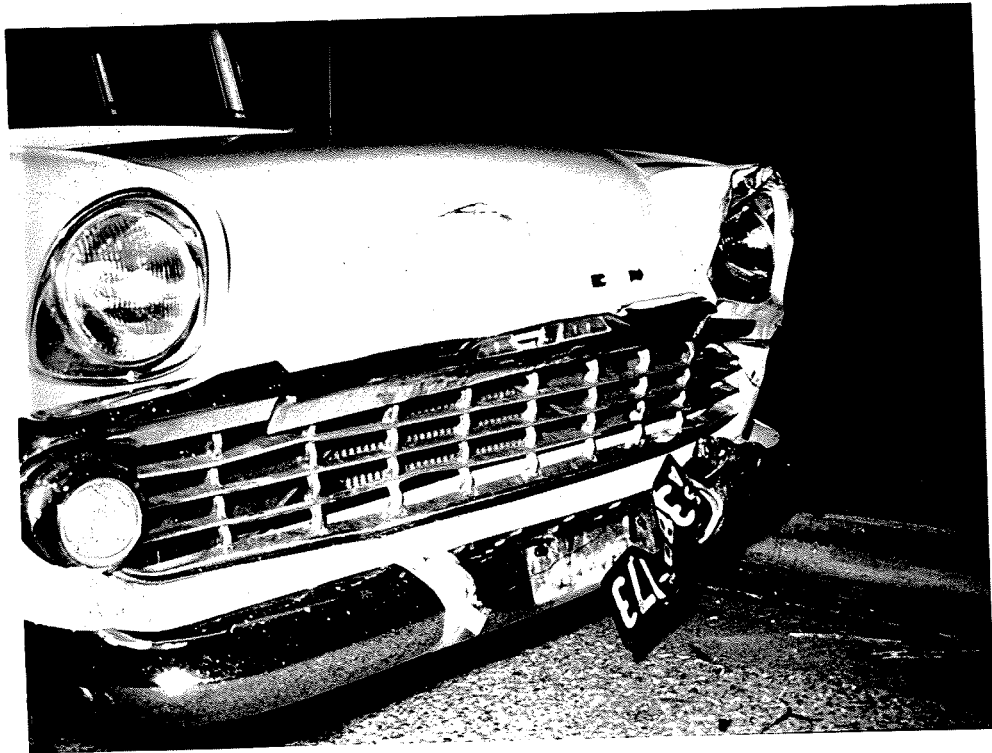
Fig. 8.37

Note the relatively small amount of damage to this car. The struck car (see Fig. 8.36) was spun anti-clockwise by the impact and rolled over.

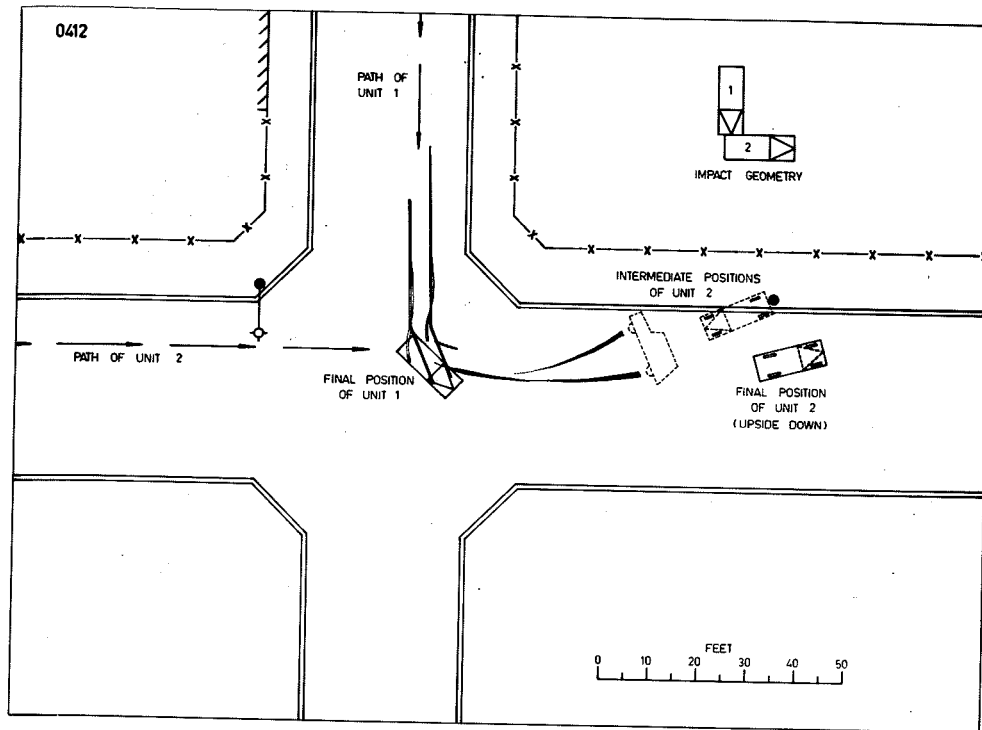
Fig. 8.38
Case 0412 (see also Figs. 8.36 and 8.37).

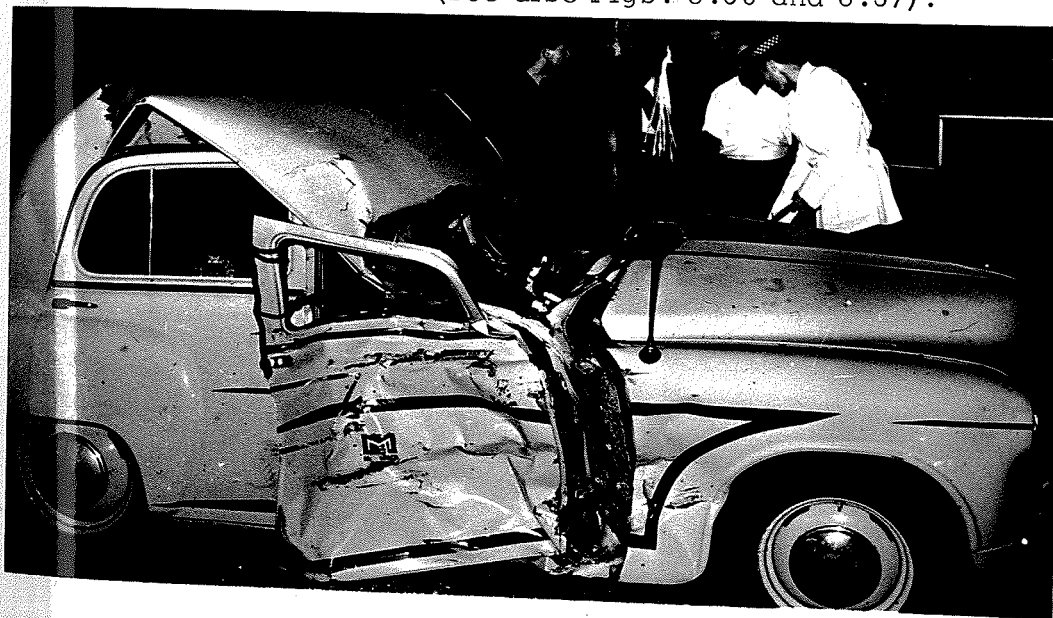
Fig. 8.39

0223 A 1954 Hillman Minx sedan was struck on the right hand side by an FC Holden utility at an intersection. The Hillman was spun clockwise and began to roll over to the left, striking a utility pole as it did so. The resulting damage to the passenger compartment was very severe (Fig. 8.39). The driver was slightly concussed, and also suffered multiple abrasions.

This Hillman Minx rolled over after being struck by another car on the door shown. It hit a utility pole while rolling over.

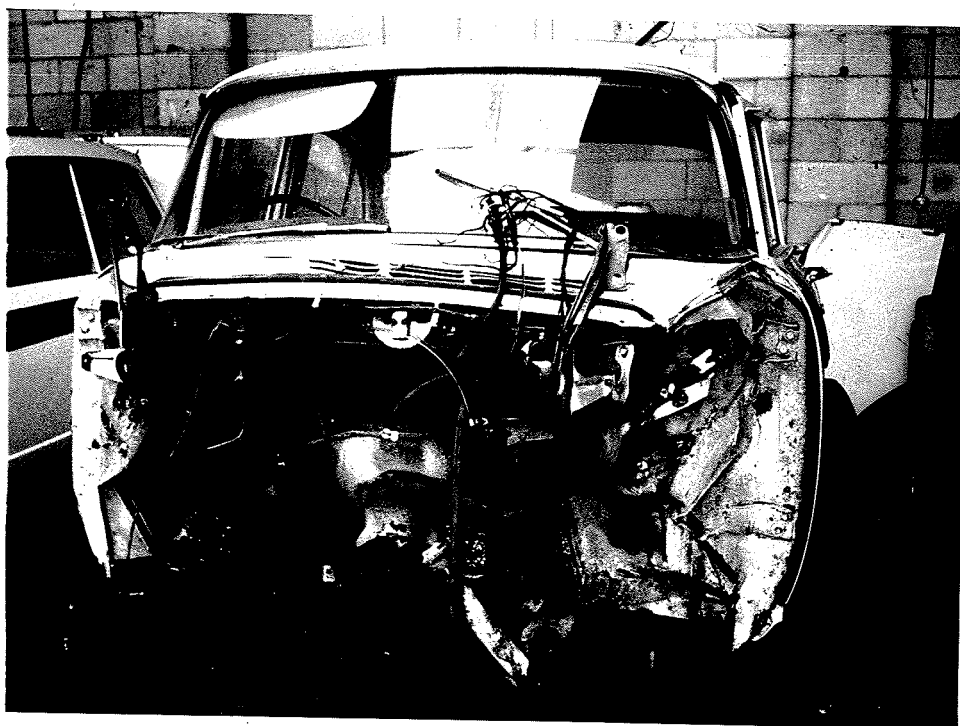
Fig. 9.4
The damaged FB Holden, shown in Figure 8.25, stripped for repairs.

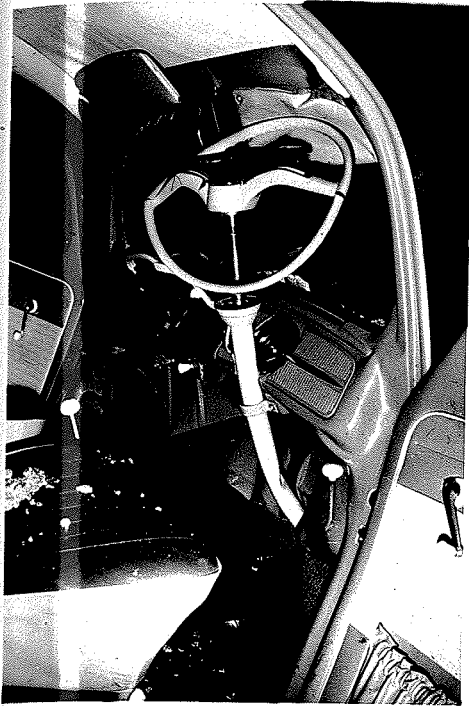
Fig. 10.1 - 1962 Volkswagen 1200 steering column forced back in a head-on collision with another car. Note also the dent in the header strip made by the driver's head and the shoe trapped by the pedals.

10.9 The illustrations to this section (Figs. 10.1 and 10.2) show that the steering column is sometimes pushed further back into the passenger compartment. (Note the mark on the column, shown in Fig. 10.2, adjacent to the mounting clamp on the instrument panel.) This is usually a consequence of an impact on the front of the car. There are some models which are very poorly designed in this regard. Of the cars in these 408 accidents the one in which the steering column proved to be the most dangerous was the Volkswagen. This does not necessarily mean that the steering columns of some other models of cars are not also dangerous.

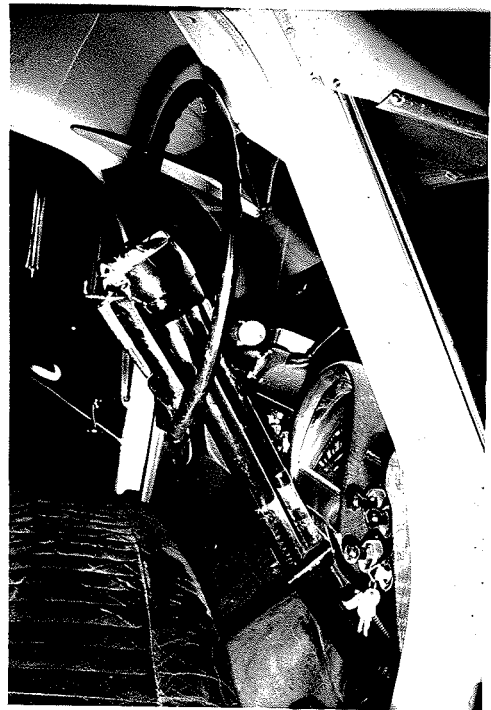
Fig. 10.2 - 1953 Ford Customline two-spoke steering wheel damaged by the driver being thrown against it. The collision, with a tree, has forced the steering column back four inches.

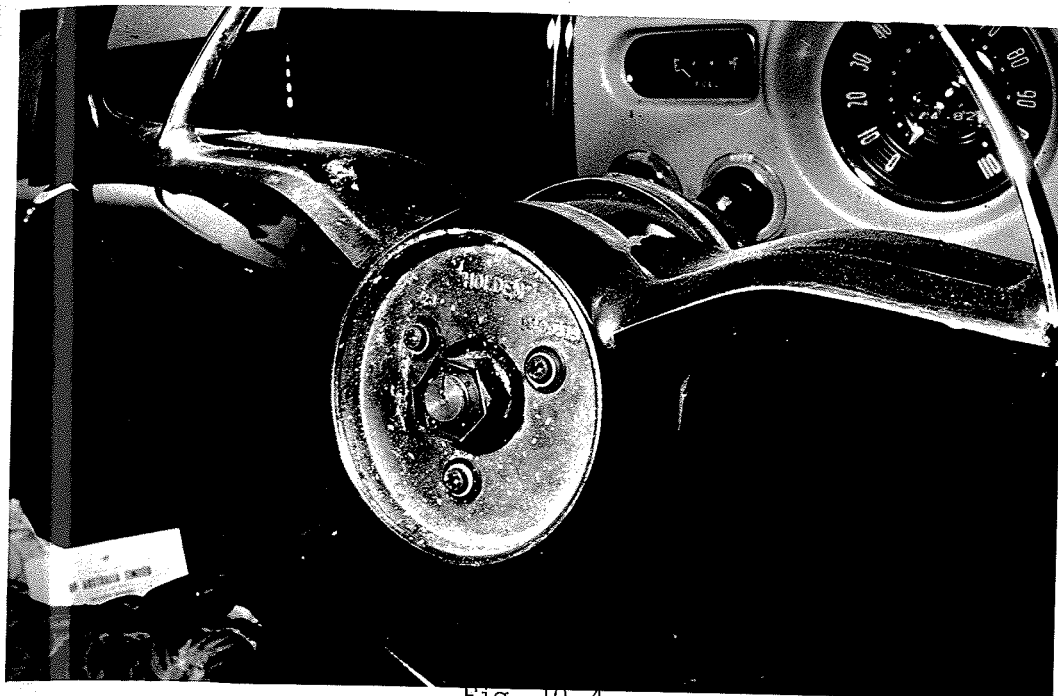
Fig. 10.4

Holden steering wheel hub. Note flanges broken off the tab washer. It is not known whether the plastic cover was in place before the accident.

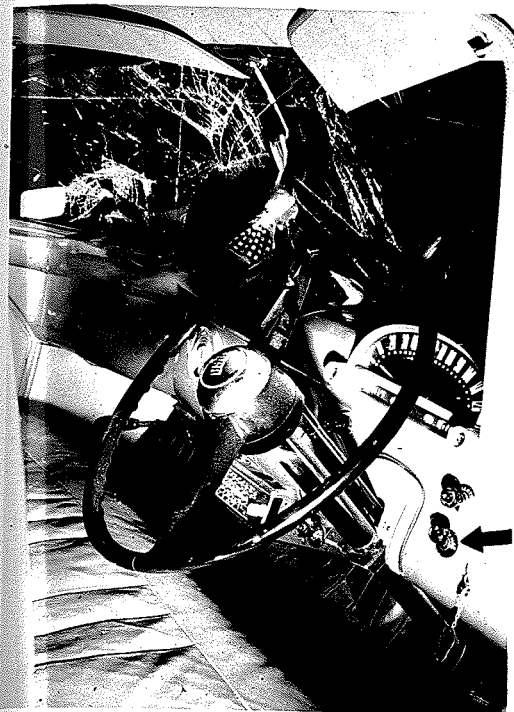
10.11 One hundred and thirty-six or 35 per cent of these 390 cars had the instrument panels damaged by the occupants being thrown against them. The panels of 100 cars received minor damage (bent knobs, etc.) and 36 were severely damaged (large dents). The bent control knob shown in Fig. 10.6 is an example of minor damage. It fractured the driver's knee cap. Fig. 10.6 shows a case of severe damage to an instrument panel, and Fig. 10.7 the resulting injury to the driver's knee.

Fig. 10.6
 Interior of 1955 Ford Mainline which collided with the Volkswagen shown in Figure 10.1. Note that the steering column has been forced back only half an inch. Arrow indicates control knob which fractured the driver's knee-cap.

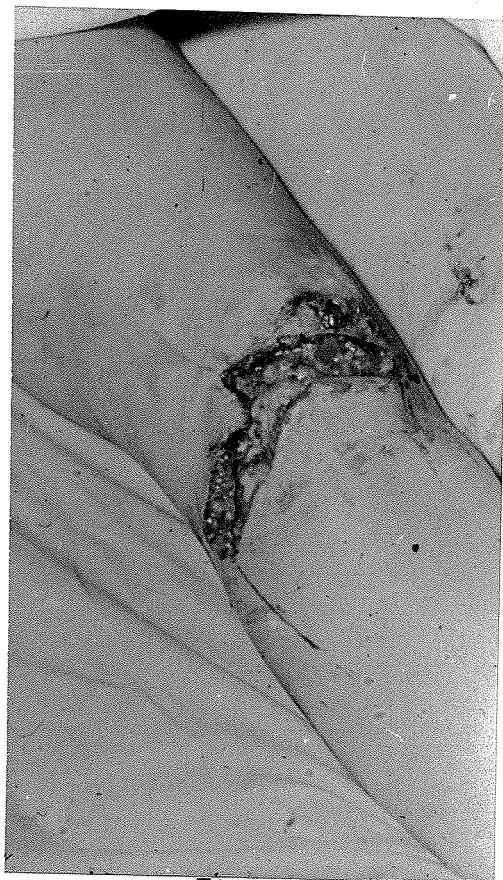
Fig. 10.7
 Injuries caused by striking the instrument panel shown in Figure 10.8.

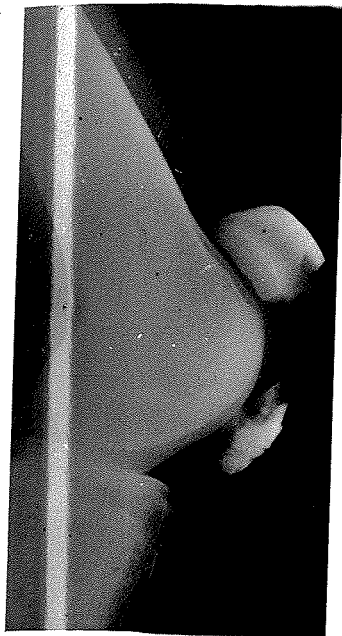
Fig. 10.9

Fractured knee-cap, resulting from striking the instrument panel shown in Figure 10.10.

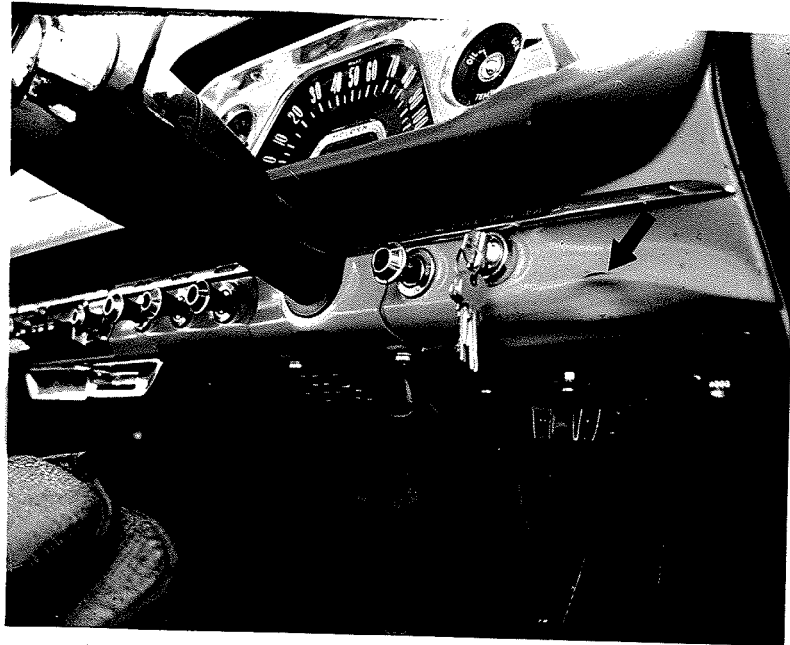
Figure 10.10

Arrow indicates dent made by driver's knee in Holden instrument panel.

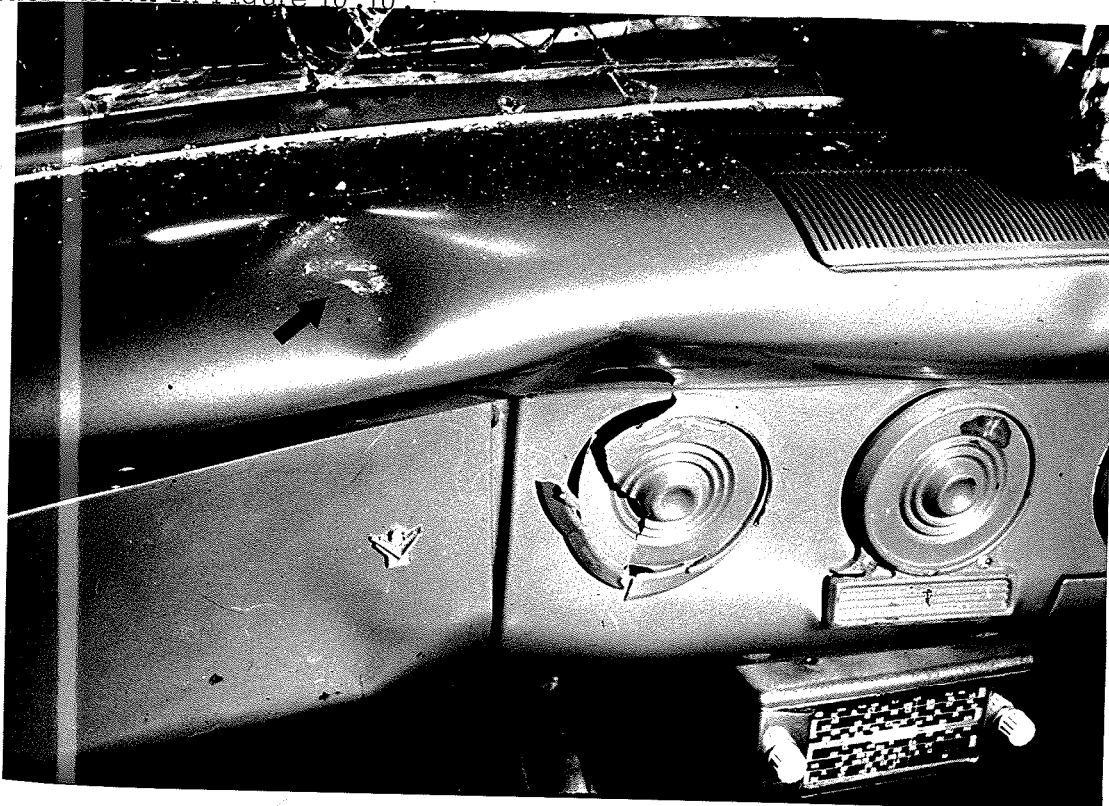
Fig. 10.11

Passenger's knees struck the front of the instrument panel. Arrow indicates teeth marks in upper surface of metal panel.

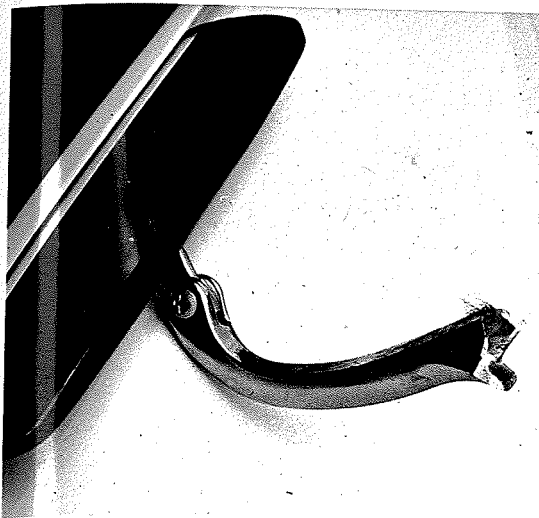
Fig. 10.12
E.J. Holden rear vision mirror
standard. Note hairs and skin on
jagged end.

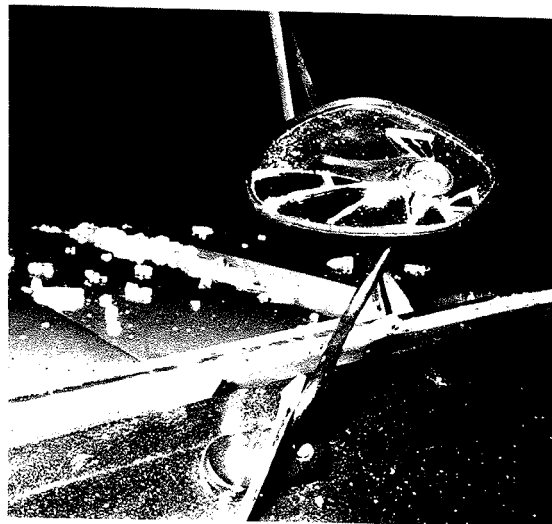
Fig. 10.13
Rear vision mirror of a 1963 Renault
R4, broken when struck by an
occupant.

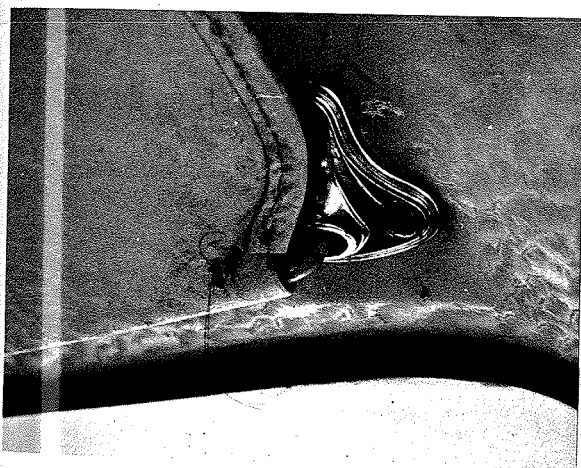
Fig. 10.14
Holden sunvisor pivot mounting.
Note skin and hair.

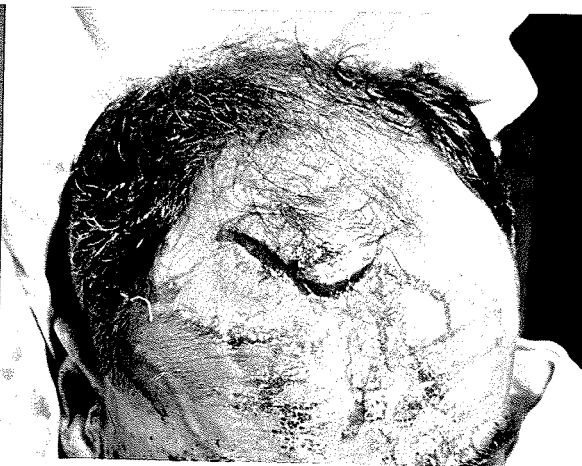
Fig. 10.15
Laceration in driver's forehead,
produced by the sunvisor pivot shown
in Figure 10.14.
