ENGINEERING ASPECTS

TRAFFIC ACCIDENTS

ADELAIDE, SOUTH AUSTRALIA.

A thesis presented for the degree of Master of Engineering of
the University of Adelaide, based on work in the Traffic Accident
Research Unit of the Department of Pathology of the University
of Adelaide.

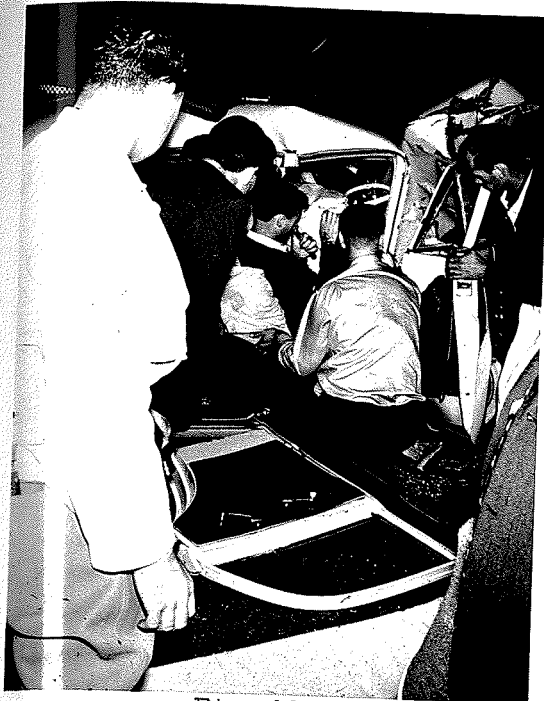
Fig. 10.16
Driver trapped in an FX Holden
by the front seat, which moved
forward in the collision.

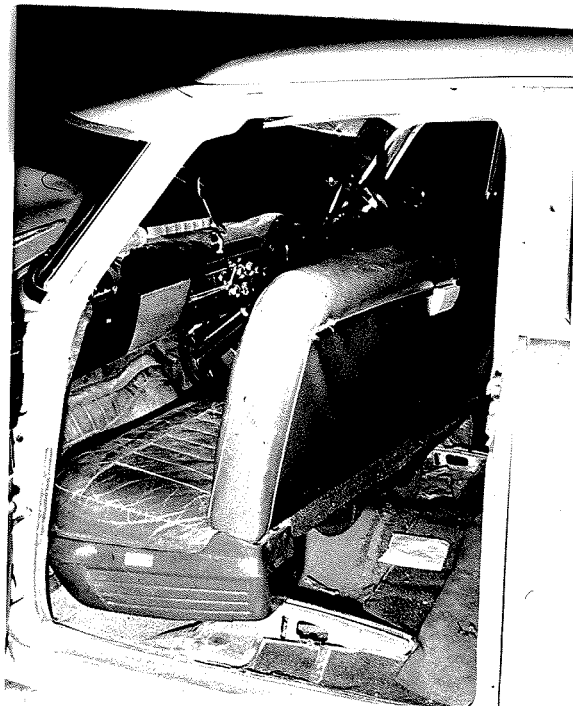
Fig. 10.17
Front seat completely off adjustment
runners, 1953 Ford Customline.

10.26 Failure of the seat mountings, whether it is failure of the adjustment catch or complete failure of the mountings, means that the front seat occupants are forced by the front seat up against the instrument panel and steering wheel in a frontal impact. This additional force alone is bad enough, but in some cases, particularly with the 'bench' seat, the seat may become jammed, wedging the occupants up against the instrument panel. Fig. 10.16 shows ambulance men, police and tow truck drivers working to release a driver who has been trapped in this way. The seat had come forwards and the damaged adjustment (Fig. 10.16) prevented it from being pushed back. The driver, who had a severe compound fracture of the right femur, was released after the seat had been unbolted from the floor of the car. The whole procedure took nearly three quarters of an hour. In some cases the complete seat will come off the adjustment runners (Fig. 10.17). While this is less likely to trap the occupants it obviously will increase the force of the impact with the instrument panel or steering wheel.

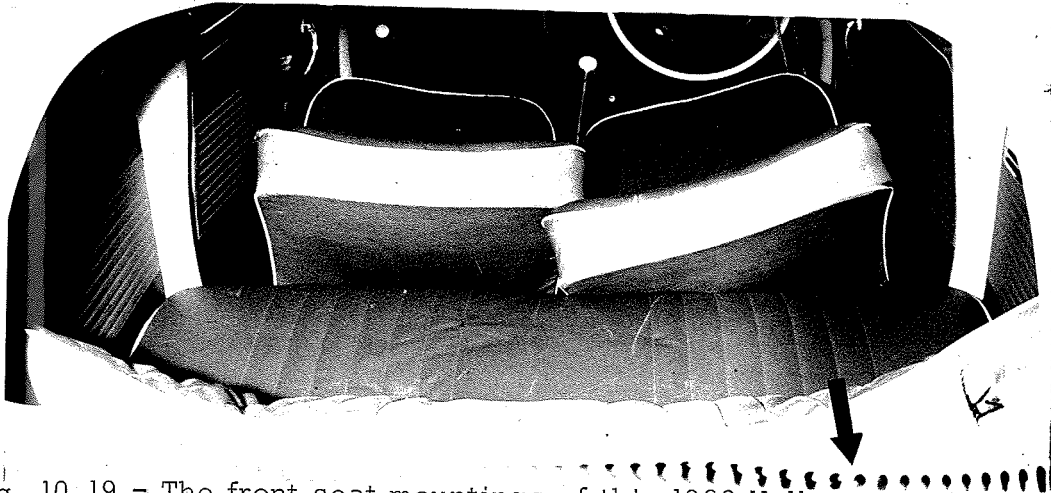
10.27 Rear end impacts also place a considerable load on the seat mountings. Fig. 10.19 shows a case in which the mountings failed and the occupants were thrown against the back of the back seat and struck their heads on the rear window surround. The window was broken and the surround dented. The occupants were both concussed.

Fig. 10.19 - The front seat mountings of this 1960 Volkswagen failed when it was hit from the rear by another car. Note the damage to the back of the rear seat, and the dent (indicated by arrow) below the rear-window, which was made by the driver's head.

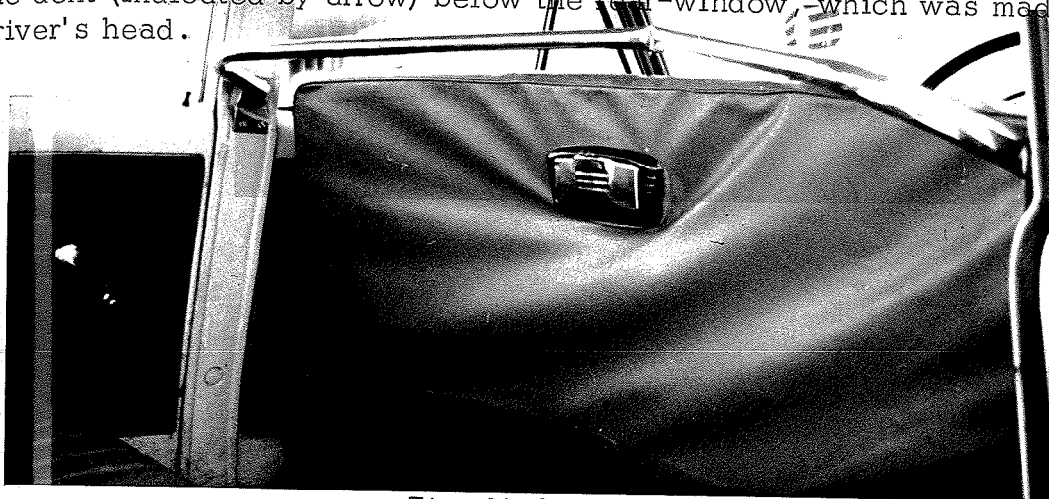
Fig. 10.20

Handrail of a 1959 FC Holden taxi, struck by a rear seat passenger.

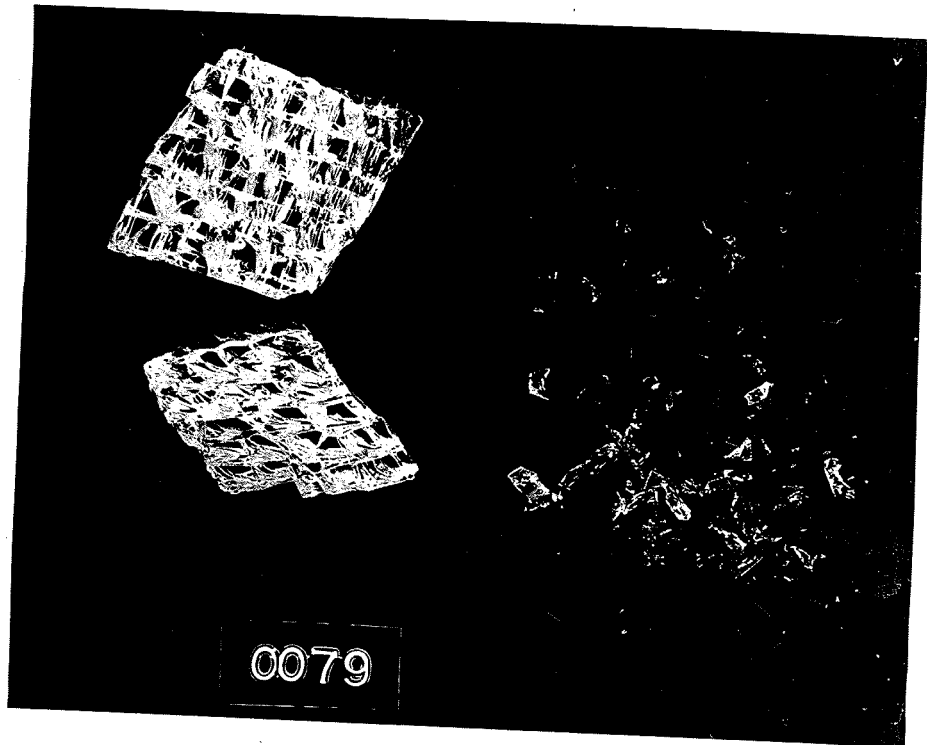
Fig. 11.3
Fragments of toughened glass from a 1961 Volkswagen windscreen (actual size).

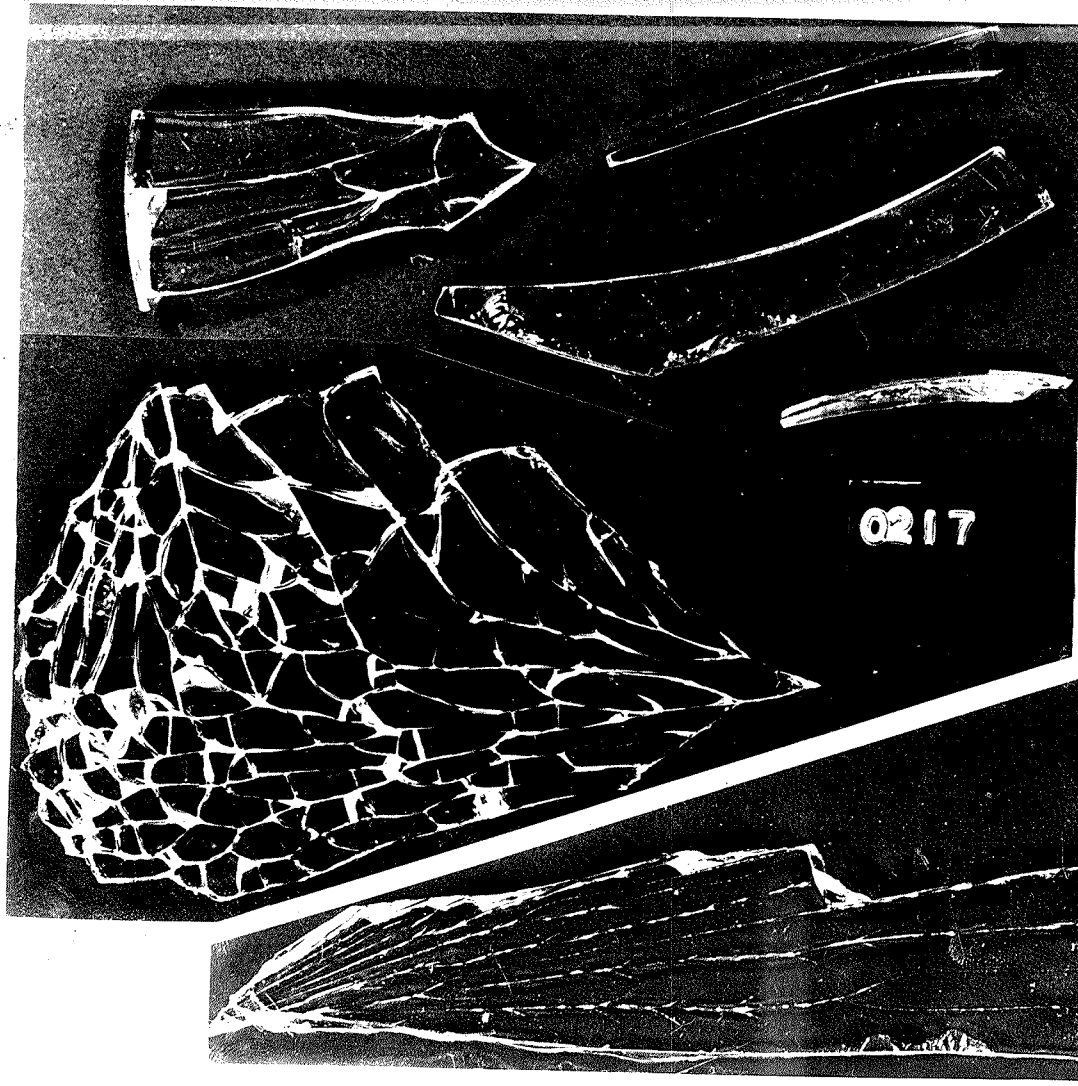
Fig. 11.5
Large fragments from 'magic
circle' windscreen (full size).

Fig. 11.6
Annealed glass fragment, 1937 Pontiac side window (full size).

11.36 The fragments of annealed glass which are released from the "magic circle" windscreen are not as large as those released from a screen composed entirely of annealed glass. A fragment of annealed glass from a side window of a 1937 Pontiac Sedan is also shown in Figure 11.6. Although the fragments from the "magic circle" are smaller, they do have the sharp edges which are common to fractured annealed glass (Ref. 30). (Annealed glass is referred to as plate glass in Table 11.1.)

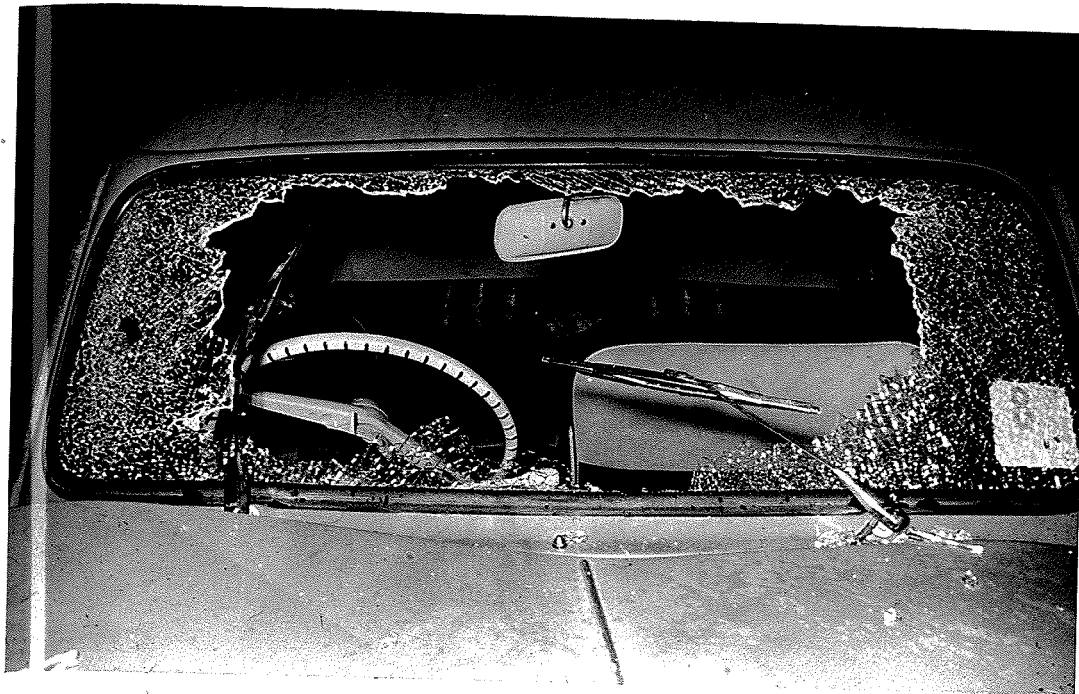
11.35 One of the early attempts to improve visibility through a shattered toughened glass windscreen was to retain a portion of annealed glass in front of the driver. One such attempt is commonly referred to as the "magic circle" windscreen. When shattered, such a screen can release large fragments from the annealed "magic circle". Case 0217 (Fig. 11.5) is an example of this. Four pieces from within the magic circle are shown together with a large composite fragment from the edge of the magic circle. This glass is from a 1958 Simca (Fig. 11.7). It was broken by the head of the front seat passenger, a 20 year old male.

Fig. 11.7
1958 Simca windscreen, struck by passenger's head. (See also Fig. 11.5
for fragments from this screen.)

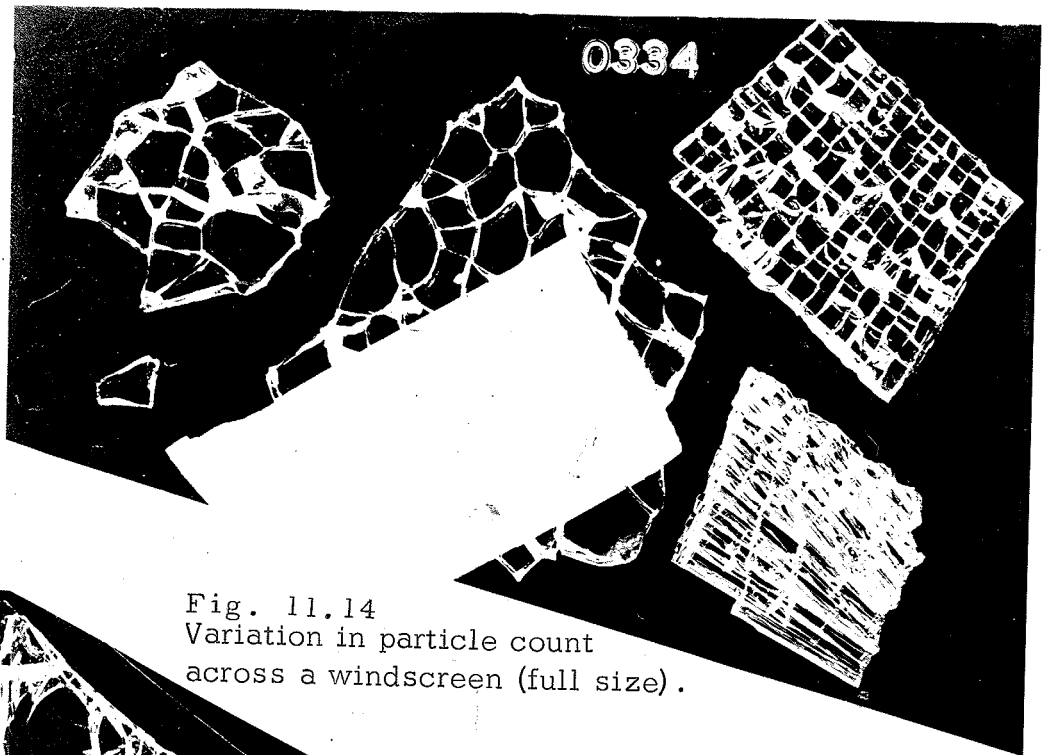
Fig. 11.14
Variation in particle count
across a windscreen (full size).

11.42 Particle size can vary greatly across a fractured toughened screen. Figure 11.14 shows fragments from the toughened glass screen of a Renault Dauphine Sedan which rolled over. The screen was broken by deformation of the frame. The large fragment in the centre is from the lower right hand corner of the screen. The white area is a paper sticker on the glass. This piece has a particle count of 17 per sq. inch. The fragment in the upper right hand corner of Figure 11.14 has a particle count of about 80 per sq. inch.

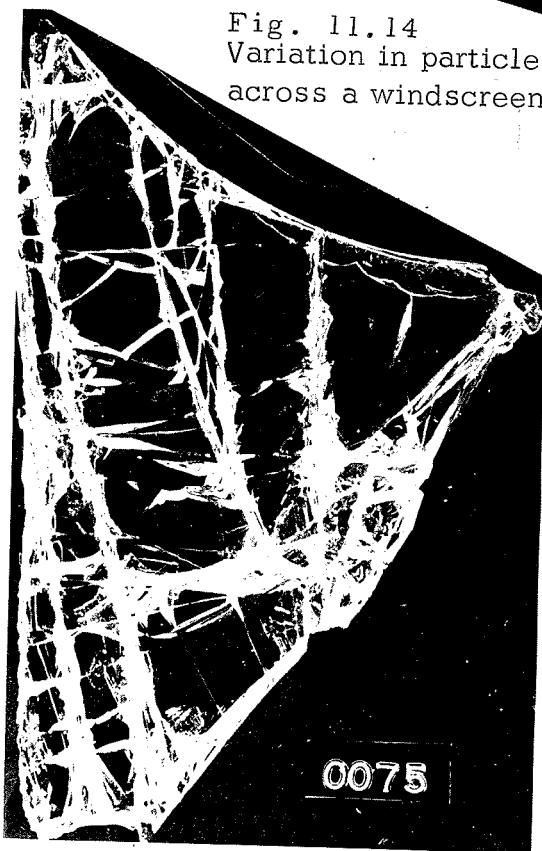
Fig. 11.15
Fragment of laminated glass (full
size) from the screen shown in
Figure 11.12.

11.44 The glass fragment from Case 75, shown in Figure 11.15, is from a laminated glass windscreen. The fractured screen is shown in Figure 11.12. The vehicle is a 2 1/2 Litre Riley Saloon, manufactured in 1952. Each side of the two piece windscreen displays a different type of laminated glass fracture. The piece on the driver's side is "grid" cracked. The piece on the passenger's side is "web" cracked. These two types of failure are further illustrated in Reference 55. The grid type of failure is caused by distortion of the frame of the glass. The web type of failure is caused by an object striking the glass. In the case shown the driver, on realizing a collision was imminent, put her left arm across in front of the front seat passenger. On impact the passenger was thrown forwards pushing the driver's forearm through the laminated windscreen, resulting in extremely severe lacerations. The fragment

shown in Figure 11.15 was pushed out by the driver's forearm. The exposed edges of this fragment have a razor sharpness.

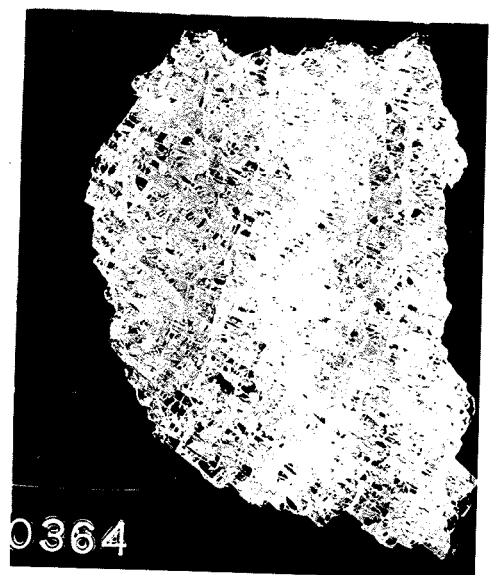
Fig. 11.16
Highly stressed toughened glass,
yields high particle count on
fracture (full size).

11.43 Variations in the degree of toughening can also affect the particle size. This is discussed at length in Reference 30, and the requirements of the British Standard (Ref. 42) have been noted above. Figure 11.16 shows a fragment of a fractured toughened glass windscreen from a 1949 Sunbeam Talbot. The screen was broken by the deformation of the frame. At the time that this screen was manufactured the British Standard required a minimum particle count of 40. There was no upper limit on the particle count. Hence some windscreens were toughened to such a degree that when fractured they were virtually opaque.

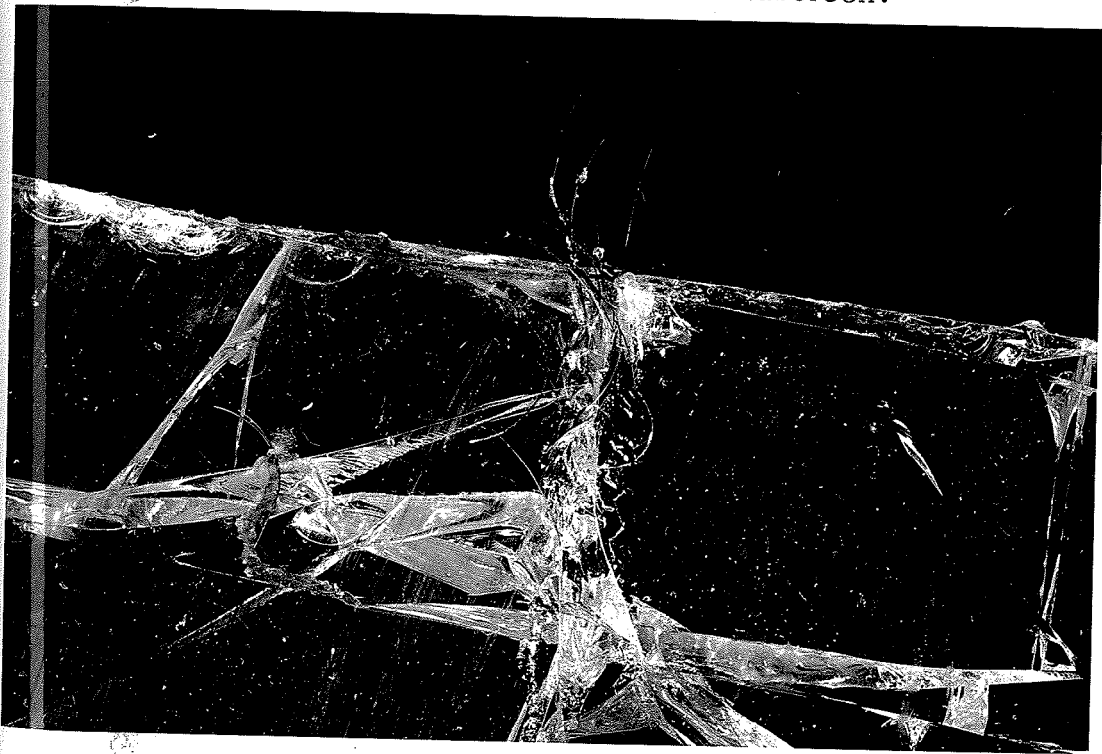
Fig. 11.18
Enlarged view of edge shown in Figure 11.19.

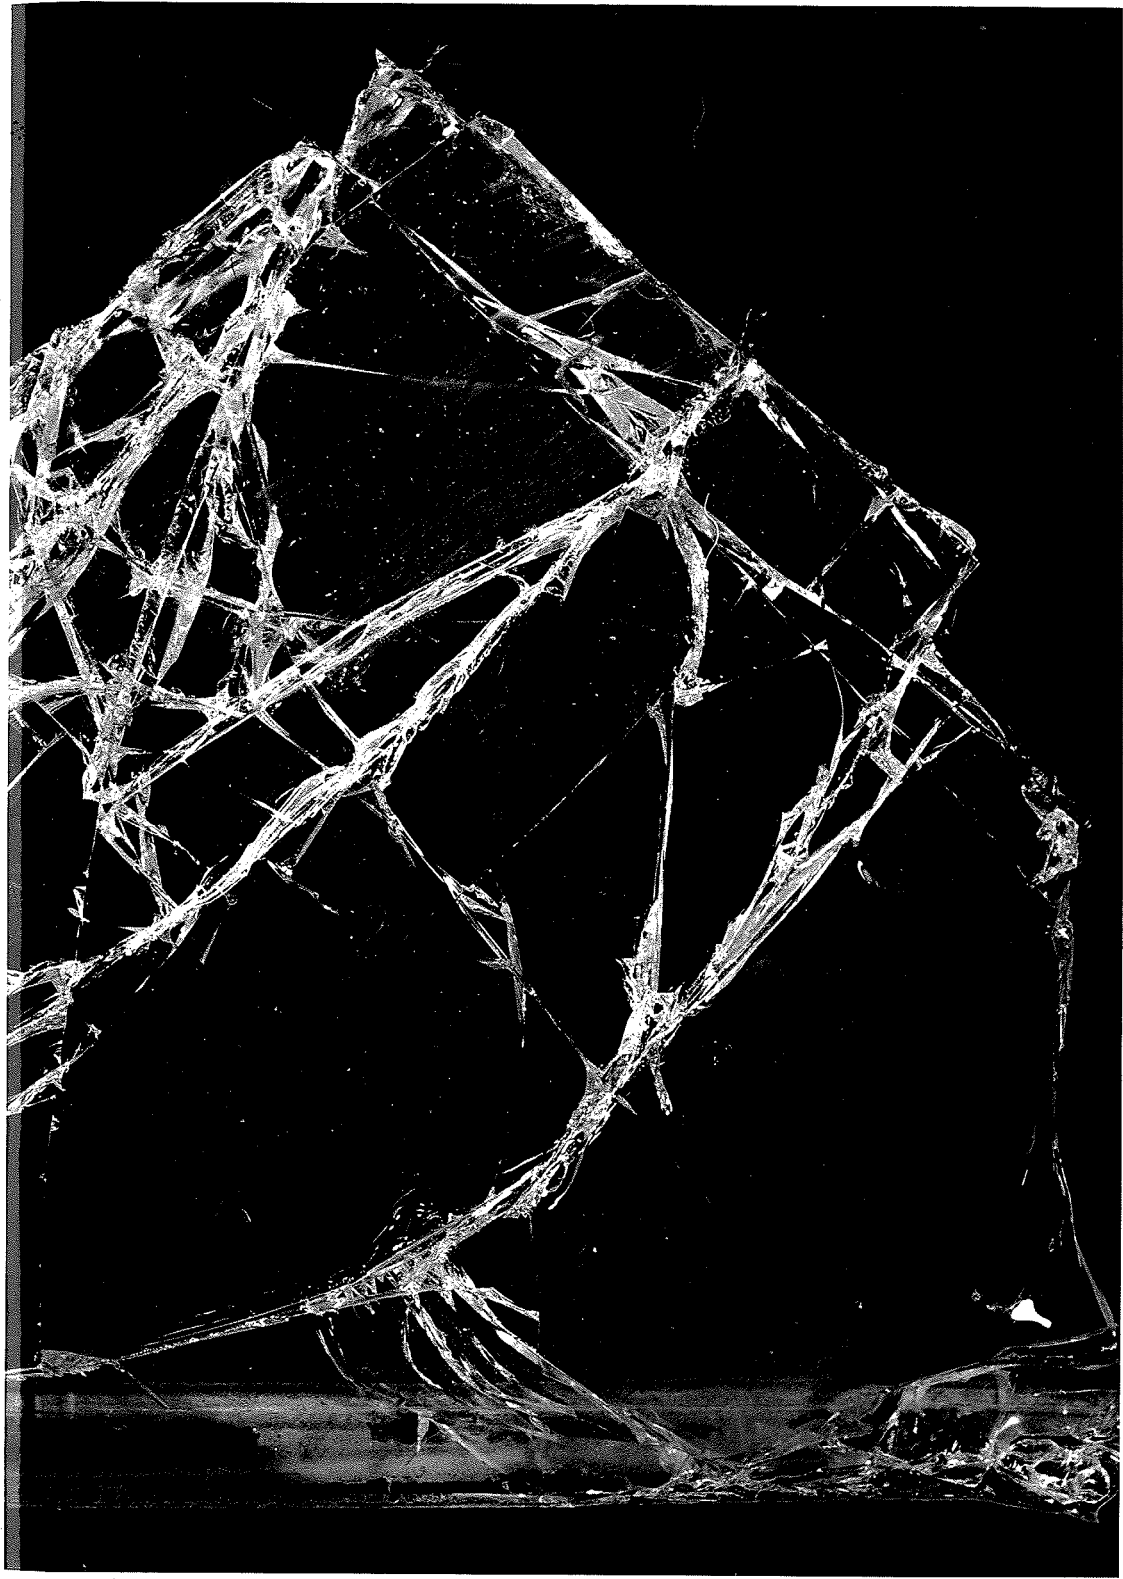
11.45 Figure 11.17 shows the windscreen of a 1954 MG Magnette. Both driver and passenger were thrown against the windscreen in a collision. The passenger, who was not deflected by the steering wheel, penetrated the inter-layer of the laminated glass screen. The left hand side of the penetrated portion is shown, full size, in Figure 11.19. An enlarged view of the edge of this portion (Fig. 11.18) clearly shows the inter-layer between the two sheets of glass. The grease smears on the glass run from the top right hand corner diagonally down to the left. This indicates that the passenger's head after going forwards and breaking the glass then moved downwards sliding across the broken glass. Strands of hair and pieces of skin and flesh are caught in the exposed sharp edges of this piece of glass. The passenger sustained a severely lacerated forehead involving arterial bleeding. He was also unconscious for nearly four hours after the collision.

Fig. 11.19
Full-size fragment from the left hand side of the screen shown in
Figure 11.17 .

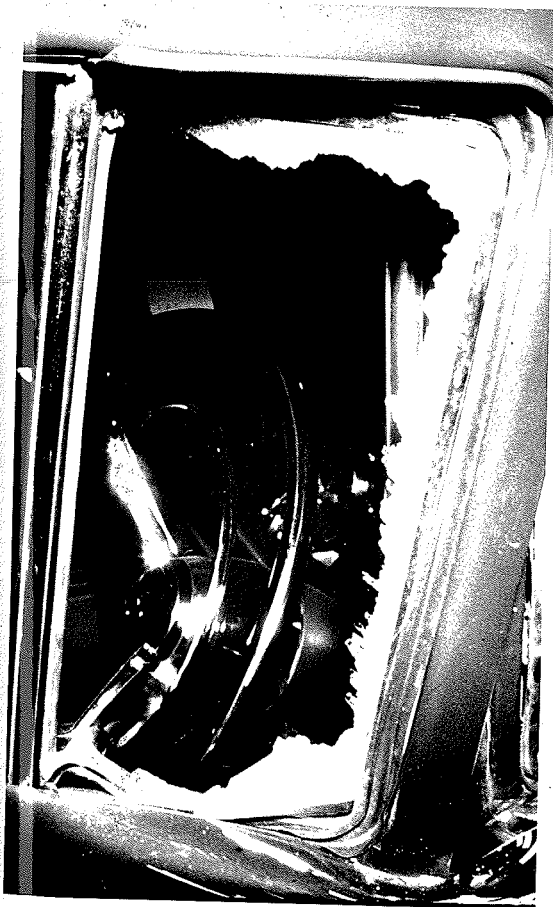
Fig. 11.21
Jagged glass edge retained in EK Holden quarter-light.

with windcreens, confined to jagged fragments which can be retained in the frame. This is most likely to occur with fixed or pivoted windows having a fixed frame. An example of this is shown in Figure 11.21.

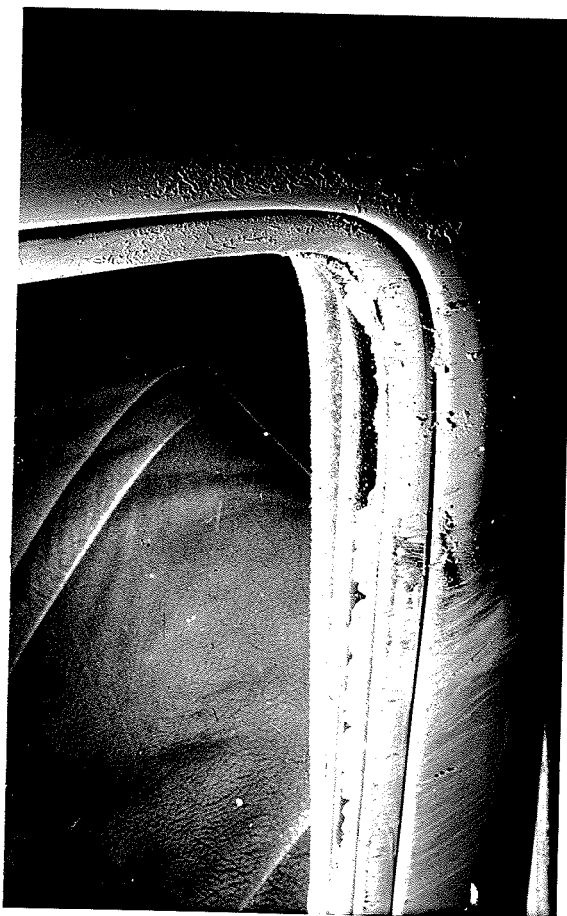
Fig. 11.22
1952 Ford Consul Sedan, window shattered by motor-cyclist during a collision. Rider received severe lacerations from jagged edge of broken glass.

11.52 Figure 11.22 shows the left front window of a 1952 Ford Consul Sedan. This car turned right across the path of an approaching motor scooter. The rider of the scooter was thrown against the side of the car and broke the window glass with his body. He then slid along the side of the car and across the jagged edge of broken glass which was trapped in the window runner. The rider sustained severe multiple lacerations across the base of his neck and over his left collarbone.

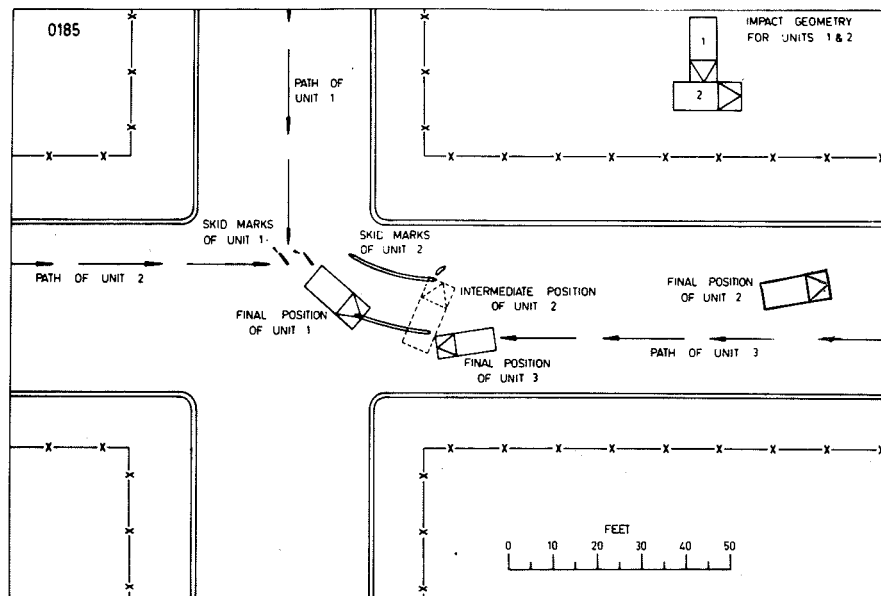
Fig. 12.1
Case 0185.

12.4 Ejection appears to be associated more with the spinning vehicle than with the one that rolls over. Spinning is generally a consequence of an impact on the side of the car, as in accident number 0185 (Fig. 12.1). The impact on the side of the car set it spinning and also sprang the doors open on the opposite side, thereby setting the stage for the ejection of the occupants.

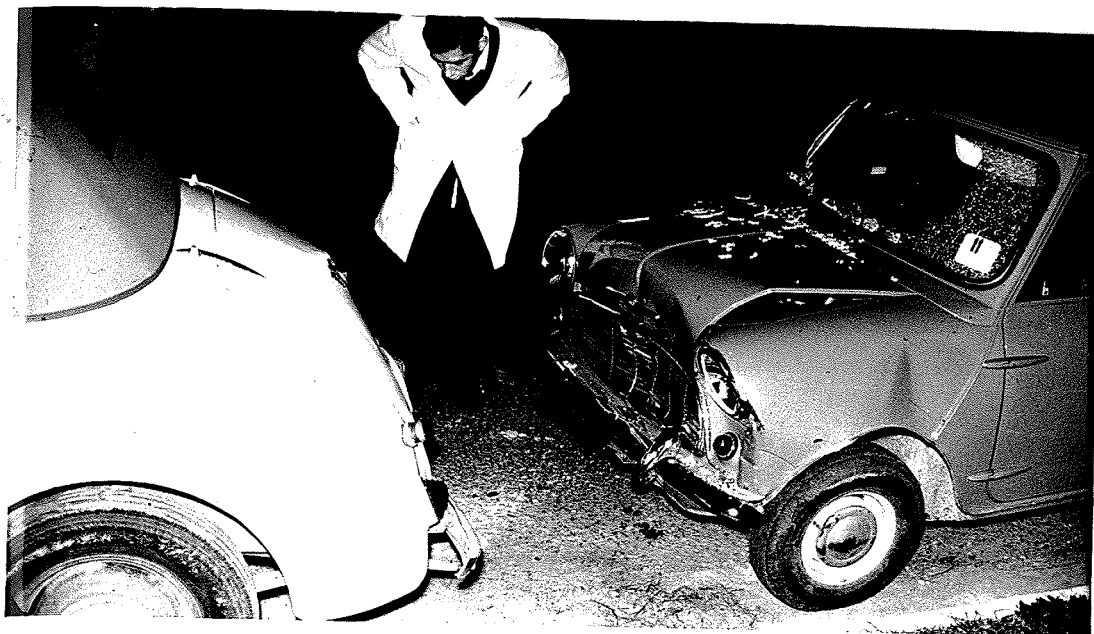
Fig. 12.2

Collision between Morris 850 and stationary Morris Convertible - seat belt not worn.

12.6 There were several cases in this survey in which the wearing of a seat belt undoubtedly reduced the severity of injury, or even protected the wearer from injury altogether. In two of these cases the accidents were almost identical (0170 and 0301). Each involved a Morris Mini Minor crashing into the back of a stationary Morris convertible. In the first case the driver, not wearing a seat belt, broke the windscreen with his head, sustaining concussion and lacerations of the face. In the other case the car sustained damage very similar to that of the first car (Figs. 12.2 and 12.3) but the driver was wearing a diagonal seat belt and suffered only momentary breathlessness and bruising of the chest. These two collisions were virtually identical, the only difference being in the wearing of the seat belt and consequent prevention of injury in the second case.

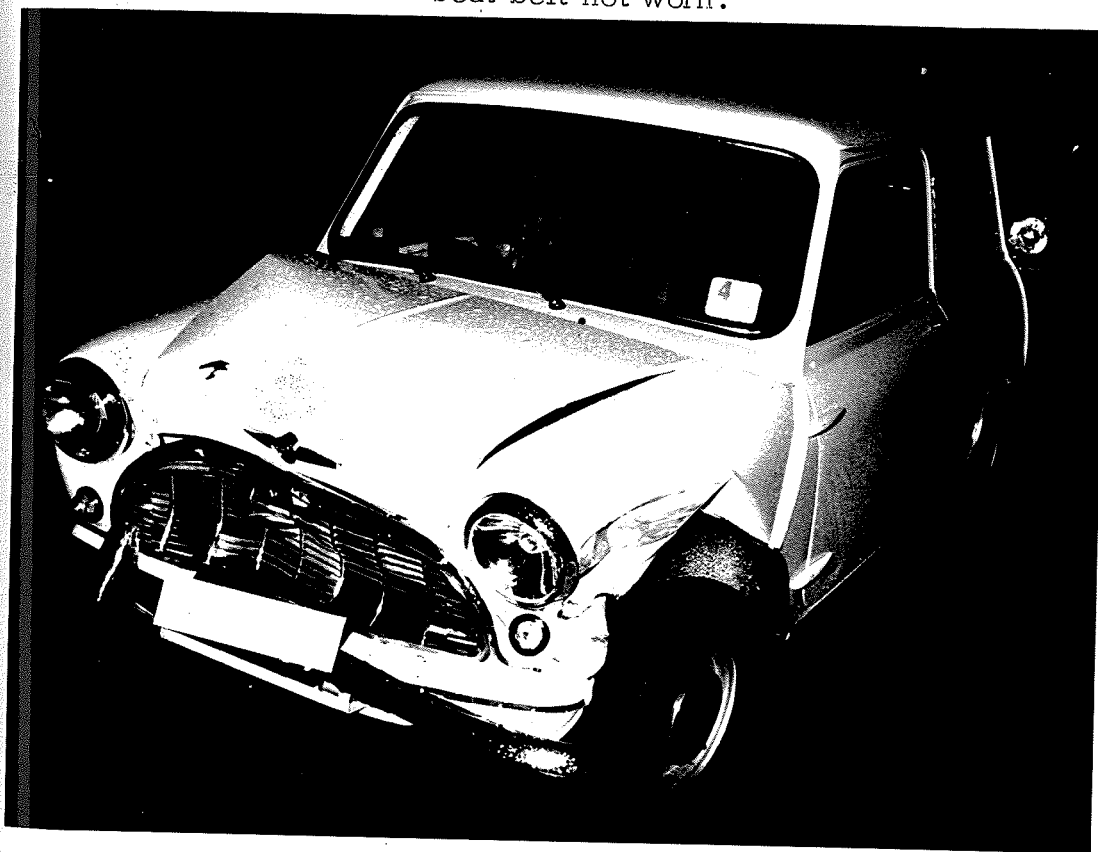
Fig. 12.3

Collision between Morris 850 and stationary Morris Convertible - seat belt worn.

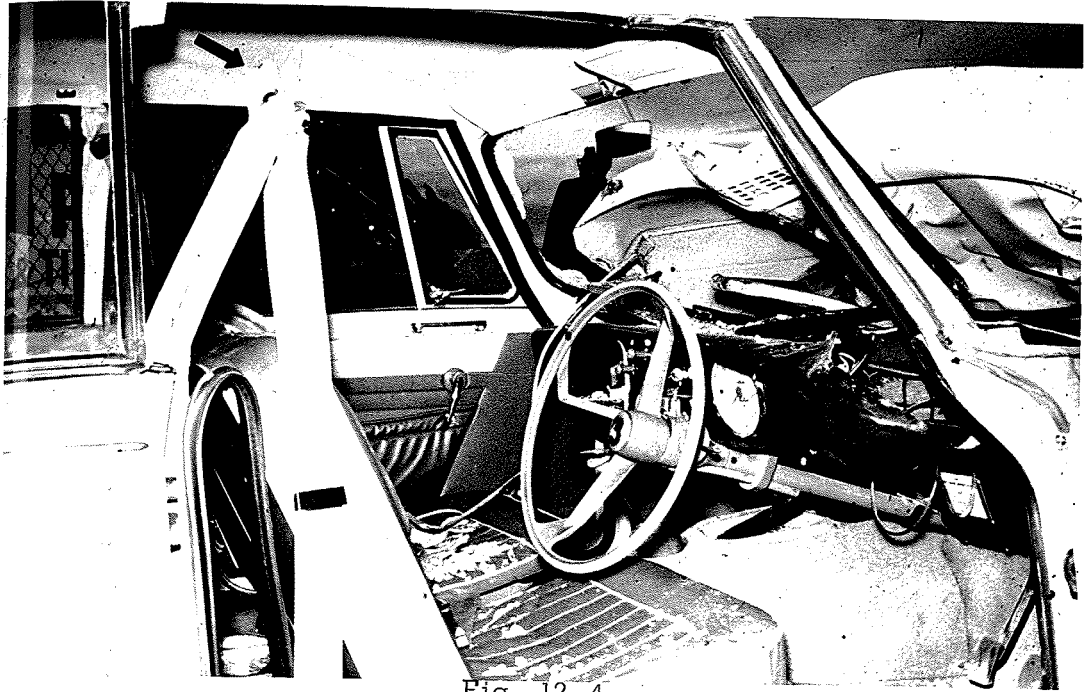
Fig. 12.4

Failure of seat belt mounting on a 1960 Triumph Herald (arrow). Distortion of the mounting on the passenger's side is also indicated. This vehicle is also shown in Figure 7.12.

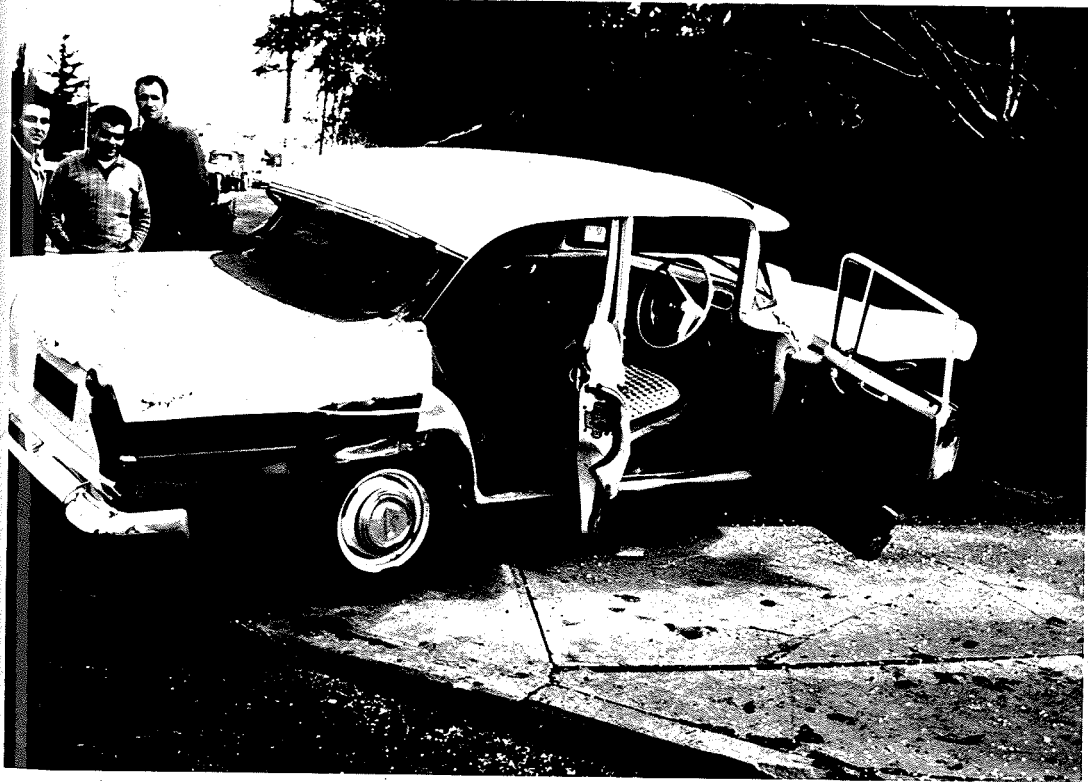
Fig. 12.5

1960 Vauxhall Victor, struck on the right side by another car at an intersection. Both doors on the right side were sprung open.

12.8 The latch on a car door has the obvious function of keeping the door closed. In normal service it does its job well, and we no longer have to worry about doors flying open as the car takes a bend. Unfortunately doors often do come open when cars are involved in accidents (Fig. 12.5). In this survey 8.6 per cent of all car doors came open. This includes all accidents involving cars. In many of these, e.g. pedestrian accidents, there is no additional loading on the door latch and doors rarely come open.

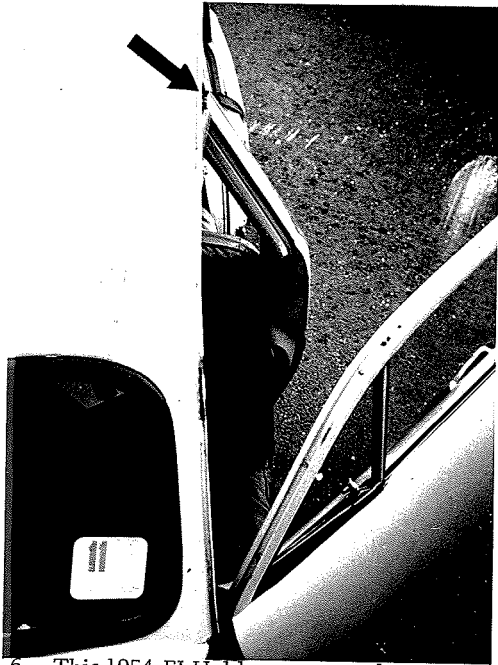
Fig. 12.6 - This 1954 FJ Holden was struck on the right side by another car. The front seat transmitted the force of the impact across the car to the centrepost, which was pushed out as shown, the spot welds being partly torn away (arrow). The rear door had been removed previously.

Fig. 12.6 shows how the front seat can break loose and transmit the collision forces from a side-on impact to the far side of the car. The centre post has been forced out, and the door opened. Even the driver being hurled sideways against the door can result in considerable damage to the door frame and failure of the lock. In the case shown in Fig. 12.9 the driver also shattered the side window with his head. He was fortunate that there was no arm rest fitted to the door, for rigid arm rests can cause serious internal injuries in cases such as this.

The additional case in the last column of the 'not applicable' category is illustrated in Fig. 12.6. The left rear door had been removed before the accident.

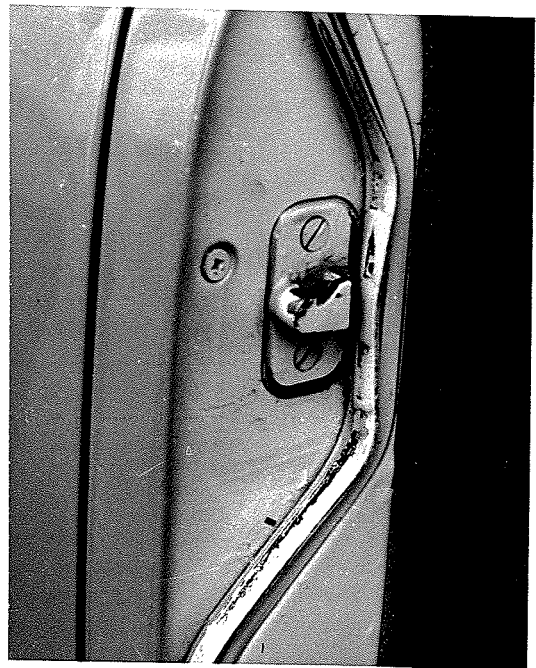
Fig. 12.7
Striker plate of a 1956 FJ Holden.

12.11 More frequently, however, the door lock is loaded by distortion of the body frame of the car or by direct impact on the door itself. Figs. 12.7 and 12.8 show the driver's door latch and striker of an FJ model

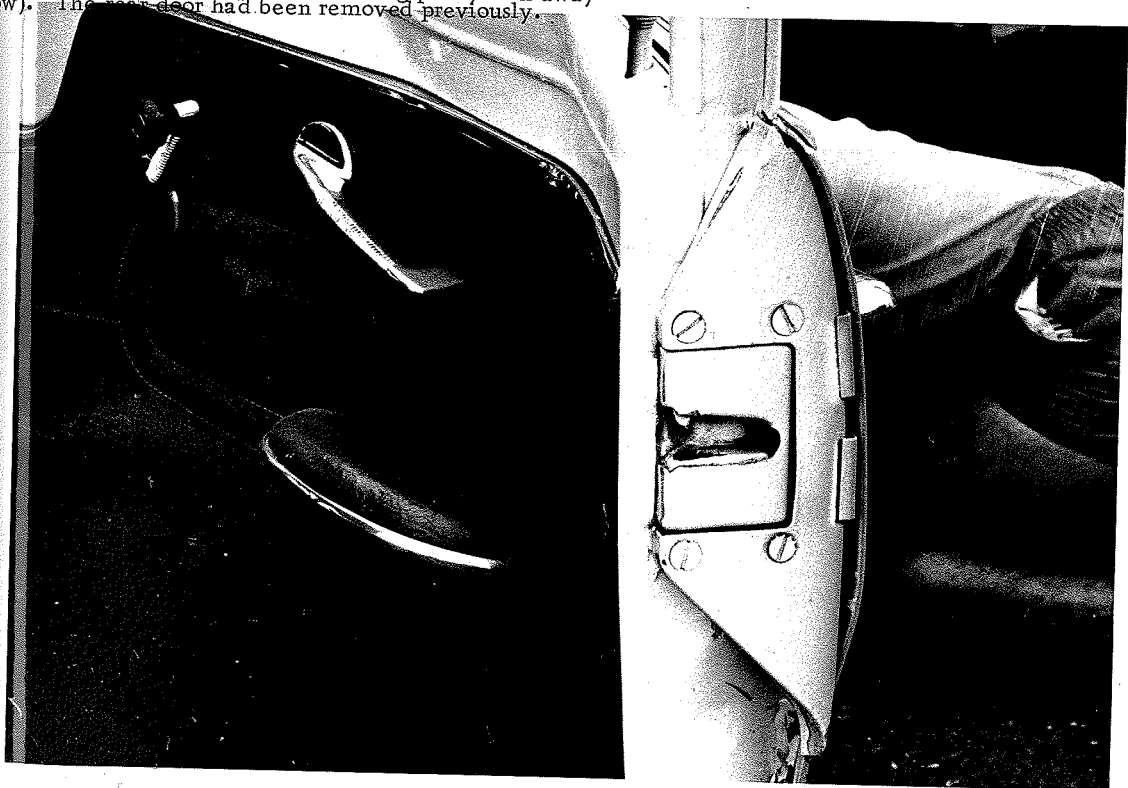
Fig. 12.8
Door latch of a 1956 FJ Holden.

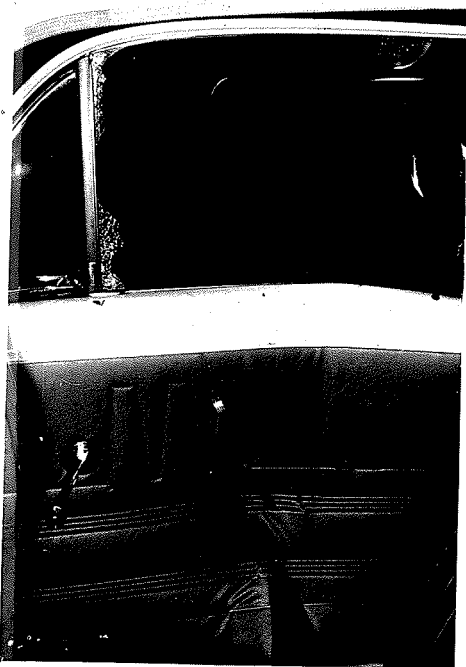
Figure 12.9 - 1964 EH Holden which hit a high kerb with the right front corner when skidding sideways. Note shattered glass and buckled door panel, both caused by the driver being thrown against the door.

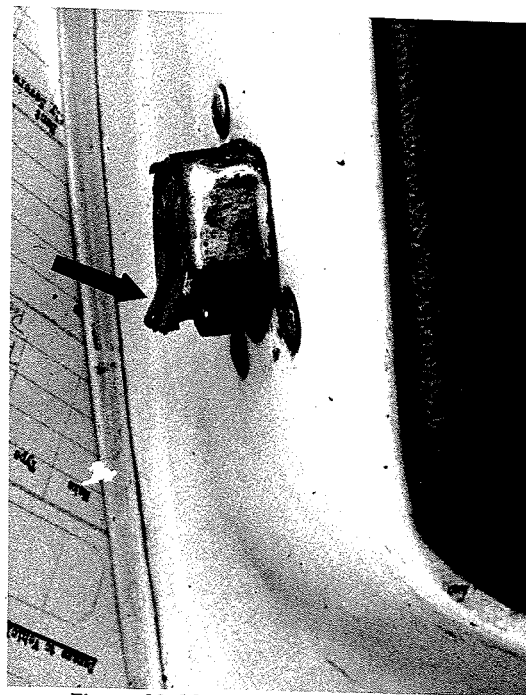
Figure 12.10 - Damaged door latch on a 1957 FE Holden. Arrow indicates bent flange. This latch superseded the one shown in Figure 12.8.

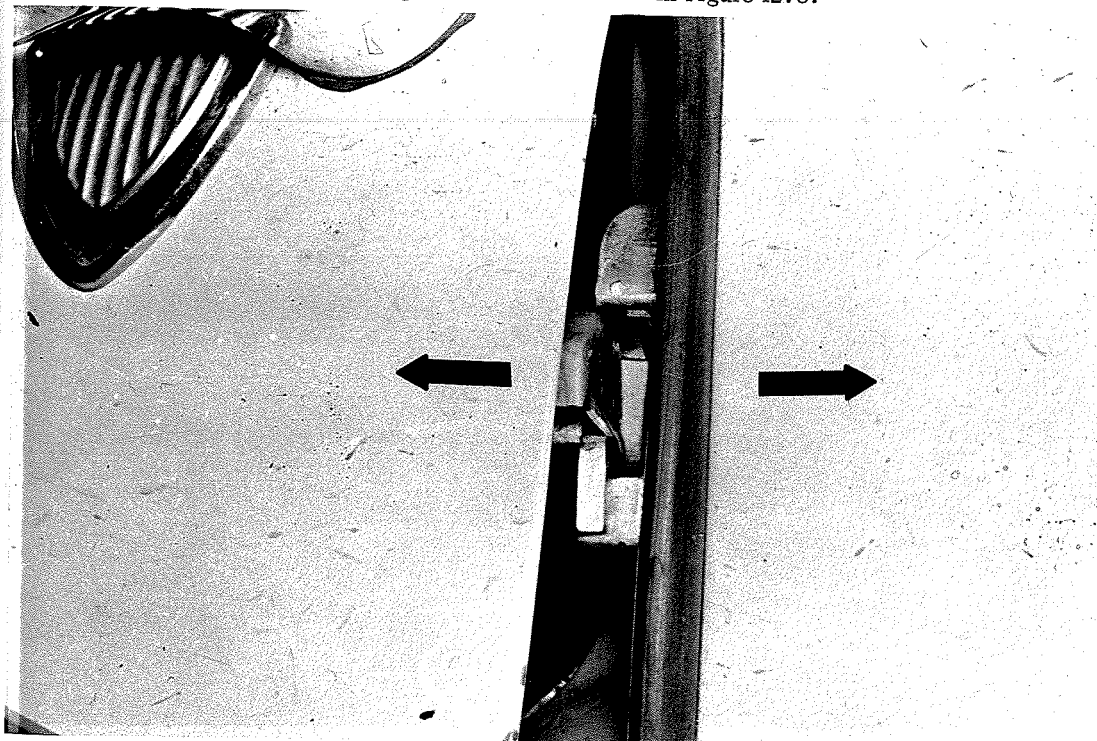
Fig. 12.11

1960 FB Holden door latch. The flange is bent, as in Figure 12.10, but the latch is still engaged with the striker plate and the door has not opened. The forces on the lock, due to the distortion of the body frame of the car, are in the directions shown by the arrows.

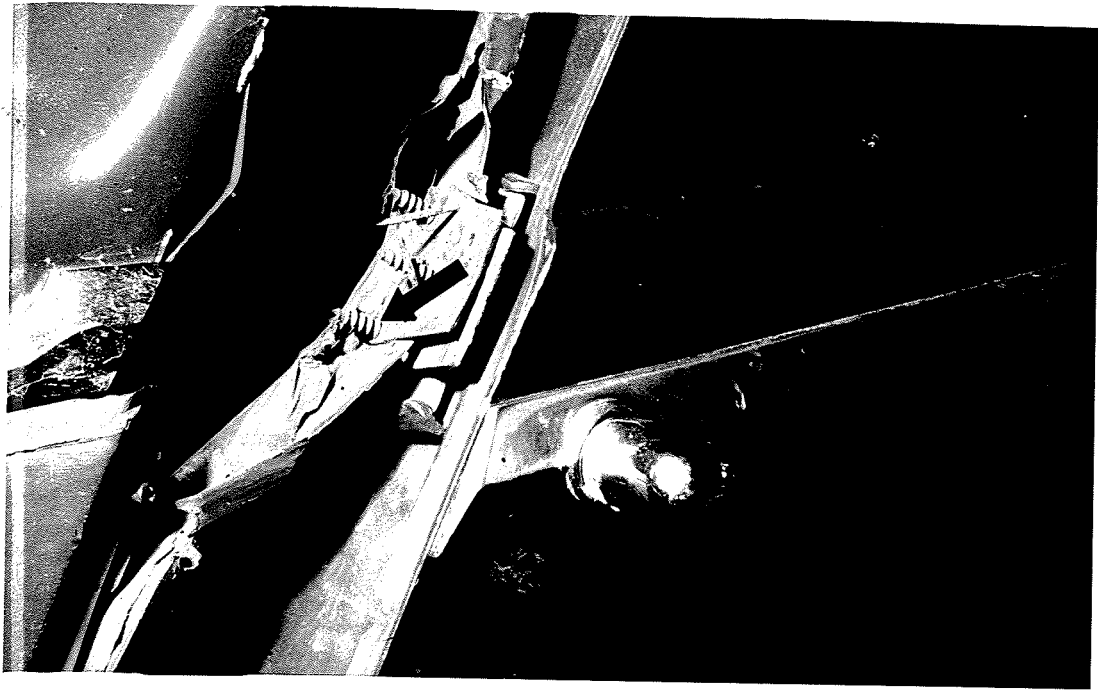
Fig. 12.12

Door lock failure on a 1952 Riley Saloon. Arrow indicates one of three wood-screws used to mount the striker plate to the body of the car.

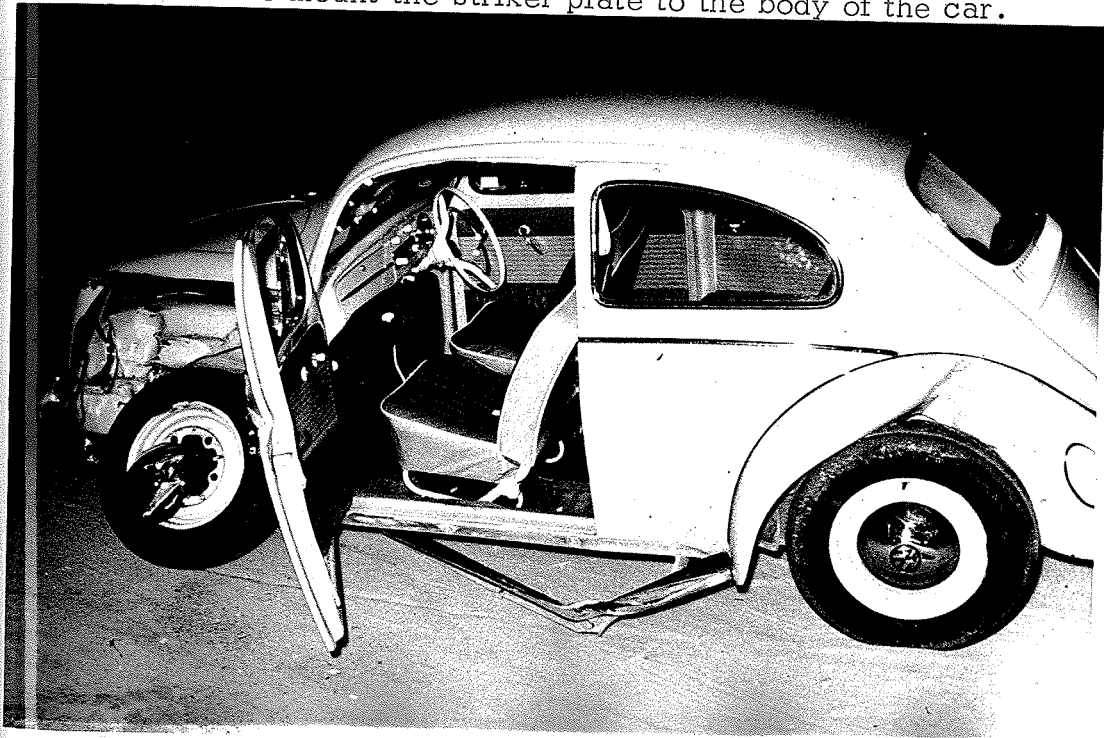
Fig. 12.13

The door of this 1960 Volkswagen came open during a collision with another car at an intersection.

12.20 One other model which appeared often enough (41 cars) in this survey to make this type of investigation feasible was the Volkswagen 1200 sedan. This car has only two doors, the locks having no form of longitudinal restraint. 11 per cent of all Volkswagen doors came open in these accidents, e.g. Fig. 12.13. This is a little worse than the early model Holdens for which the figure was 8.9 per cent.

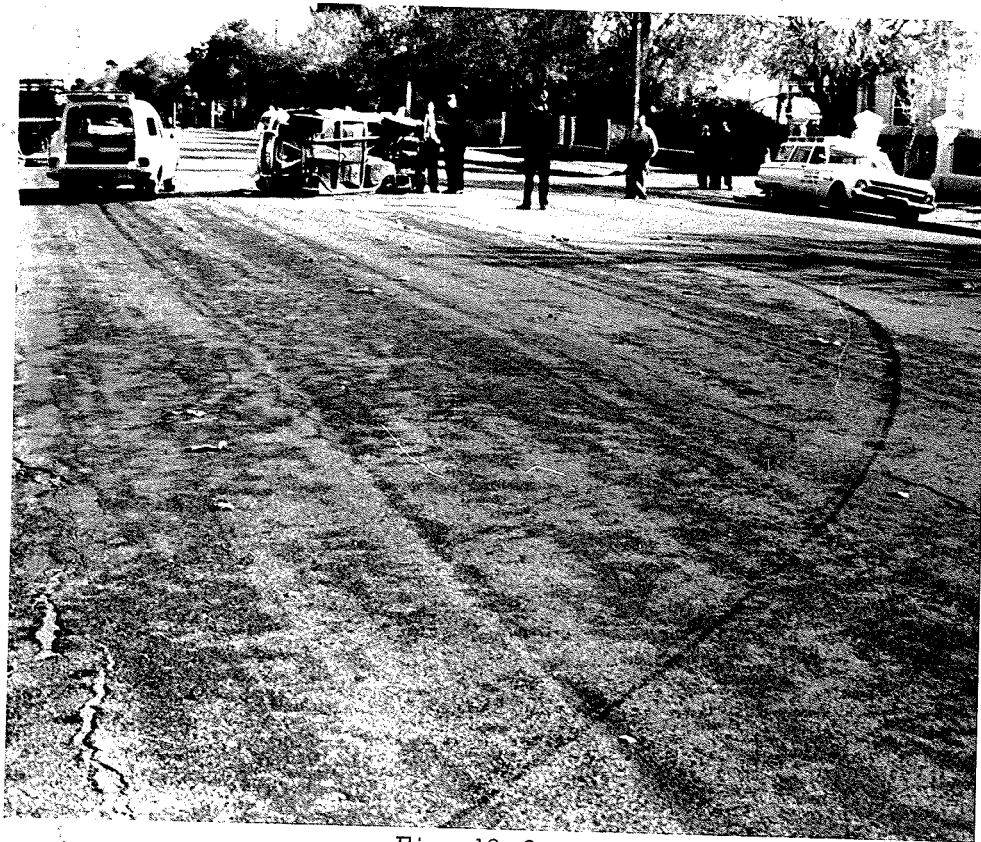
Fig. 13.3

The driver of this 1962 Renault Dauphine swerved to the left to avoid a vehicle on his right at an intersection. His car skidded and rolled over.
