ENGINEERING ASPECTS

TRAFFIC ACCIDENTS

ADELAIDE, SOUTH AUSTRALIA.

A thesis presented for the degree of Master of Engineering of
the University of Adelaide, based on work in the Traffic Accident
Research Unit of the Department of Pathology of the University
of Adelaide.

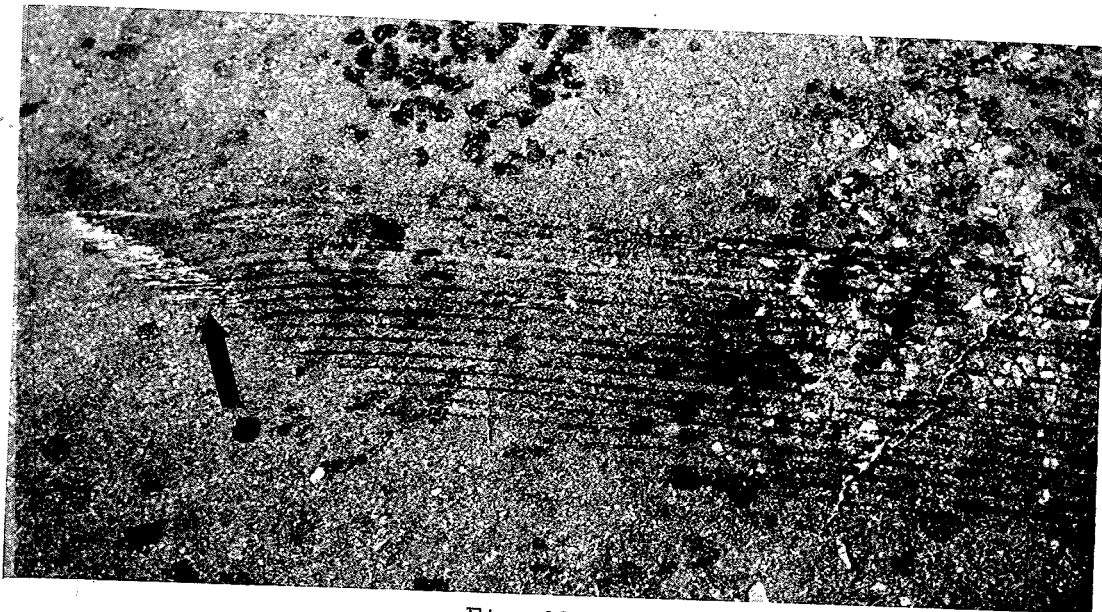
Fig. 13.4

The arrows indicate the ends of the skid marks made by the 1959 Ford Zephyr as it slid sideways before rolling and after being struck on the left side by another car. The braking skid marks of the other car can be clearly seen.

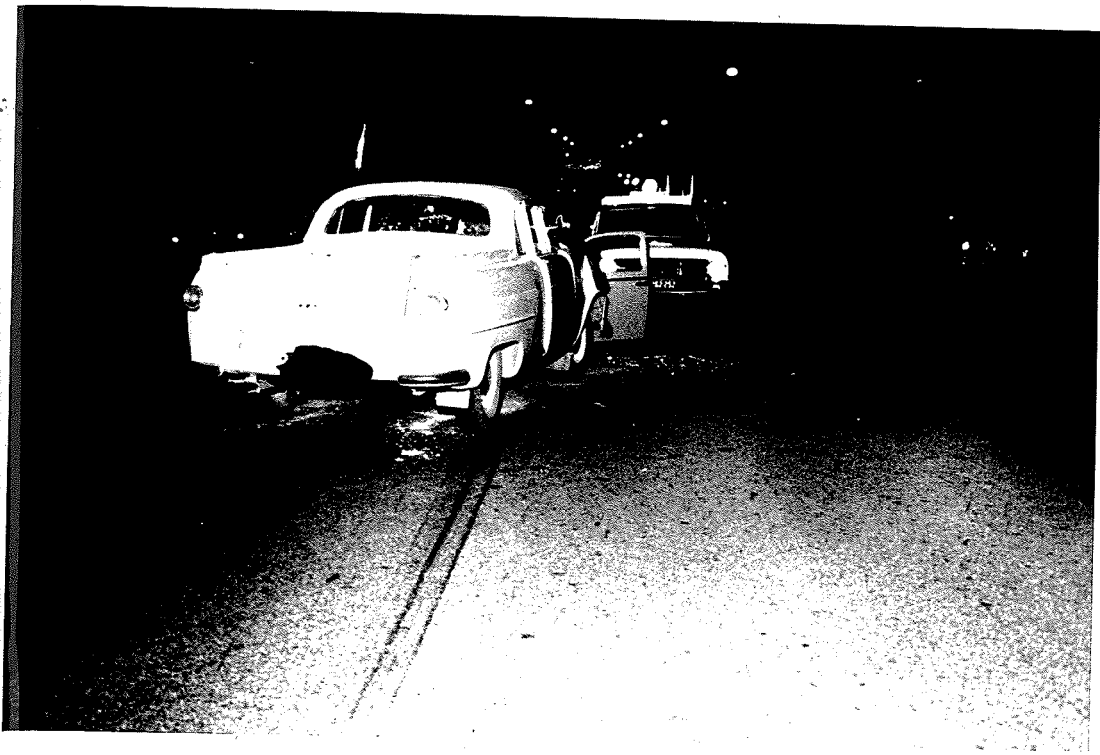
Fig. 13.7
Skid marks due to braking. This accident is also shown in Figure 8.2.

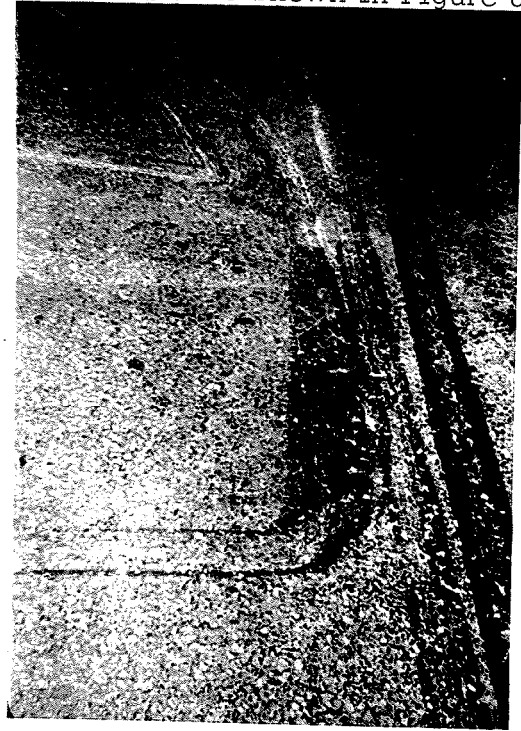
Fig. 13.8
The braking skid marks referred to in the text are those on the right. The car on the left was pushed sideways by the impact.

13.7 In an emergency, when it is necessary to stop in as short a distance as possible, it is therefore desirable not to lock the wheels, to achieve maximum braking and retain effective steering control. There are devices which will permit a driver to brake as hard as he can and yet not lock the wheels (Ref. 67). These have not yet found ready acceptance by the automobile industry. There may be some drivers who, in an emergency, can stop a car in the most efficient manner, i.e. braking as hard as possible without locking the wheels. I suspect that such people are few and that virtually all drivers will brake so hard that their vehicle is likely to skid in an emergency stop. The braking skid marks shown in Fig. 13.8 were made by an experienced racing driver.

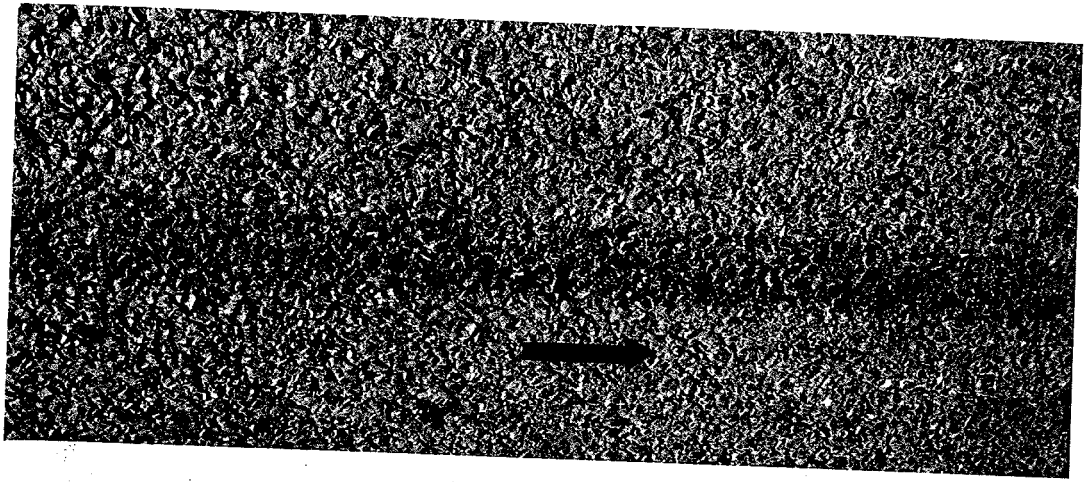
Fig. 13.9
Braking skid marks.

13.12 A stopping distance of 22 yards from 30 m.p.h. on a dry, clean bitumen surface is most surprising. The particular surface is shown in Figs. 13.9 and 13.10 and the poor skid resistance is apparently due to the large aggregate being coated with bitumen, which is melted by the heat generated by the tyre sliding over it. The resulting skid mark is a molten tar mark and not an abraded rubber mark. The vehicle is in fact sliding on molten tar. This surface is a basecourse for the final layer of hot mix. As there often seems to be a delay of some months before the final layer is applied signs should be displayed warning motorists of the slippery surface.

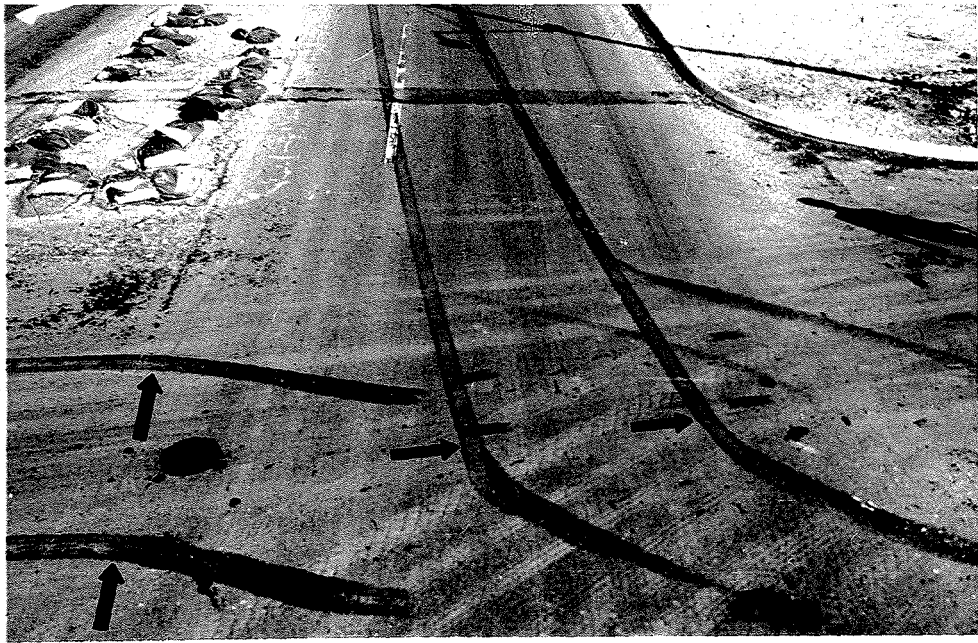
Fig. 13.11
Collision between a bus and a car. The arrows indicate the positions of the front wheels on impact.

13.24 Skid marks on the road convey much more information than merely an indication that a vehicle has skidded. Figure 13.8 shows that one car has been knocked sideways on impact. The position of the wheels on impact is often very clearly defined (Fig. 13.11). As was noted above, all steering control is lost when a vehicle skids. If all four wheels lock a car will continue straight ahead. The only deviation, if any, will be due to the car sliding down the camber of the road or to irregularities in the road surface. The sharp deviation in the skid marks running down from the top of Figure 13.11 is due to the impact of a bus from the left of the picture. Note that the deviation in the skid marks made by the bus is

13.26 The post-impact path of a car may also be clearly shown by its skid marks. In Figure 13.11 the car, which was struck on the right side, has been pushed sideways while still retaining some forward motion. The resulting path is as shown. Note that the back wheels, which were tracking behind the front wheels, before the impact, have followed paths that are parallel to but separate from the front wheels after impact. If the track and wheelbase of the car are known it is possible to determine the position of the car at any point along its skid marks. This can be of great assistance when trying to find out what was happening to a car at the moment when, for example, an occupant was ejected. This method has shown that ejection of a car occupant, through a door of the car, often occurs as the car slides sideways after a collision.

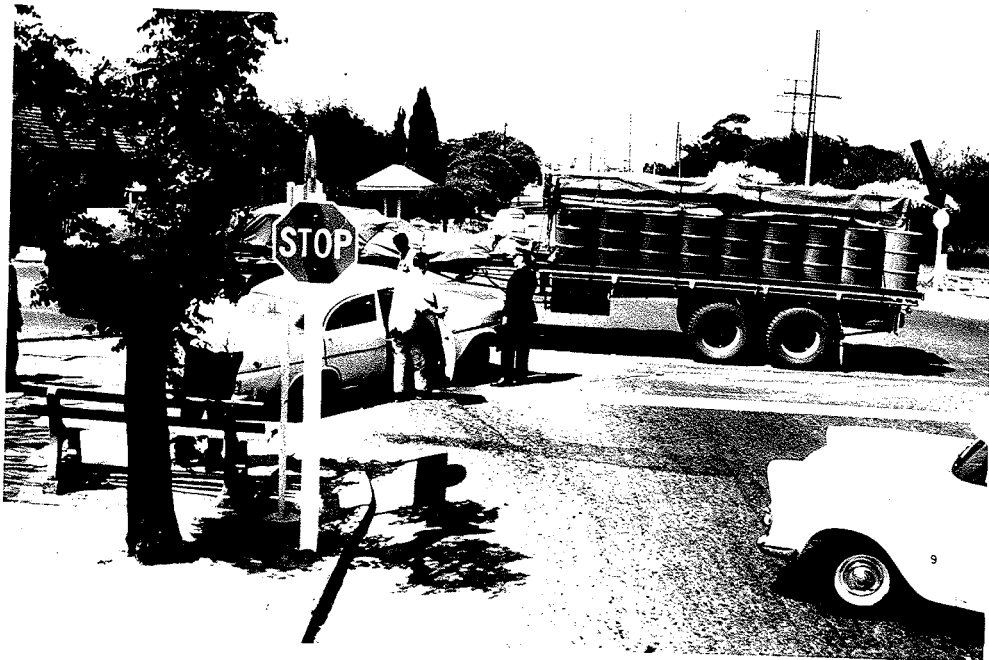
Fig. 14.1

Stop signs: this semi-trailer was unable to slow down sufficiently to avoid hitting the car which had moved off from the stop sign (arrow) on the far side.

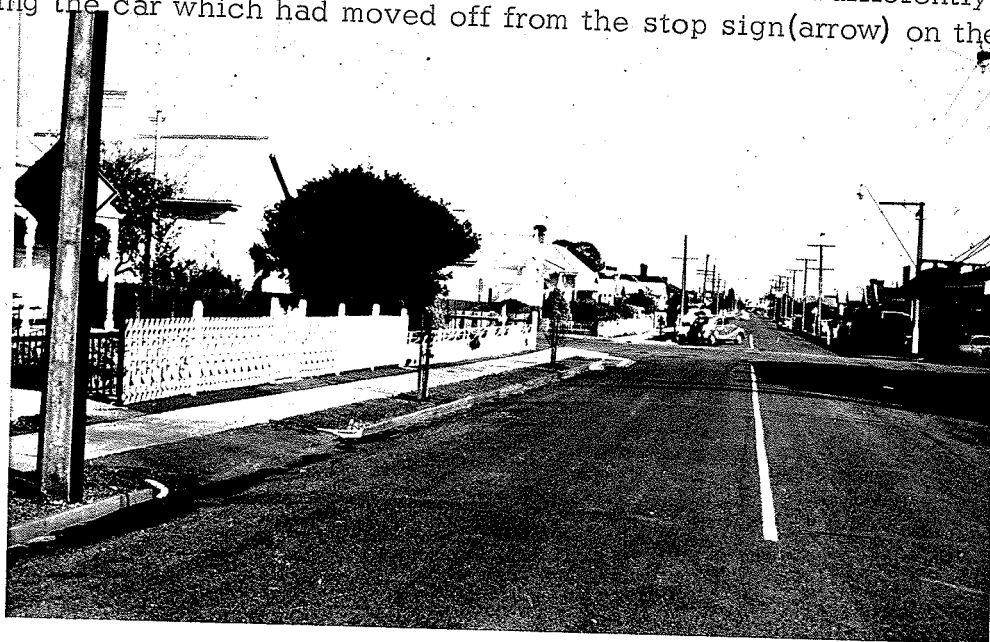
Fig. 14.2

Note the cross-road warning sign hidden by the utility pole. The car in the distance had just been pushed back onto its wheels after being rolled over in a collision.

14.7 Maintenance of signs is important, and this includes such details as cutting back foliage to ensure that the sign is not hidden from the motorist. A far more original attempt to fool the motorist is shown in Fig. 14.2, in which a utility pole has been placed directly in front of a cross road warning sign (the car at the intersection had just been rolled back onto its wheels after a collision).

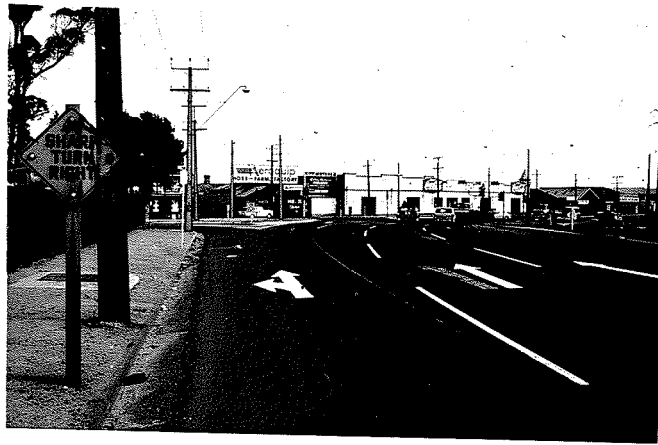
Fig. 14.3
Warning sign left in
position after changes
to the road layout.

14.8 Redundant signs are also obviously undesirable, e.g. Fig. 14.3. If drivers become accustomed to ignoring a sign such as this they may

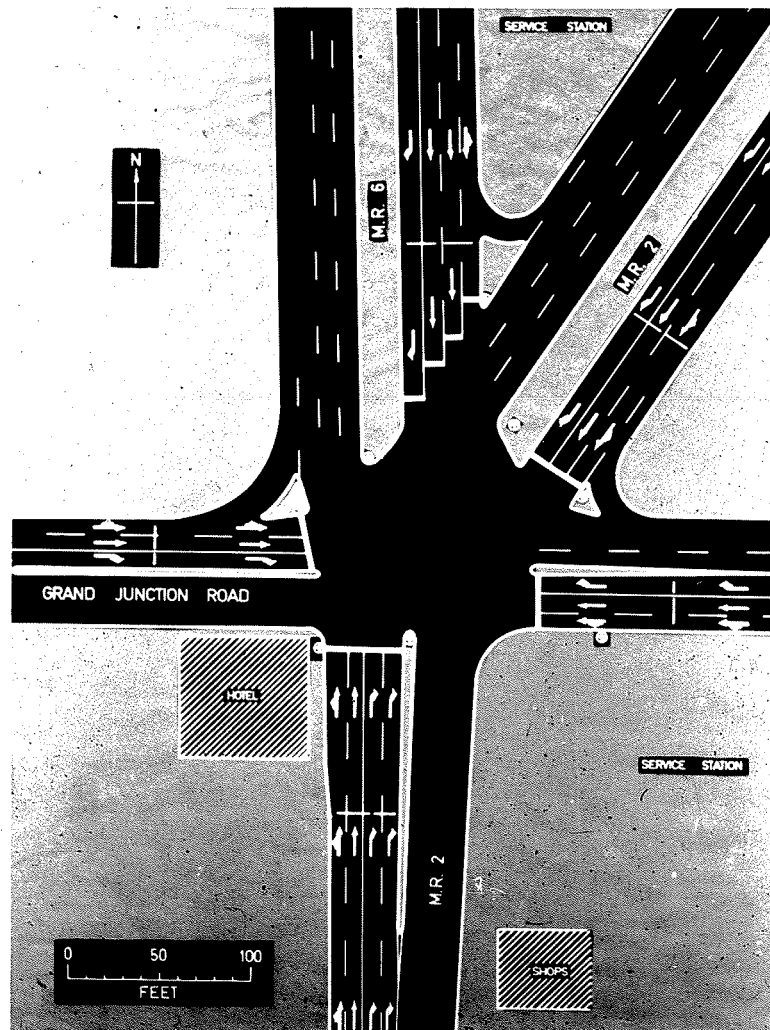
Fig. 14.4
Gepps Cross intersection.

14.13 Curiously enough the intersection attended most frequently in the course of this survey is controlled by traffic lights. This is Gepps Cross, which is situated near the northern boundary of the Adelaide metropolitan area (Fig. 14.4).

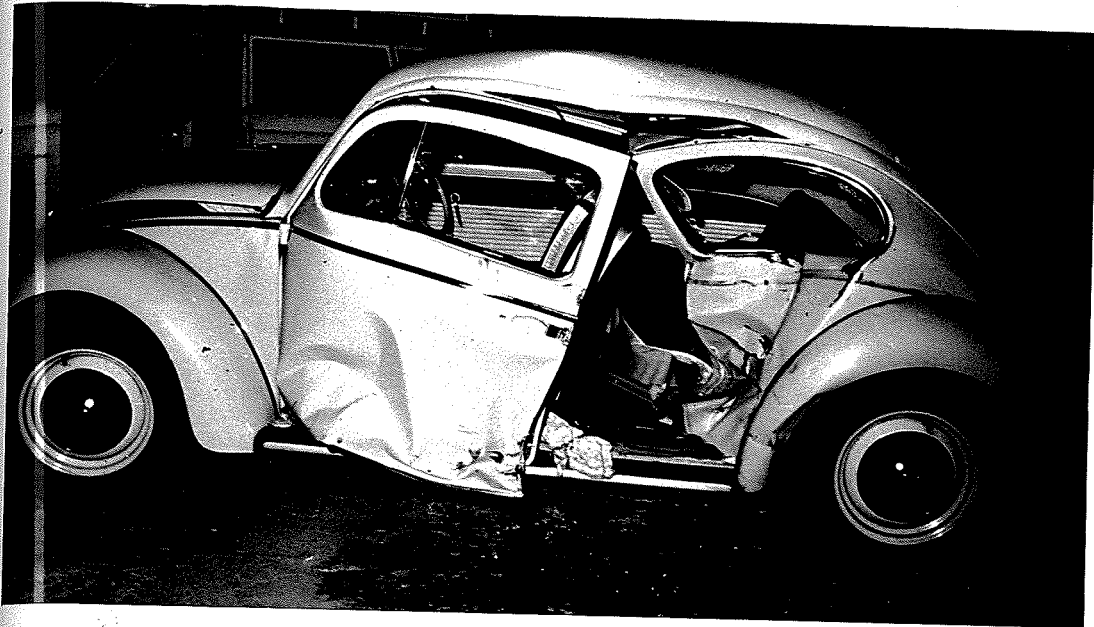
Fig. 14.5
The Volkswagen 1200 Sedan from accident 0320.

0320 A Volkswagen 1200 sedan was stationary, facing south, at the traffic lights on M.R.2. When the lights changed to green this car moved off and began to bear right to continue on along Grand Junction Road. An FE Holden sedan entered the intersection from the south at about 30 m.p.h. after the lights had turned green. This car was proceeding straight ahead, to enter M.R.6. Neither driver saw the other car until just before the left front corner of the Holden struck the left side and rear wheel of the Volkswagen, which was moving at about 20 m.p.h. The Volkswagen was spun twice by the impact and the front seat passenger, a 48 year old woman, was ejected. She was concussed and also received many abrasions and injured the small vertebrae at the base of her spine. The passenger in the left rear seat, a 19 year old girl, received concussion, abrasions and bruises. The driver's face was lacerated on the left side. The 20 year old man driving the Holden was not injured. The damage to the left side of the Volkswagen is shown in Figure 14.5. This accident happened on a fine, clear night.
