Evaluation of the use of 80 km/h advisory speed signs on unsealed roads in South Australia

CN Kloeden

CASR REPORT SERIES

CASR130

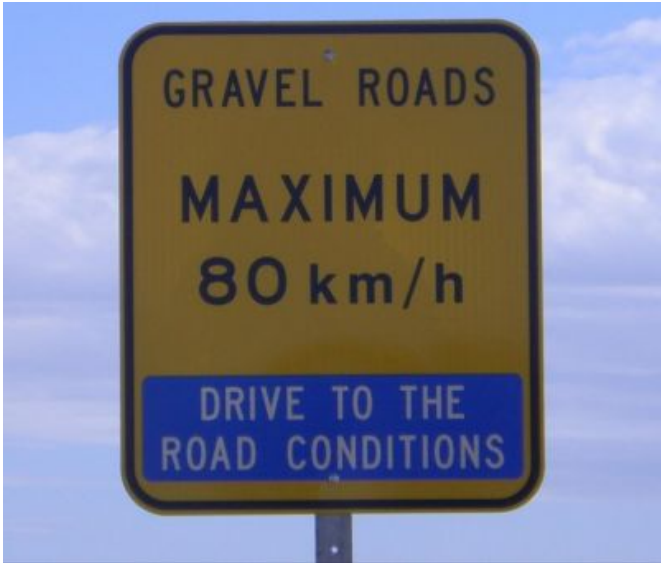
Figure 2.2
Advisory speed sign

Advisory speed signs were erected in November 2014 at each end of the affected roads or at the start of sections of road with speed limits above 80 km/h. An example sign is shown in Figure 2.2.

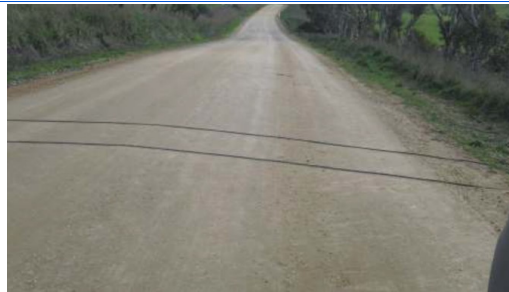
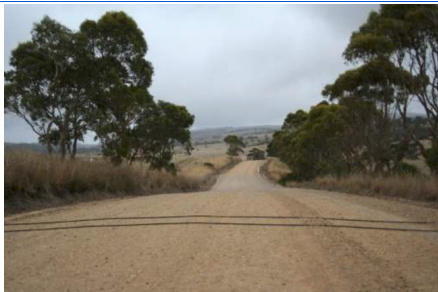
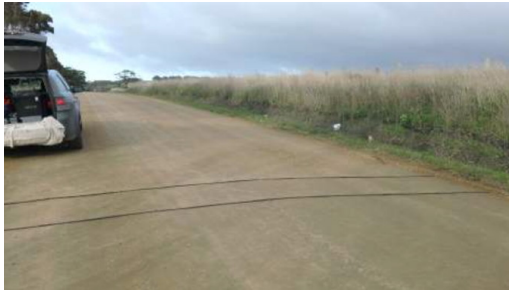
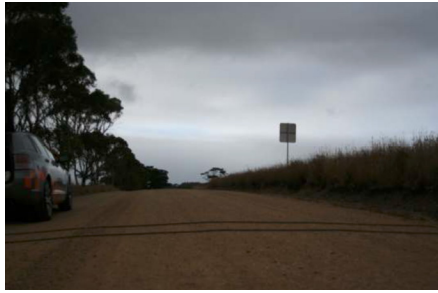
Site US01 - Bald Hills Road

June 2014	January 2015
Looking North

Looking South

Site change comment from data collector		Very similar to last time.
North Bound Traffic Speeds

ID	Road Name	Changes in road surface from 2014 to 2015
US01	Bald Hills Road	Similar
US02	Fork Tree Road (Reservoir Road end)	Similar - less loose material
US03	Fork Tree Road (Southern end)	Similar - less loose material, some extra pot holes to East
US04	Hay Flat Road (Abattoir end)	Fewer pot holes
US05	Hay Flat Road (Mid site)	Fewer pot holes
US06	Hay Flat Road (Southern end)	Similar
US07	James Track (after Martins Road)	Less loose material and fewer pot holes
US08	James Track (Mid site)	Less loose material and fewer pot holes
US09	James Track (Northern site)	Fewer pot holes
US10	Myponga Beach Road	Similar
US11	Rowely Road (East end)	Similar - more rutting
US12	Rowely Road (West end)	Similar

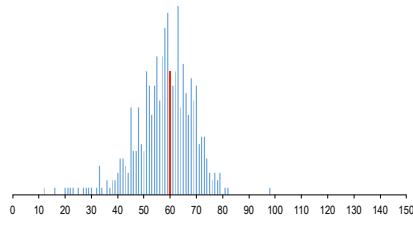
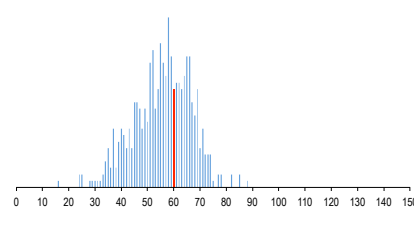
<p>Mean speed = 57.96</p>

<p>Mean speed = 55.65</p>
South Bound Traffic Speeds

Location	Jun 2014	Jan 2015	Change	Changes in road surface from 2014 to 2015
US01N	57.96	55.65	-2.31	Similar
US01S	57.59	56.26	-1.33	Similar
US02E	63.77	63.05	-0.71	Similar - less loose material
US02W	64.32	61.47	-2.84	Similar - less loose material
US03E	66.57	63.46	-3.11	Similar - less loose material, some extra pot holes
US03W	68.07	63.83	-4.24	Similar - less loose material, some extra pot holes
US04N	76.13	79.94	3.81	Fewer pot holes
US04S	73.78	72.97	-0.81	Fewer pot holes
US05N	60.55	64.54	3.99	Fewer pot holes
US05S	61.77	63.51	1.74	Fewer pot holes
US06N	63.42	62.13	-1.28	Similar
US06S	66.19	62.30	-3.89	Similar
US07E	60.82	59.85	-0.97	Less loose material and fewer pot holes
US07W	58.92	58.01	-0.91	Less loose material and fewer pot holes
US08N	61.79	65.68	3.88	Less loose material and fewer pot holes
US08S	61.13	68.97	7.84	Less loose material and fewer pot holes
US09N	67.08	68.80	1.72	Fewer pot holes
US09S	69.74	67.75	-1.99	Fewer pot holes

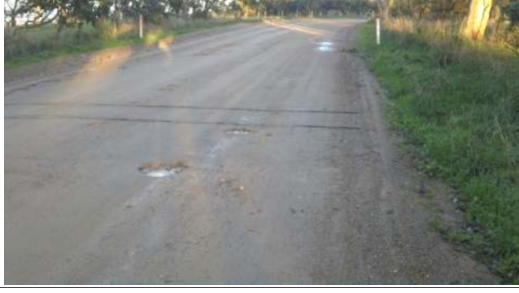
Site US02 - Fork Tree Road (Reservoir Road end)

June 2014	January 2015
Looking East	 	 
Looking West

Site change comment from data collector		Less loose material compared to last time. However road length generally in similar condition to last time.
East Bound Traffic Speeds	  <p>Mean speed = 63.77</p>

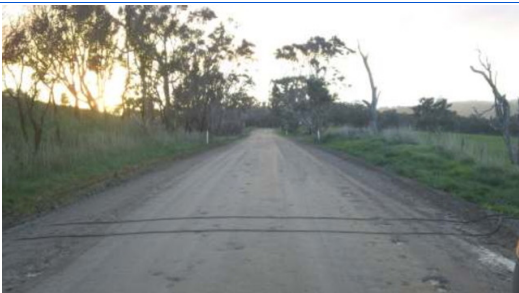
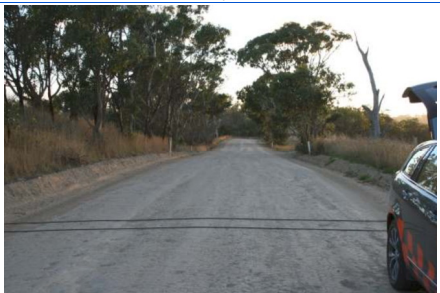
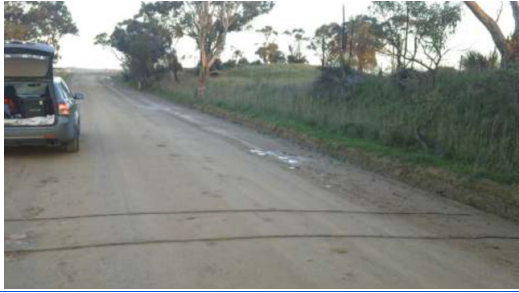
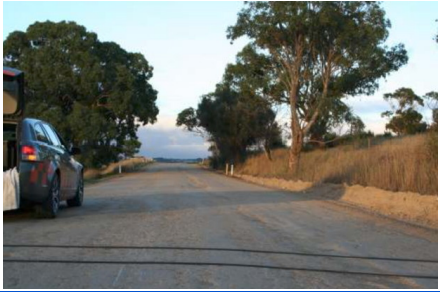
Site US03 - Fork Tree Road (Southern end)

June 2014	January 2015
Looking East

Looking West

Site change comment from data collector		Site similar to last time. Less loose gravel. Pot holes in the immediate area similar. Some significant longitudinal pot holes to the west which are expected to impact speeds.
East Bound Traffic Speeds

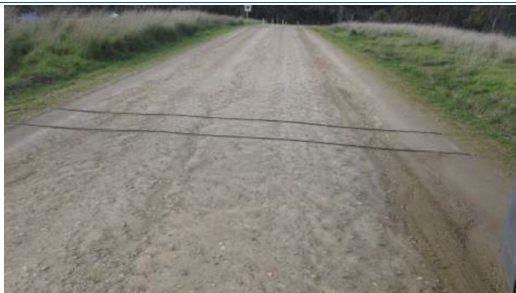
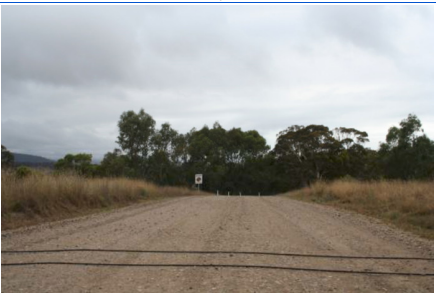
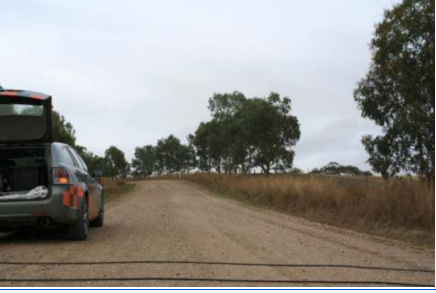
Site US07 - James Track (after Martins Road)

June 2014	January 2015
Looking East

Looking West

Site change comment from data collector		Less loose gravel and less pot holes compared to last time. Not really conducive to higher speeds.
East Bound Traffic Speeds	  <p>Mean speed = 60.82</p>

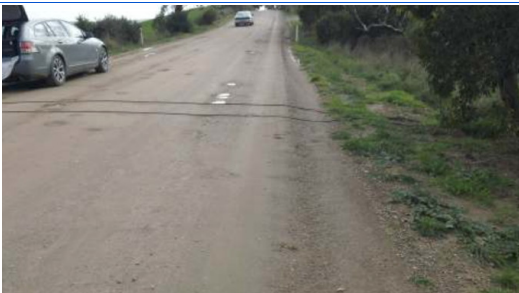
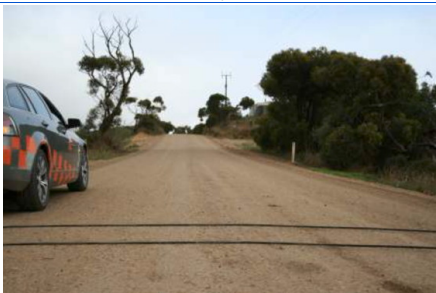
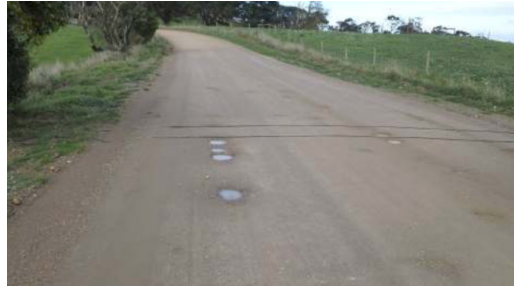
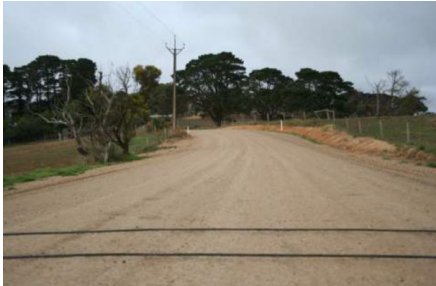
Site US09 - James Track (Northern site)

June 2014	January 2015
Looking North

Looking South

Site change comment from data collector		Less pot holes compared to last time. May contribute to higher speeds.
North Bound Traffic Speeds

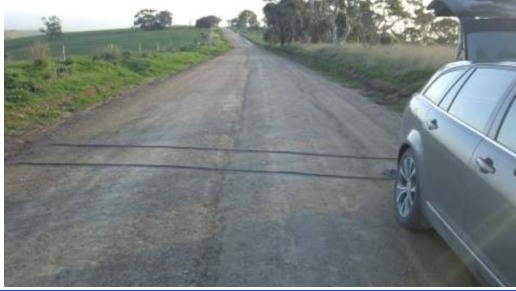
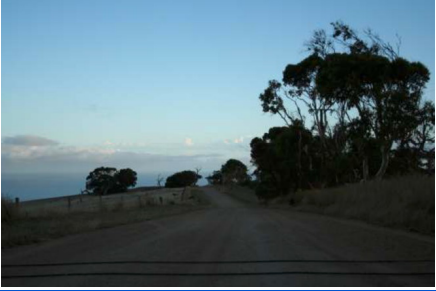
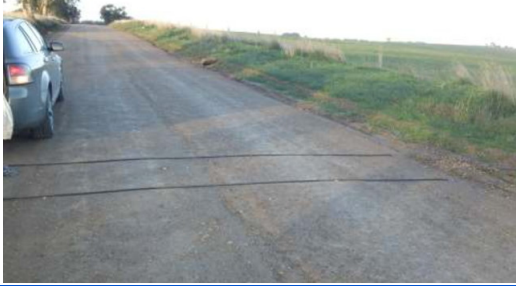
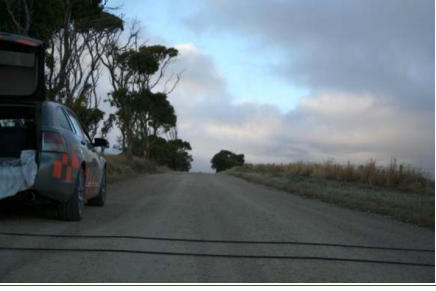
Site US10 - Myponga Beach Road

June 2014	January 2015
Looking North

Looking South

Site change comment from data collector		Similar to last time.
North Bound Traffic Speeds
